# CTV Building Collapse Investigation

# How and Why?

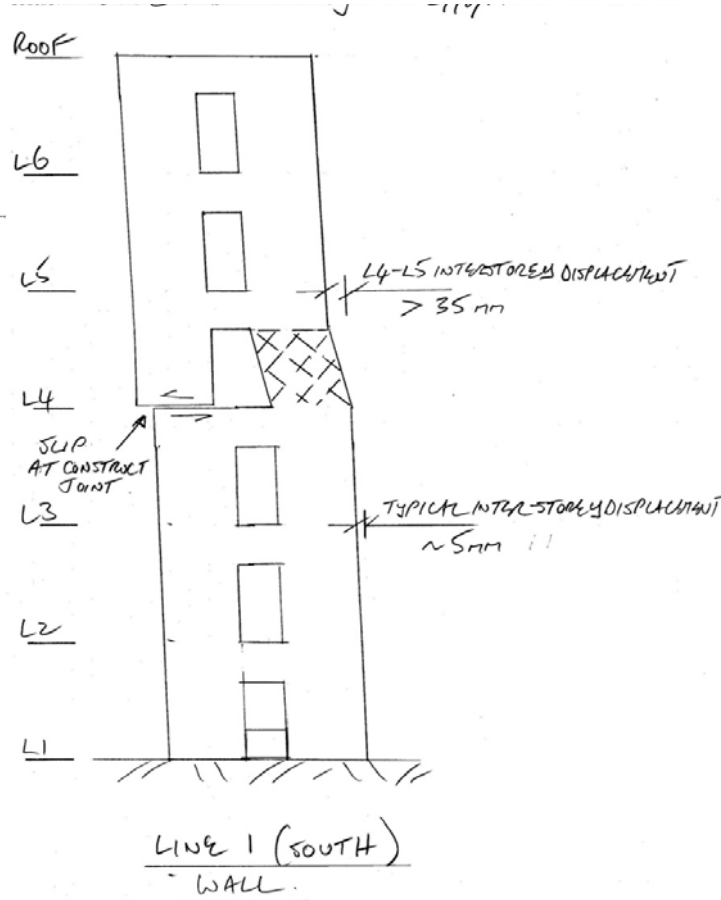
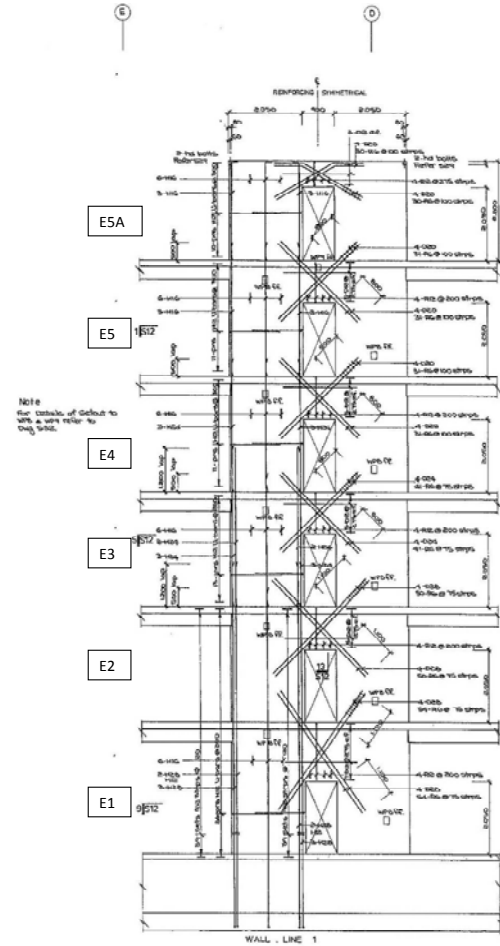
# Torsional Soft Storey L4 to L5

- Sliding shear failure in South Wall (Line 1)
  - West panel construction joint slip
  - East panel takes double shear
  - East panel yields, elongates and loses strength in shear
  - L4 to L5 Inter-storey displacement increases
  - Shear demand below L4 capped

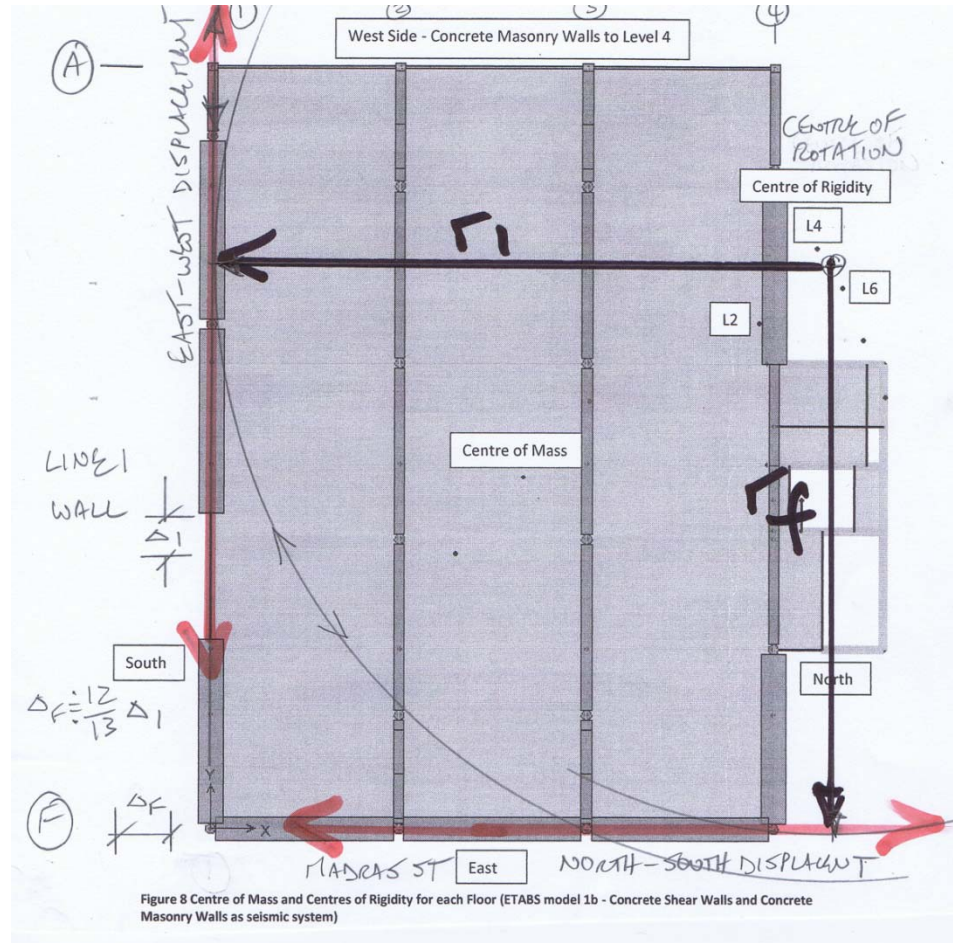
# Rotational Displacements

- Many columns form 2 flexural hinges
  - Top and bottom
  - Won't collapse if axial capacity adequate
  - Shear demands redistribute to shear walls
- Madras St columns for 3 hinges at L4 to 5
  - Rotational displacement effect
    - Displacement east-west on South wall (Line 1)
    - Same displacement north-south on Madras St (Line F)

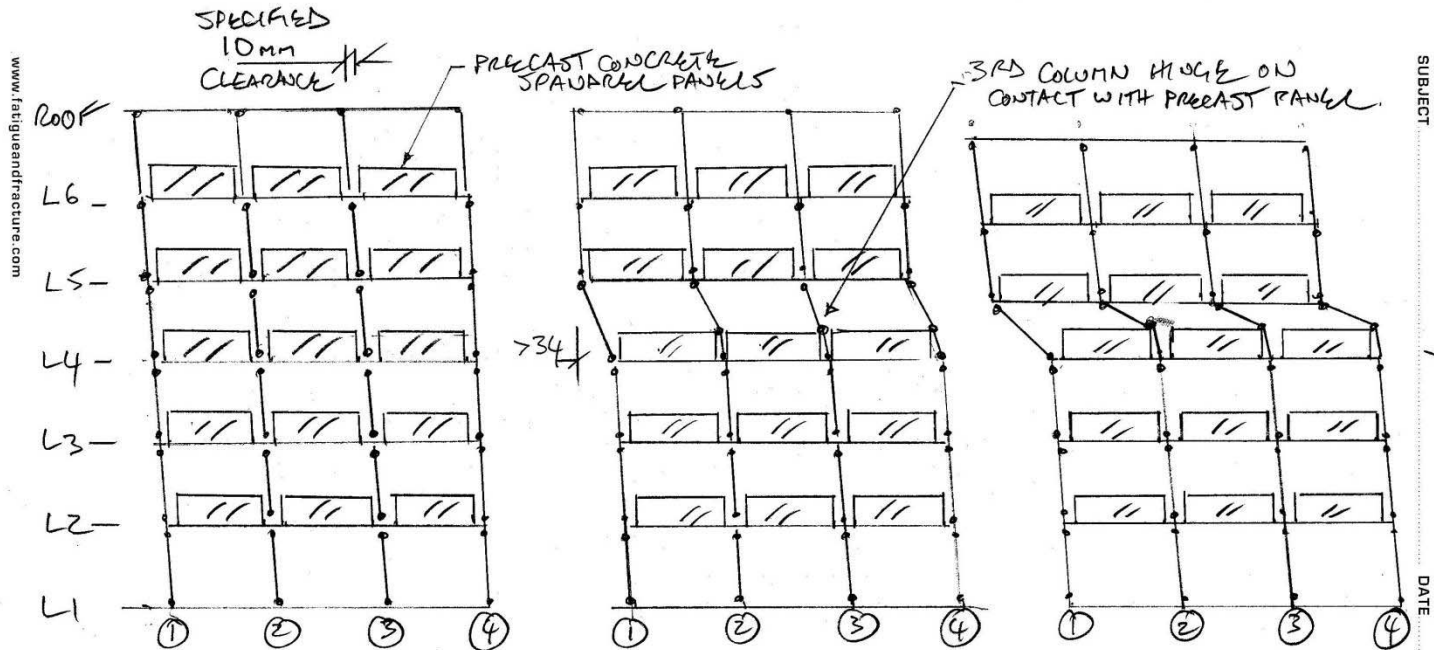
# Madras St Columns Collapse

(A) INTERSTOREY DRIFTS  $< 34\text{mm}$  COLUMN HINGES TOP & BOTTOM

(B) SOFT STOREY DRIFT  $> 34\text{mm}$   
 3RD HINGE DEVELOPS AT L4 TO L5 COLUMNS ON CONTACT WITH SPANDREL PANELS

(C) COLLAPSE INITIATES IN LEVEL 4 TO 5 COLUMNS
