CTV Building: Site Examination and Materials Tests

For: Department of Building and Housing

21st July 2011

DBH 110329 CTV Building: Site Examination and Materials Tests (Interim)

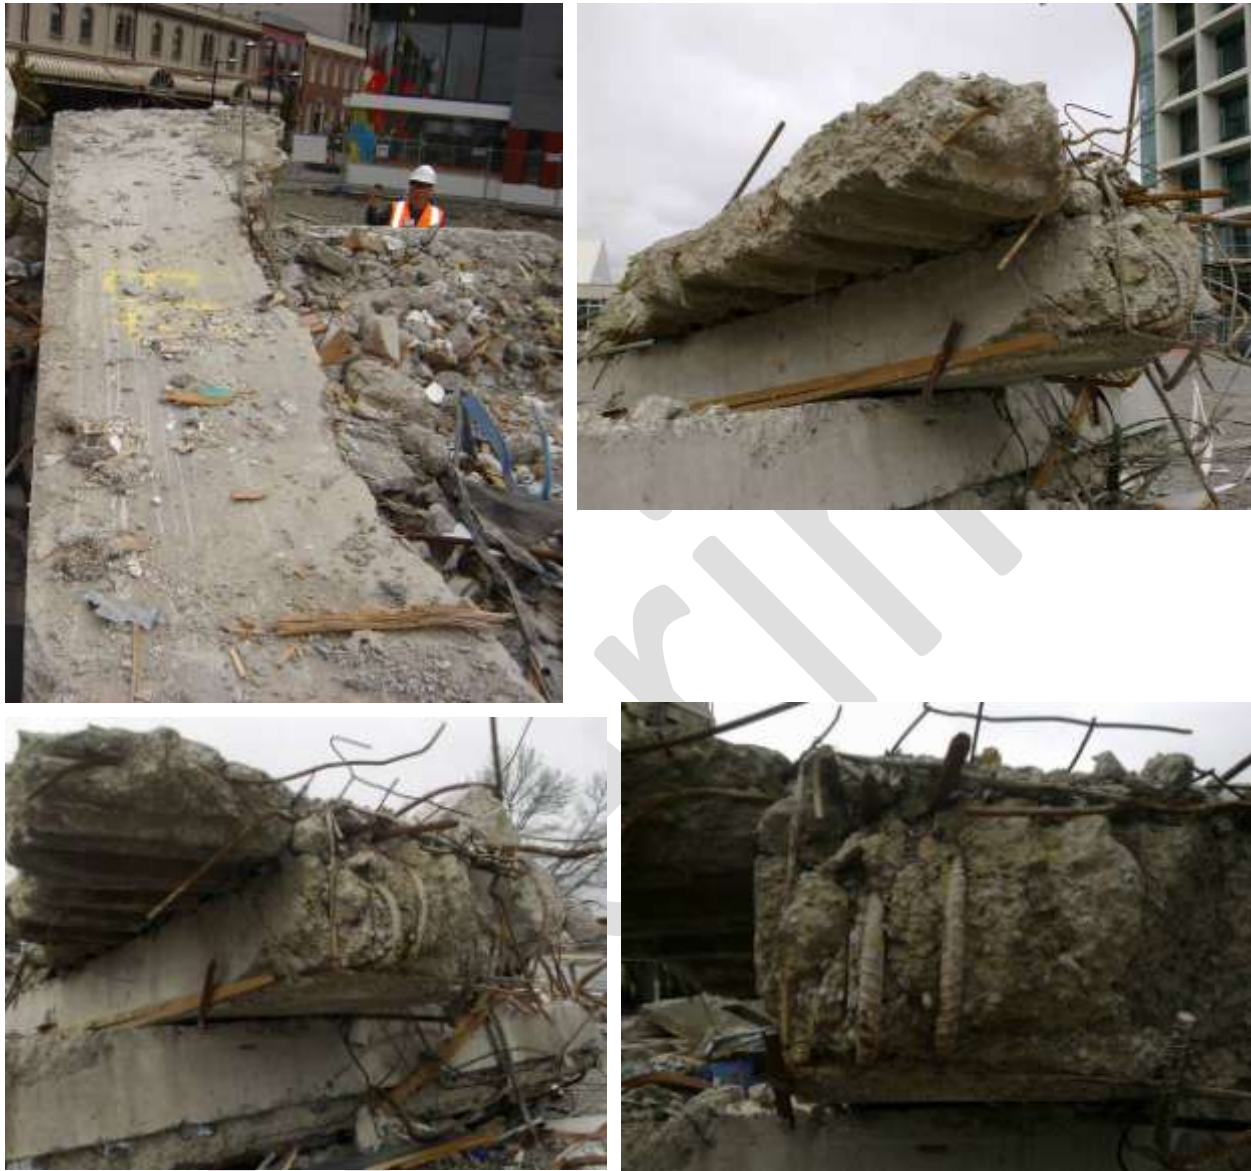
ii. Grid 4/B-C : Item E14

Figure 5 Pre-cast shell beam (Item E14) from northern face Grid 4, west side of lift core (DENG B23 Dwg S18 (Figure 59)). (clockwise from top left) a) Top face with slab fracture along edge of shell beam, extending out further at far end adjacent to lift core attachment; b to d) Fractured slab outstand remnant at east end from which slab concrete cores were extracted. The bottom H24 bars from shell beam have been turned back into the concrete infill rather than embedded in shear wall as specified (DENG Detail 5 Dwg S19). Refer also bar imprint on wall at the connection seen in Figure 22 at Level 4 and Figure 23 at Level 3.

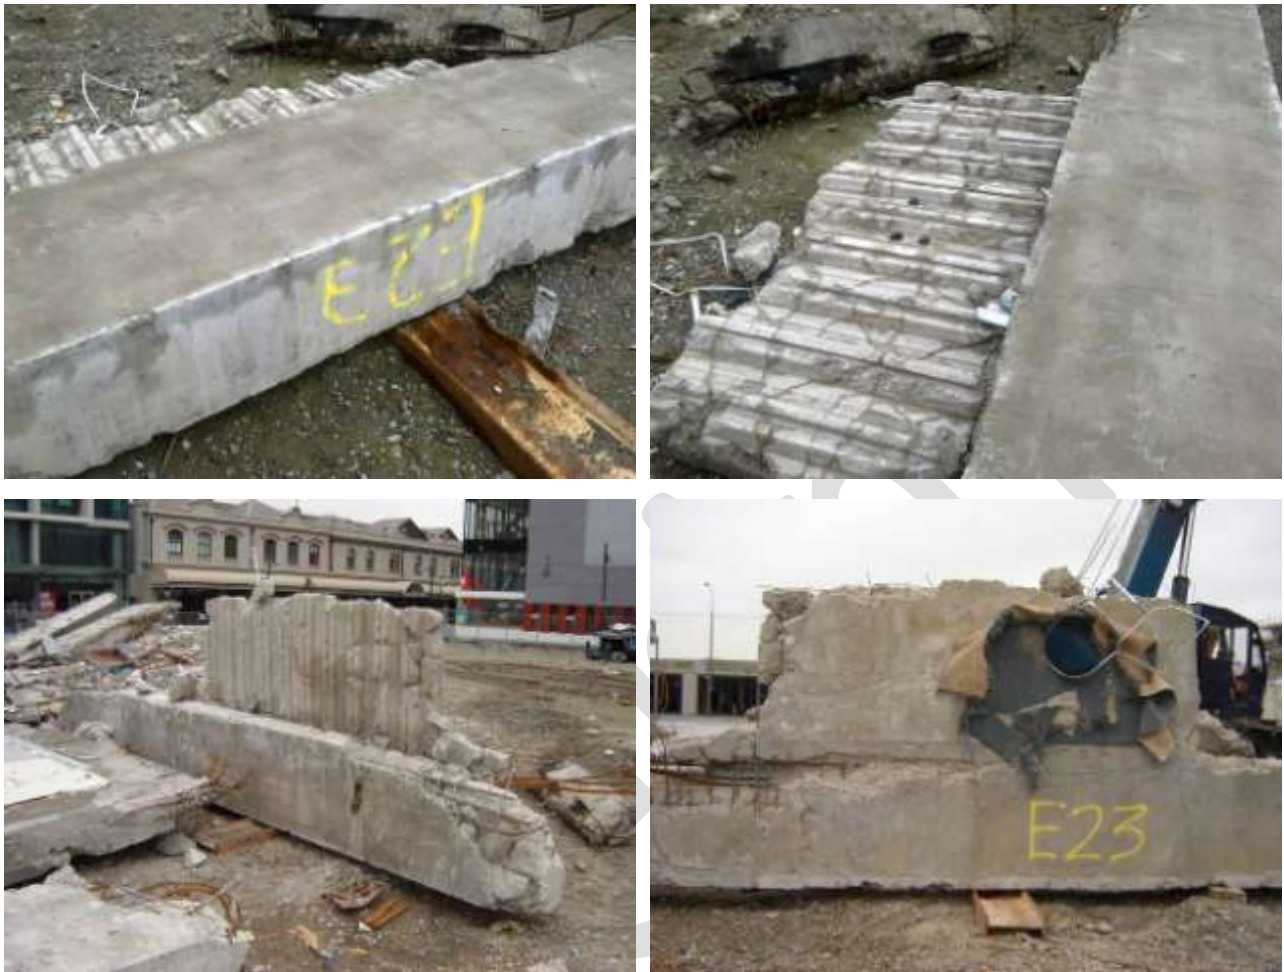
iii. Item E23

Figure 6 Edge Shell Beam (Item E23) from Line 1 or 5. (Clockwise from top left) a) Underside and outer face; b) Underside showing 1200 mm slab outstand with metal decking pulled away and diagonal cracking indicating shear in diaphragm; Holes are where concrete cores were taken for testing c) Carpet remnant on top of slab; d) Damaged shell beam.

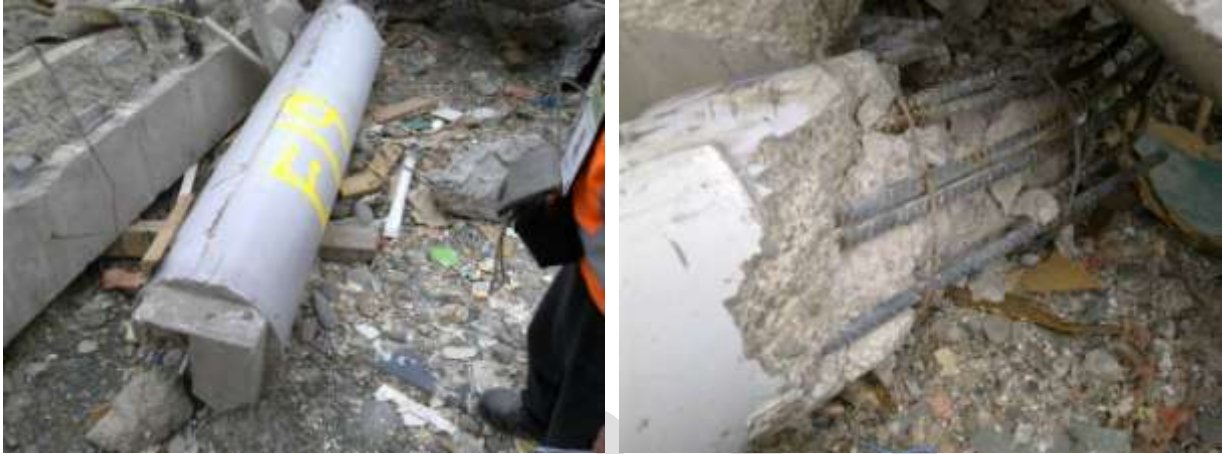
i. Item E19

Figure 7 400 mm diameter column Item E19. (Left to right) a) Level 6 to Roof, likely location Grid F (Figure 57) based on roof steelwork hold down attachment detail; b) Flexural fracture at base in lap zone of vertical reinforcing steel. R6 spirals at 250 centres can be seen (Figure 61).

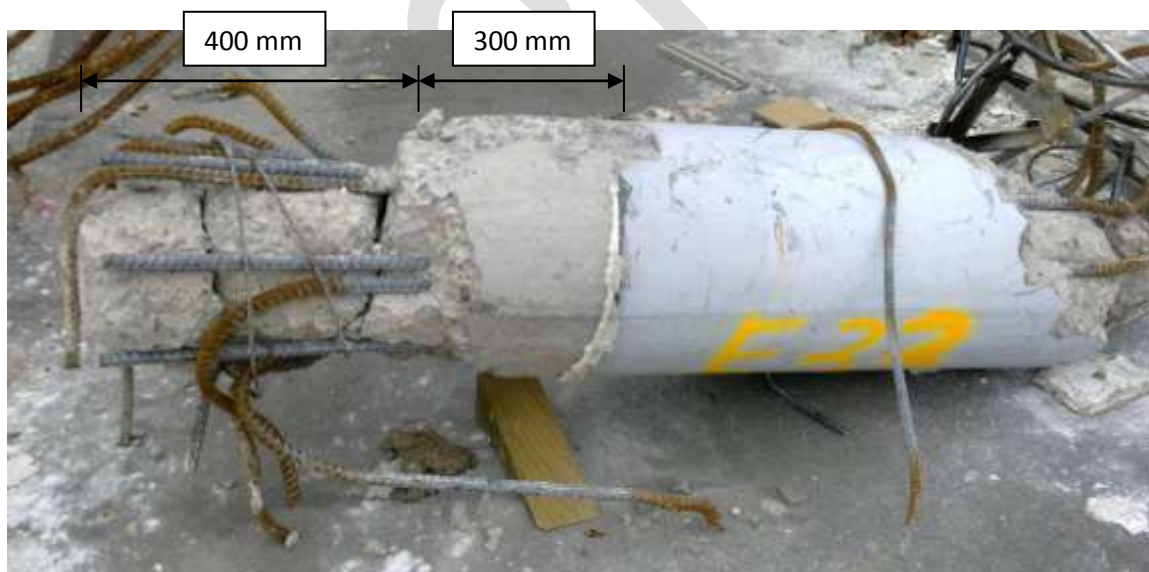
ii. Item E33

The exterior 400 mm diameter column Item E33 had flexural failure at the floor level lap joint of the vertical reinforcing steel and compression-flexural fracture at the upper end of the column (Figure 8).

Figure 8 400 Diameter Exterior Column Item E33. (DENG C5 or C11, Dwg S15 (Figure 61)). Left end is bottom of column at floor level with concrete spalling over lapped vertical reinforcing. Horizontal cracking in core confined by R6 spiral which had fractured. The unpainted portion measured at 700 mm long was protected by spandrel panels (Figure 3, Figure 65 and Figure 66). Right-hand end fracture occurred below beam-column joint.

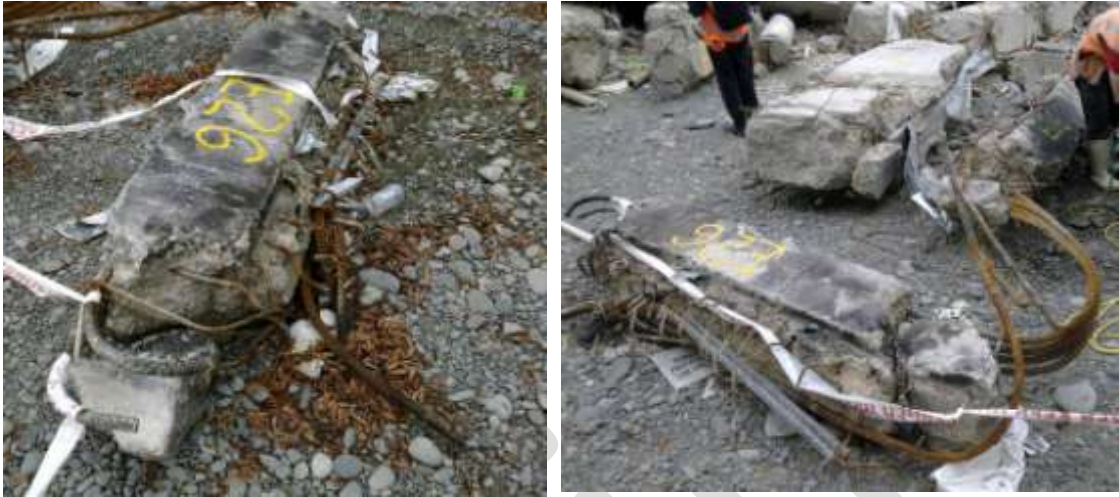
i. Item E26

Figure 9 Interior Pre-cast Log Beam from Line 2 and 3 (DENG Section 3 Dwg S15 (Figure 58)) (left to right) a) Diagonal shear damage at end and smooth formed surface at beam-column joint; b) Mid-portion of beam concrete has broken away and stirrups are pulled apart.

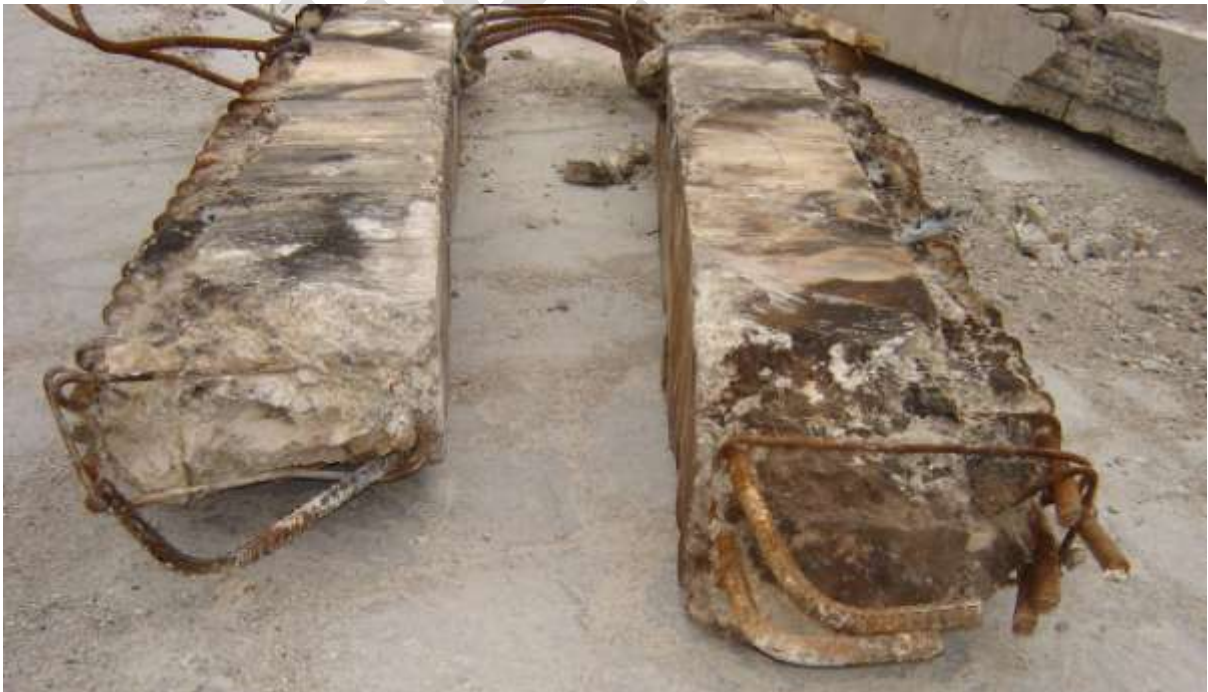
Figure 10 Interior Pre-cast Log Beams from Line 2 and 3 (DENG Section 3 Dwg S15 (Figure 58)) showing smooth concrete formed for beam-column joint and bottom hooked bars that have pulled out of beam-column joints without any obvious straightening; metal decking has pulled away from slab seating; no slab remains attached to the beams

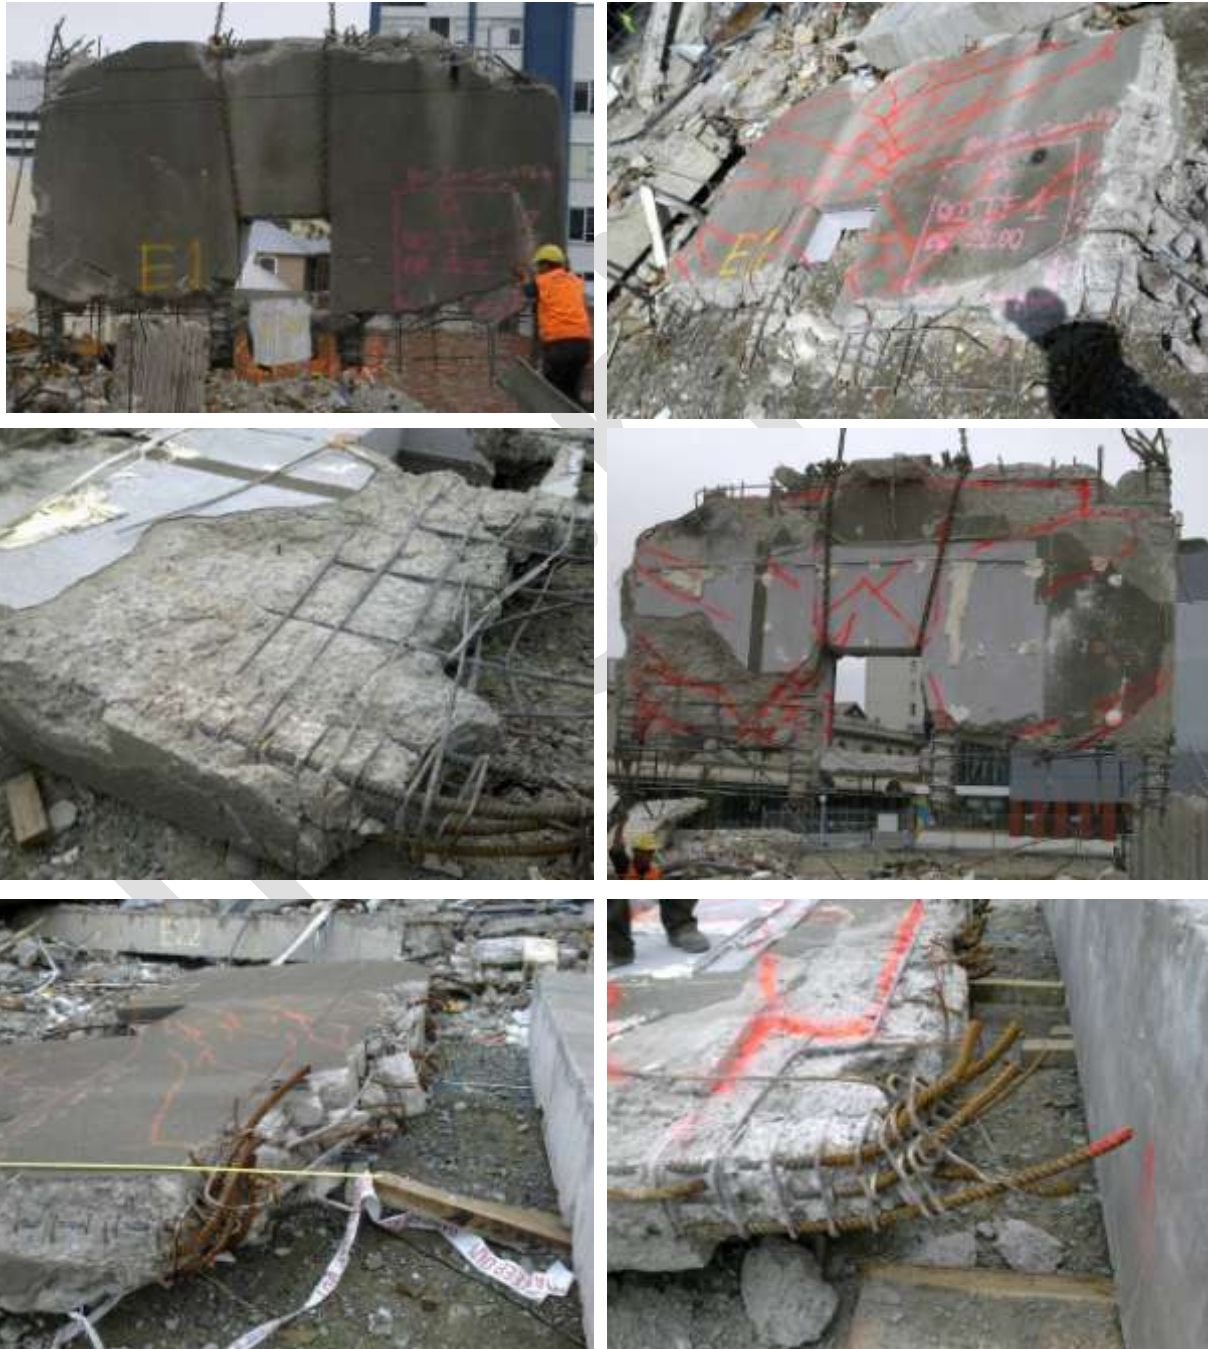
i. Line 1 Wall Level 1 to 2: Item E1

This panel showed flexural cracking patterns typical of cantilever shear walls (Figure 12).

Reinforcing steel taken from the east end of the wall was found to have yielded and elongated prior to the collapse of the building (p.59).

Figure 12 Line Shear Wall (Item E1) (clockwise from top left) a) Outer face of wall with lower portion of concrete removed during deconstruction exposing the reinforcing steel; b) Outer face with cracks highlighted by red paint; c) Inside face with cracks highlighted by red paint; c) Top west corner; d) Top east corner; e) Inside face of east pier

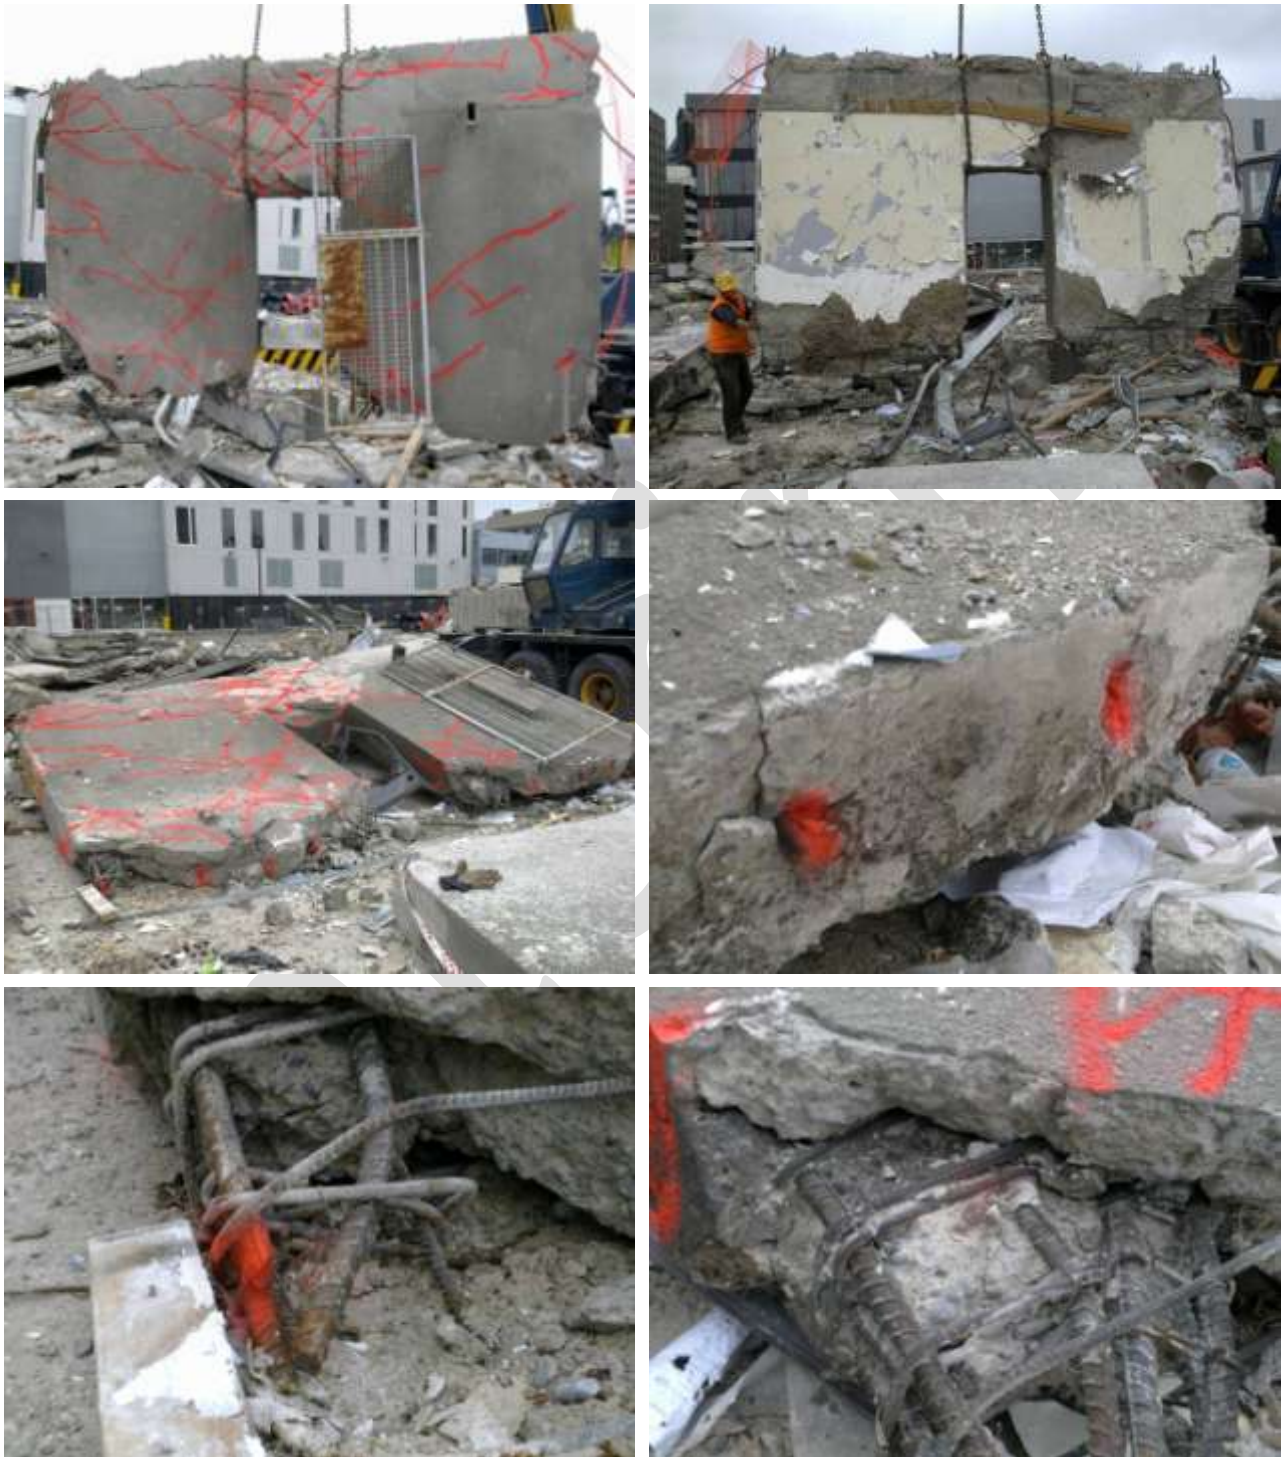
ii. Line 1 Wall Level 2 to 3: Item E2

This panel had diagonal cracking in the piers consistent with cantilever wall behaviour and two way diagonal cracking in the door head coupling beam (Figure 13).

Figure 13 Line 1 Shear Wall Level 2 to Level 3 (Item E2) (clockwise from top left) a) Outside face with fire escape door attached. Cracks marked by red paint; b) Inside face of wall; c) east pier construction joint with necked and fractured bars indicated by red paint; d) Escape door edge of east pier showing thick cover concrete to reinforcing; e) Outer edge of west pier showing necked and fractured bar indicated by red paint others were cut; f) Outer face of wall with cracks and fractured bars marked.

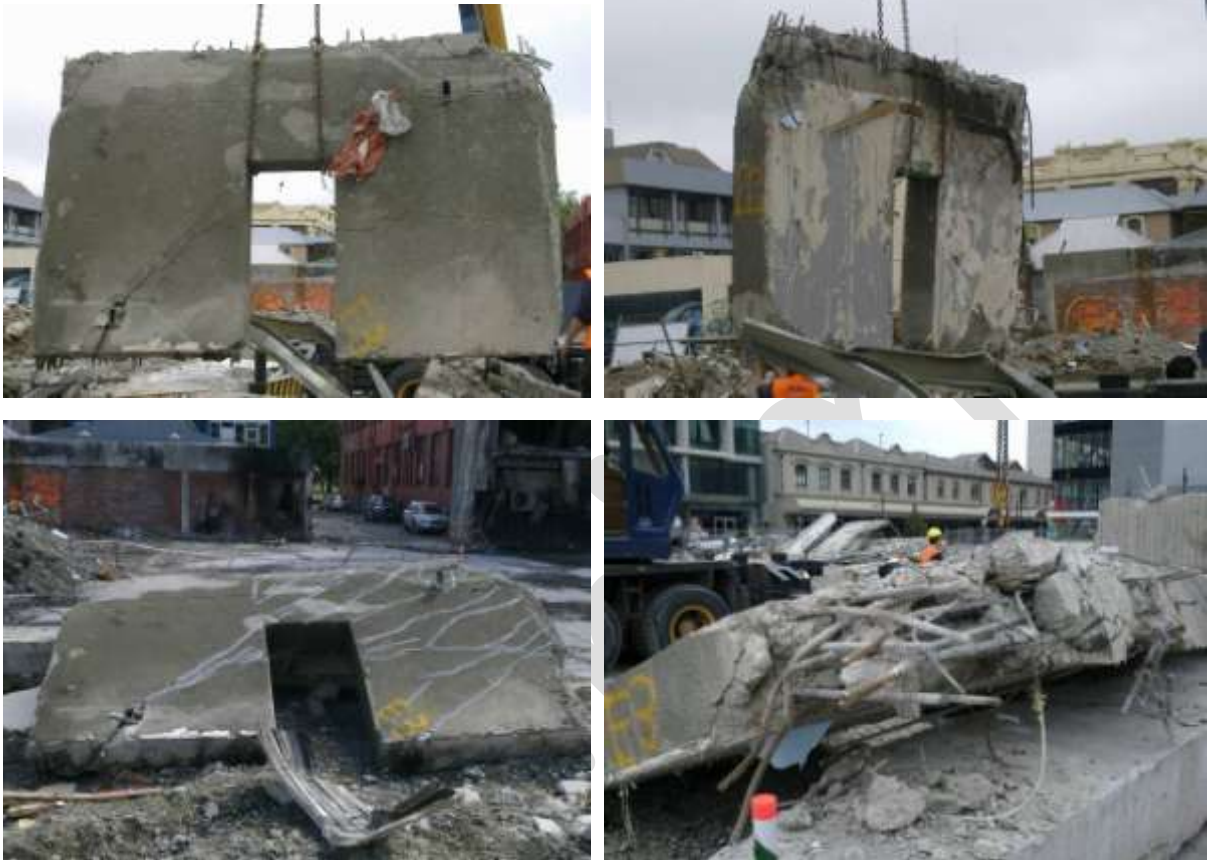
iii. Line 1 Wall Level 3 to 4: Item E3

This panel had dominant uni-directional diagonal cracking running from the bottom west corner to the top east end (Figure 14).

Figure 14 Line 1 Shear Wall Level 3 to Level 4 (Item E3) (clockwise from top left) a) Outer face; b) Inner face; c) Damaged top east corner; d) One way diagonal cracks running from bottom west to top east side marked by paint on outer face.

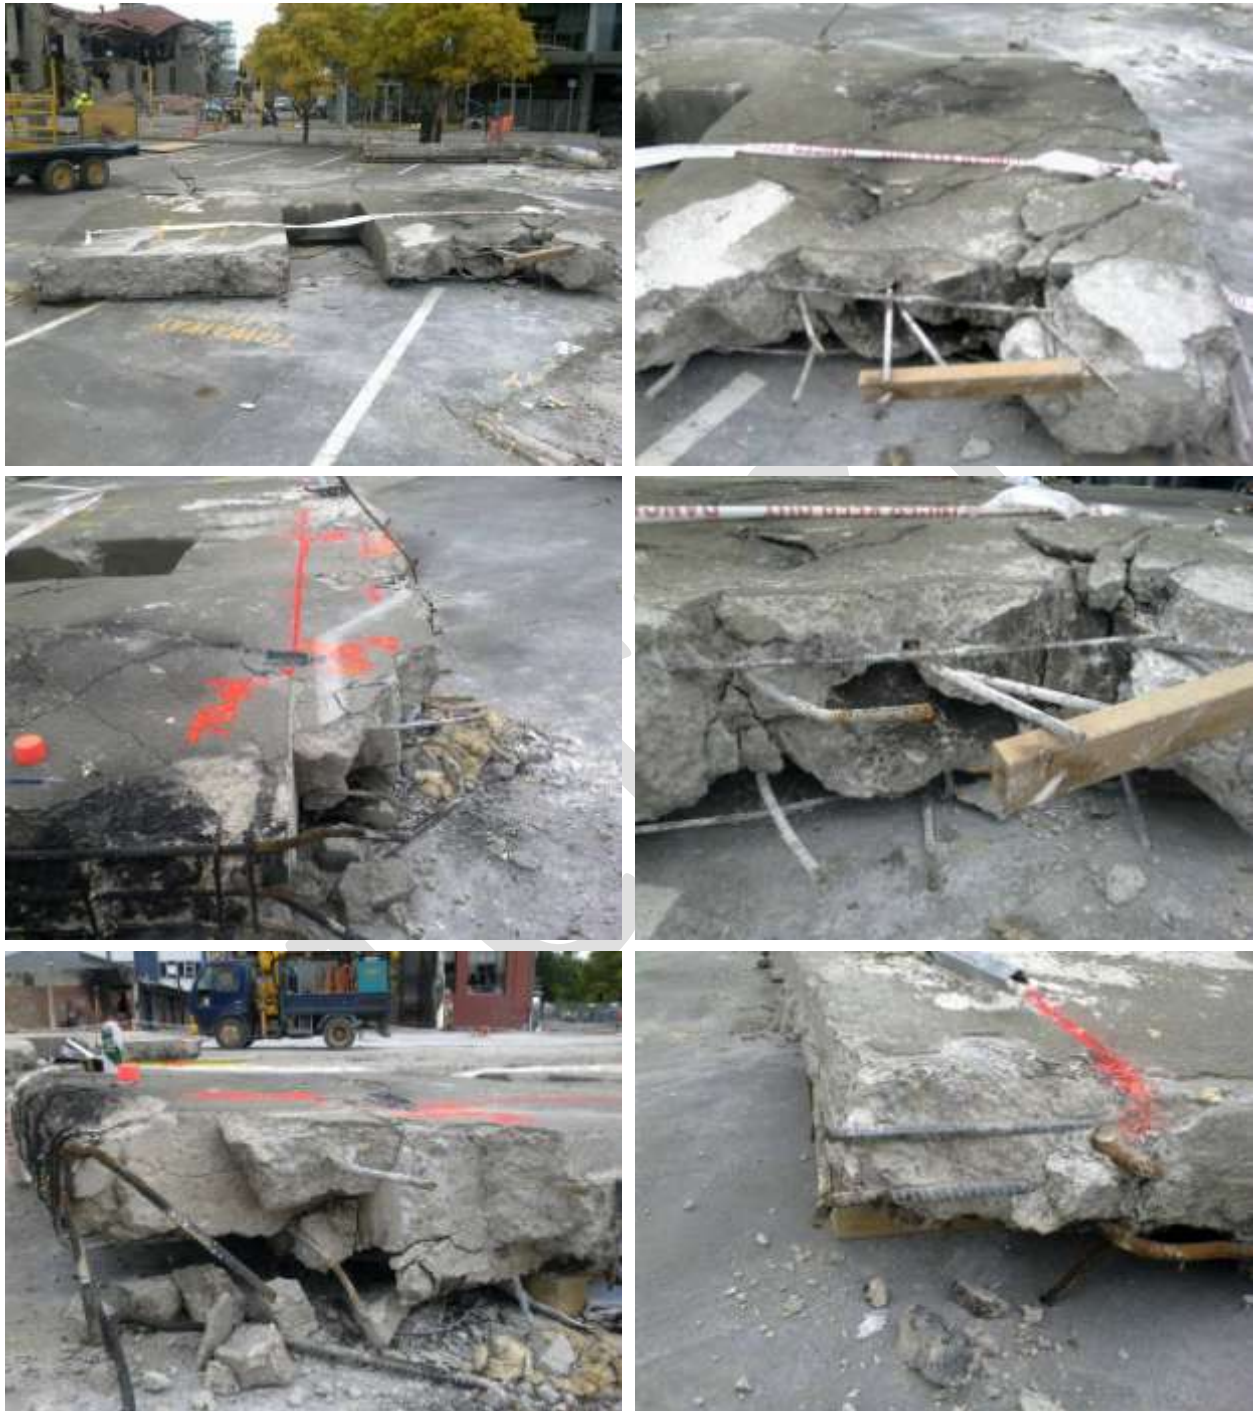
iv. Line 1 Wall Level 4 to 5: Item E4

Severe two-way diagonal shear cracking in east pier and loss of cover to vertical reinforcing steel on east edge.

Figure 15 Line 1 Shear Wall Level 4 to Level 5 (Item E4) (clockwise from top left) a) Outer face with east pier on right with severe shear damage, and timber formwork remnant; b) and c) Charring on fractured concrete surfaces prior to deconstruction; d) Top west corner showing saw-cut on top edge from deconstruction; e) Top east corner showing smooth construction joint at interface with pre-cast beam B15 (DENG Dwg S18 (Figure 59)) and fire charring to spalled eastern edge; f) View from east to west of top east corner construction joint notch.

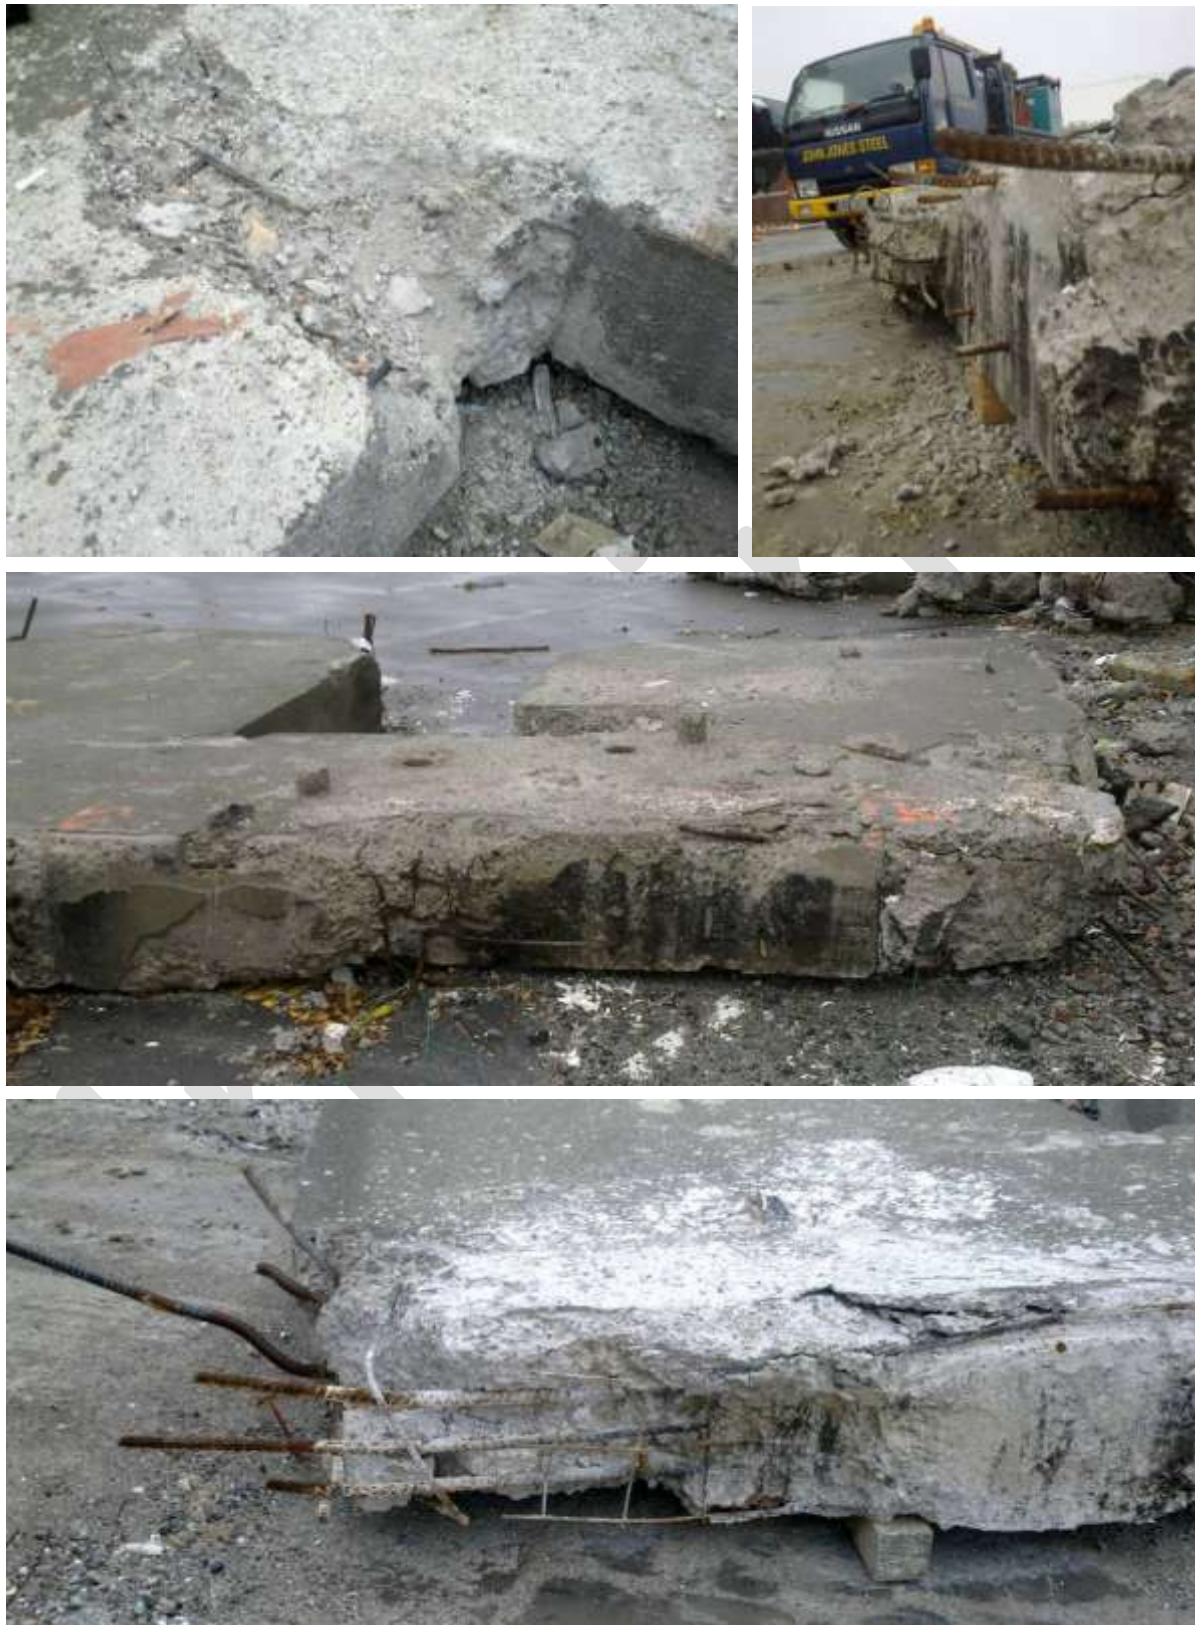
v. Line 1 Wall Level 5 to 6: Item E5

Figure 16 Line 1 Shear Wall Level 5 to Level 6 (Item E5) (clockwise from top left) a) Crumbly concrete at door edge of west pier able to be dislodged by boot; b) Smooth and charred construction joint on top west surface looking east; c) Charred construction joint above west pier. Door sill on left; d) Top east corner with fractured top 3-H24 bars. Floor 664 mesh exposed.

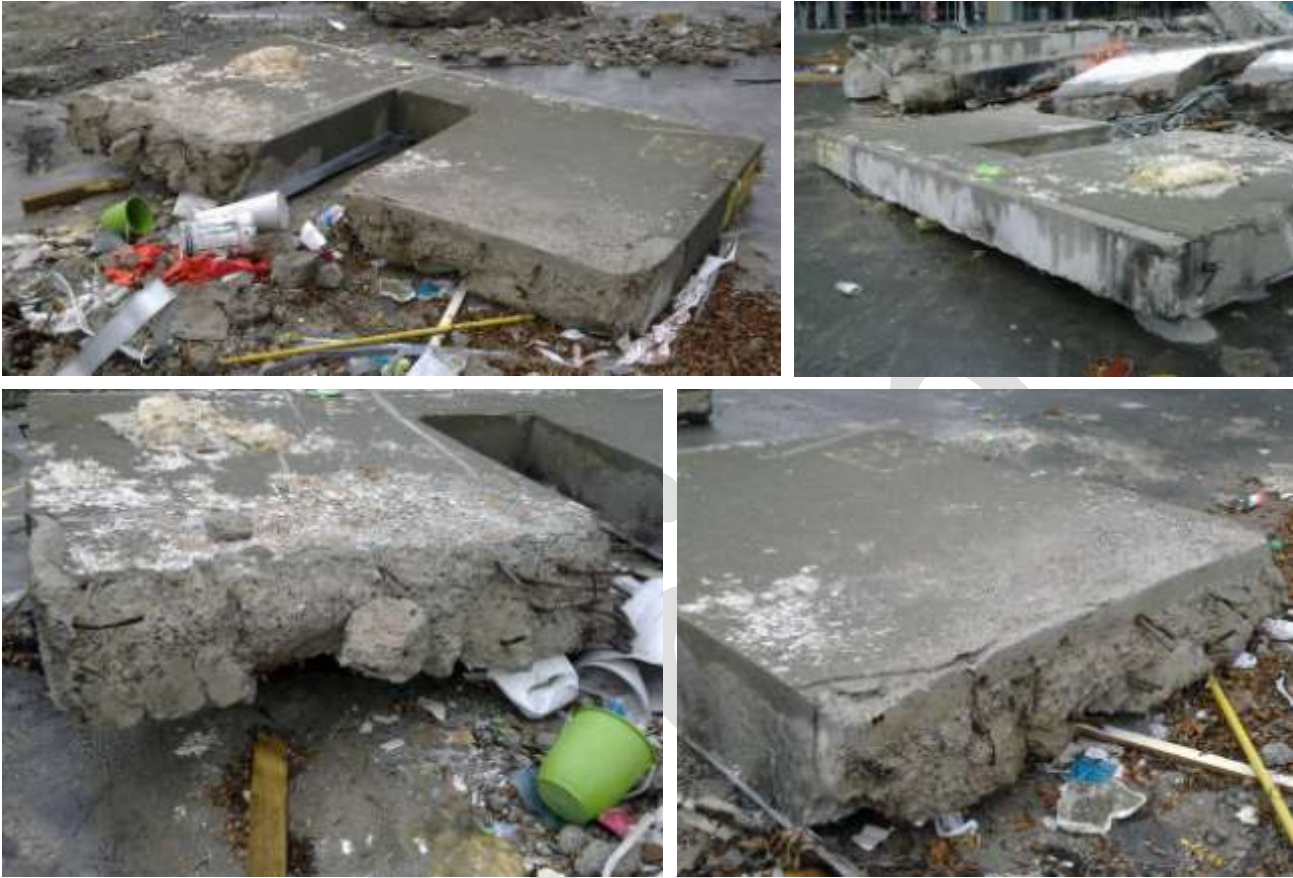
i. Line 1 Wall Level 6 to Roof: Item E5A

No obvious cracking in the wall piers or door head coupling beam (Figure 17).

Figure 17 Line 1 Shear Wall Level 6 to Roof (Item E5A) (clockwise from top left) a) Outer face; b) Top surface at roof; c) East pier with saw-cut from de-construction; d) West pier at construction joint

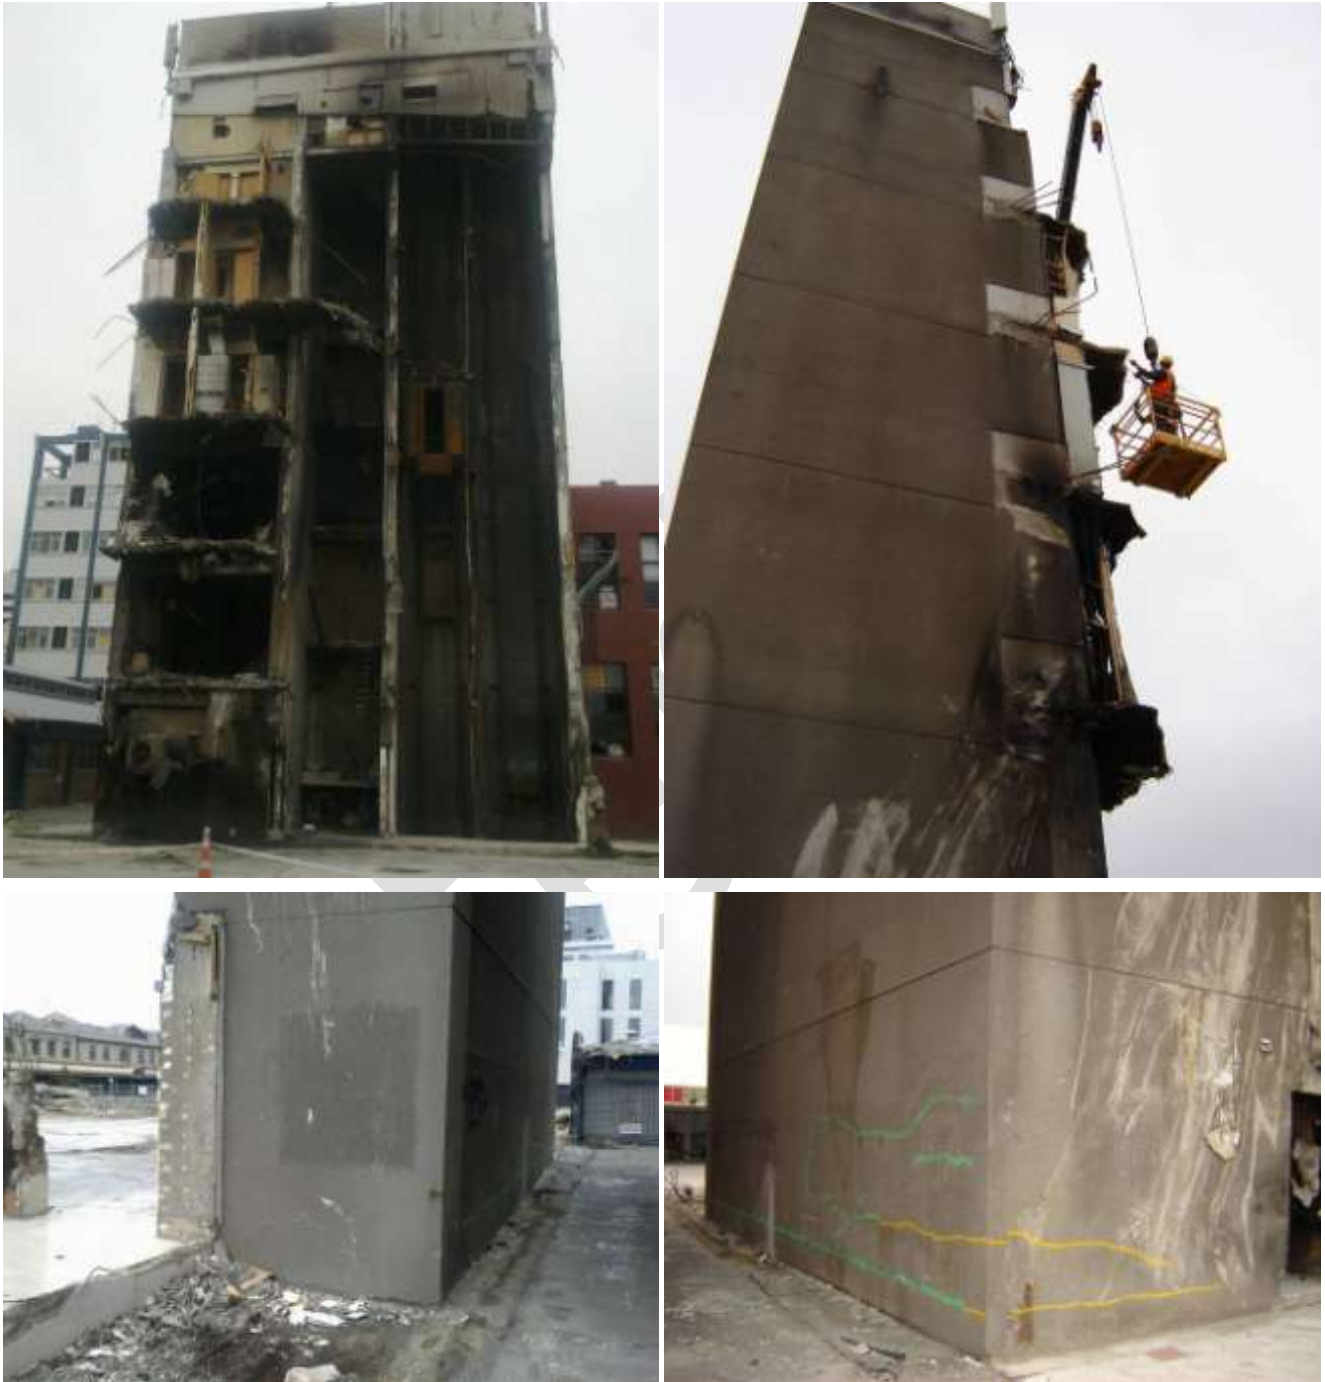
Horizontal flexural cracking on west and north face at Grid C/5 (Figure 18).

Figure 18 Line 4 to 5 Shear Core (DENG Dwg S15 (Figure 57)) (clockwise from top left) a) South face after site cleared with lift shaft for two cars on right, stair well in middle and amenity rooms on the left; b) West face; c) West and north face at Grid C/5 corner Level 1 to 2 with horizontal flexural cracks and construction joint identified by paint; d) East face with column C18 remnant at far left

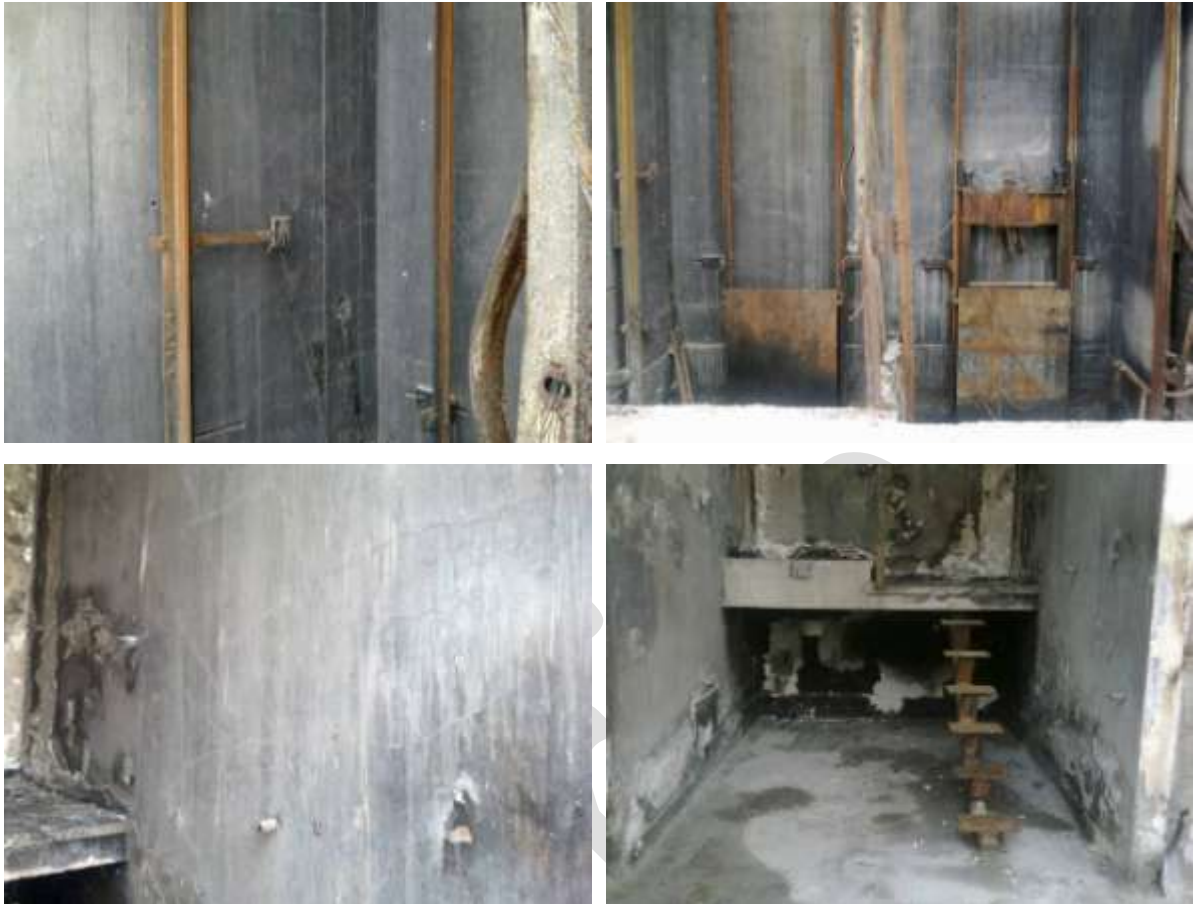
Fine two-way diagonal cracking on the inside faces of Level 1 to 2 walls (Figure 19).

Figure 19 Lift and Stair well wall cracking Level 1 to Level 2 (clockwise from top left) a) Lift wall face of Line D wall with fine diagonal shear cracking in both directions; b) Lift wall face of Line 5 wall with fine diagonal cracking in both directions; c) Stairwell area with steel stair stringer where concrete cores were extracted; d) Stair well face of Line D wall with fine diagonal cracking in both directions.

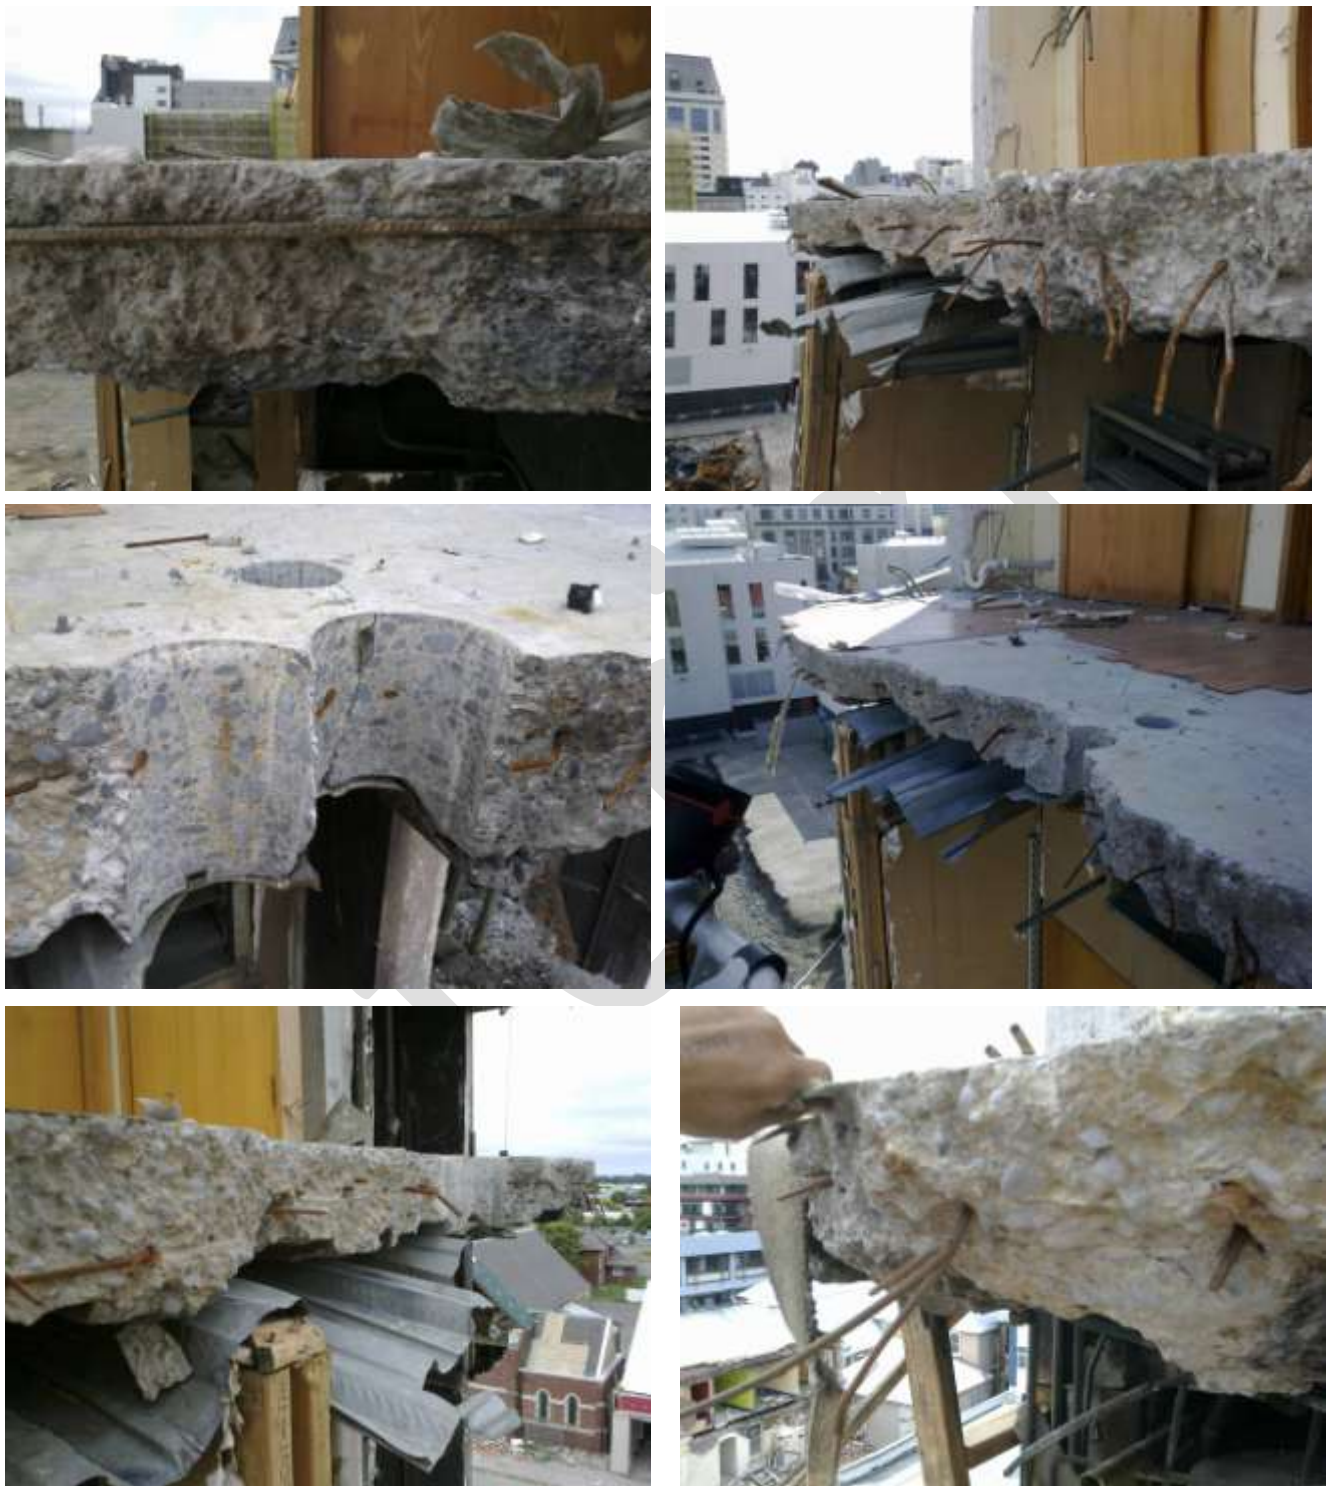
i. Level 6 Slab Remnants

The slab had a vertical fracture face that coincided with the ends of the H12 saddle bars from the support beam on Line 4 (Figure 20).

664 mesh in the slab had fractured in a ductile manner.

Figure 20 Line 4 Core Wall Slab Remnant at Level 6 amenity area (clockwise from top left) a) Slab edge on stairwell wall looking west with H12 saddle bar exposed and ends of mesh below it; b) Vertical concrete fracture surface with reinforcing mesh fractured; c) Slab looking west with cores cut in floor for amenities; d) Fractured mesh angled downwards; e) Fractured slab edge looking east. Torn metal decking aligned approximately with concrete fracture edge; mesh at varying height within slab; f) Cores for amenities at fracture edge.
