CTV Building: Site Examination and Materials Tests

For: Department of Building and Housing

21st July 2011

DBH 110329 CTV Building: Site Examination and Materials Tests (Interim)

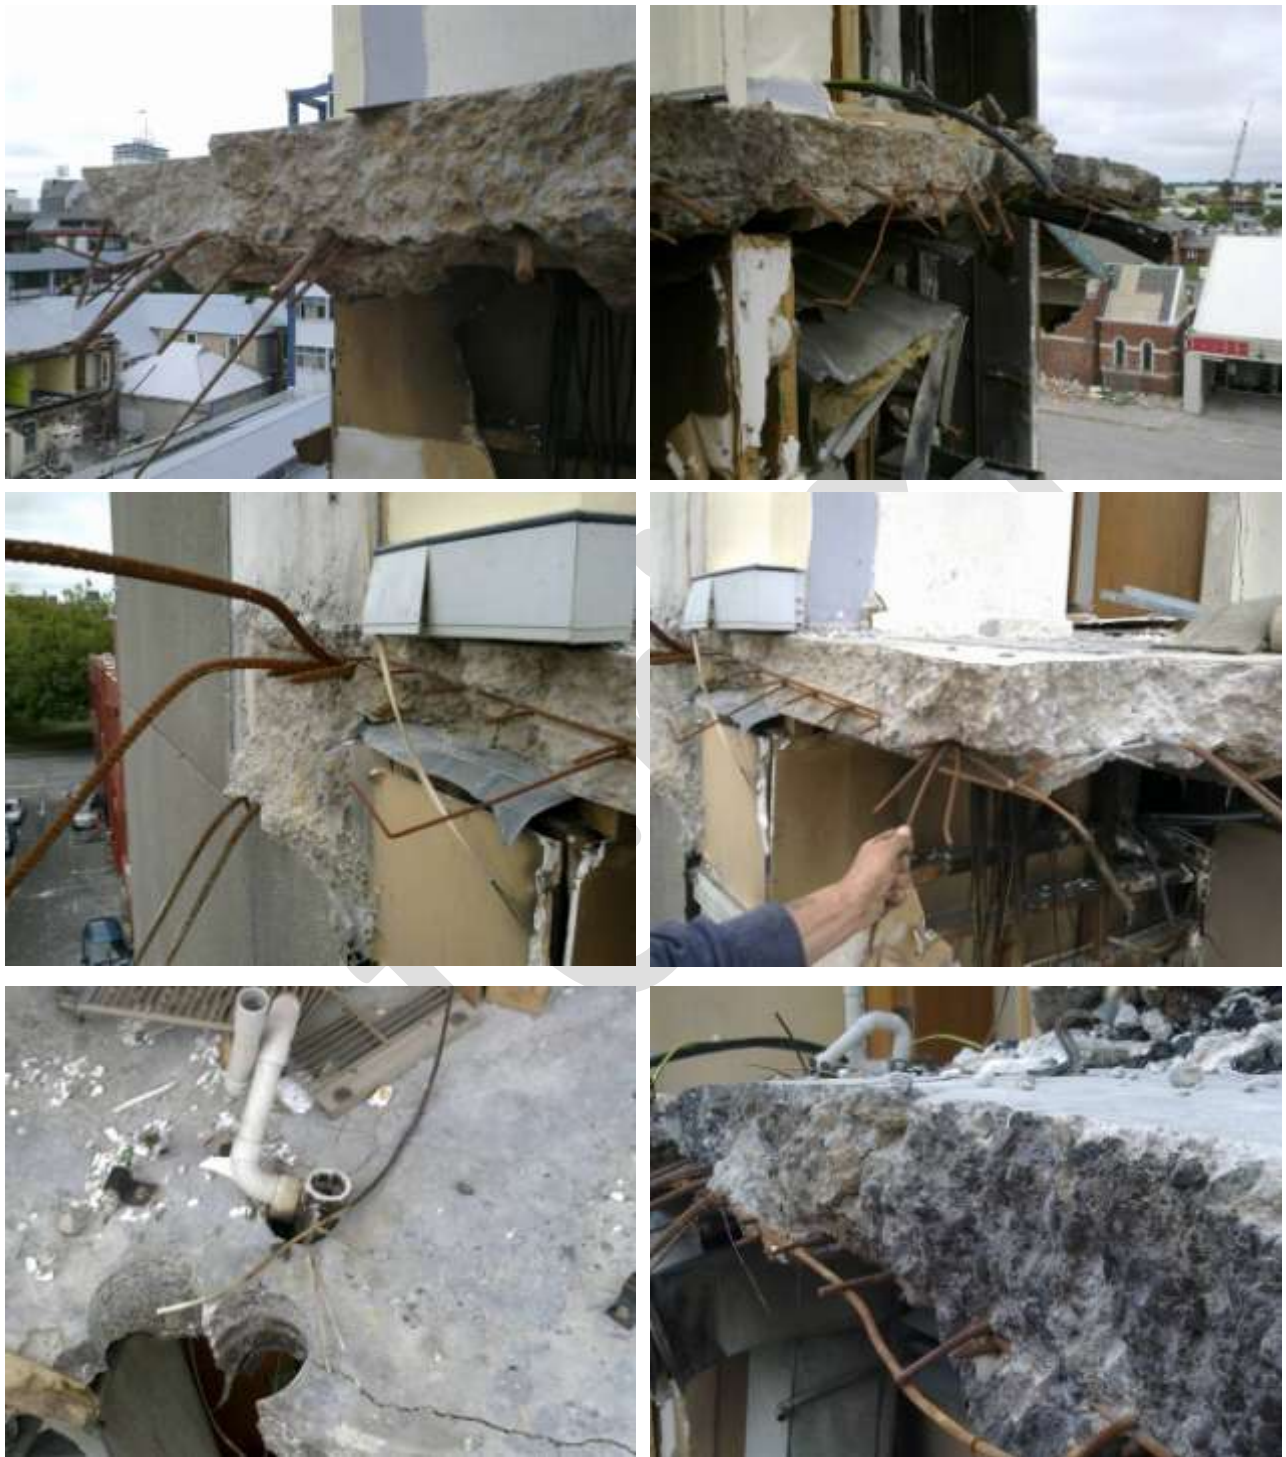
ii. Level 5 Slab Remnants

The fractured edge of the slab was similar to that at level 6.

Figure 21 Line 4 Core Wall Slab Remnants Level 5 (clockwise from top left) a) West end with H12 bar ends and mesh at bottom of slab above ribs. It was required on eth drawings to be located near the top surface (DENG Dwg S16 (Figure 68)); (b) Looking east. Reinforcing angled down. c) Slab edge on Grid C west end. Mesh angled down in bottom of slab on top of ribs. d) Fire charred vertical fractured slab edges adjacent to stair well. Mesh located low down in slab at top of slab ribs. Edge of mesh sheet with closely spaced parallel wires exposed. Fractured wires can be seen from the lapped mesh below. e) Cracking in slab running from cored holes; f) Connection of shell beam to wall with two fractured H24 top bars and two de-bonded top bars. No bottom bars from shell beam embedded in wall (DENG B23 Dwg S18 (Figure 59), Detail 5 S19 (Figure 64)), corresponding to the bent back bottom steel in shell beam Item E23 (Figure 6).

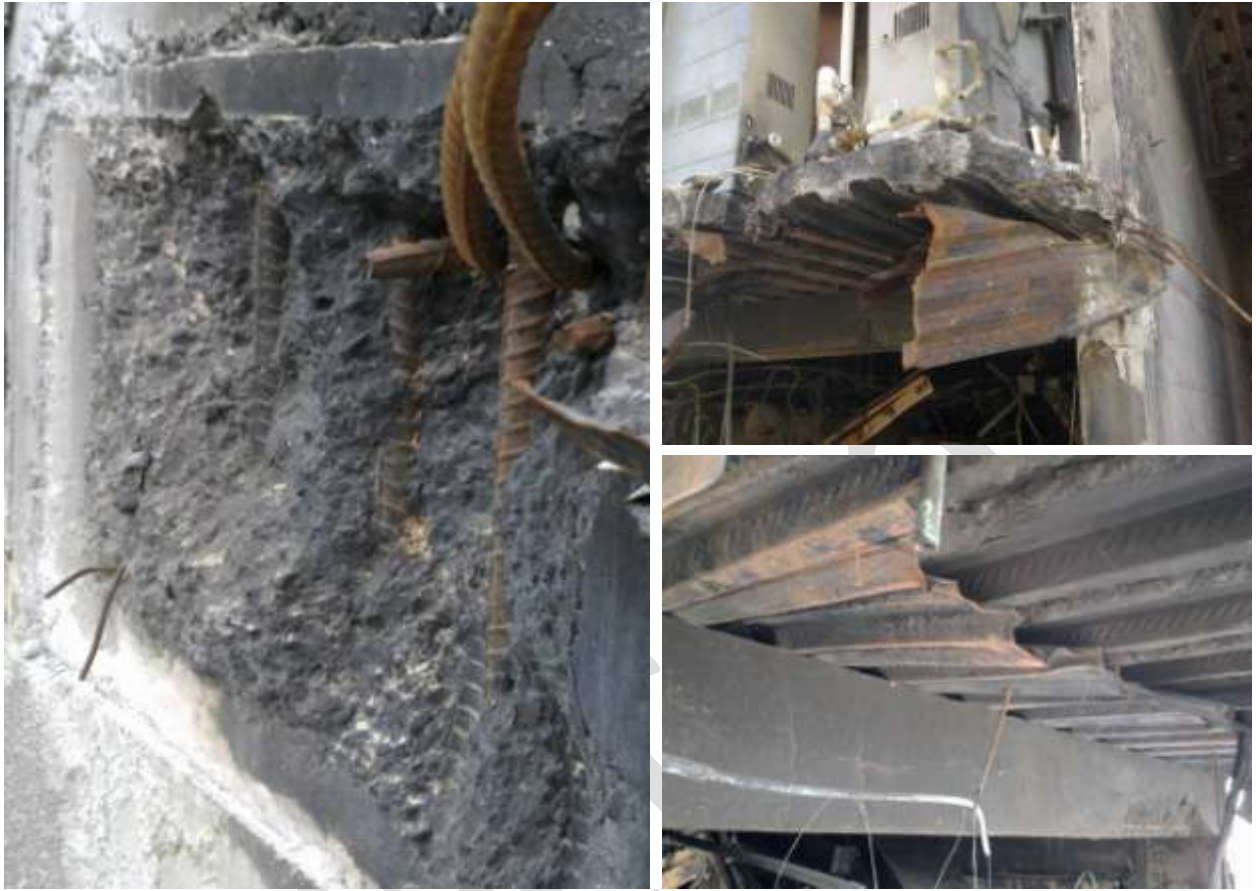
iii. Level 4 Slab Remnants

Figure 22 Line 4 Core Walls Level 4 slab remnants (top to bottom) a) Connection of shell beam to wall with two fractured H24 top bars and two de-bonded top bars. No bottom bars from shell beam embedded in wall but imprints from bars evident (DENG B23 Dwg S18 (Figure 59), Detail 5 S19 (Figure 64)), corresponding to the bent back bottom steel in shell beam Item E23 (Figure 6). b) Fractured vertical face of slab at stairwell wall, with fractured slab support beam (DENG B25 Dwg S18 (Figure 59)) top bar and charred fracture surface. c) Torn Hi-bond sheeting de-bonded from slab but still fixed in at pre-cast beam support.

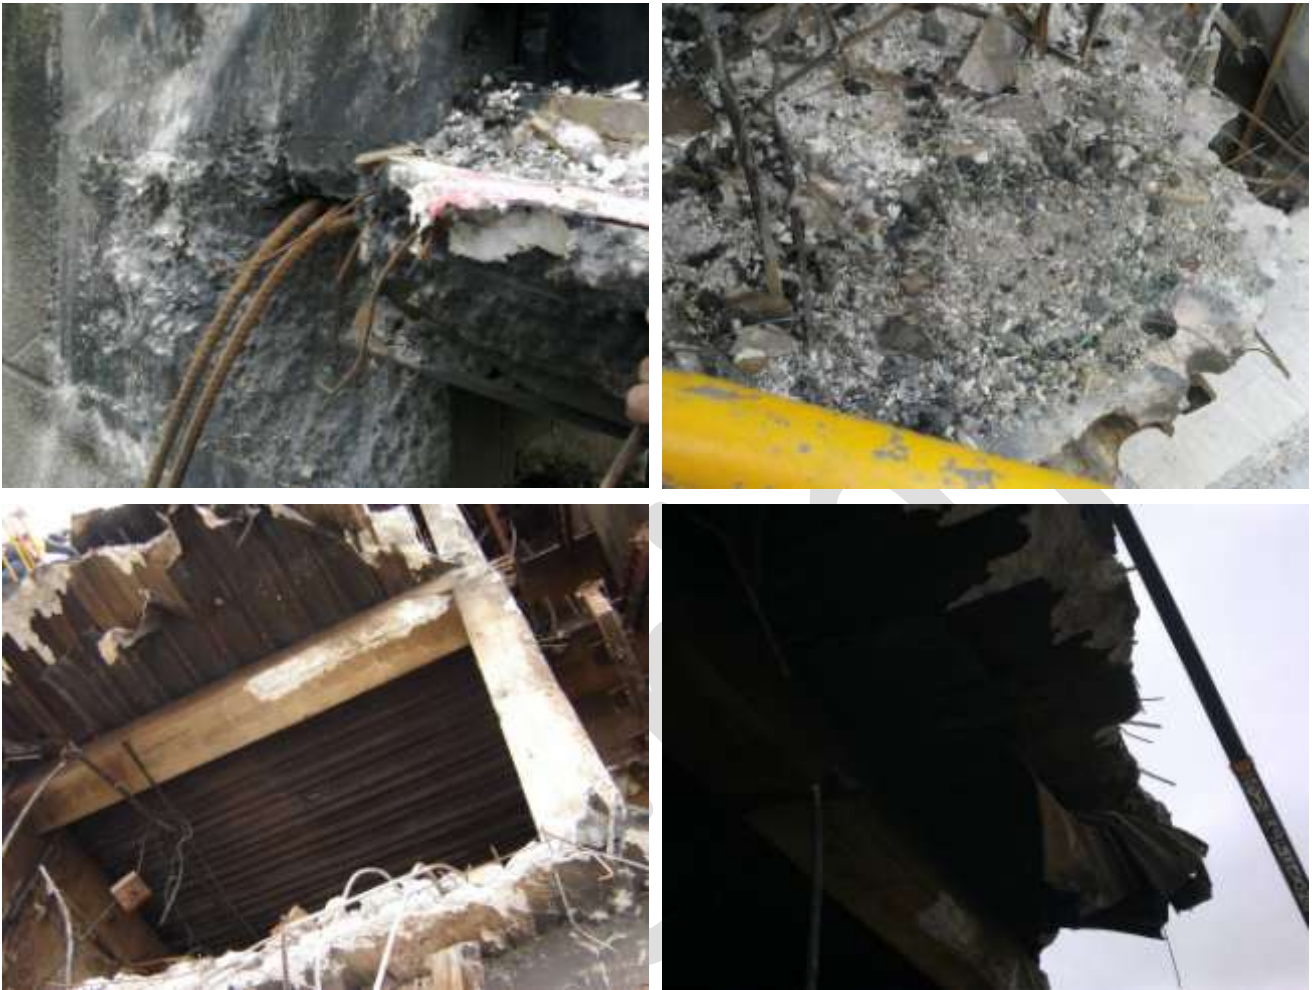
iv. Level 3 Slab Remnants

Figure 23 Line 4 Core Walls Level 3 slab remnants (clockwise from top left) a) Connection of shell beam to wall with two fractured H24 top bars and two de-bonded top bars. No bottom bars from shell beam embedded in wall but imprints from bars evident (DENG B23 Dwg S18 (Figure 59), Detail 5 S19 (Figure 64)), corresponding to the bent back bottom steel in shell beam Item E23 (Figure 6). b) Ash on slab. Cored holes at fractured edge. c) Torn Hi-bond sheeting de-bonded from slab but still fixed in at pre-cast beam support (DENG B24 Dwg S18 (Figure 59)). d) Hi-bond deck and slab from below supported on beam B24

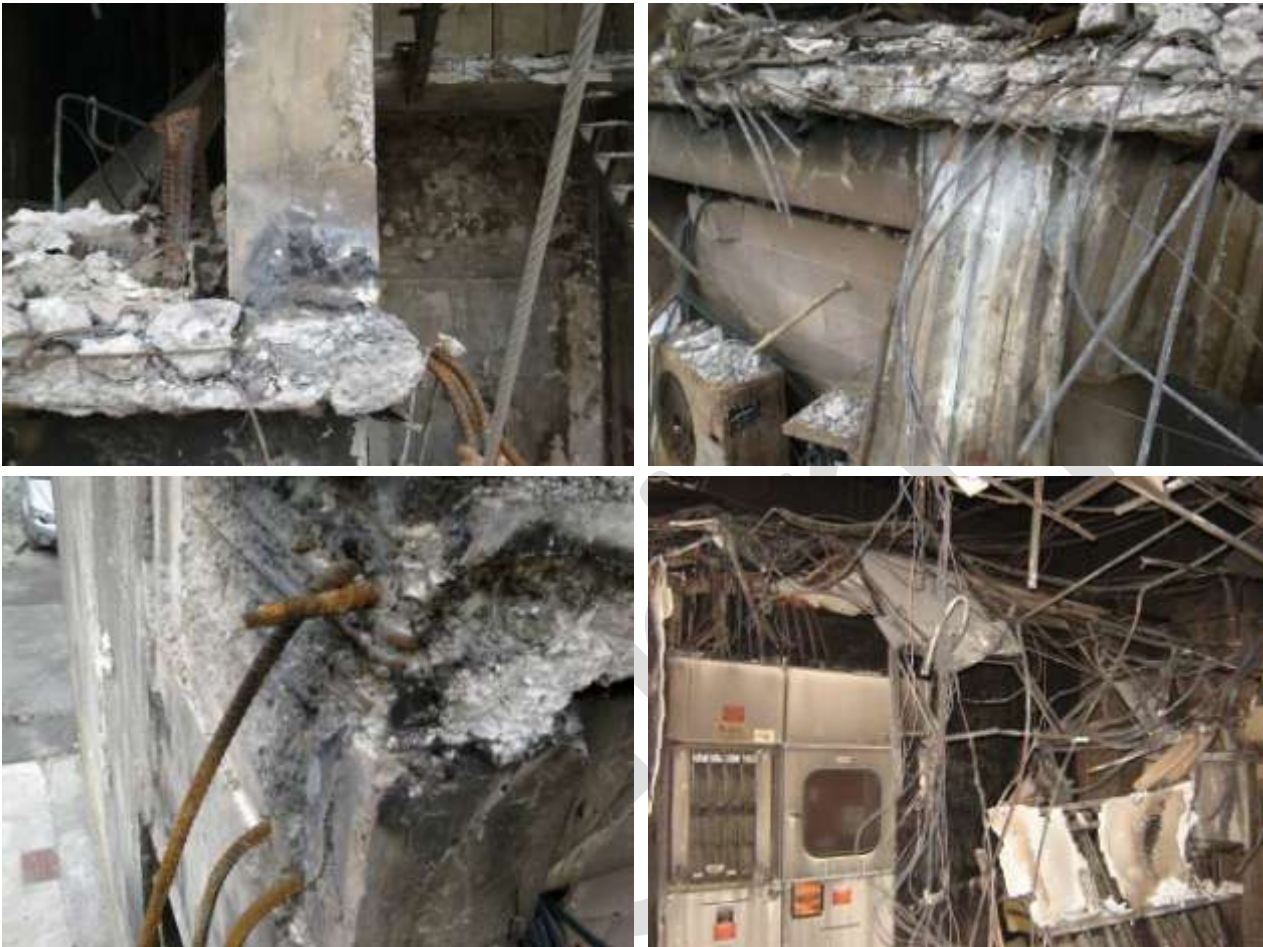
v. Level 2 Slab Remnants

Figure 24 Line 4 Core Walls Level 2 slab remnants (clockwise from top left) a) Slab edge broken back during de-construction adjacent to stairwell wall; b) Broken back slab with H12 saddle bars exposed. Masonry wall with separation along top course; c) Switch room under Level 2 slab; d) Connection of shell beam to wall with two fractured H24 top bars and one de-bonded top bars. Bottom bars from shell beam have been embedded in wall as specified (DENG B23 Dwg S18 (Figure 59), Detail 5 S19 (Figure 64)). Some diagonal beam-wall joint zone shear cracking can be seen in the wall end.

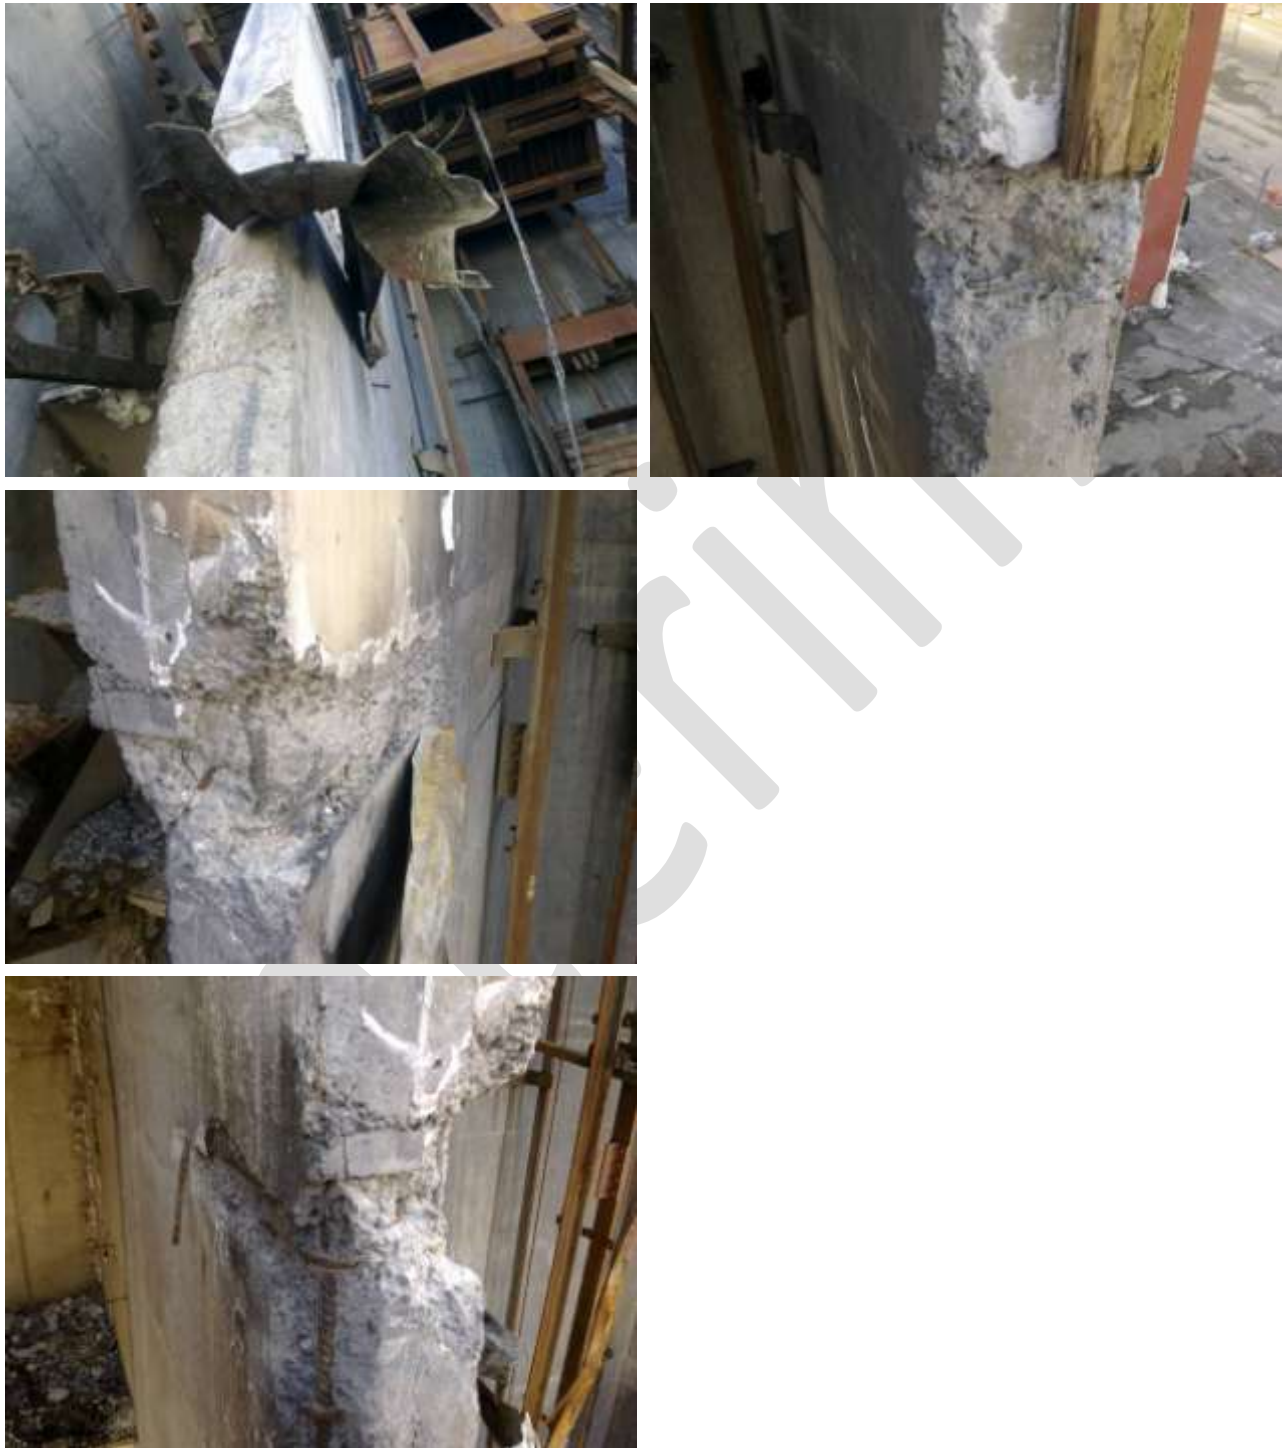
An H12 bar was found fractured at the end of the west wall D.

No reinforcing steel was found to have connected the east wing wall D.5 to the slab (Figure 28).

Figure 28 Level 3 Lift Well Wing Walls Grid D and D.5 (anti-clockwise from top left) a) Hi-bond decking side lapped into western Grid D wall, just hanging on; b) H12 bar necked and fractured at centre of wing wall (indicated by chalk arrow). c) Concrete cover broken away as slab pulled southwards; d) Localised spalling of concrete. No reinforcing found connecting end of east wall with slab.

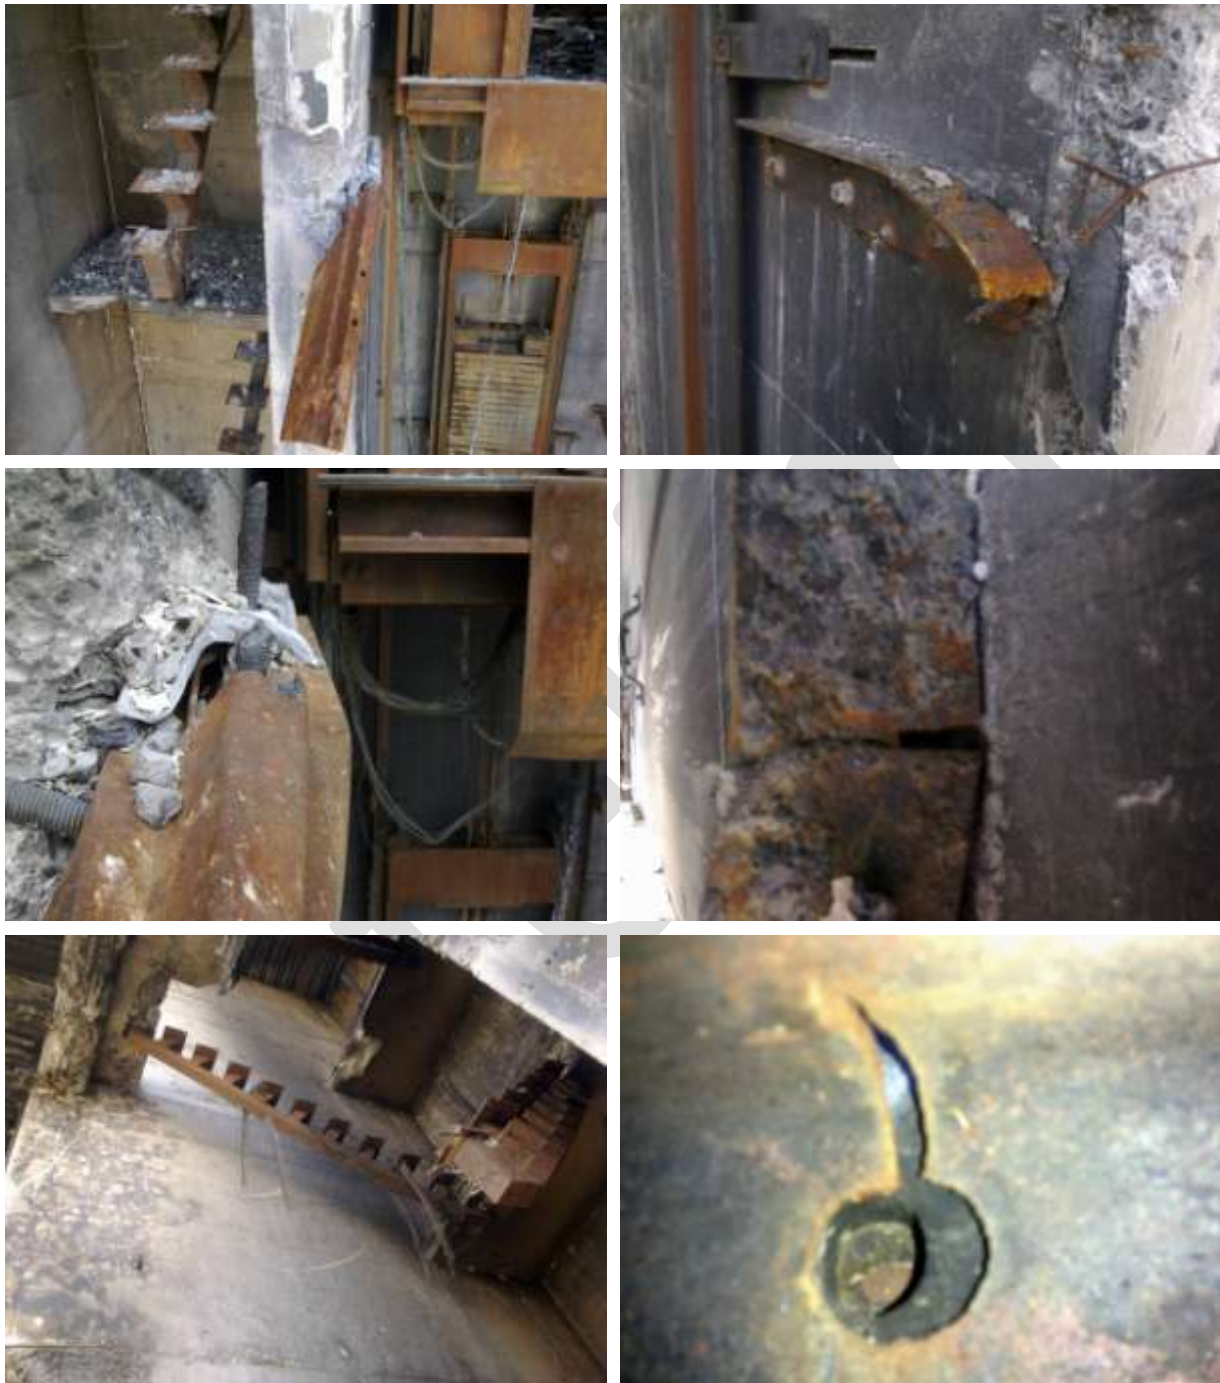
The drag bar items on both the west and east wing walls had partially fractured in bending and tension. The bolts that passed vertically through the slab and into the drag bar on the west wall had fractured in tension as the slab pried it off as it rotated downwards during the collapse (Figure 29 and Figure 30).

Figure 29 Level 4 Lift Well Wing Walls Grid D and D.5 (anti-clockwise from top left) a) 150x150x10 L with 50 x 3 SHS; 3 M24 bolts into wall and 6 –M20 bolts 350 mm long bolted through the slab at the Hi-bond rib with epoxy grout around bolt; b) Three M20 bolts remaining in the Grid D drag bar have fractured in tension at the underside of the bolt at the slab surface. The 50 x3 SHS has fractured in bending and tension at the bolt hole adjacent to last bolt into wall. c) Stair stringer running up to Level 5 fixed rigidly into landings with visible vertical bow (DENG Stair S8 Dwg S31 (Figure 69). d) Initiation of angle fracture at elongated hole without bolt into east wall. d) Fracture in angle running from corner of angle out towards toe viewed from above. f) Remnant of 150x80x10 L drag bar with 4 M24 bolts into grid D.5 wall. Angle has fractured in bending and tension two bolts in. End has been gas cut during de-construction.

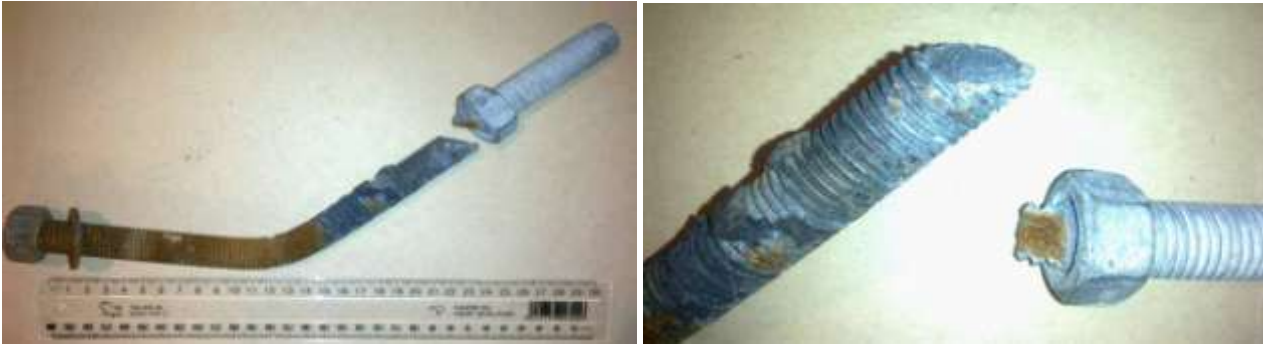
Figure 30 M20 Drag Bar Bolt (left to right) a) Rusted portion had been through underside of steel drag bar. Grey portion with epoxy residue had been in slab; Diagonal fracture surface immediately below nut. (Portions shown are from two different bolts). b) Smooth diagonal surface to left indicative of tensile fracture in combination with some shear. Necked and dimpled fracture surface at underside of bolt (to the right) typical of direct tensile fracture in threaded rods.

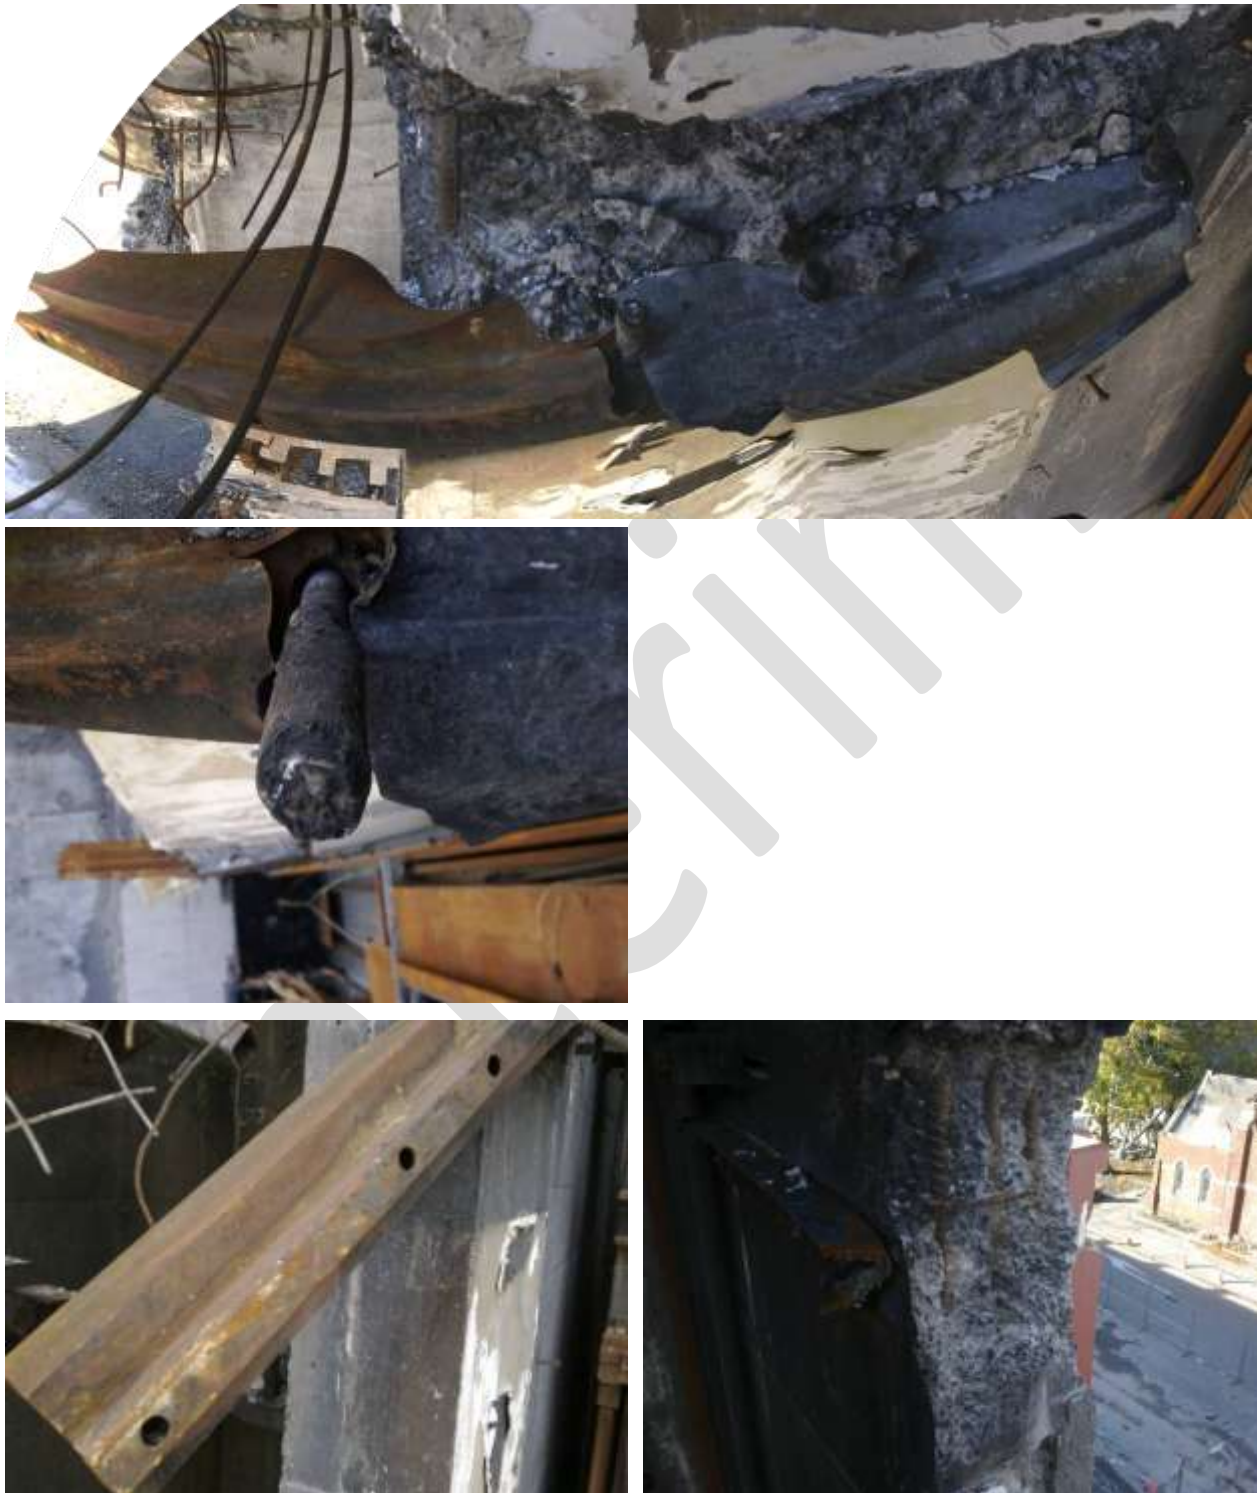
Figure 31 Level 5 Lift Well Wing Walls Grid D and D.5 (anti-clockwise from top) a) 150x150x10 L with 50 x 3 SHS; 4-M24 bolts into wall and 6 –M20 bolts 350 mm long bolted through the slab at Hi-bond rib with epoxy grout around bolt; Three M20 bolts remaining in the Grid D drag bar have fractured in tension-shear at the underside of the bolt at the slab surface. The 50 x3 SHS has fractured in bending and tension at the bolt hole adjacent to last bolt into wall and twisted with the slab. b) Epoxy grout around bolt through slab; c) Holes for 3 M20 bolts through slab in twisted drag bar; d) 150x80x10 L drag bar with 5 M24 bolts into wall D.5. End of bar has been gas cut during de-construction.

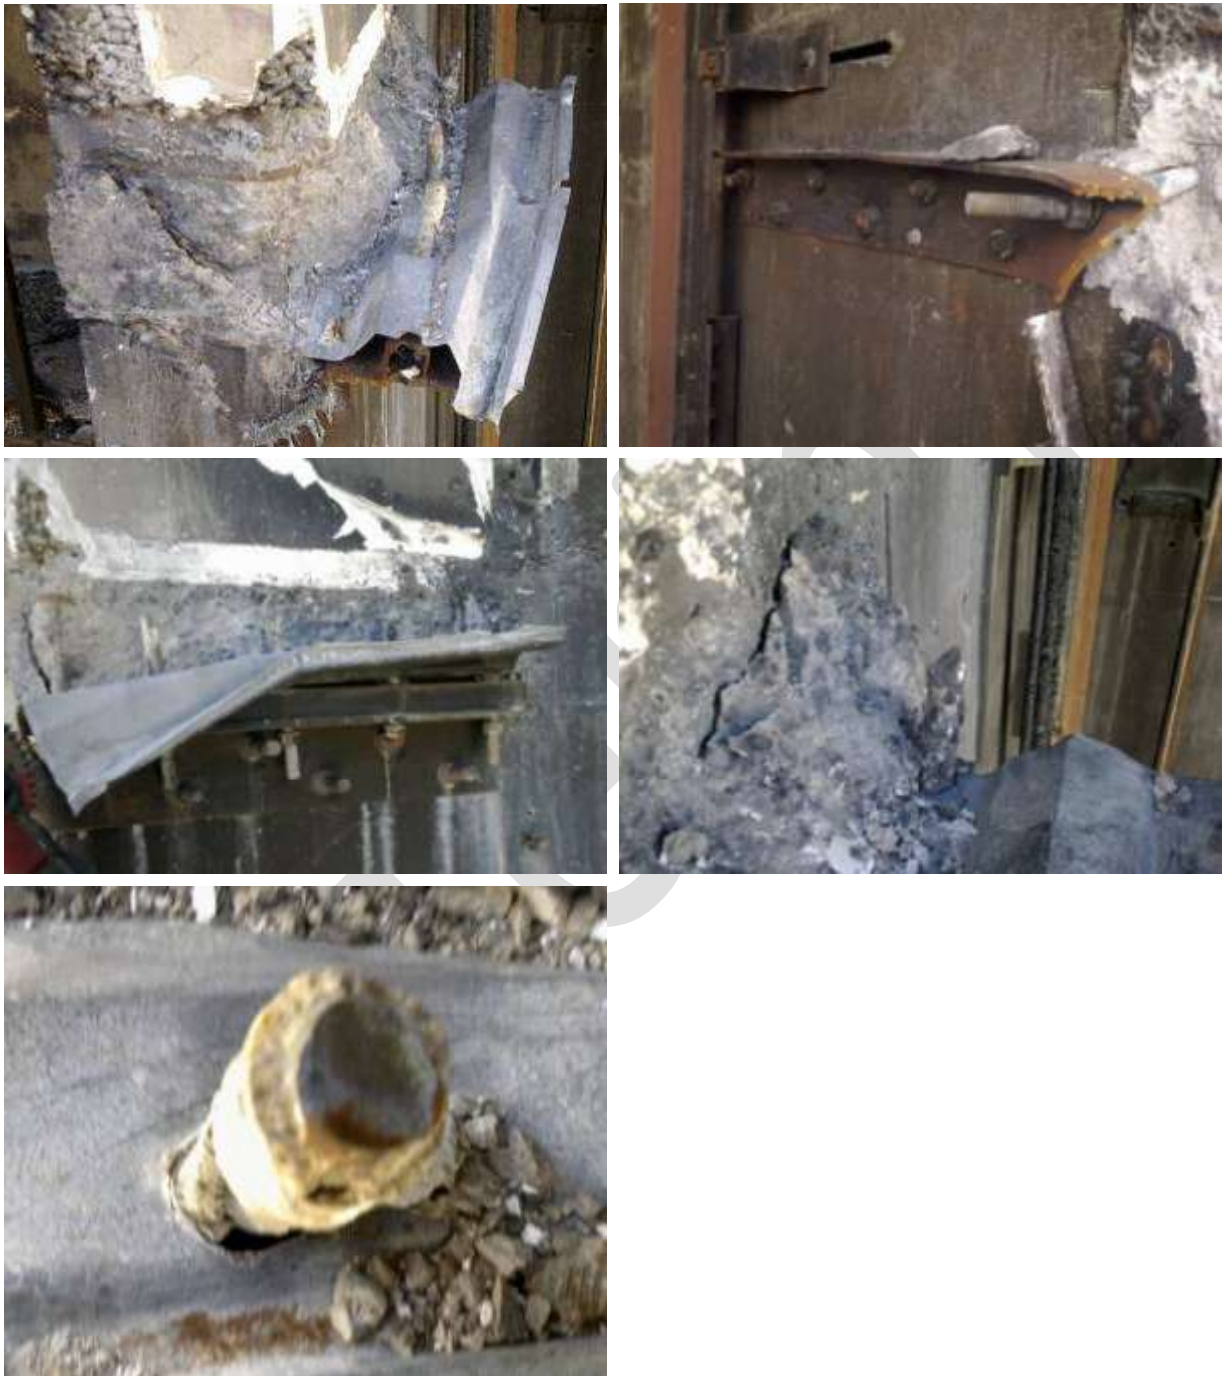
Figure 32 Level 6 Lift Well Wing Walls Grid D and D.5 (anti-clockwise from top left) a) 150x150x10 L with 50 x 3 SHS into west wall on Grid D, similar to Level 5 and 4 drag bars; 6-M24 bolts into wall; The remaining 4 –M20 bolts 350 mm long had been bolted through the slab at the Hi-bond rib with epoxy grout around bolt; These have fractured in tension-shear at the underside of the bolt at the slab surface and were measured with 110 mm stick-out above the item. The 50 x3 SHS has fractured in bending and tension at the bolt hole adjacent to last bolt into wall and the bar has twisted with the slab. b) Side view of drag bar remnant showing deck uplift at end bolt; c) Fracture surface of M20 bolt with smooth diagonal face indicative of tension-shear fracture; Epoxy grout around bolt through slab. f) End bolt with diagonal fracture and slab concrete remains; e) 150x80x10 L drag bar with 7- M24 bolts into east wall D.5. End of bar has been gas cut during de-construction.

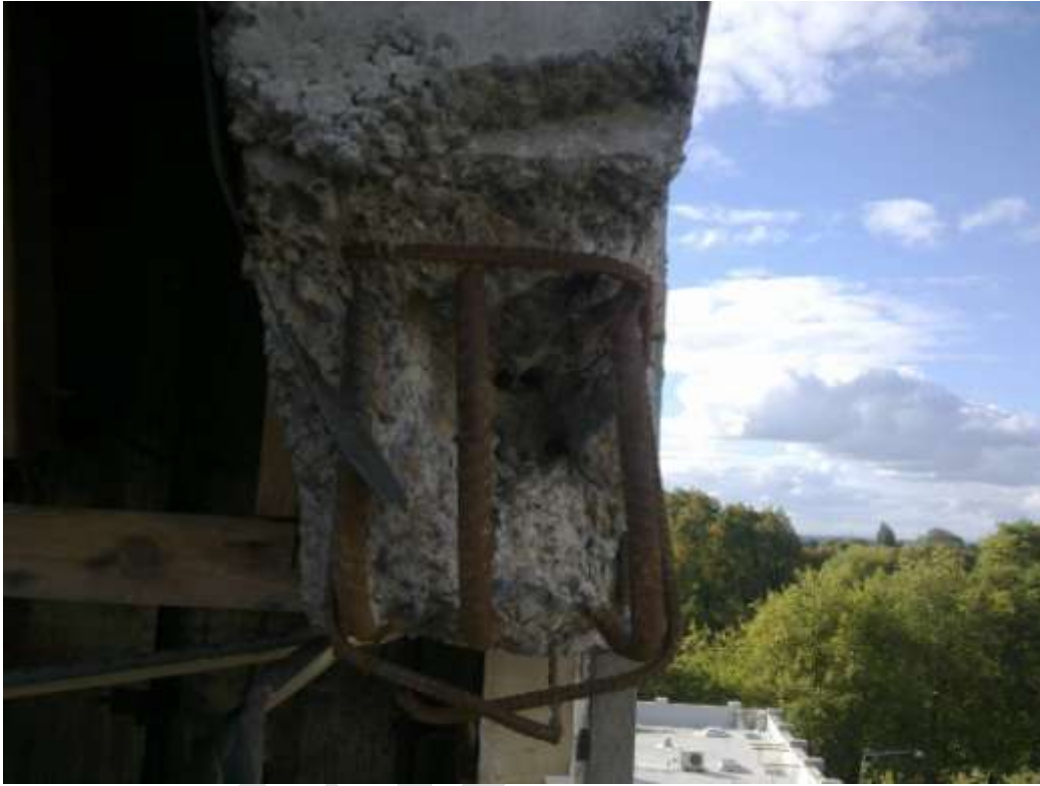
Figure 33 Lift Well Wing Wall D.5: Column C18 Connection (DENG Dwg S14 (Figure 61)); 3 x 20 to 24 mm diameter holes can be seen where reinforcing bars from column have pulled out. The drawing shows that 4-H20 bars were required to be bent in to the wall.

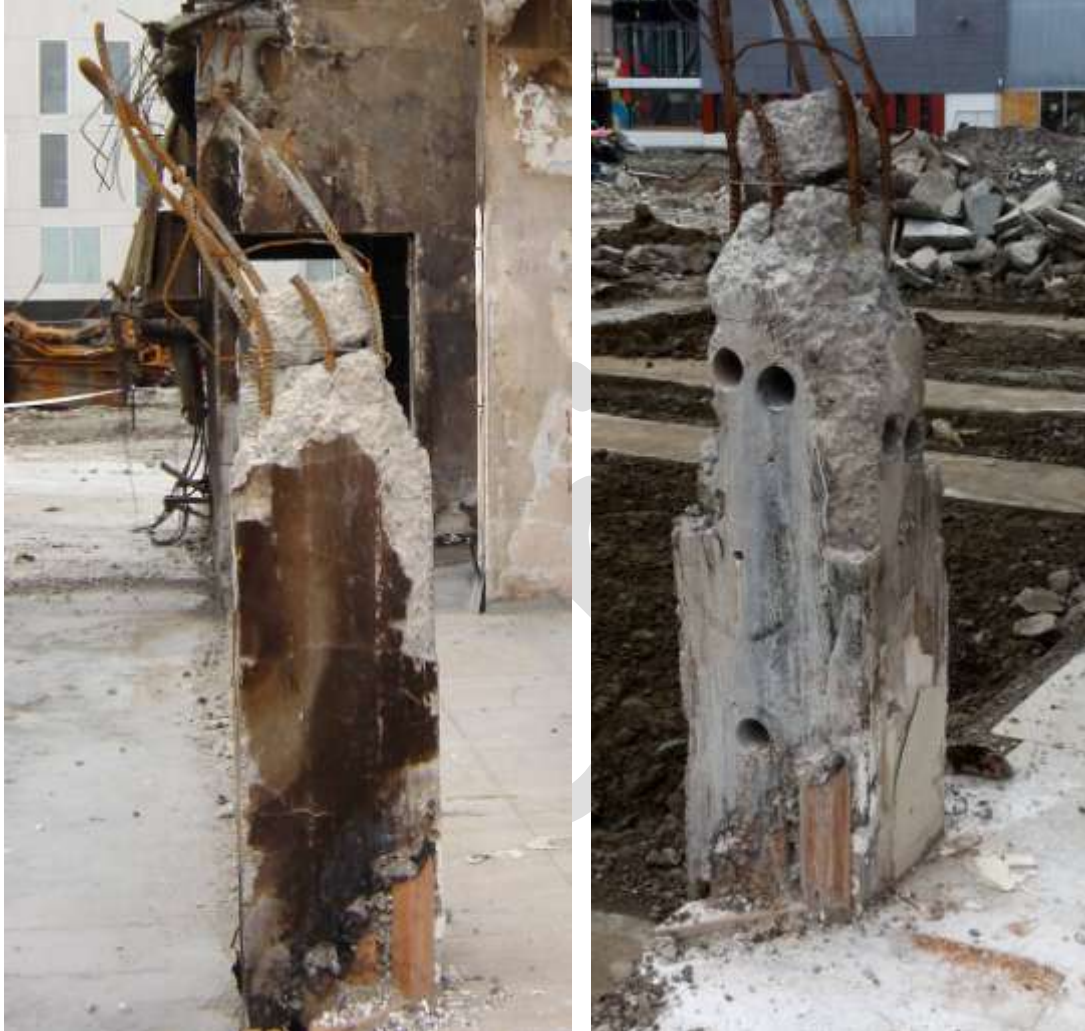
Figure 40 400 mm Square Column C18 at Grid 4/D.5 adjacent to lift core walls showing compressive failure (left to right) a) Spear head shape of failure surface indicative of compressive failure. Fire scorching to surface from smouldering fire; b) Holes showing locations of drilled cores extracted for compression testing.

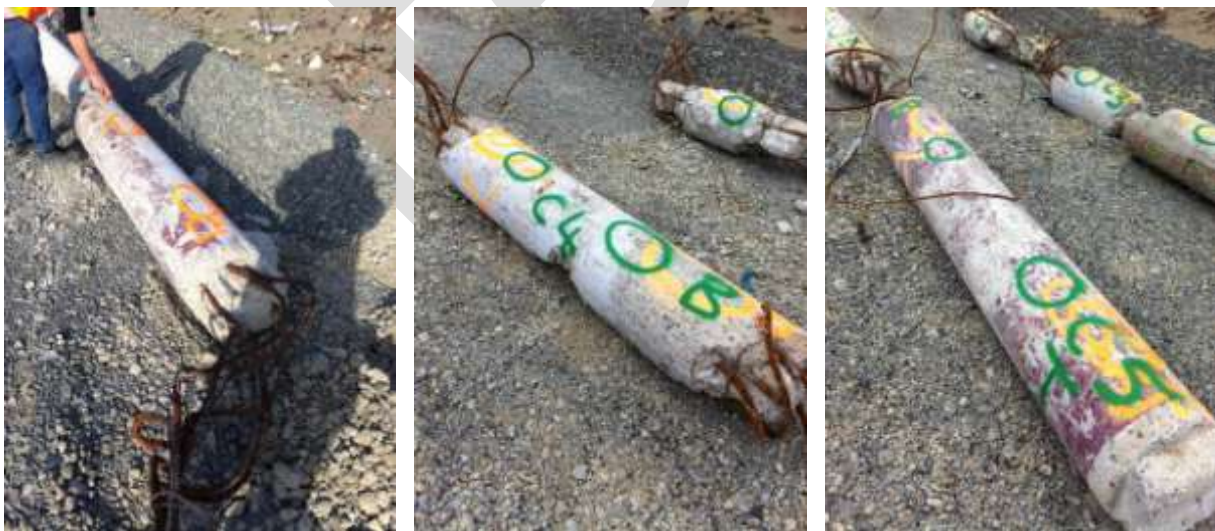
Figure 43 400 mm diameter columns full height (left to right) a) Test Item C1 Level 6 to roof column with base hinging failure, still connected by reinforcing to C8 below; b) C4 hinging top and bottom; c) C5 Level 6 to roof column with hinging at base.

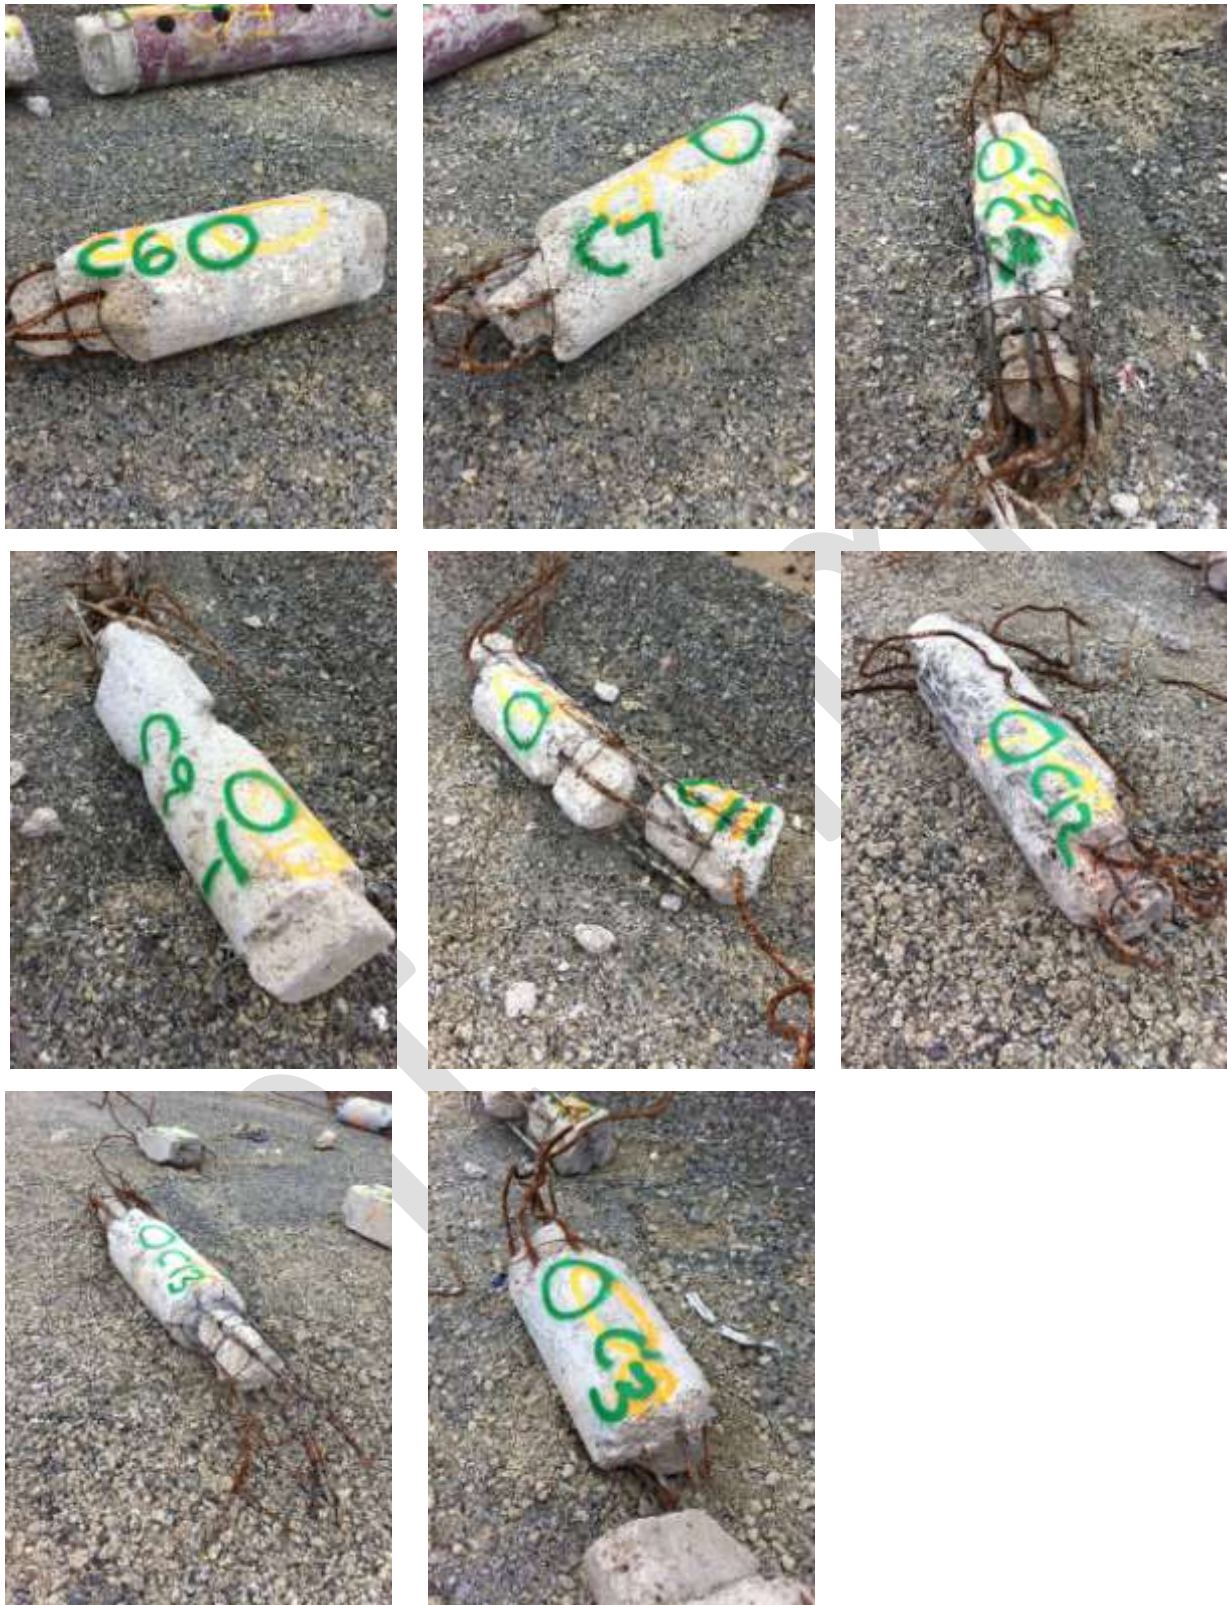
10. A number of circular columns examined showed mid-height hinging failures as well as hinging at the base. This was also seen in a column remnant identified as being a perimeter column located between precast spandrel panels. Other circular columns were found full height with hinging damage top and bottom.

Figure 46 400 mm Diameter Columns at Burwood showing similar base and/or mid-height failures (Left to right, top row down) a) Test item C6 Level 6 column head with mid-height failure; b) C7 with base and mid-height failures; c) C8 with base flexural (near end) and mid-height spearhead failures; d) C9 Level 6 column head with mid-height failure; e) C11 base (near end) and mid-height failure; f) C12 base and mid-height failure; g) C13 base and mid-height flexural failure (near end); h) C3 similar to C13 but lower bars have been cut during de-construction at start of spalling.

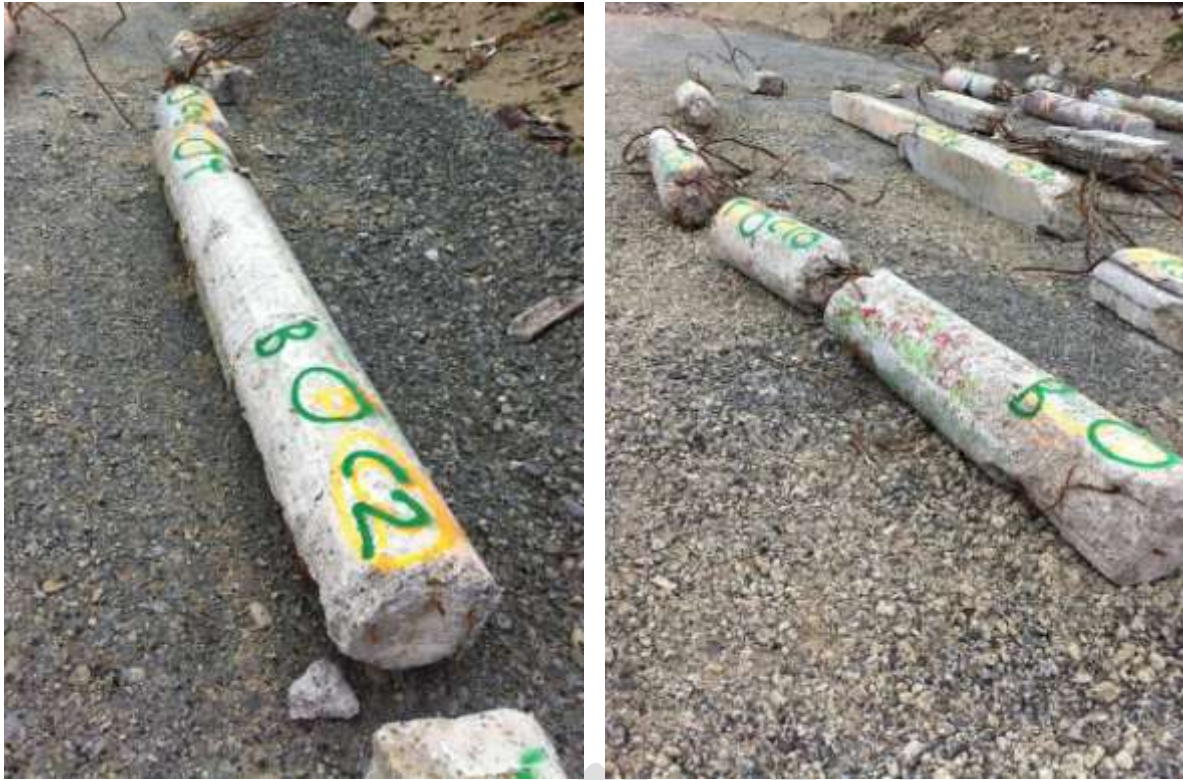
Figure 47 Level 1 Entry 400 mm Diameter Columns (left to right) a) Test item C2, 6-D12 vertical bars fractured at base (DENG Dwg S14 C23); b) Item C10 with down pipe cast in (DENG Dwg S14 C21 or C22)
