CTV Building: Site Examination and Materials Tests

For: Department of Building and Housing

21st July 2011

DBH 110329 CTV Building: Site Examination and Materials Tests (Interim)

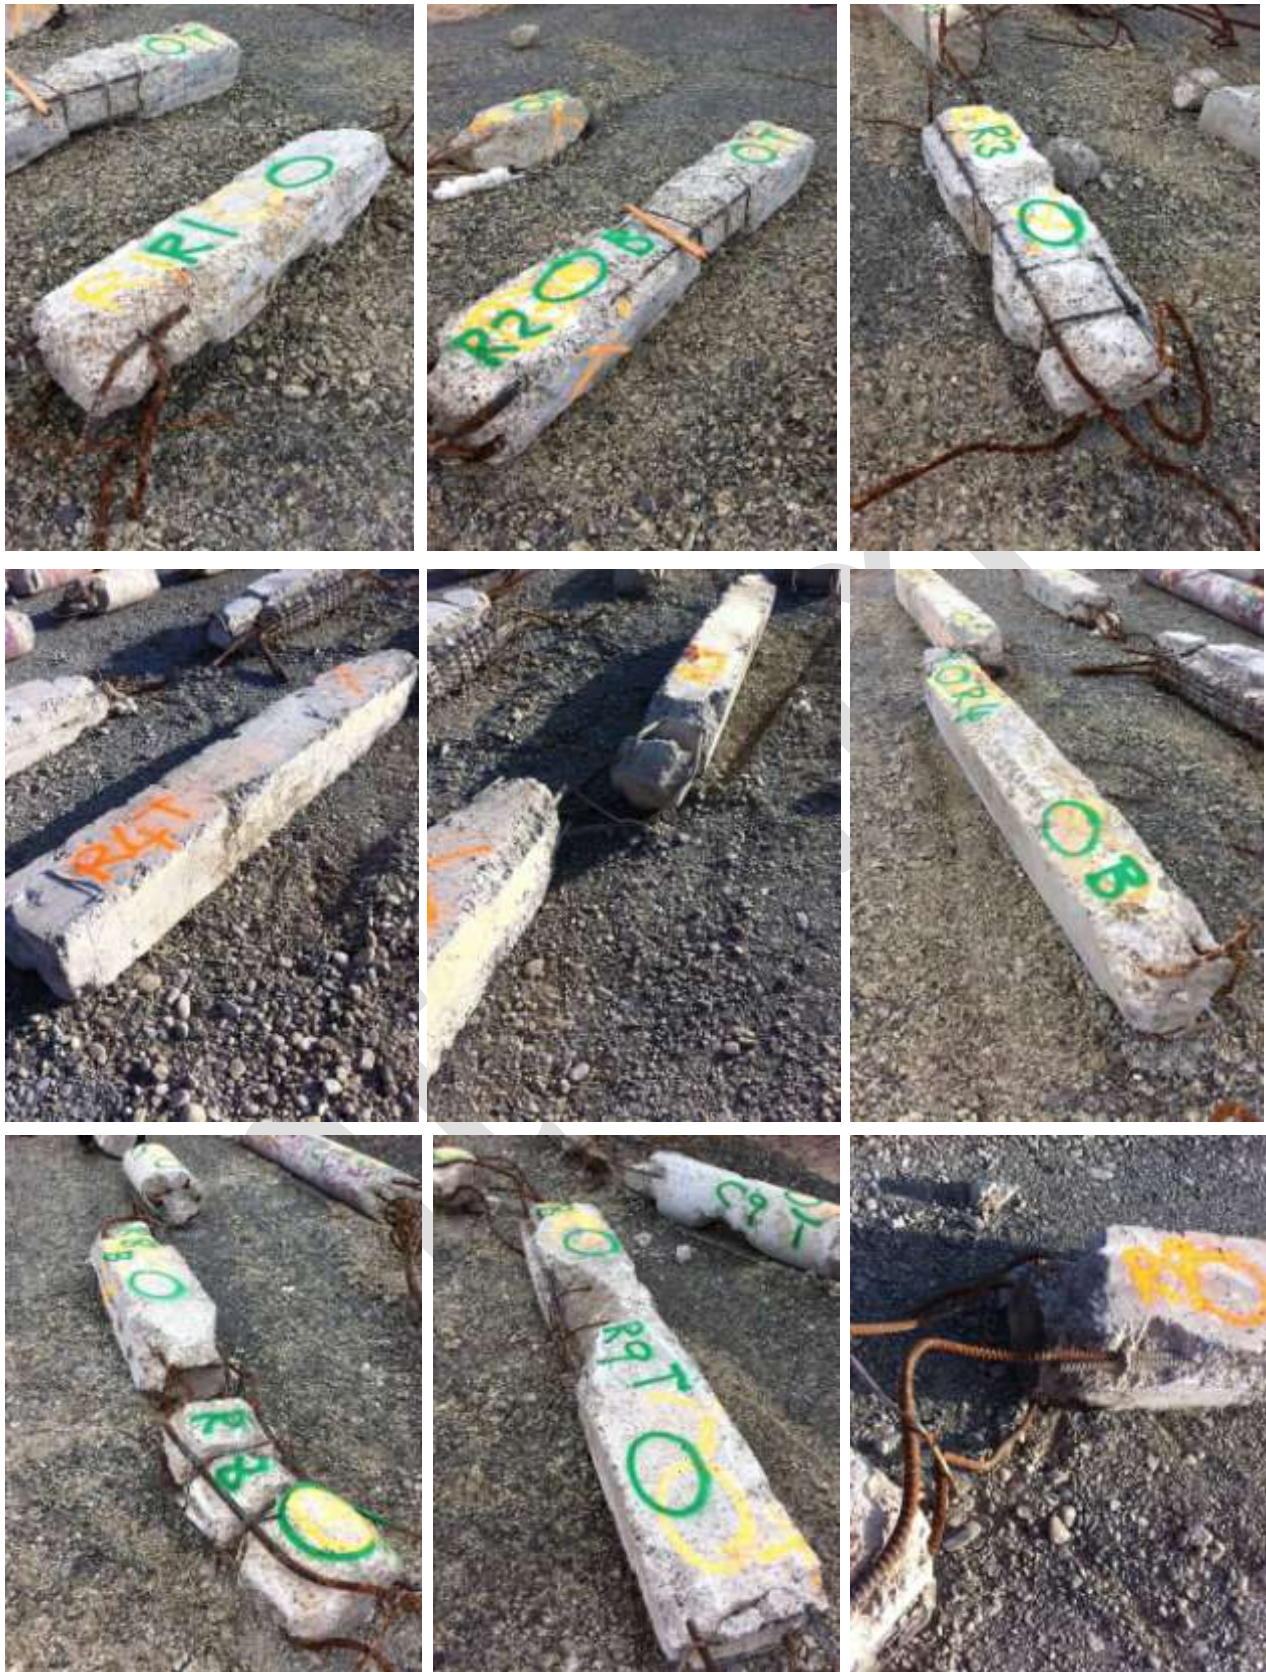
11. Rectangular columns which were all located on Line 1 in the structure, typically exhibited beam-column joint failure as well as other damage.

Figure 48 400 x 300 mm Rectangular Columns (Left to right, top down) a) R1 beam-column joint failure at base, mid-height failure; b) Level 6 to Roof base or beam-column joint failure; c) R 3 failure base and top; d) R4 Level 6 to Roof with beam-column joint failure, still connected by rebar to e) R4' below which also f) indicates beam-column joint failure at R4' base (near camera); g) R8 with damage from mid-height still connected to R9 above h) with beam-column joint failure with i) underside of R9 smooth.

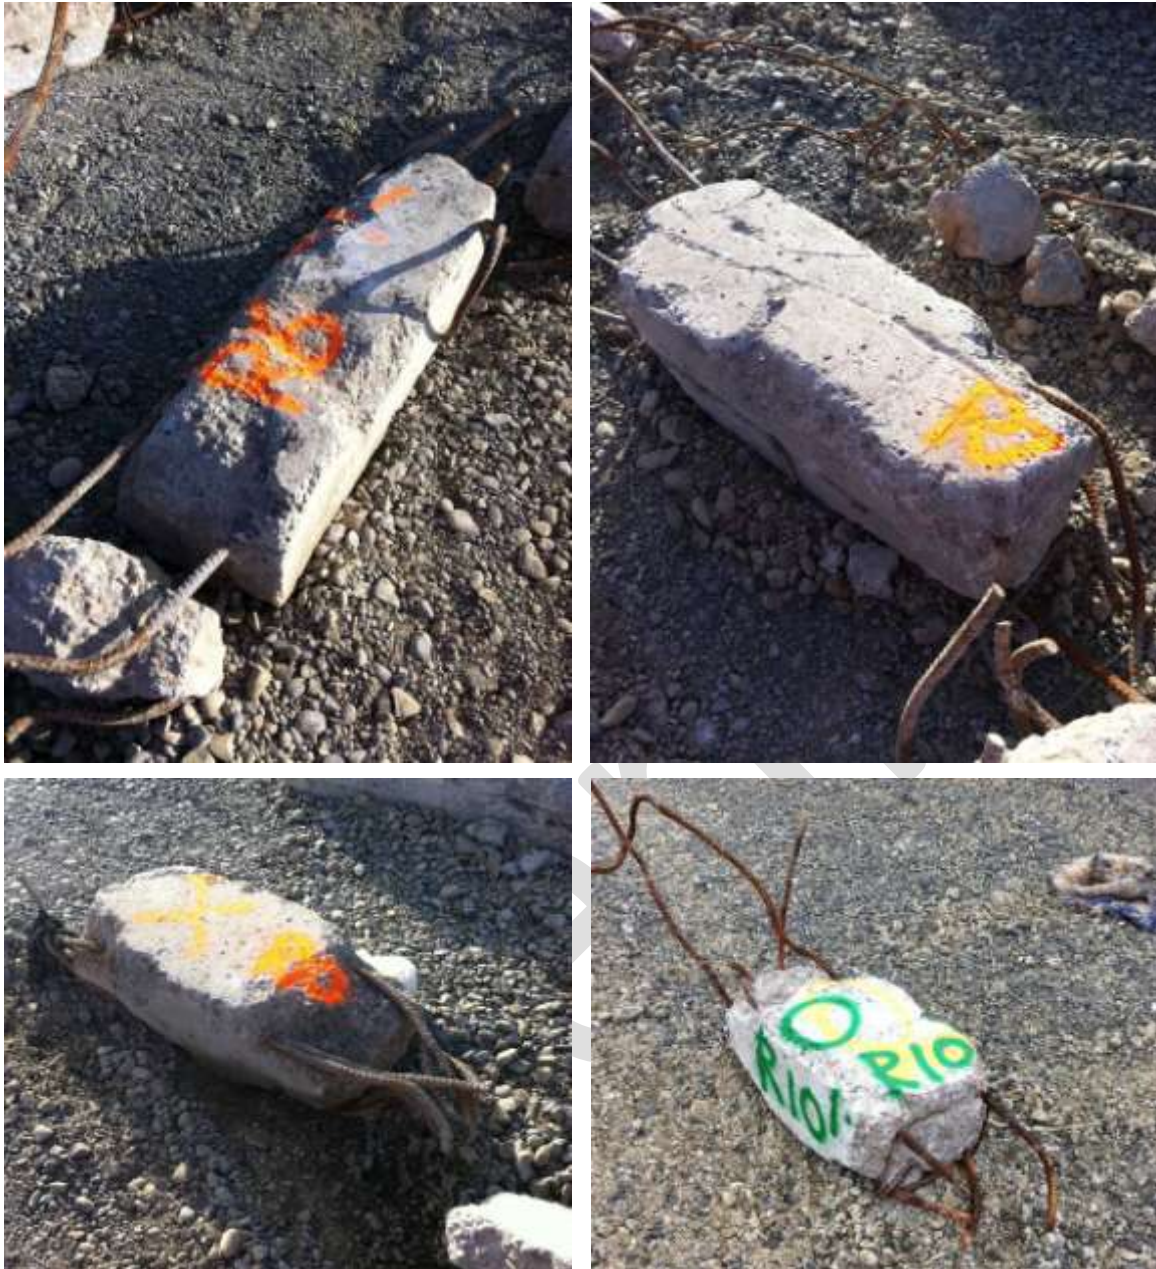
Figure 49 400 x 300 mm Rectangular Columns (from left to right and top down) a) R6 base at far end connected by reinforcing to b) R7 below, with beam-column joint failure; c) R10 remnant; d) R10' remnant.

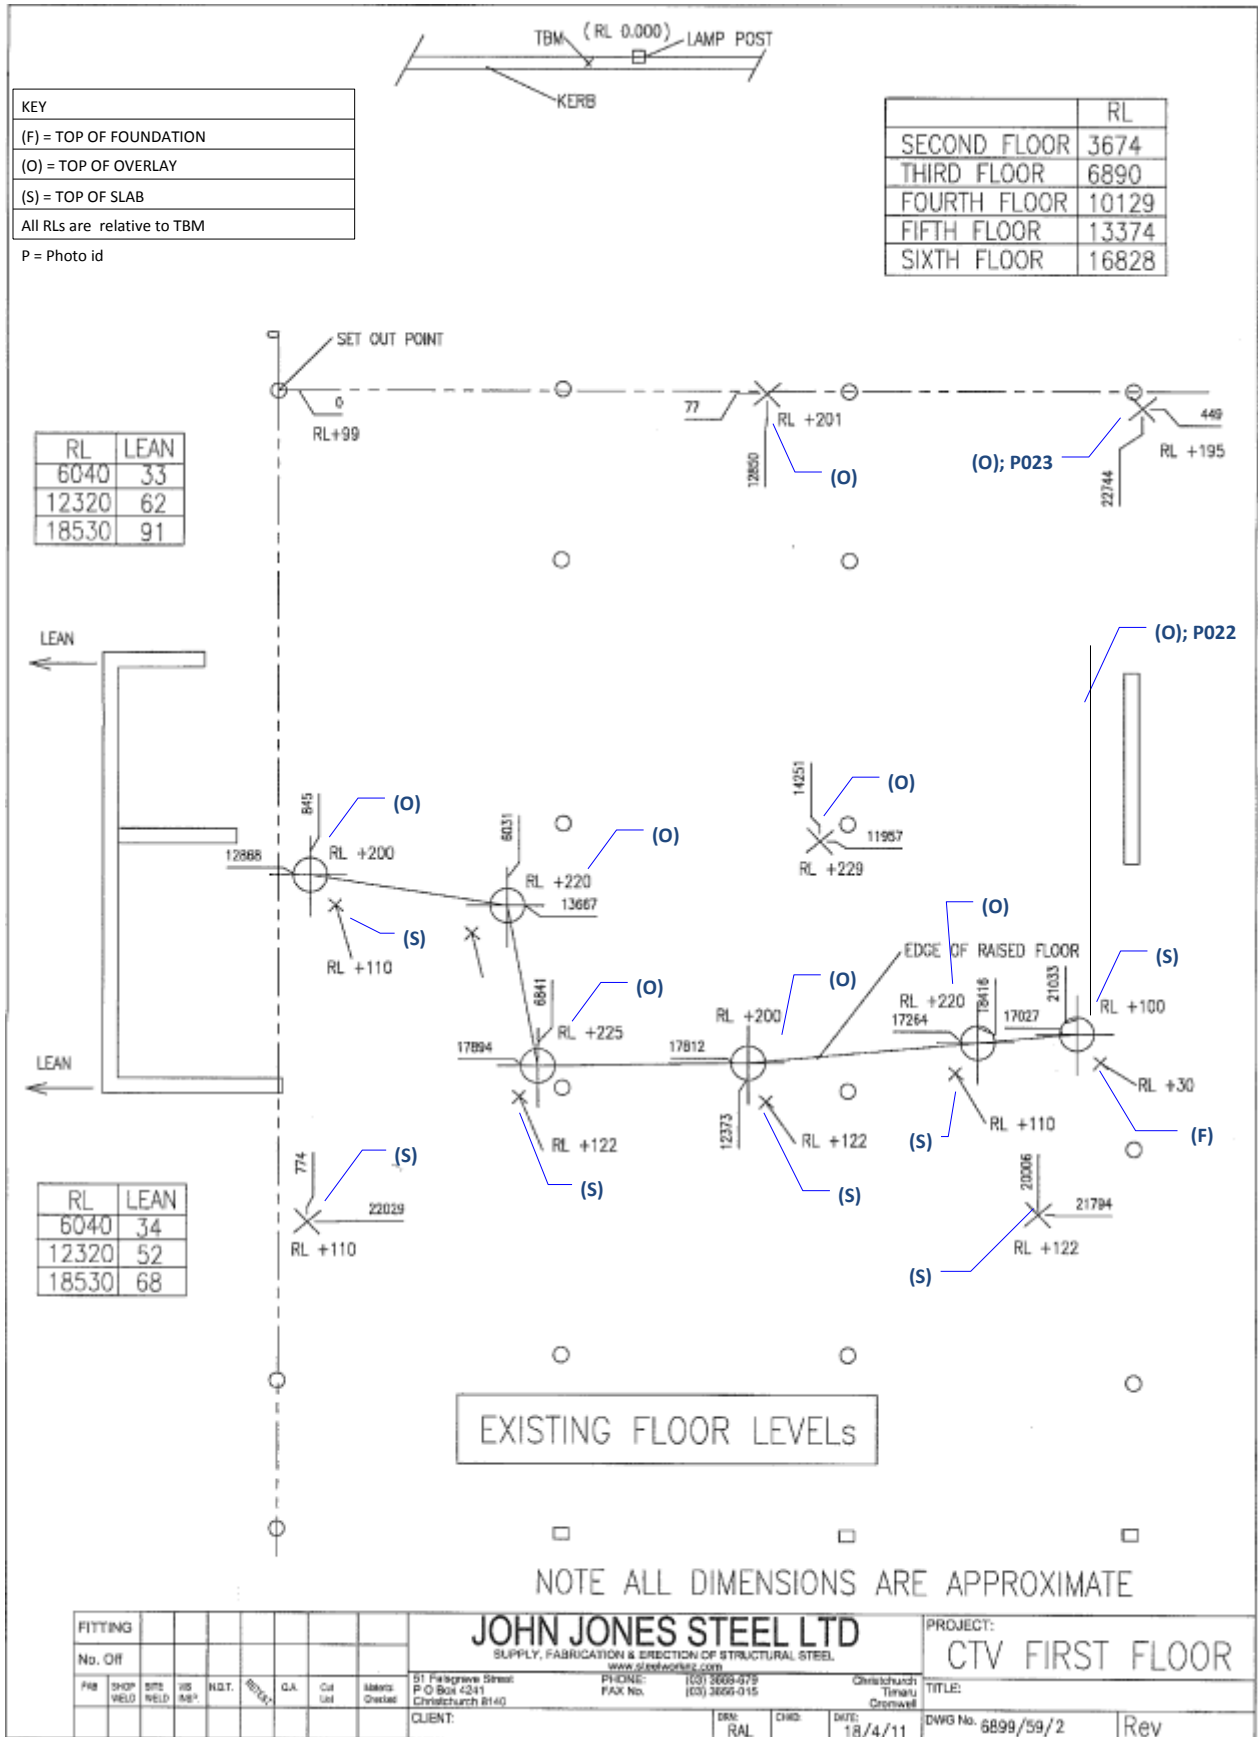
As no damage was found to the foundation beams around the core and no evidence of settlement could be inferred from the level survey of the slab, overlay and foundation beams it is concluded that the northward lean was caused during the construction of the core walls (Figure 50).

Figure 50 JJS Dwg 2: Location of overlay edge and lift core lean annotated with levels on adjacent concrete identified as 100mm overlay (O), 125mm slab (S) or foundation beam (F).
