CTV BUILDING COLLAPSE INVESTIGATION  
FOR CEBPTI PANEL  
FOR DEPARTMENT OF BUILDING AND HOUSING  
11TH AUGUST

Report Title: CTV Building Collapse Investigation  
Report Number: DBH 110628

Report Issue Date: 15<sup>th</sup> August 2011  
Report Issue Status: Draft

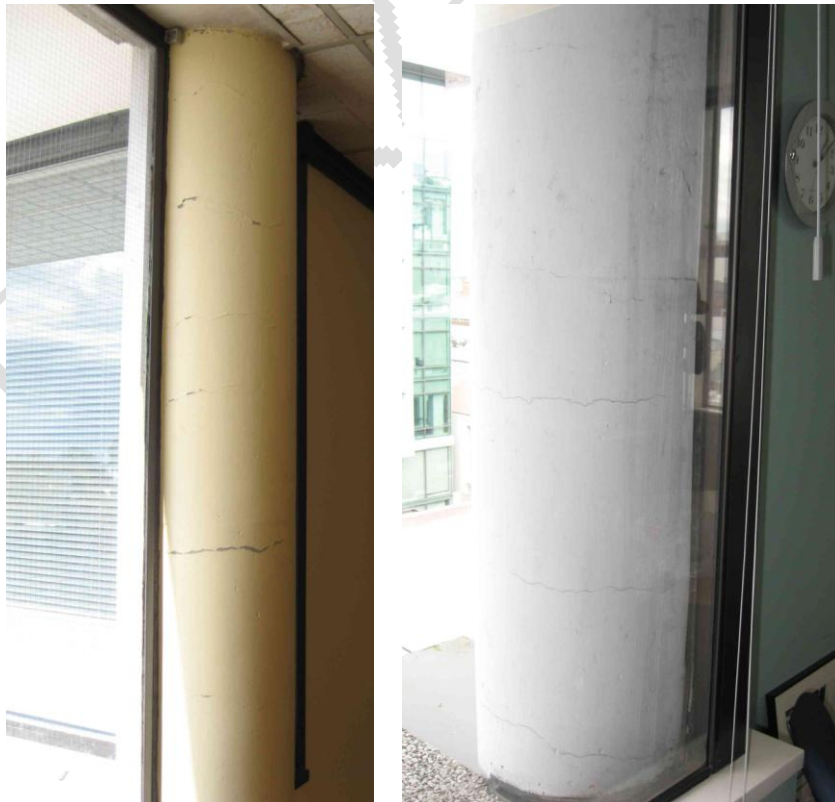
Figure 7 Level 6 400 mm diameter columns (Left to right) a) Column C18 outside lift; b) Column C3 on Line 1/A-B with hairline horizontal cracking

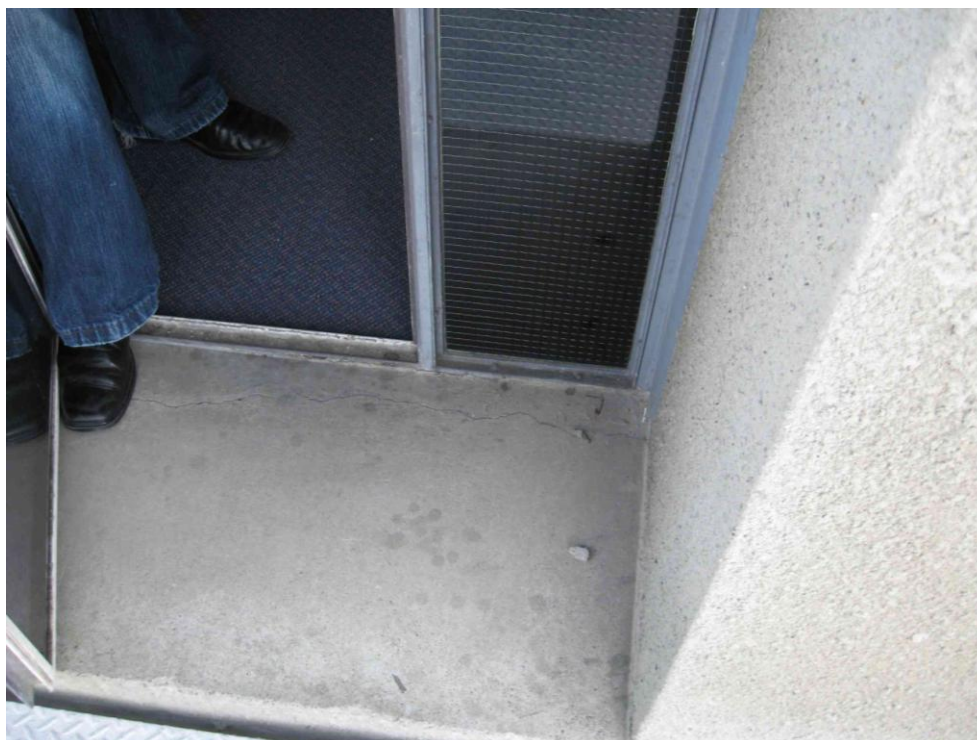
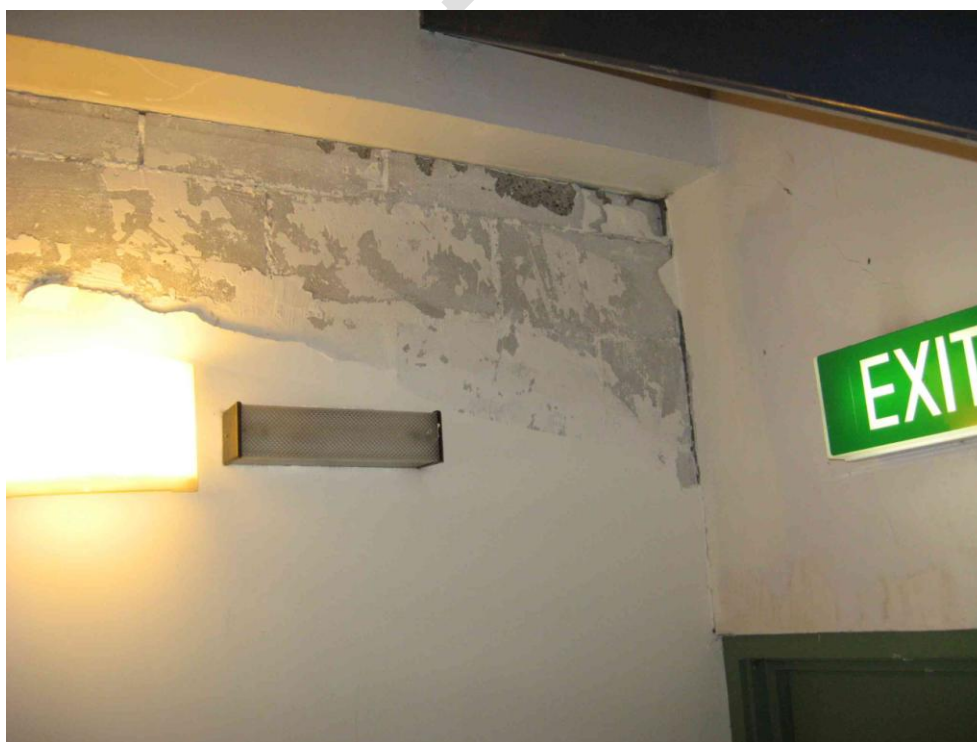
Figure 8 (Top to Bottom) a) hairline cracking in slab at Line 1 shear wall door at Level 4; b) Damage to plaster on infill blockwall at Level 1 Line 4

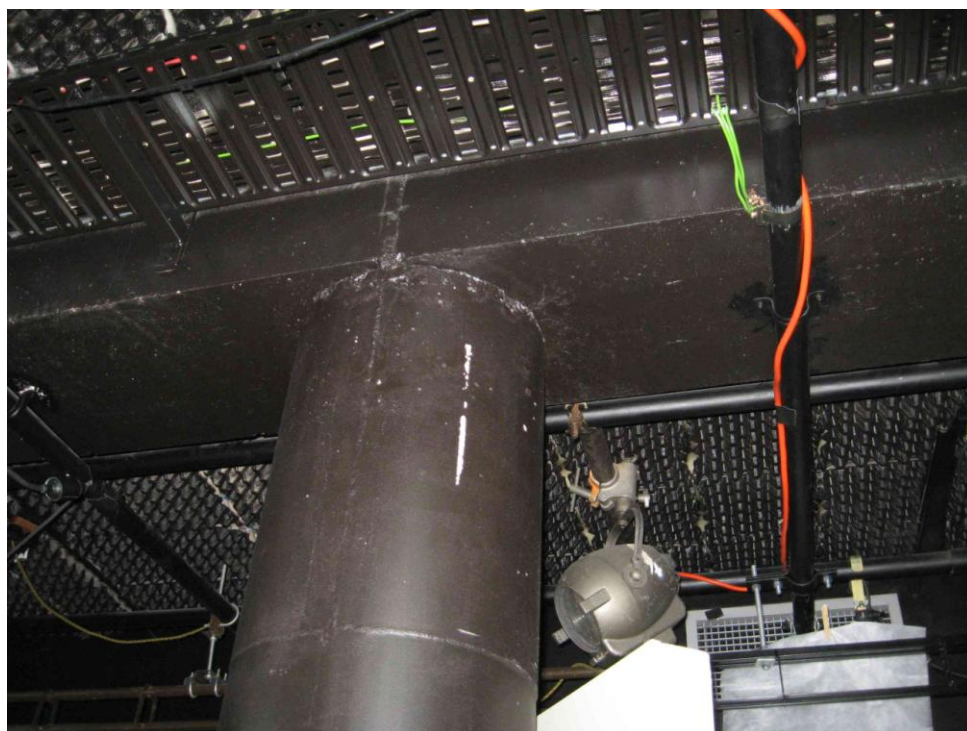
Figure 9 beam column joint on Line 2 or 3 at Level 1

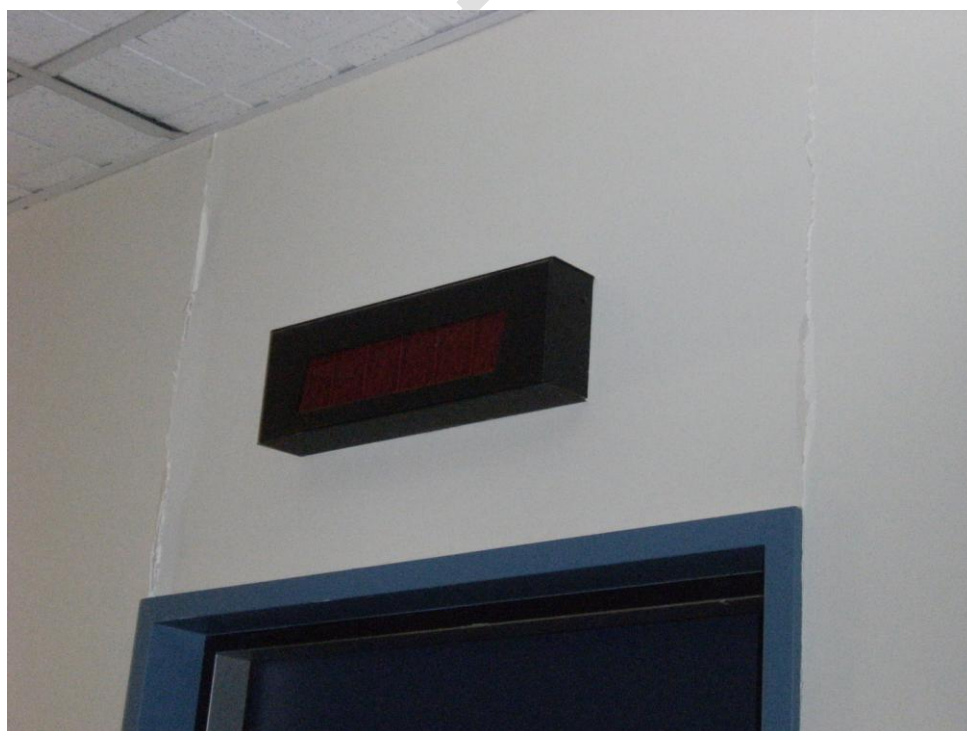
Figure 10 damage to wall Linings

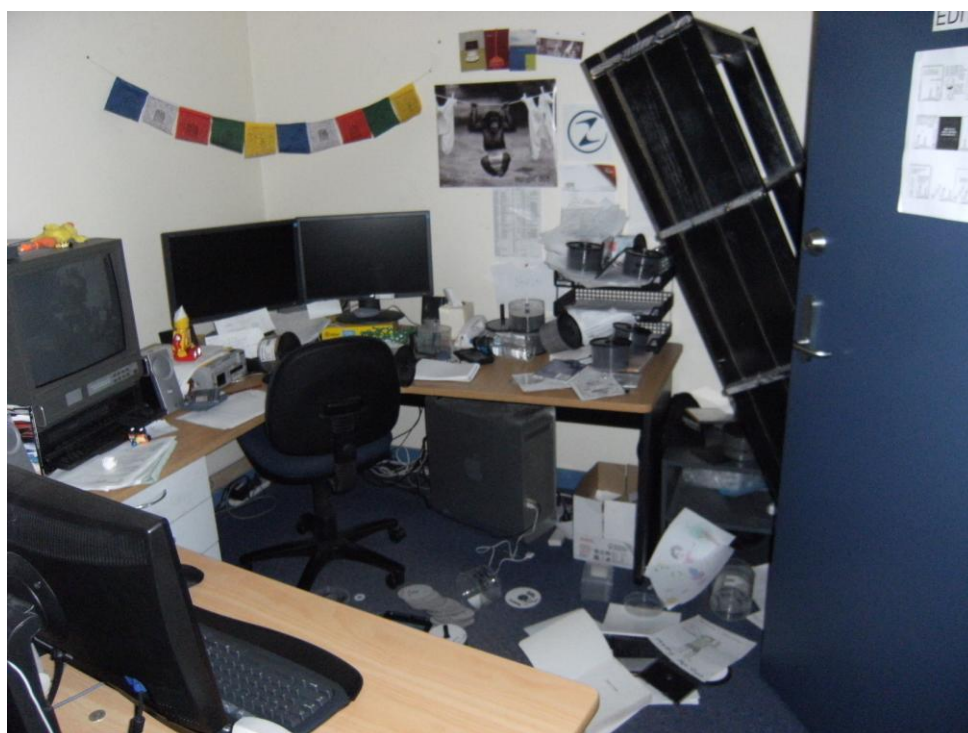
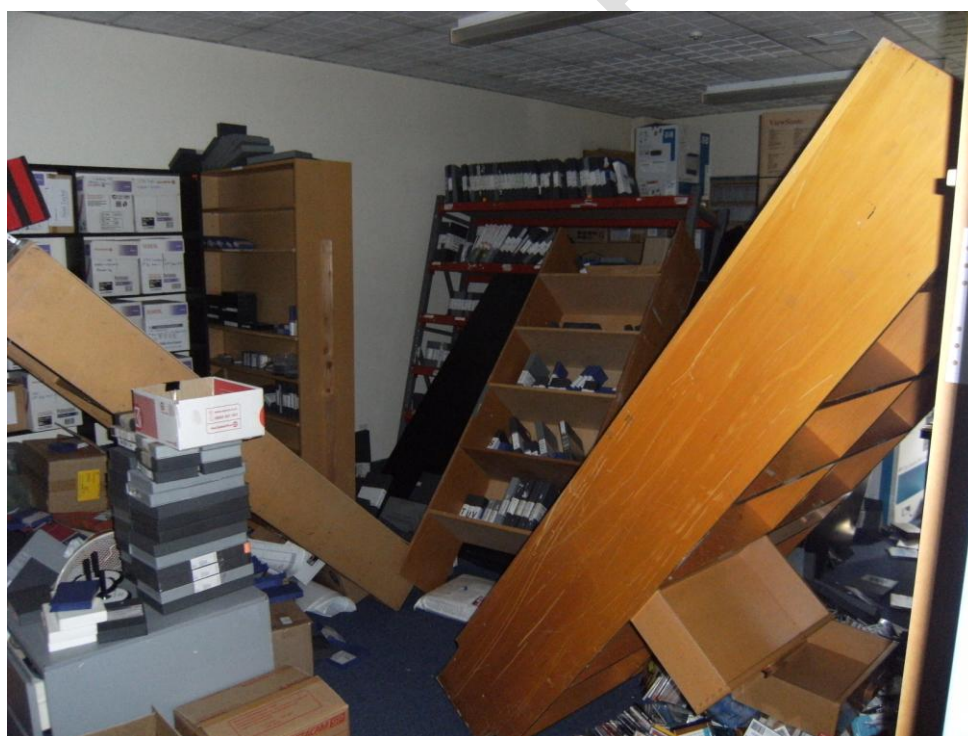
Figure 11 Contents damage on Level 2

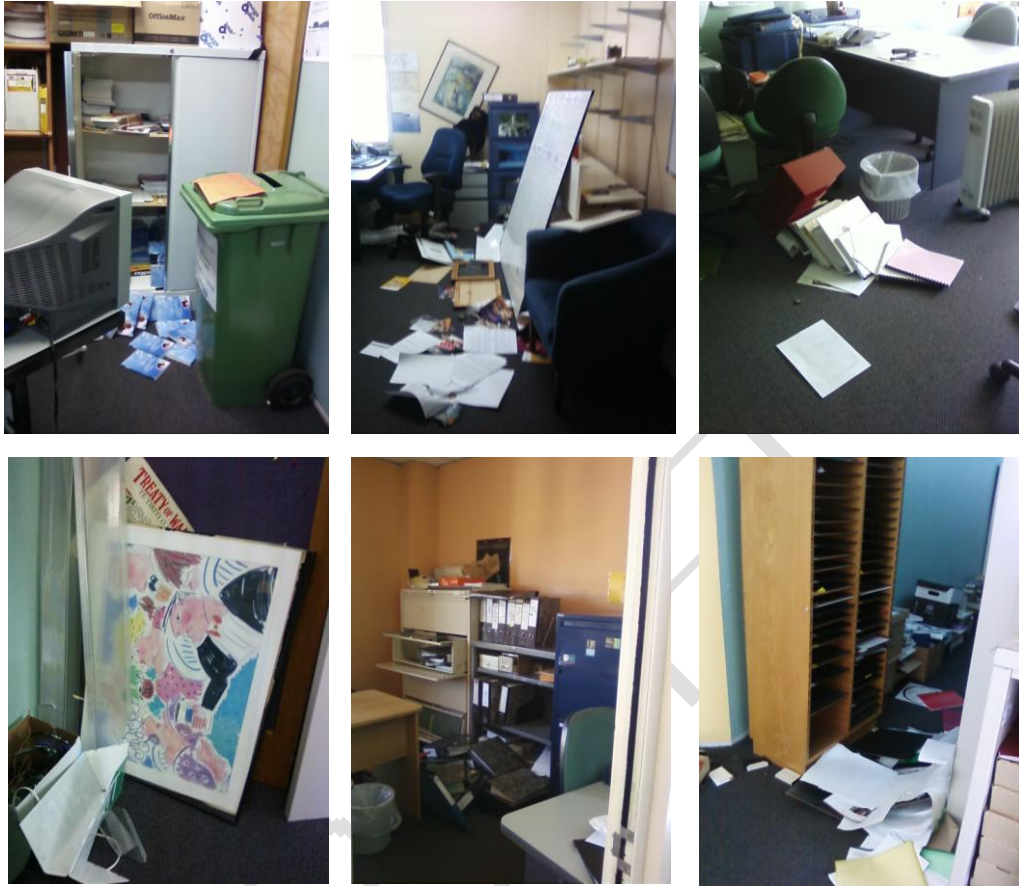
It is concluded on the basis of the above that there was no significant structural damage to the building after the 26<sup>th</sup> December aftershock, though damage to glass, partitions and hairline cracking to some structural concrete.

Figure 13 Damage after 26th December , 2010 after-shock on Level 6 of CTV Building (clockwise from top left) a) Cabinet door had opened but hadn't fallen over though not attached to the wall (Line 3/B-C); b) As it was except that the filing cabinet had been stood back up (Line 2/A-B); c) Oil heater had been righted. Two filing cabinets had fallen to the floor; (Line 1/B-C) d) The cubby-hole unit had not emptied of papers in the earthquake on 4<sup>th</sup> September. However in December it had fallen against the corridor wall towards Cashell Street. It had been righted before the photo was taken (Line 2/B-C) E) The shelves and filing cabinets had gone down, but had been righted before the photo was taken (Line 4/A-B). F) The painting had fallen from the wall. (Line 1/A-B).

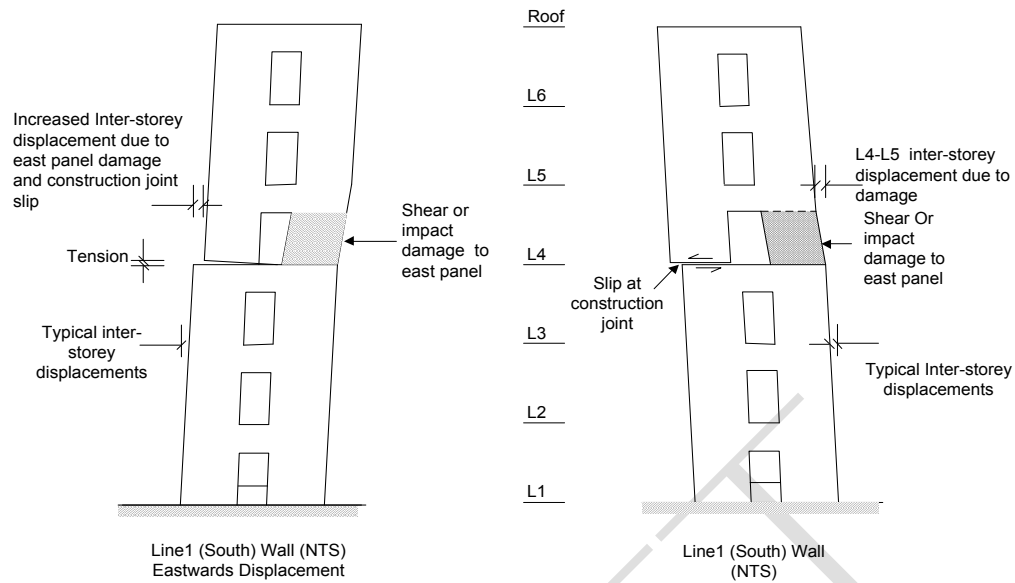
The damage to the east panel of the Line 1 shear wall may have further increased the differential inter-story floor displacements between Level 4 and 5 and the resulting damage to the perimeter columns (Figure 16).

Figure 16 Shear or impact damage on Line 1 shear wall at Level 4 to 5

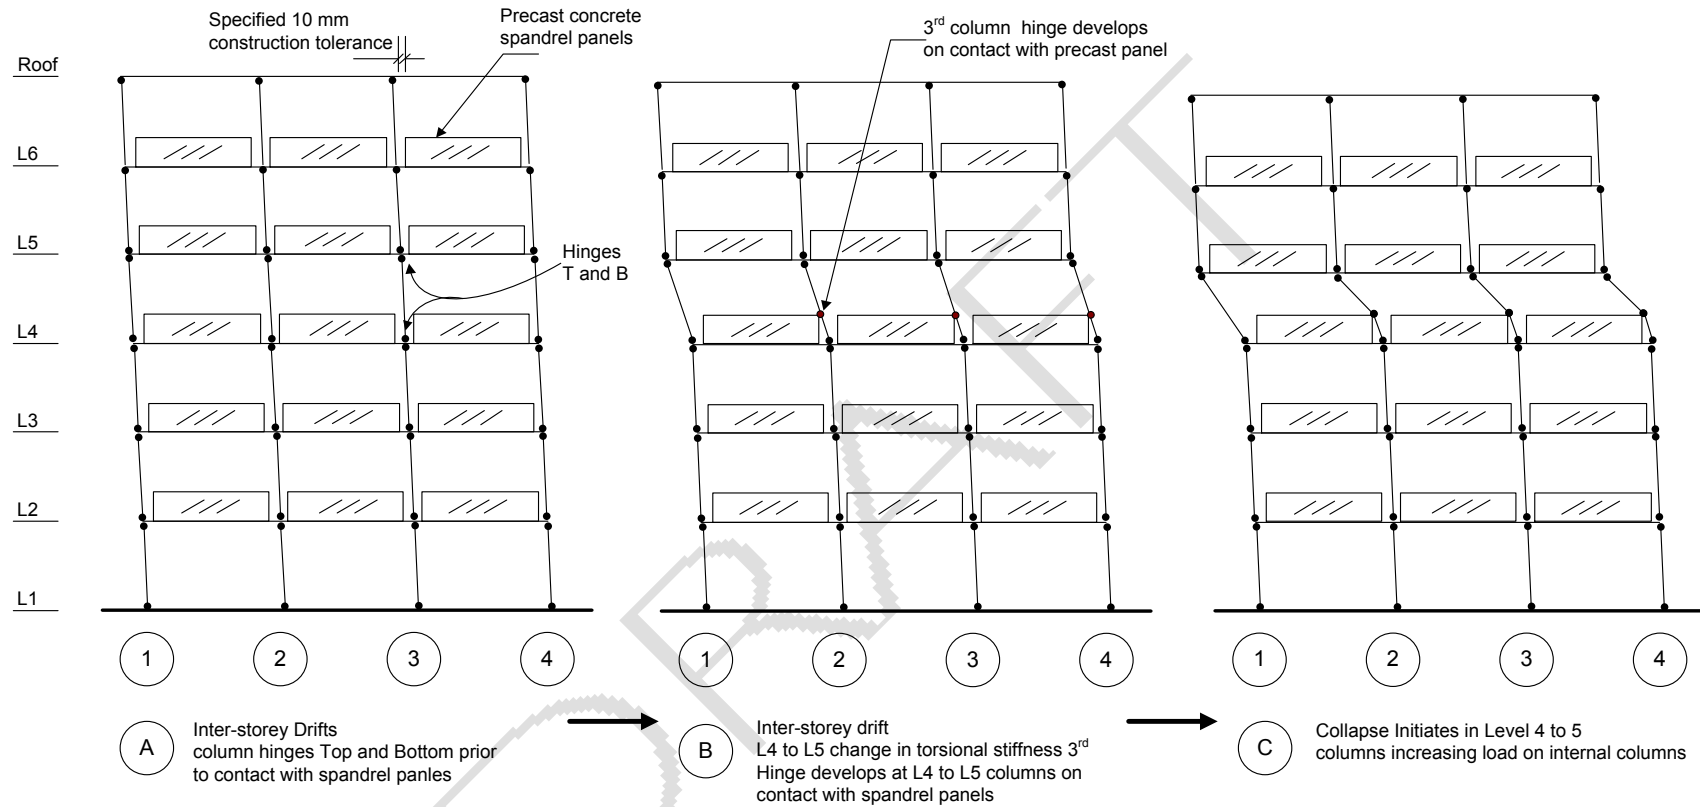
Figure I7 Development of perimeter column collapse mechanism on Madras Street Line F at Level 4

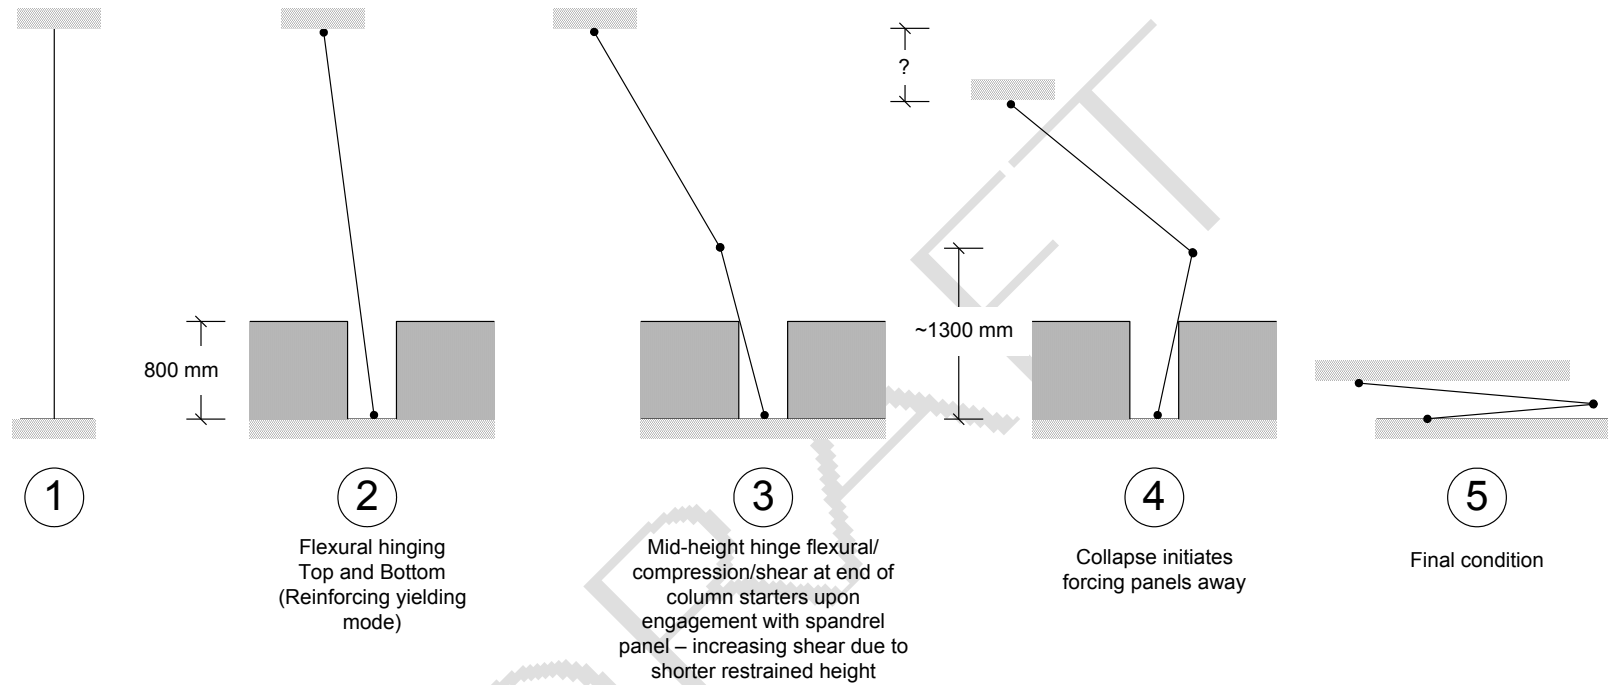
The development of a column collapse mechanism in the level 4 perimeter columns initiated the collapse of the building. Structural hinging damage at the top, bottom and mid-height of perimeter columns formed a mechanism in them that meant those columns could not sustain any vertical actions (Figure 18).

Figure 18 Perimeter column collapse mechanism development from interaction with spandrel panels

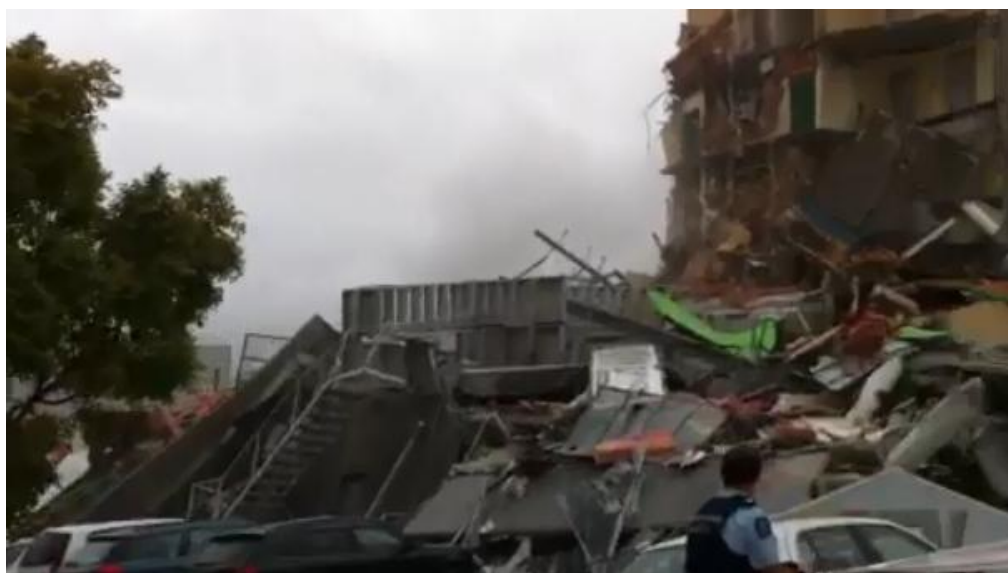
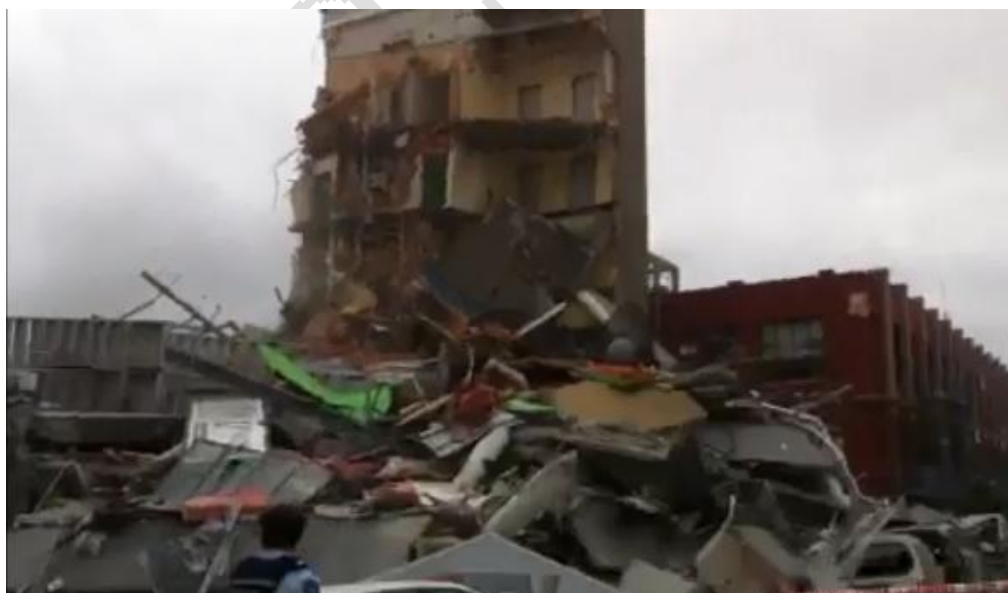
Figure 44 Corner of Cashell and Madras Street faces (Line 1/F). Fractured columns in foreground

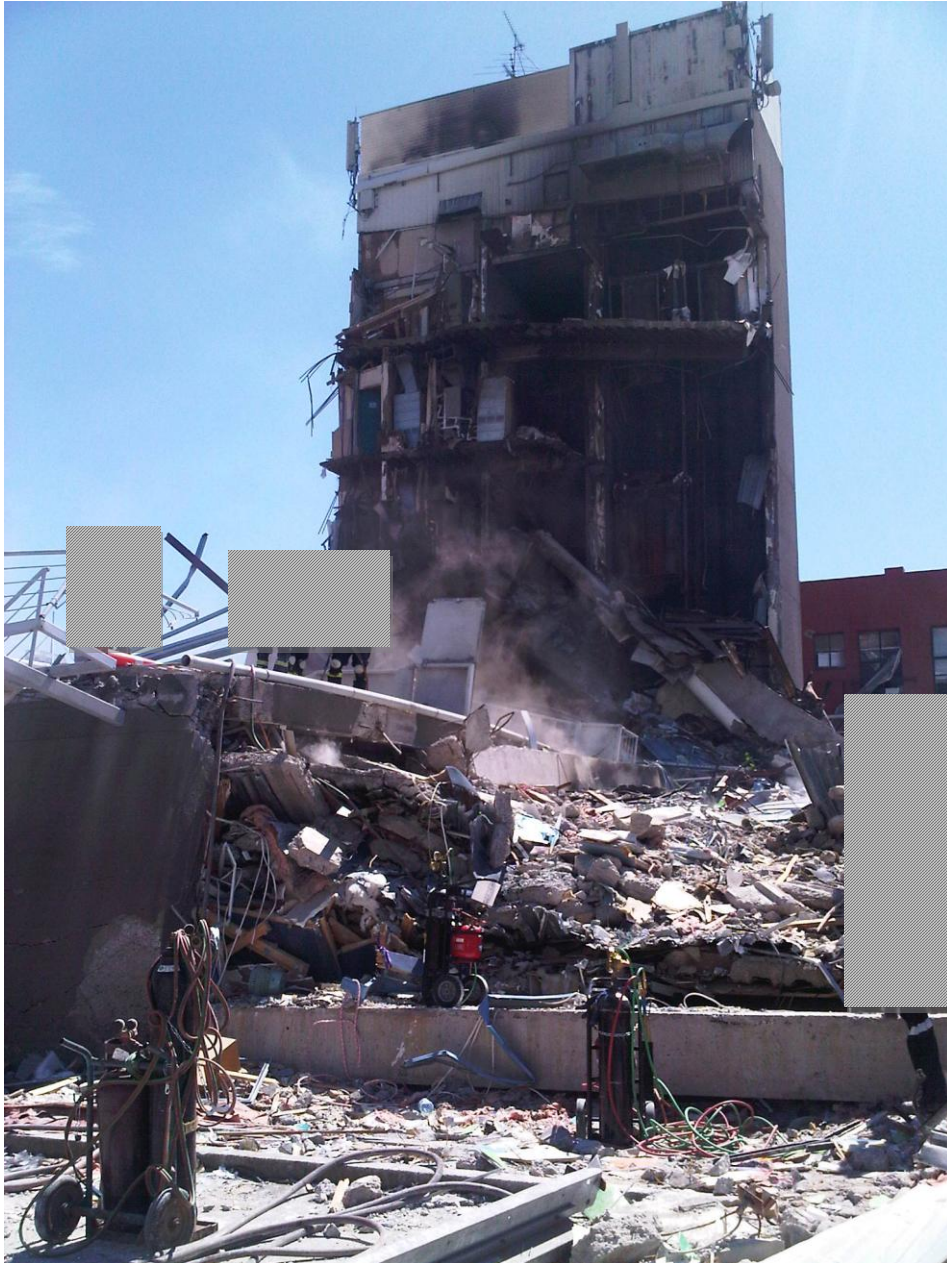
Figure 53 View from Cashell Street east side of Line 1 with Line 1 shear wall lying on debris at left; trapezoidal end profile of floor slabs laying on top of each other in foreground; Remnant of lift core slabs and column C18 at rear. Level 6 slab in front of lift core still in place though column C18 has collapsed below.

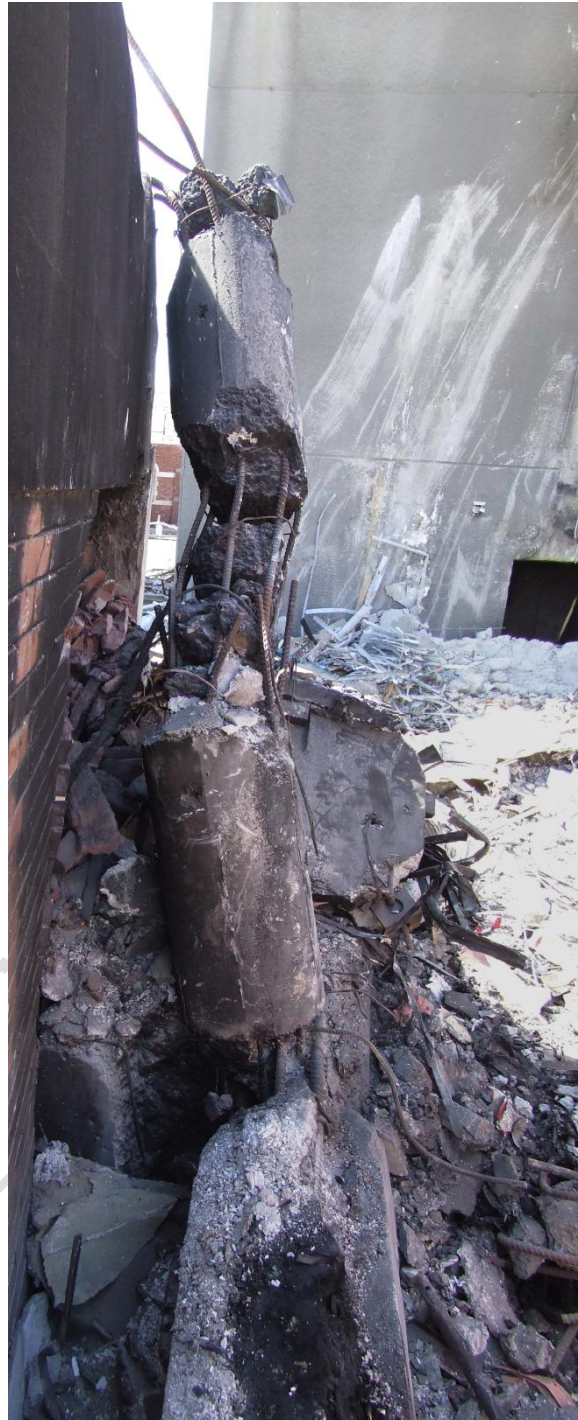
Figure 69 Line 4 / B spandrel column with B22 precast log beam in foreground and B23 shell beam at rear. No hinging is apparent at the base of the column compared to the perimeter column Item E33 (refer Site Examination and Materials Test Report)

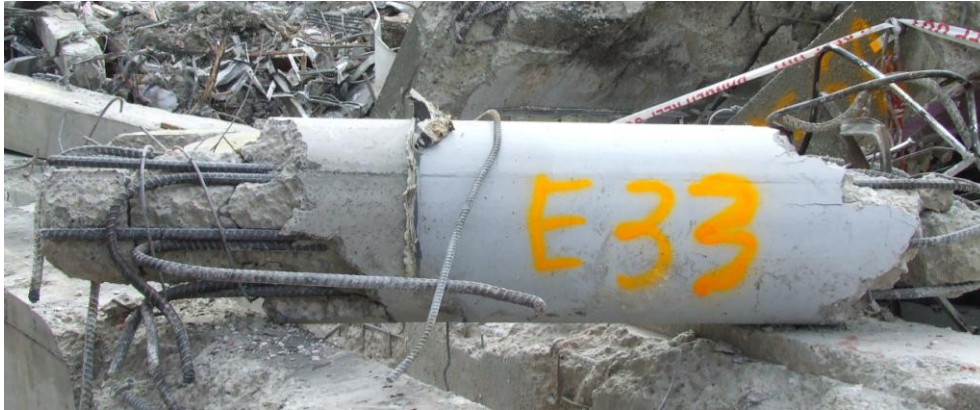
Figure 70 Perimeter 400 mm diameter column with spalled base and bar lapping zone at left unpainted portion that would have been located at spandrel panel infill areas (refer Site Examination and Materials Test Report)

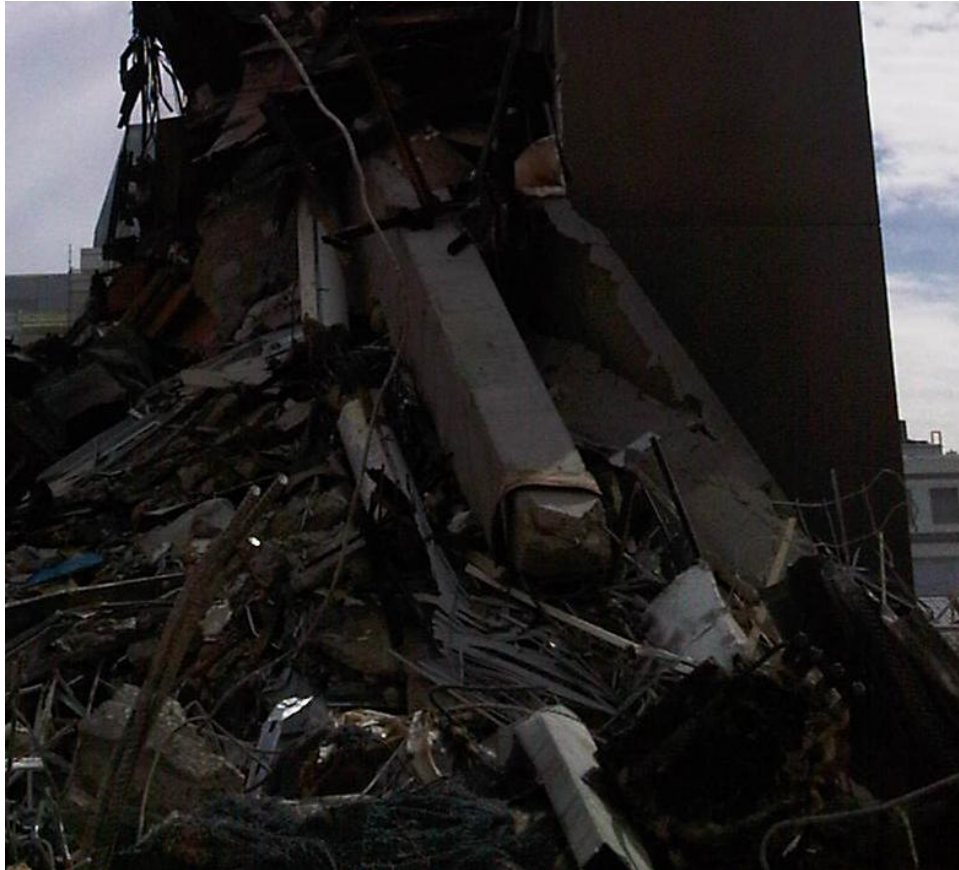
Figure 72 Lift core column C18 remnants among debris

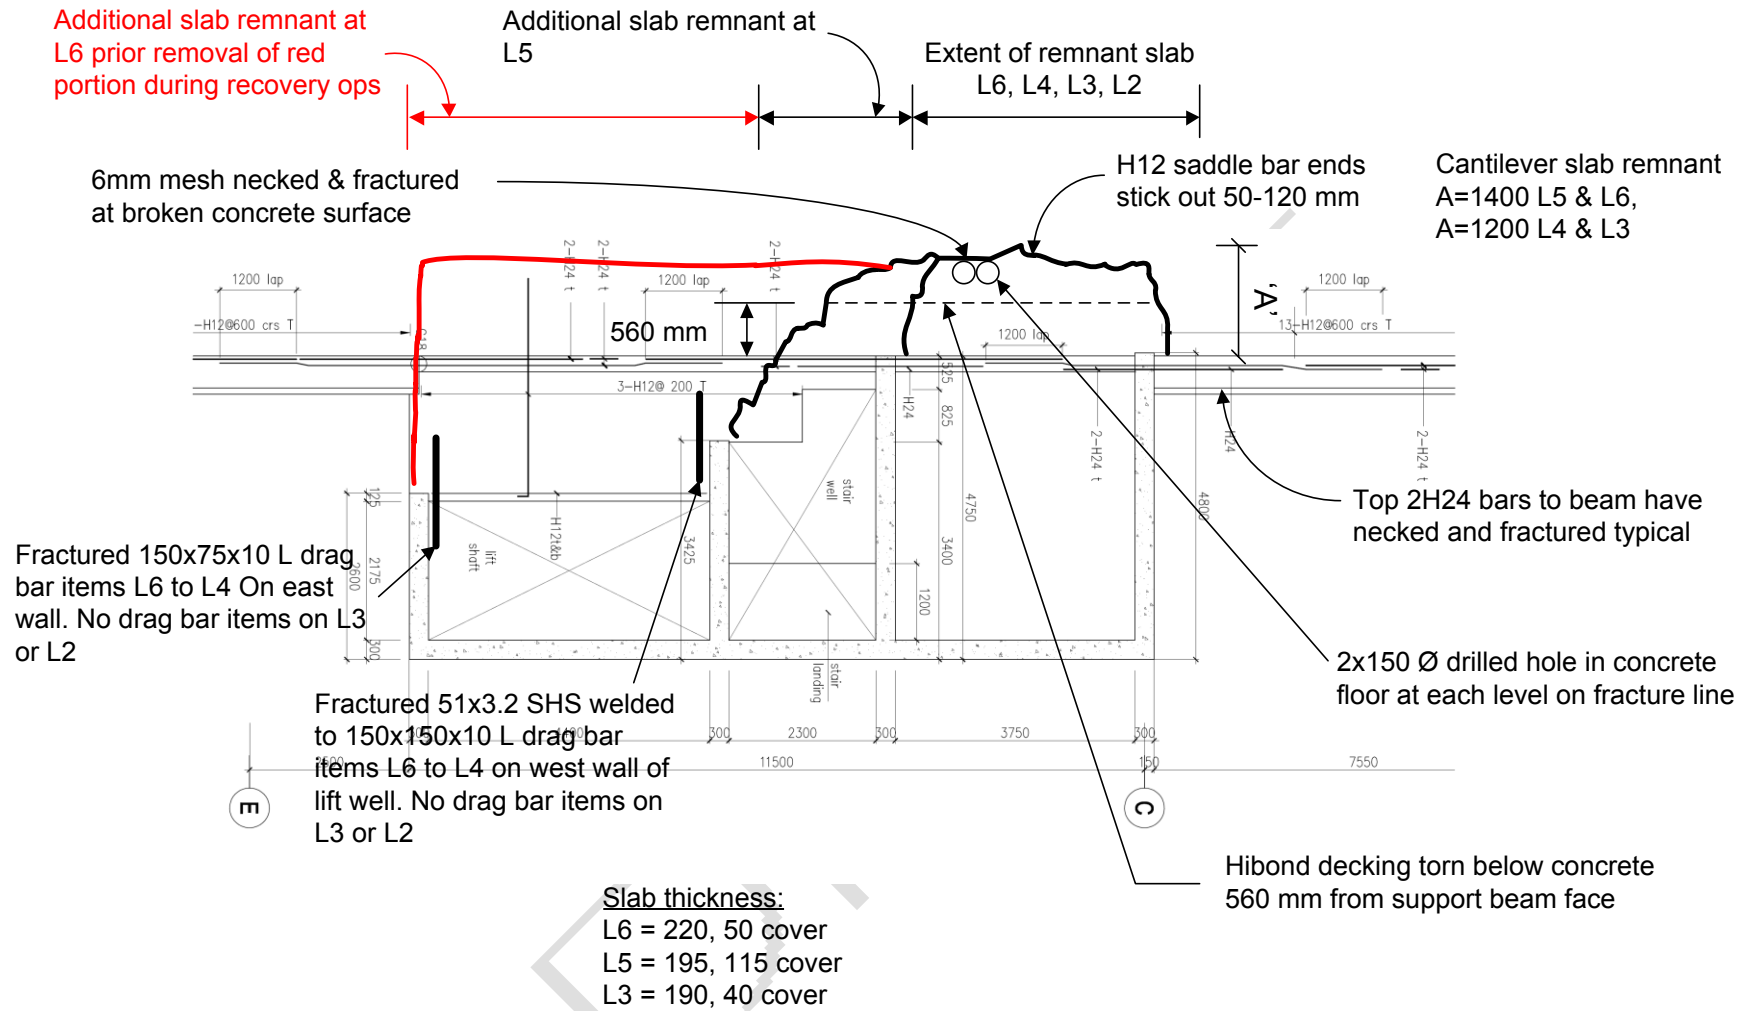
Figure 73 Lift core slab remnants after collapse

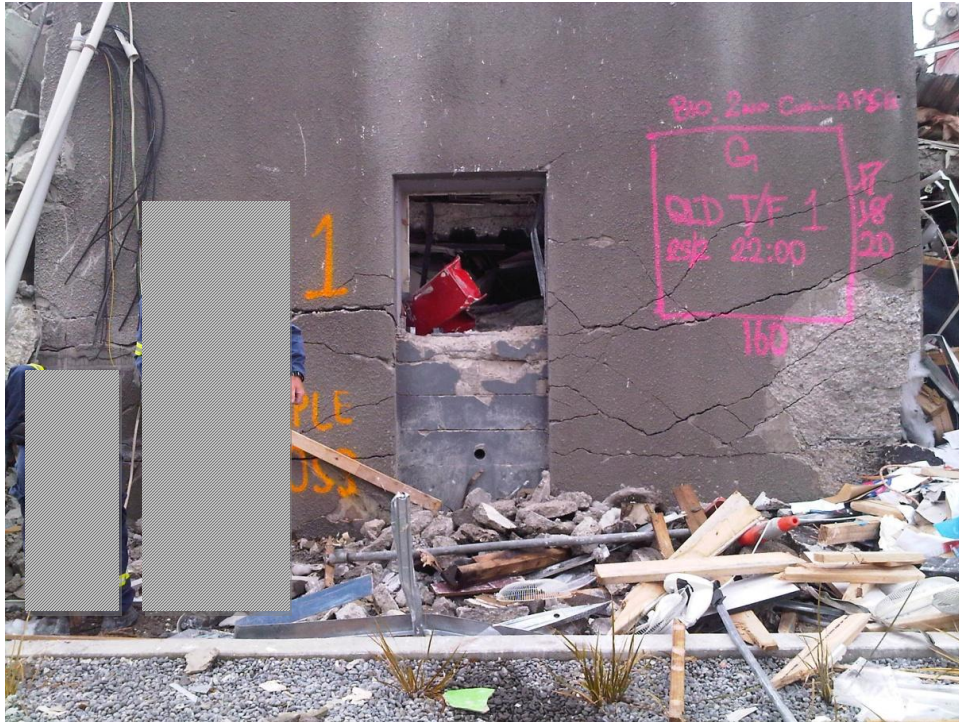
Figure 74 Line 1 shear wall at Level 1 showing masonry in-fill at door opening, in-plane flexural cracking and spalling of concrete at right (east) end

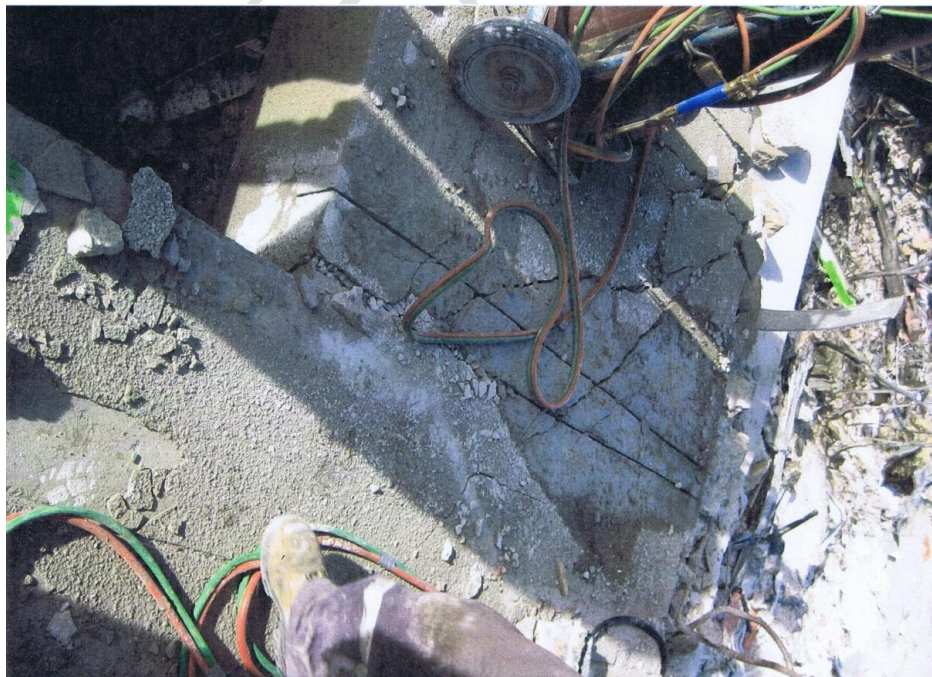
Figure 75 Line 1 shear wall at Level 4 being prepared for cutting and removal. Shear cracking in panel is visible under cutting equipment and hoses.

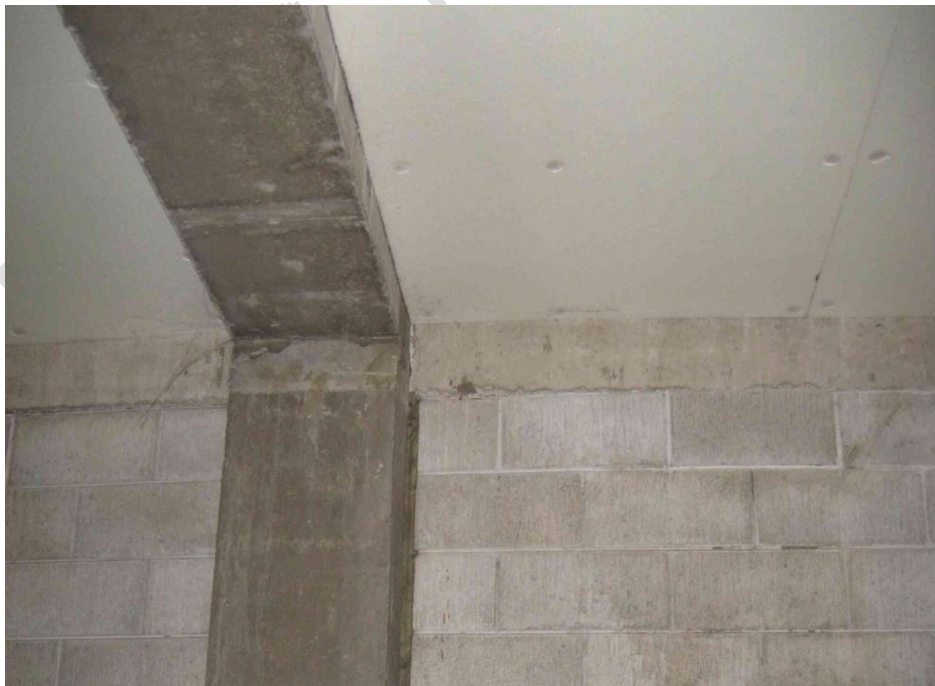
Figure 80 West Wall inside Level I car park after 4th September earthquake showing no apparent damage with sealant on vertical joint against column apparent on near side and no gap to underside of Line I floor beam above.

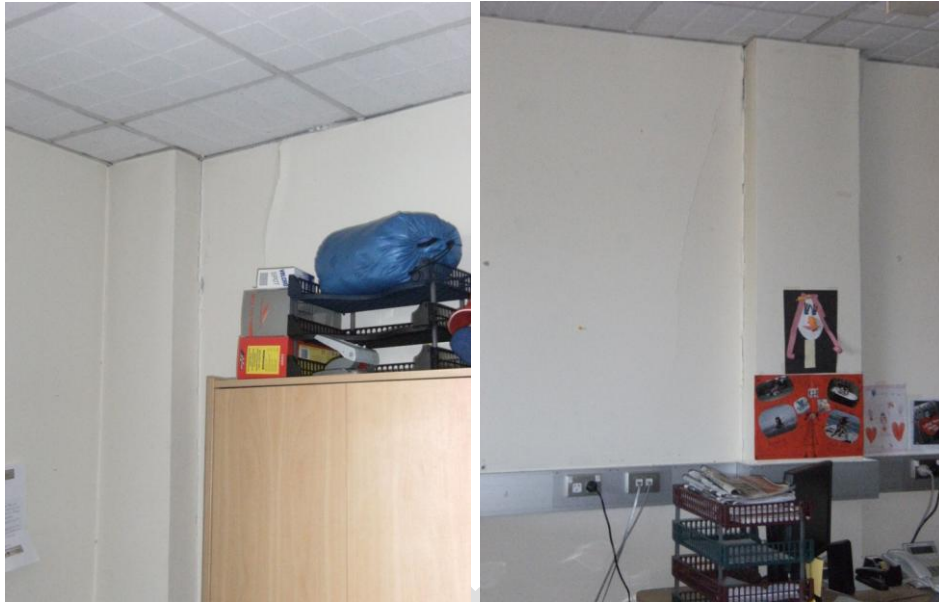
Figure 81 Inside of the west wall on Level 2 after the 4<sup>th</sup> September earthquake shows some damage to the linings

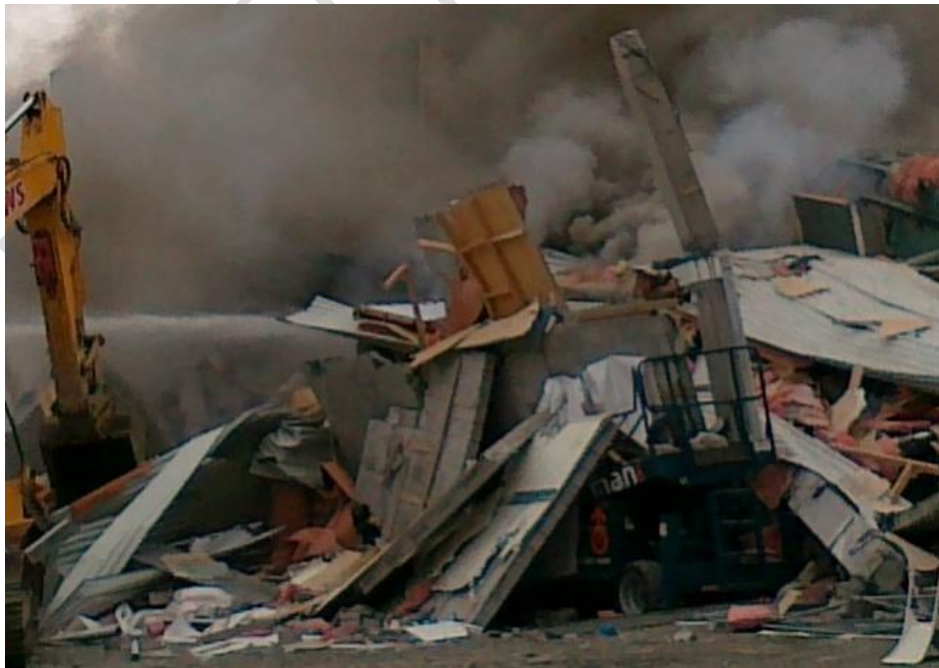
Figure 82 West (Line A) wall at south (Line 1) corner showing collapsed masonry in-fill panels

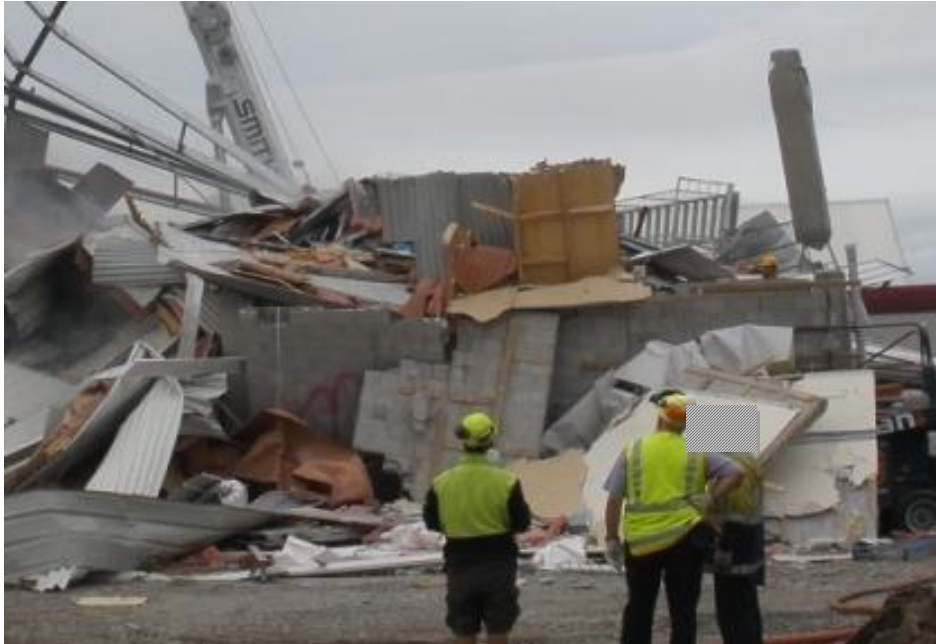
Figure 83 West wall shortly after collapse. The corner Grid 1/A column is still standing and the wall panels have broken free in panel sections in places. The edges of the panel section are square consistent with the design drawings
