Report to the Royal Commission of Inquiry

The Performance of Unreinforced Masonry Buildings in the 2010/2011 Canterbury Earthquake Swarm

Associate Professor Jason M. Ingham

August, 2011

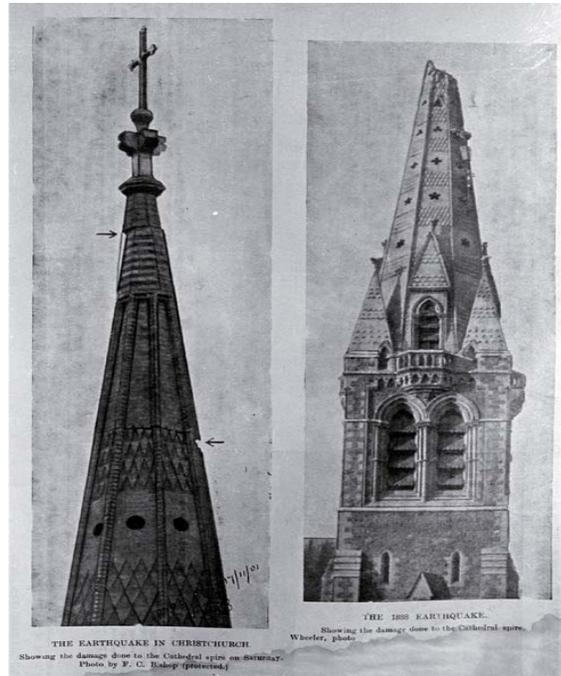
Figure 1.3 Damage to the Cathedral Spire in the 1888 (left) and 1901 (right) earthquakes (Bishop & Wheeler, 1901).

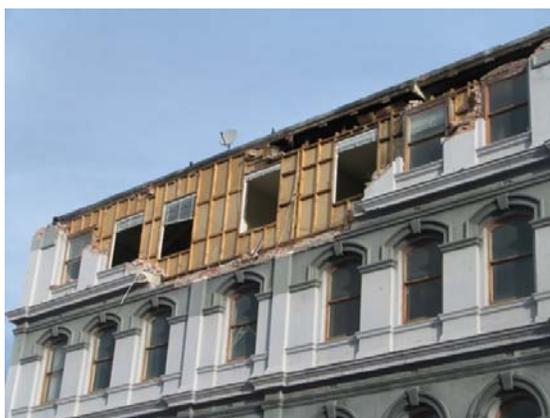
As shown in Figure 3.11, several examples of face load wall failure closely resembled observed damage in dry stack masonry experiments (Restrepo-Velez and Magenes, 2009), providing further support to the supposition that many of the wall failures were partly attributable to poor mortar strength.

(a) Wall damage at 140 Linchfield Street

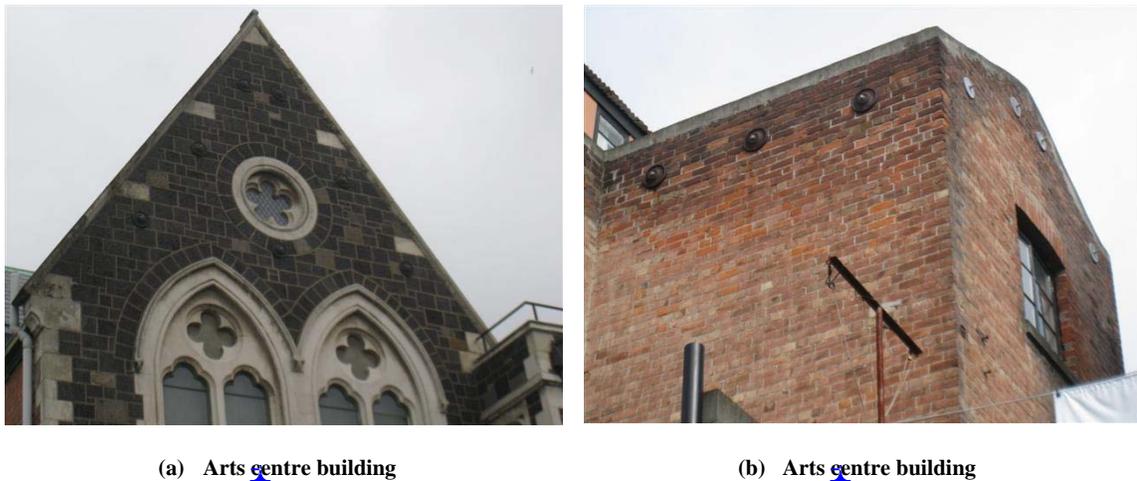
A significant feature of the earthquake was the number of occasions where anchored walls performed well during the earthquake. Photographs showing this are presented in Figure 3.14 and Figure 3.15. A typical wall-to-diaphragm (roof or floor) anchor typically consists of a long 20 mm bolt with a large circular disk of about 150-200 mm diameter between the wall exterior and nut that clamped the disk to the wall. This detail is shown quite clearly in Figure 3.13(a).

Figure 3.14 Successful gable end wall and side wall anchorages

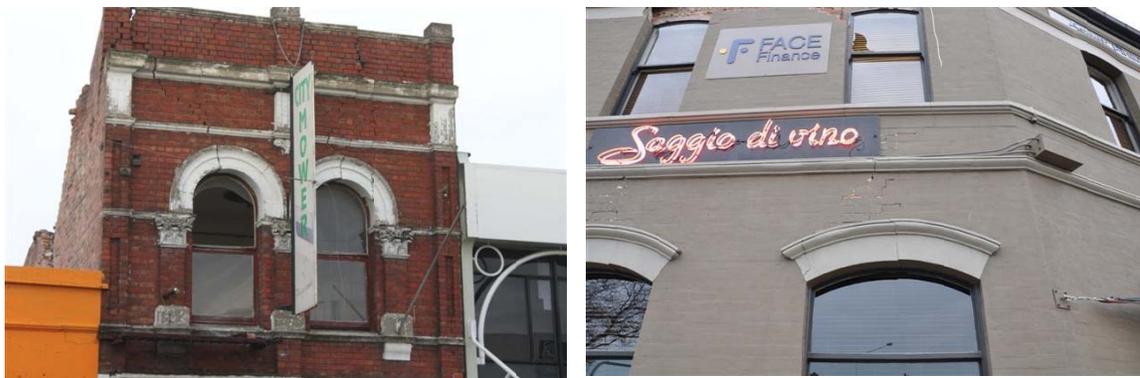
(a) Extensive vertical cracking above window openings

(b) Vertical crack above window opening

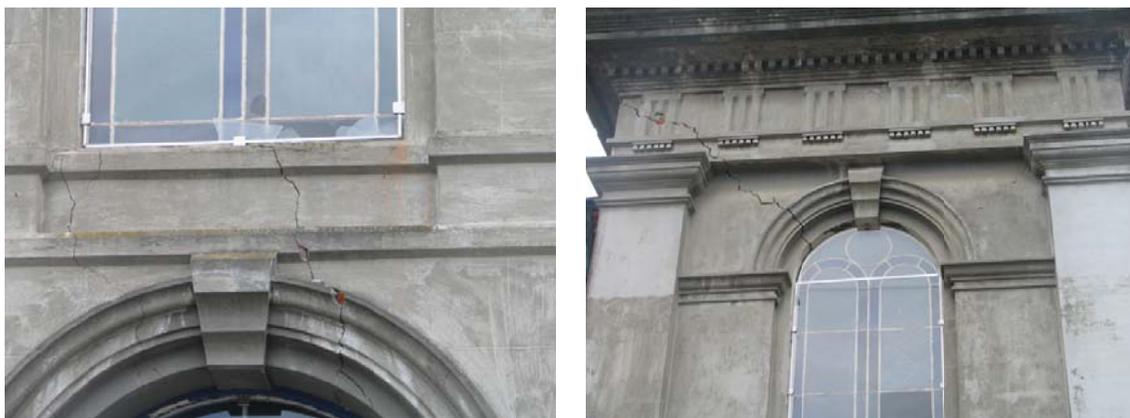
(c) Vertical crack through spandrel

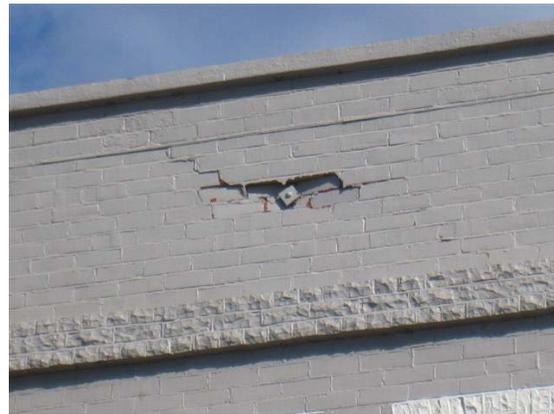
(b) Detail of partial anchorage failure

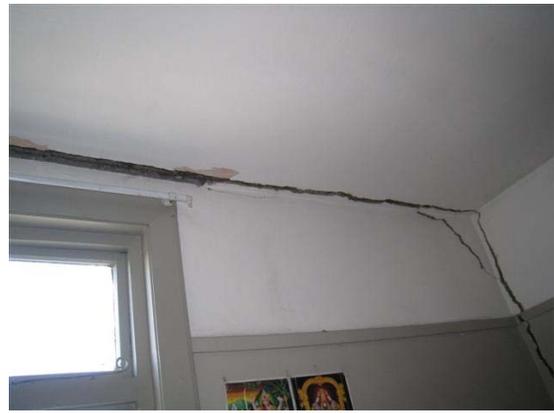
(d) Internal view showing wall separation

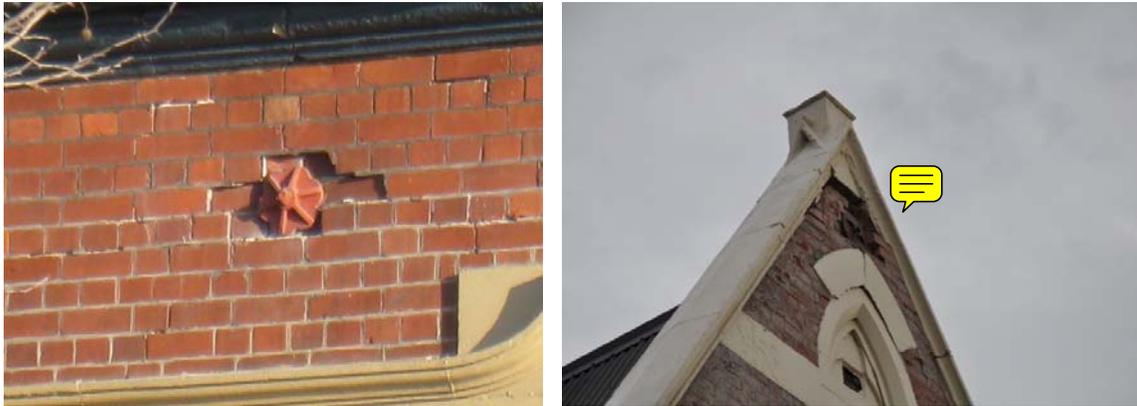
(a) Wall-roof anchorage failure

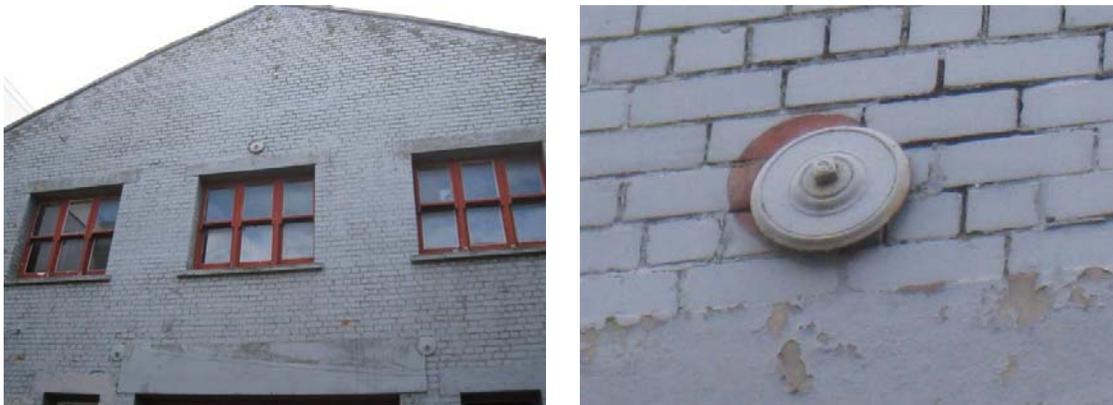
There were frequent examples of wall-diaphragm anchors that had deformed plastically. In these photographs (Figure 3.19), the circular plate can be seen to be slack due to plastic stretching of the anchor rod.

(a) Overview of wall anchors

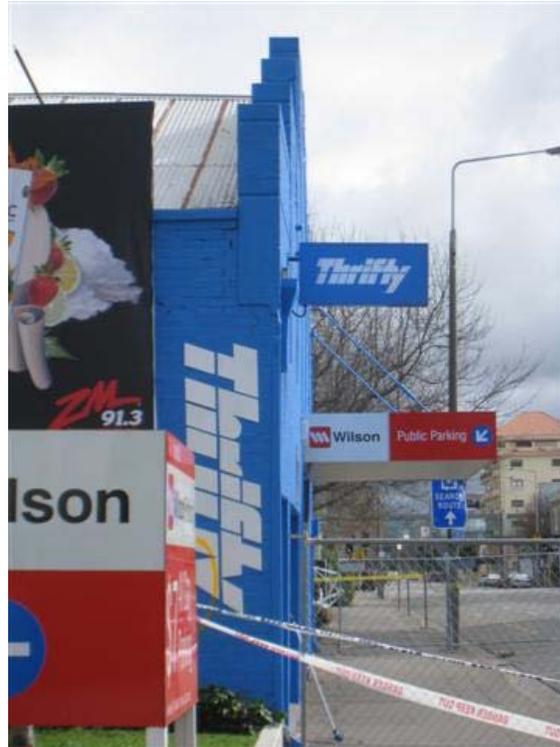
(c) Front wall curvature

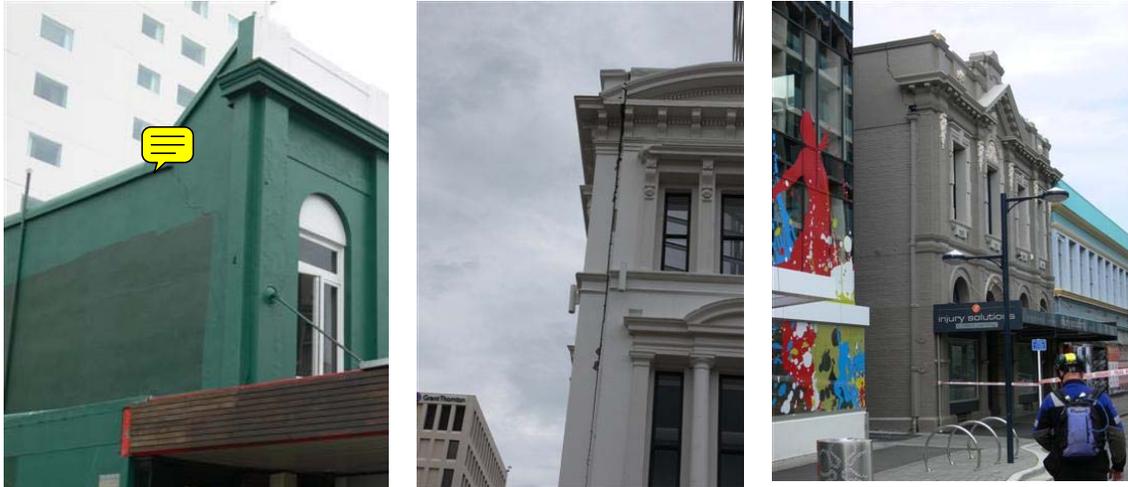
Figure 3.21 Examples of wall separation at corners of buildings

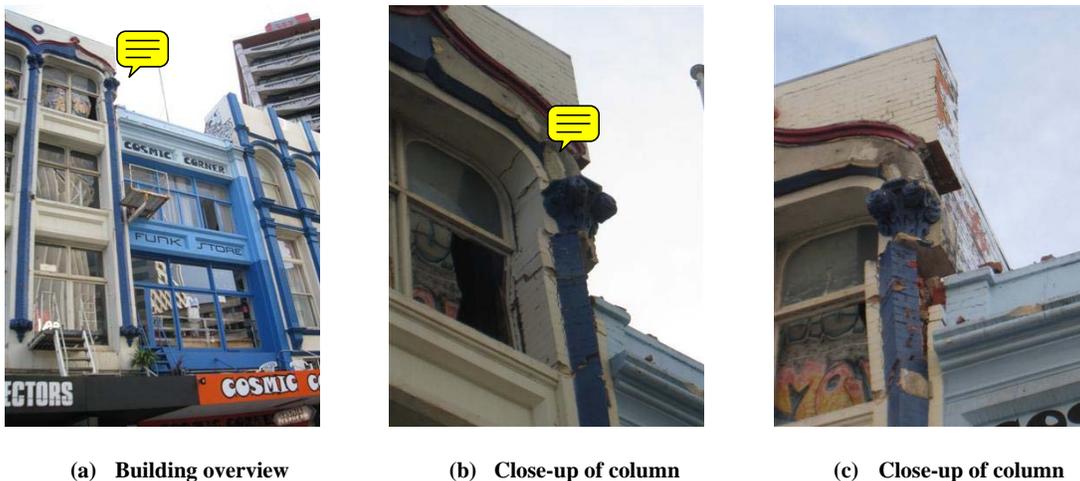
Several instances of damage due to buildings pounding against each other during the earthquake were observed. Figure 3.22 shows how the shorter building in the centre, which has different floor heights than the building to the left, damaged the column of the taller building at its top storey.

(a) Building overview

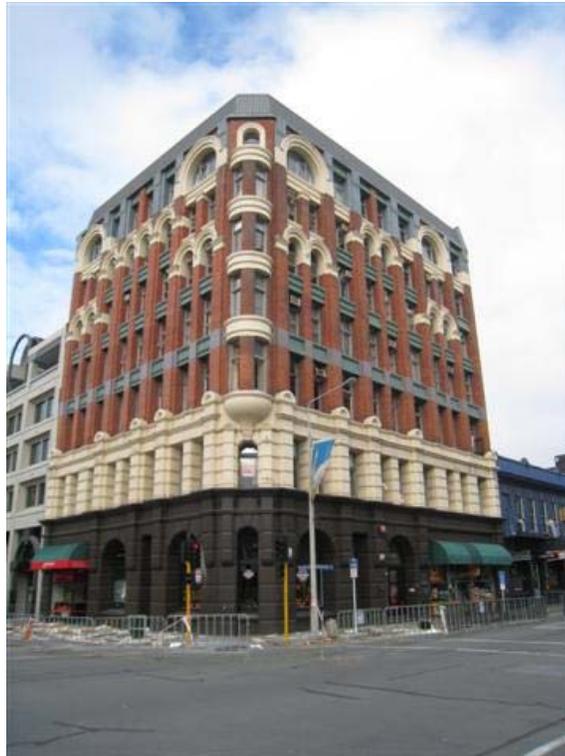
bearing unreinforced masonry piers around the exterior of the building and a steel frame internally (columns spaced roughly at 5 m) with timber floors throughout (New Zealand Historic Places Trust, 2010). The masonry piers, having dimensions of approximately 1200 x 900 mm, were badly cracked at levels 3 and 4 (Figure 3.24). This damage was most likely due to the transition from concrete to masonry at level 3 and the fact that the adjoining 2-storey building located along the southern wall side stopped providing lateral support at that level. It appears that the lift core had received some strengthening previously, as well as the roof, perhaps in the late 1980s as reported by the New Zealand Historic Places Trust (2010). Close up photographs of the masonry piers at levels 3 and 4 show the primary damage that concerned the assessment teams (Figure 3.24). Further inspection by the assessment team exposed the internal face of one pier on the western face of the building to reveal that the external cracking continued through the entire pier thickness.

Figure 3.23 Manchester Courts building (view from NW)

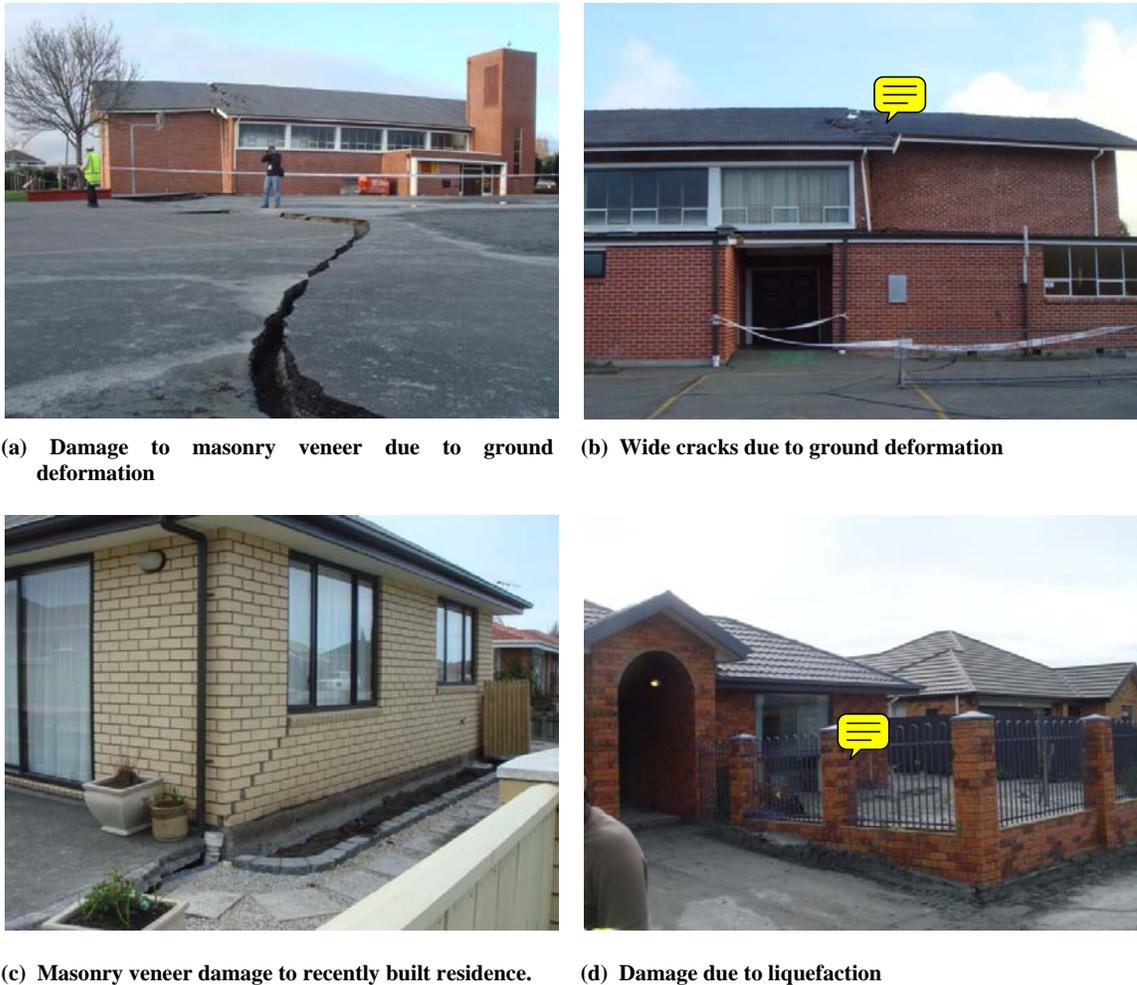
Figure 3.26 Damage to buildings having masonry veneer over timber frame, due to ground deformation and liquefaction

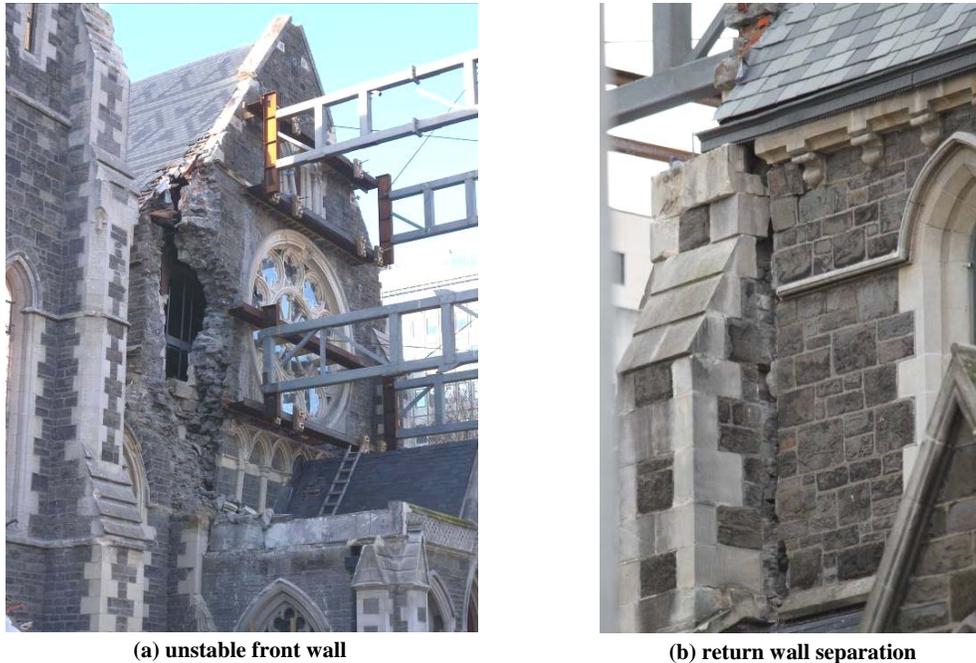
Figure 3.30 Christchurch Anglican Cathedral – front façade damage

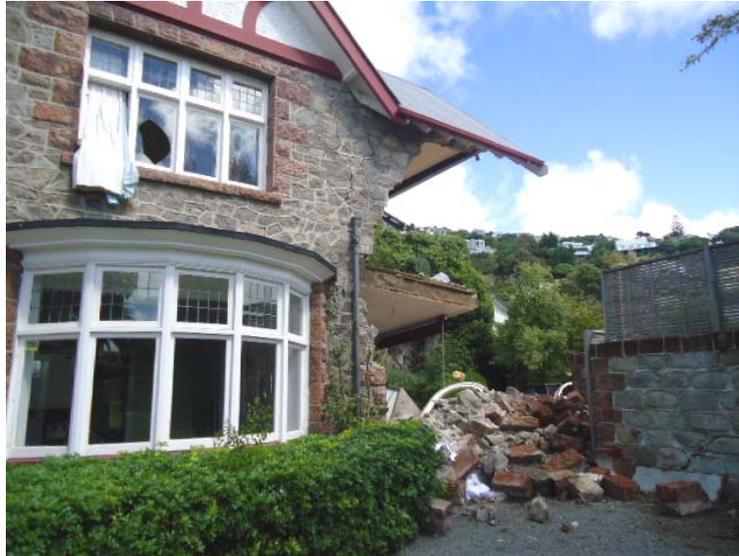
Figure 3.31 Rockvilla dwelling with complete collapse of the north and east façades

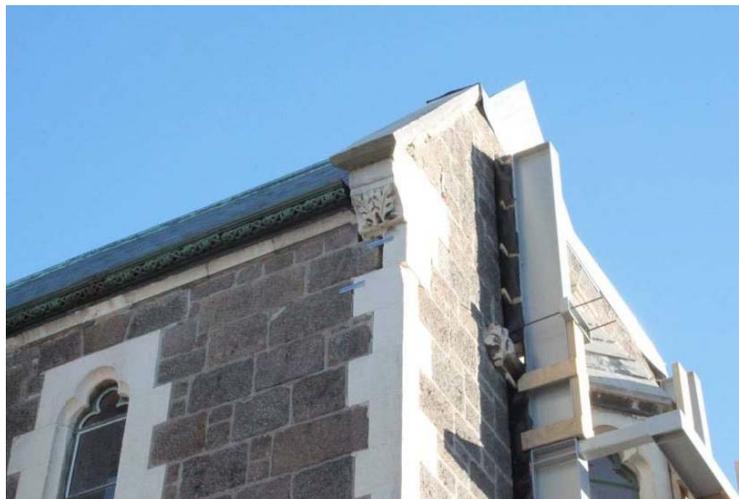
Figure 3.32 Christchurch Arts Centre (former Old Boy's High building), with severe damage due to instability of the façade at the second storey

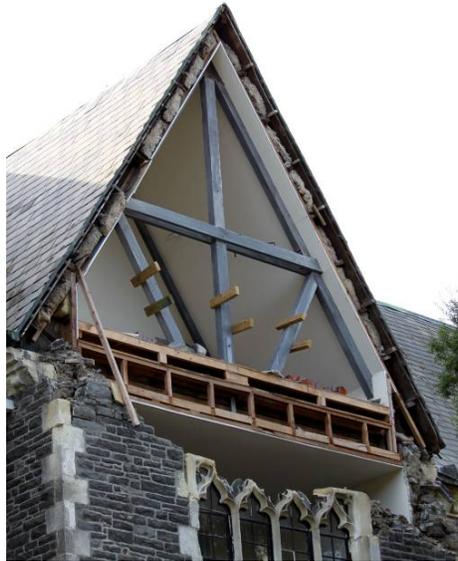
Figure 3.33 Cramner Court, showing complete collapse of a gable

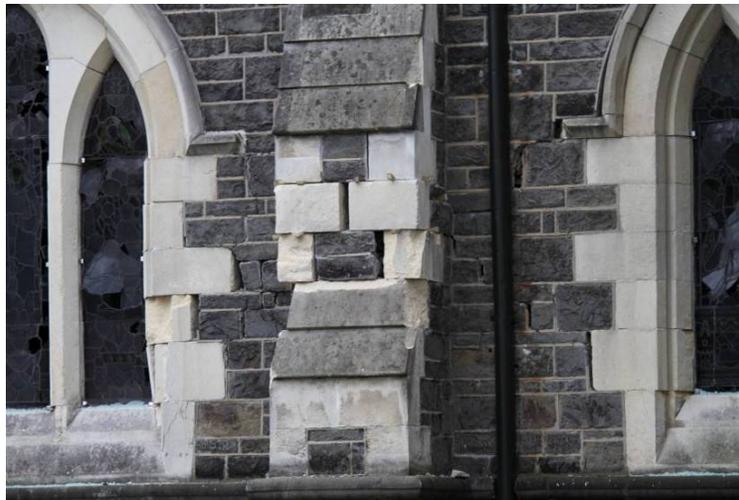
Figure 3.34 Christchurch Anglican Cathedral - diagonal cracks in the south façade piers

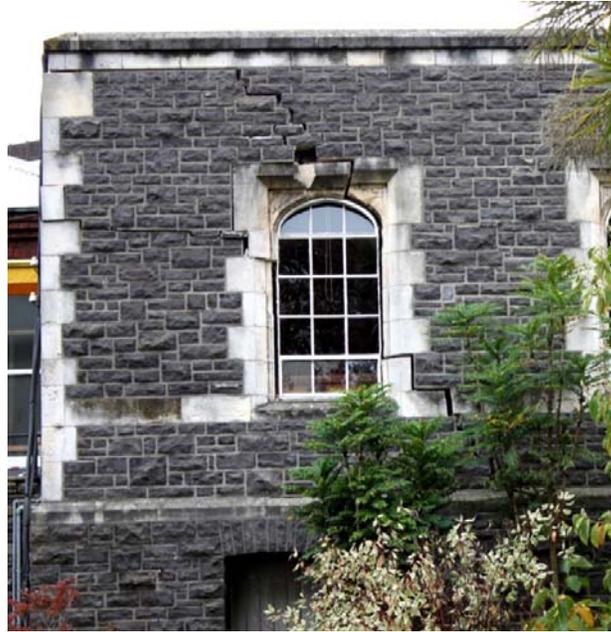
Figure 3.35 Canterbury Provincial Chambers - diagonal crack through entire south façade of the east annex

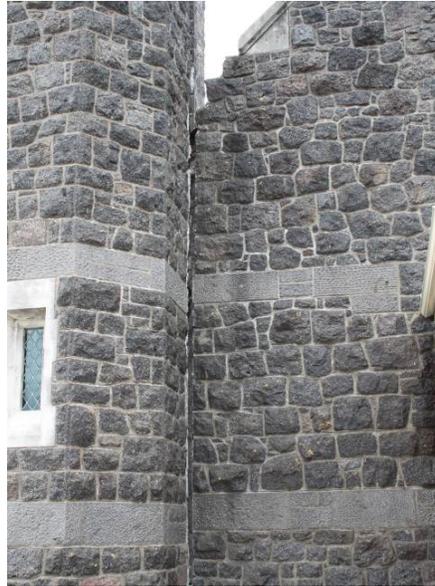
Damage that was attributable to plan irregularity was frequently observed, particularly for stone churches, due to interaction between adjacent structural elements at the intersections between walls. In most churches where the bell tower or low annexes are connected to the nave, damage developed at the intersection of the different structures (see Figure 3.36 and Figure 3.37).

Figure 3.37 St. Mary's Anglican Church - detachment of the bell tower from the nave

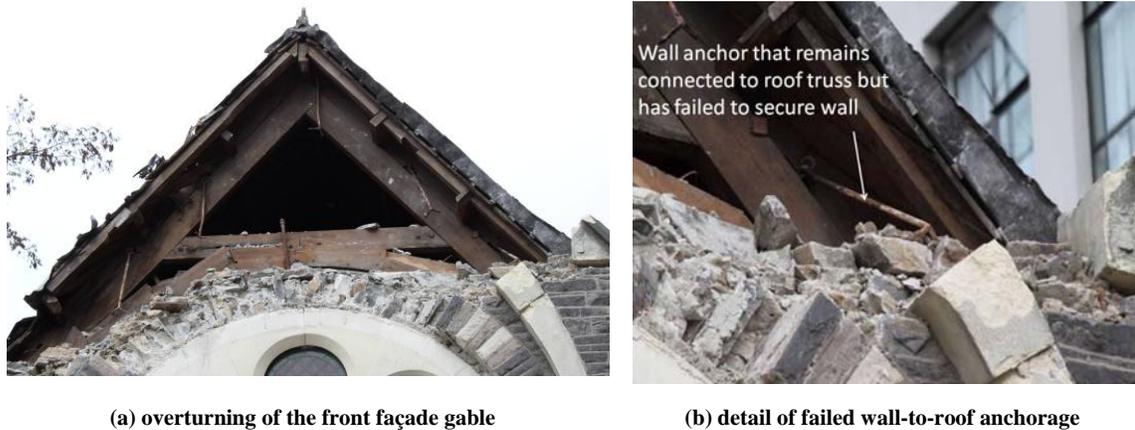
Figure 3.39 Former Trinity Church, showing details of gable ended out-of-plane wall failure

Two cases are presented to show the different behaviour induced by the presence and effectiveness of anchoring. Figure 3.39(a) shows the damage resulting from overturning of the gable of the main façade of the former Trinity Church in the Christchurch CBD while the detail in Figure 3.39(b) illustrates how the anchoring was insufficient in size and spacing to secure the wall in place. Figure 3.40 shows some examples of successful wall-to-roof anchoring in the Arts Centre building.

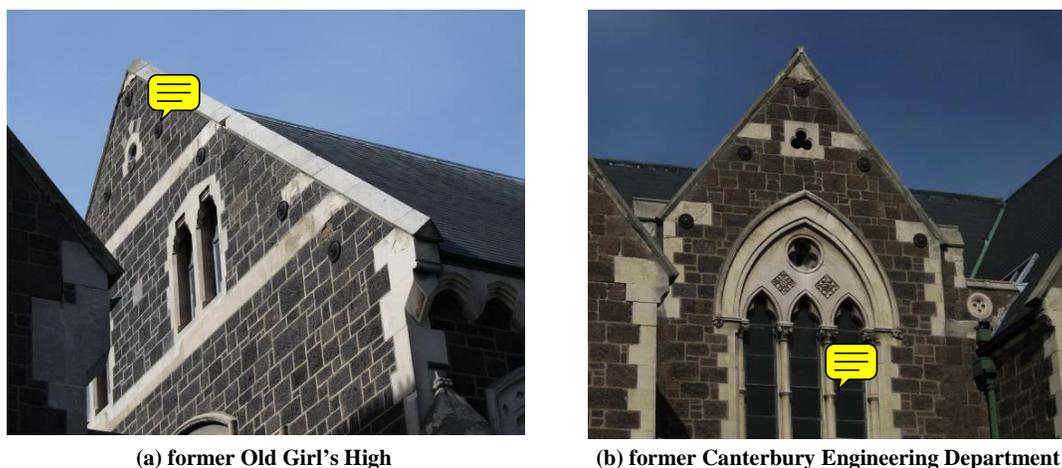
Figure 3.40 The Christchurch Arts Centre, showing successful use of wall-diaphragm anchorages

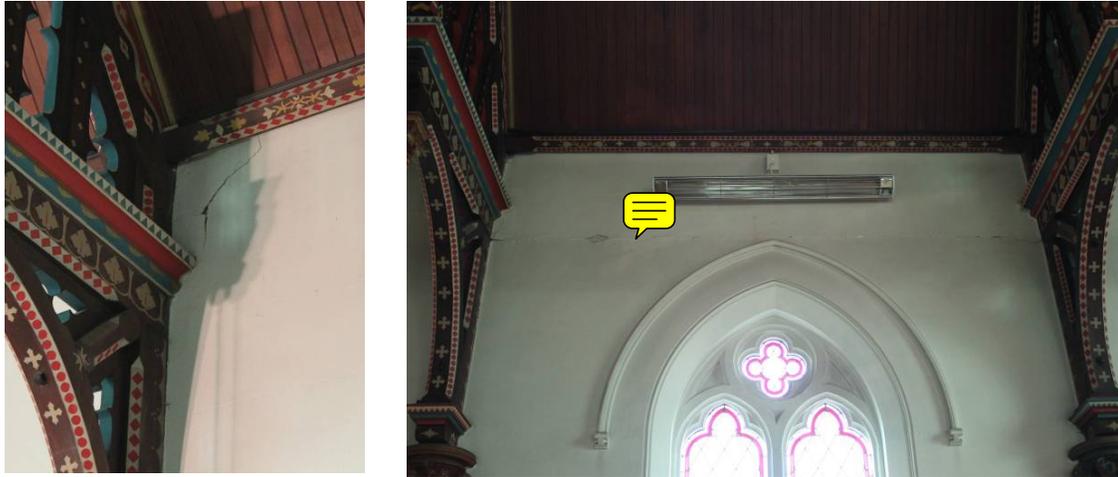
Figure 3.41 St James' Church, hammering of roofing elements on the walls of the nave

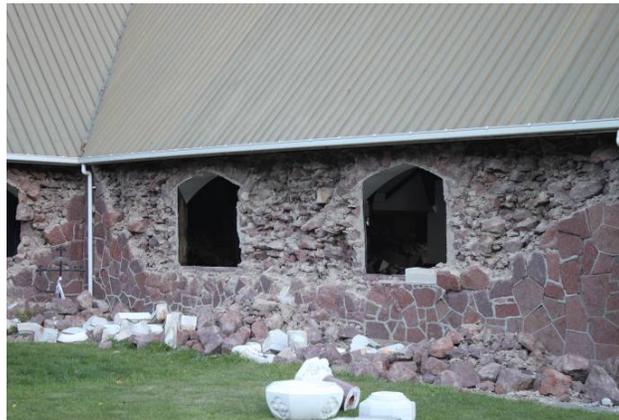
Figure 3.42 Lyttelton Holy Trinity Church. Damage induced by hammering of the roof

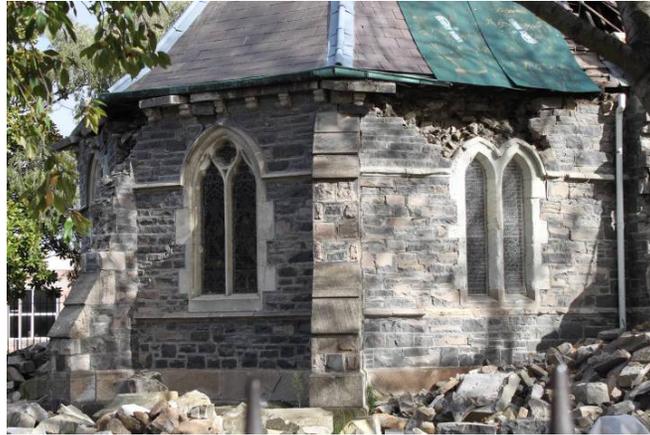
Figure 3.43 St. John's the Baptist Church. Local collapse of material

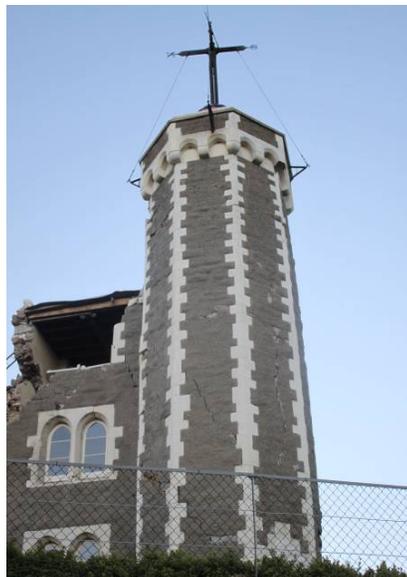
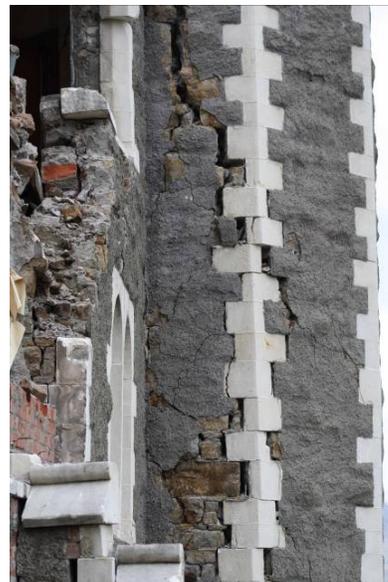
Figure 3.44 Time Ball Station. Damage in the Time Ball tower

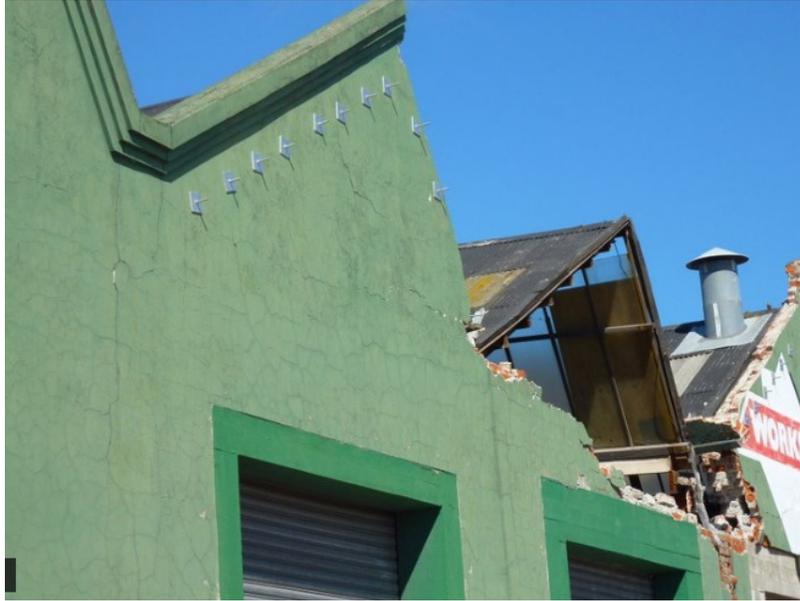
Figure 4.1 Example of a secured gable end that survived earthquake loading and a companion failed gable end that was not secured

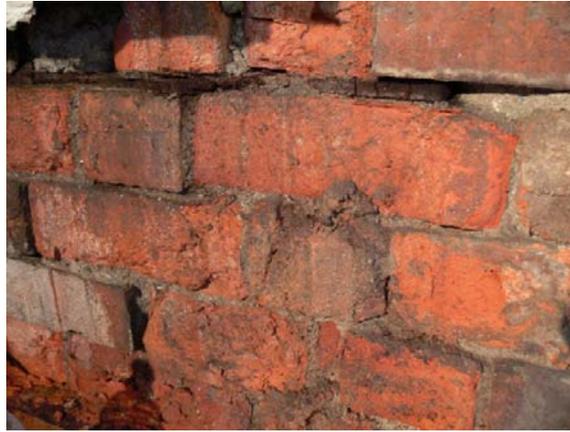
Figure 4.2 Severely degraded bricks and mortar due to moisture ingress

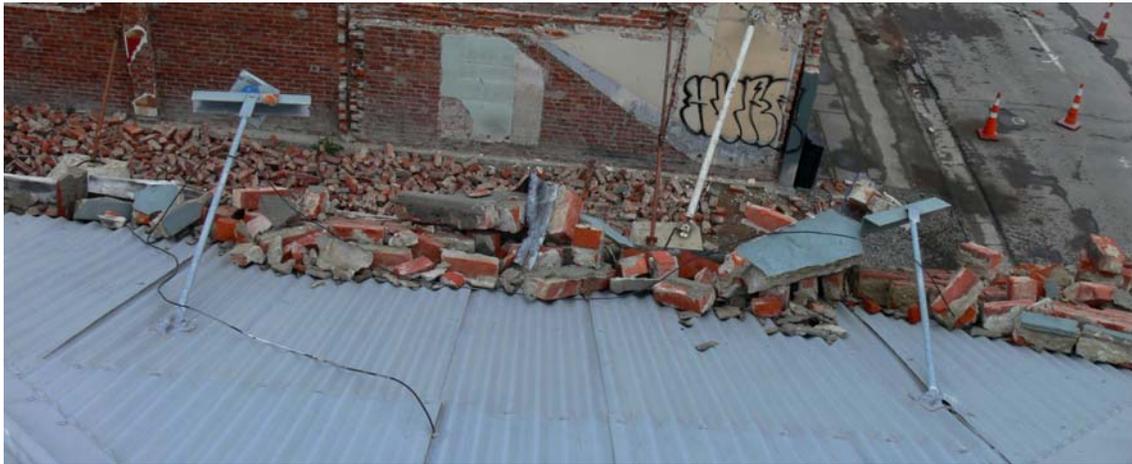
(a) Roof level view of failed parapet restraint

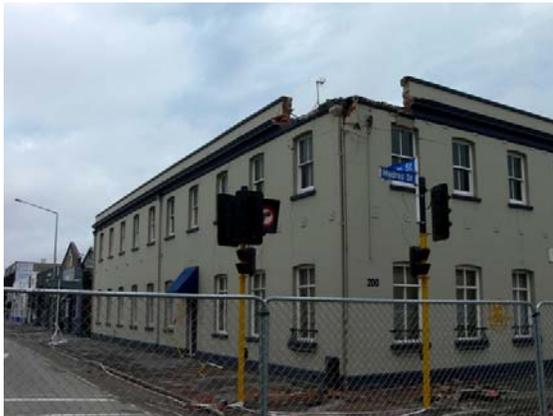
(b) Exterior view of failed parapet at corner

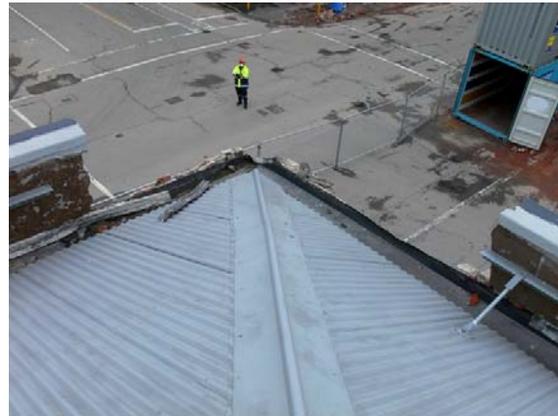
(c) Roof level view of failed parapet at corner

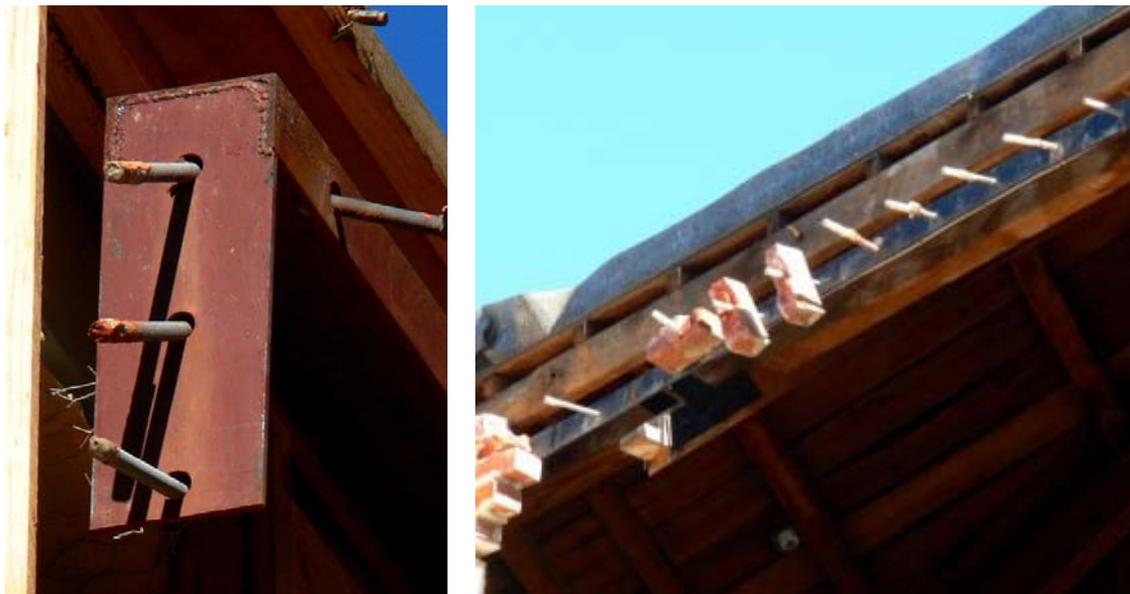
(a) Failure of a steel fixing due to anchor withdrawal

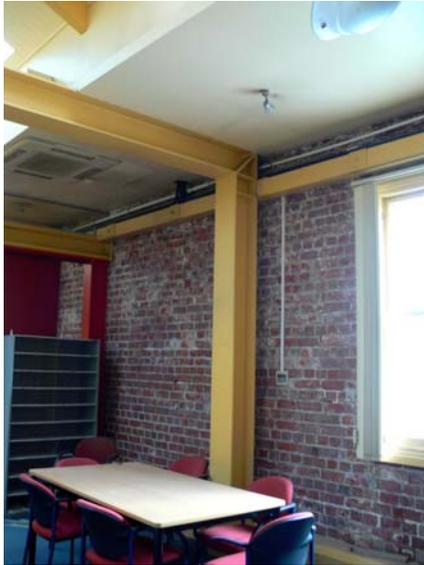
(a) Post-earthquake condition of a URM building having an internal steel frame retrofit

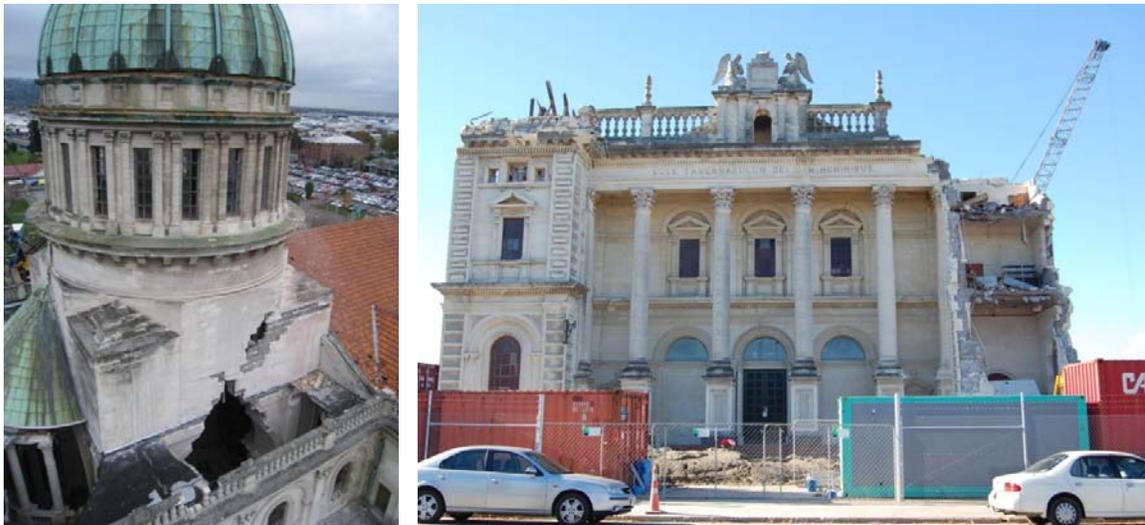
(a) Damage to drum at base of dome

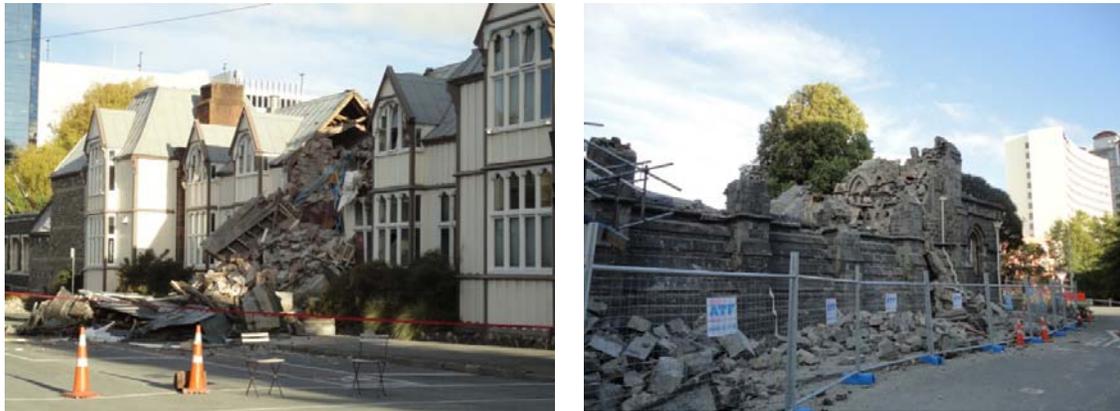
(a) Stone masonry collapse

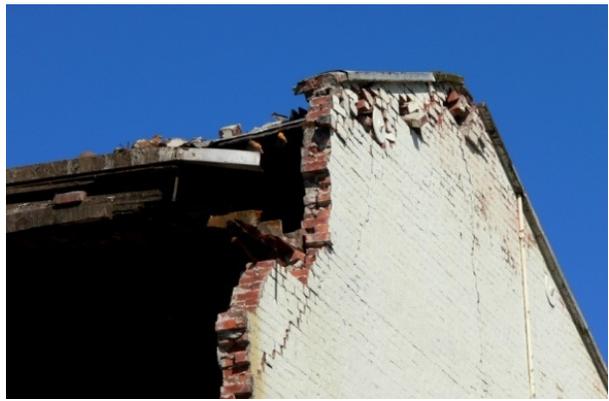
(b) 139 Manchester Street, through steel anchors and rotten timber roof diaphragm

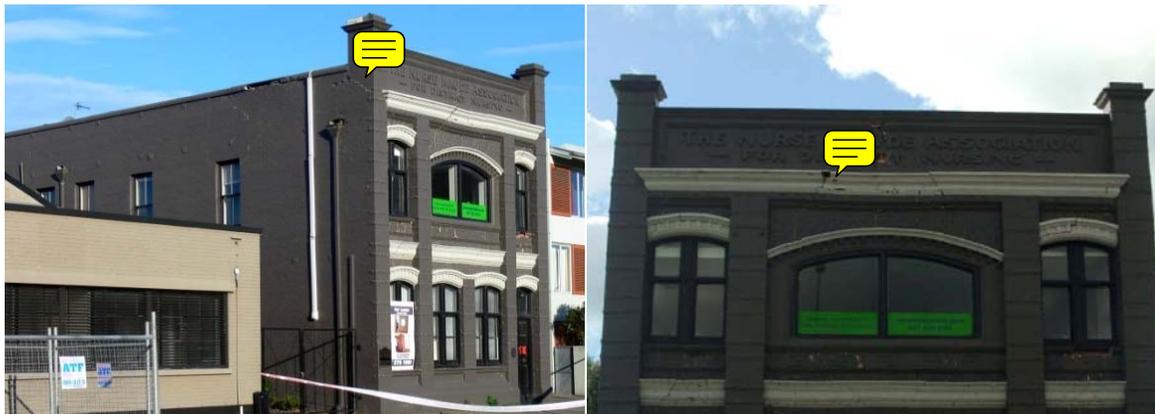
(a) cracking through top spandrel
