**Christchurch Earthquake
CBD Building Performance Technical Investigation**

**Report on the Structural Performance
of the
Hotel Grand Chancellor
in the
Earthquake of 22 February 2011**

Prepared By:
Dunning Thornton Consultants Ltd

Final: 26 September 2011

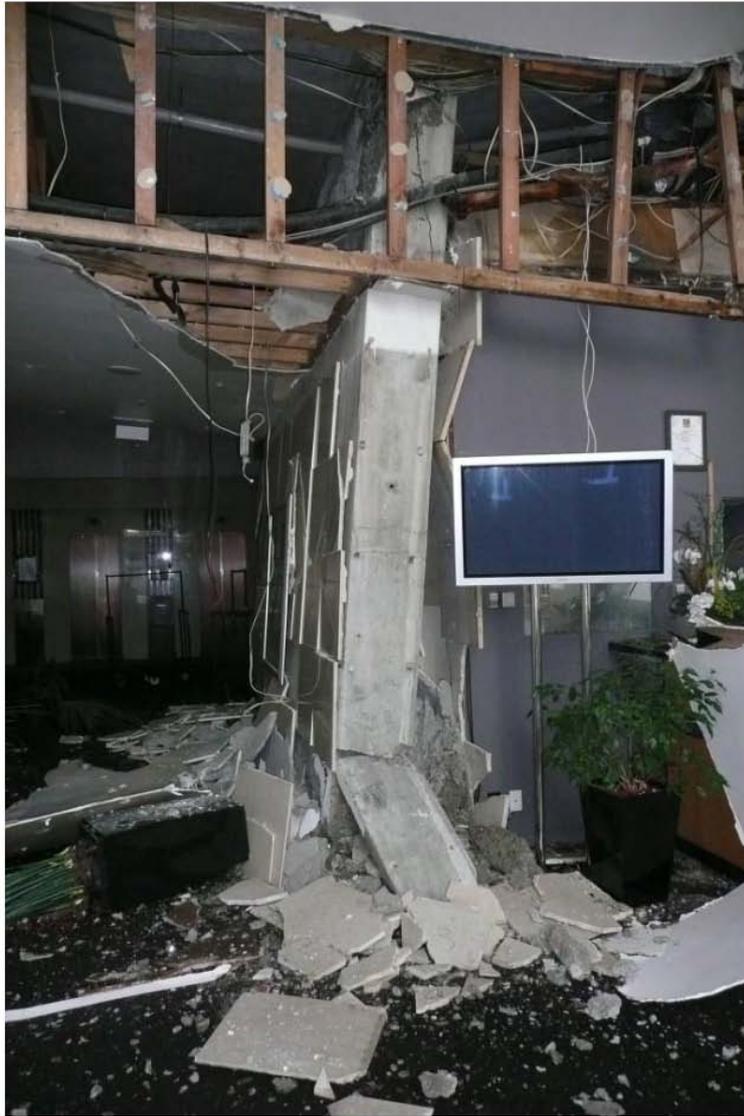
Fig. 8

This wall failed between ground and first floor and effectively shortened by approximately 800mm. As a result, the tower structure developed a lean towards the south-east corner. The failure took the form of a brittle diagonal failure transversely across the wall that appears to have originated at the top of a vertical reinforcing splice located 700mm above the ground floor. The wall dropped, sliding off the diagonal crack, moving towards the west. There was

evidence of a corresponding lateral hinge at the underside of the first floor.
[Refer App. B page 12 & App. C Photographs 6-10]

Photo 6 - Shearwall D5-6 - Base Failure

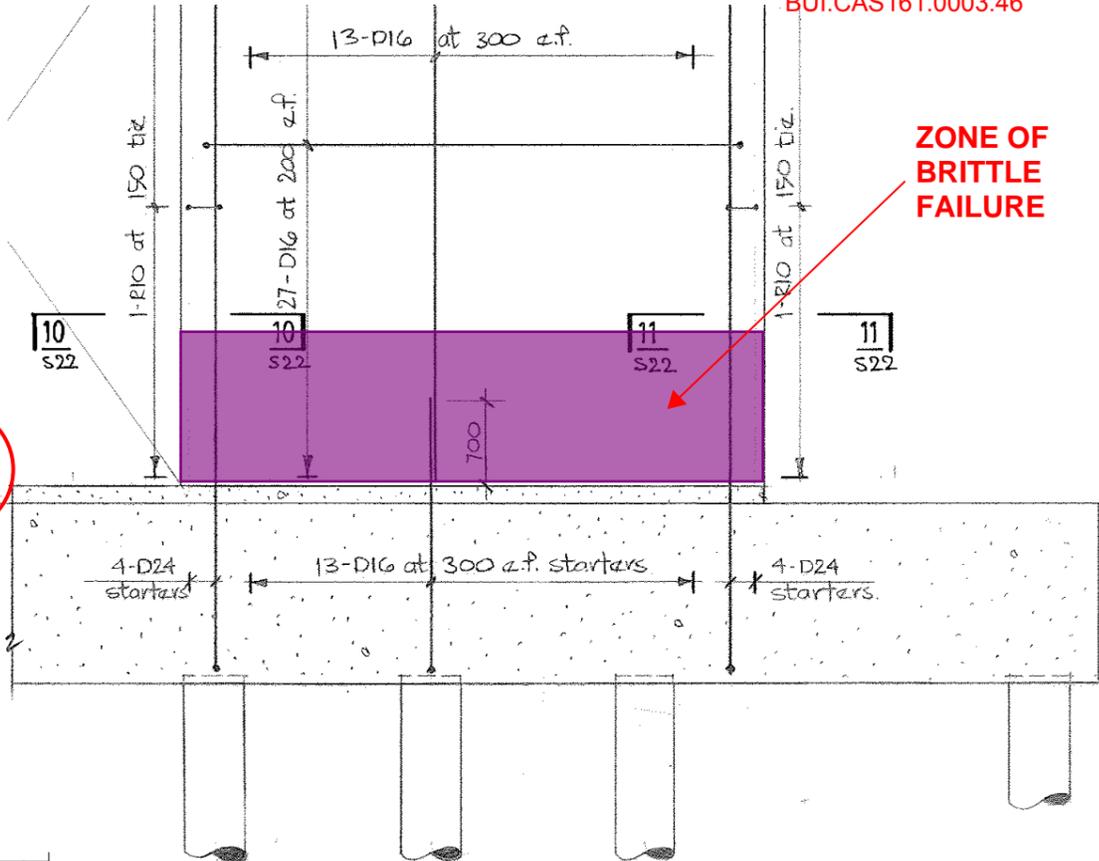
CROSS-SECTION SHOWING FAILURE MODE

ZONE OF BRITTLE FAILURE

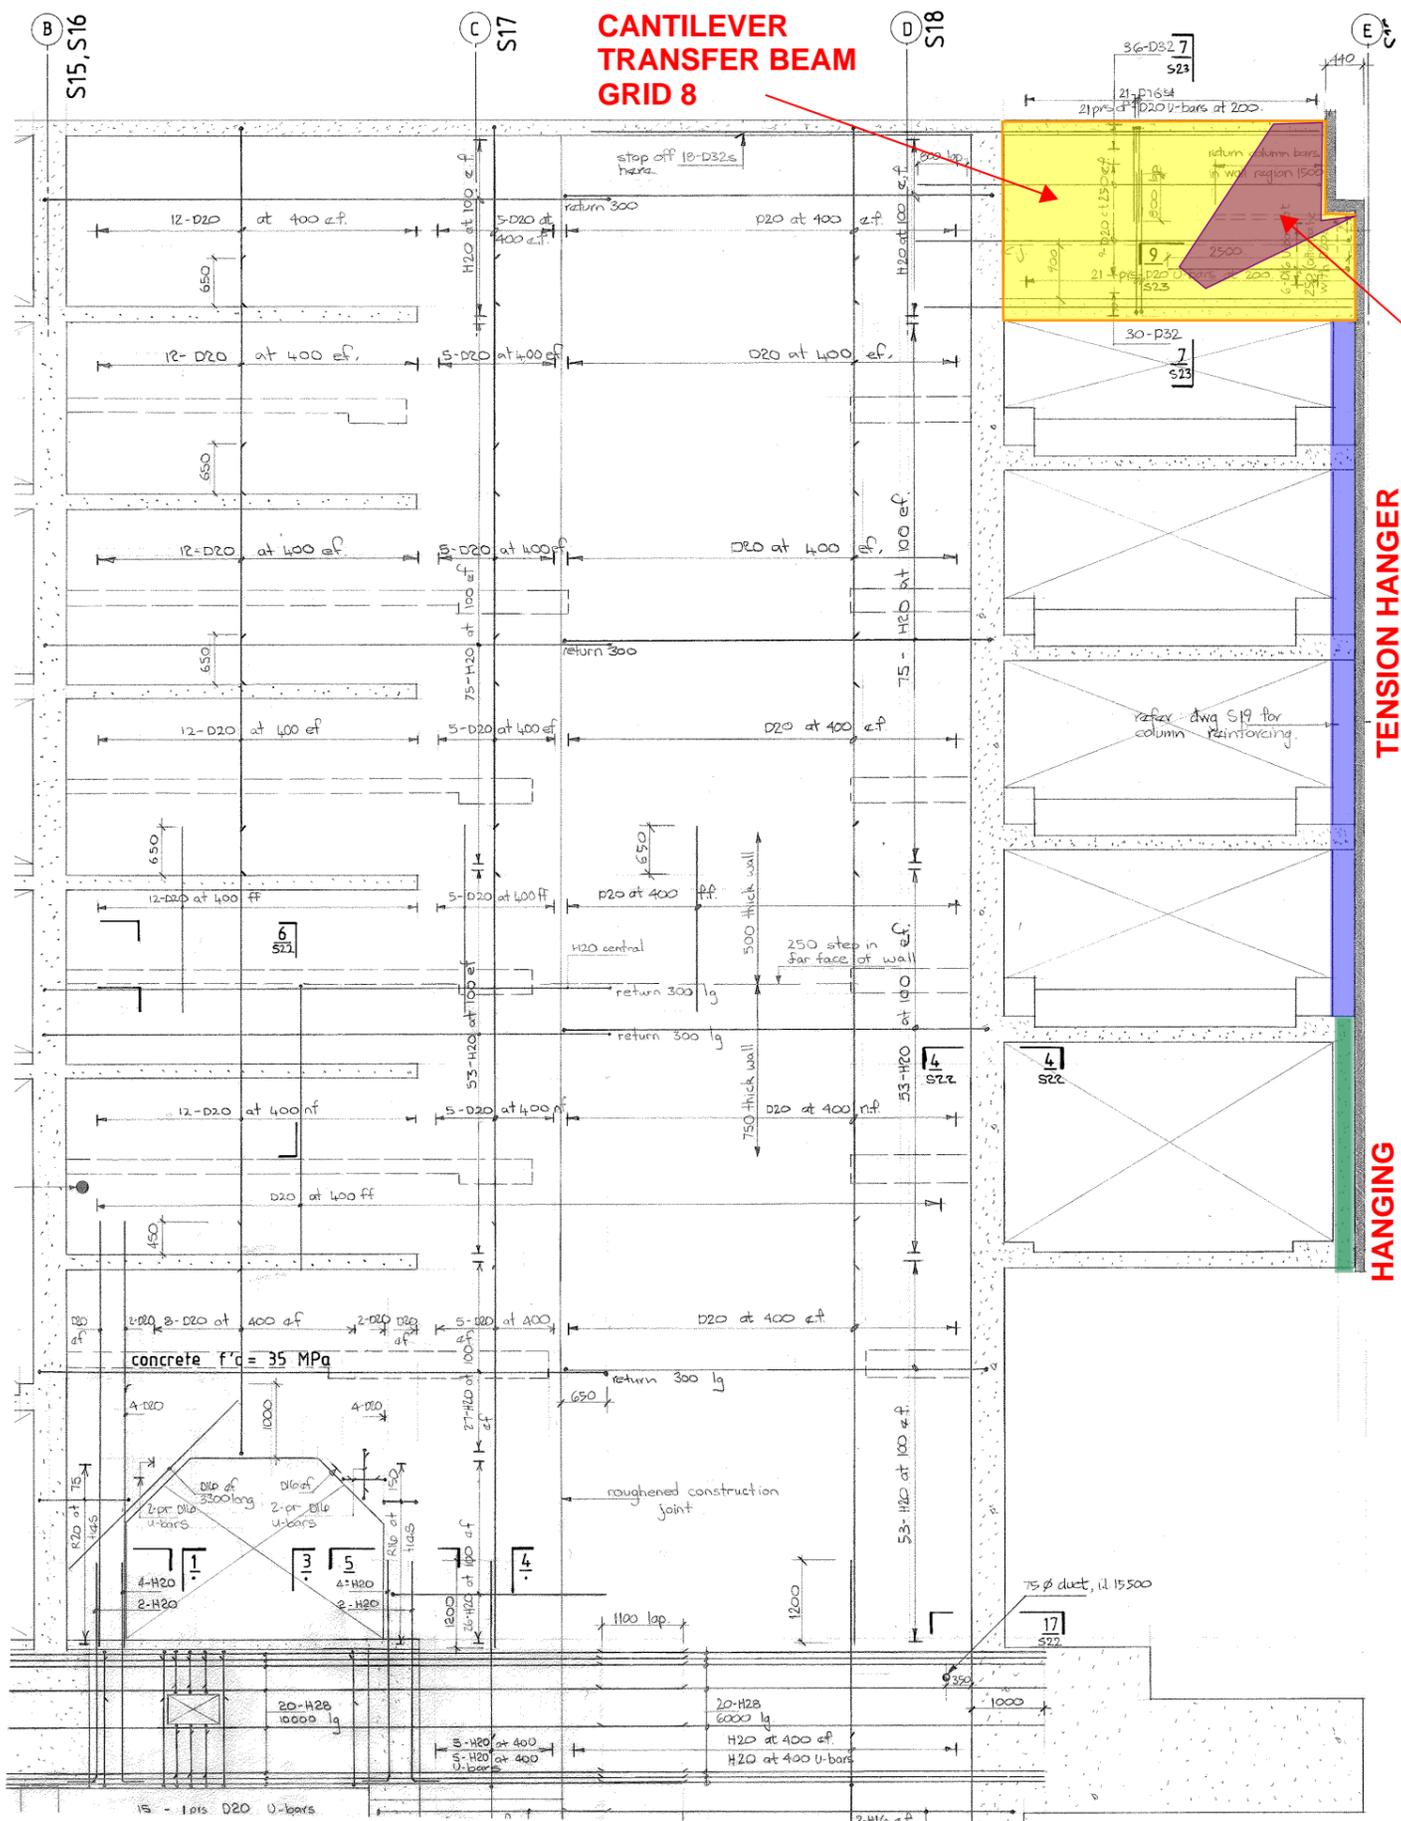
WALL D5-6

LAP FAILURE

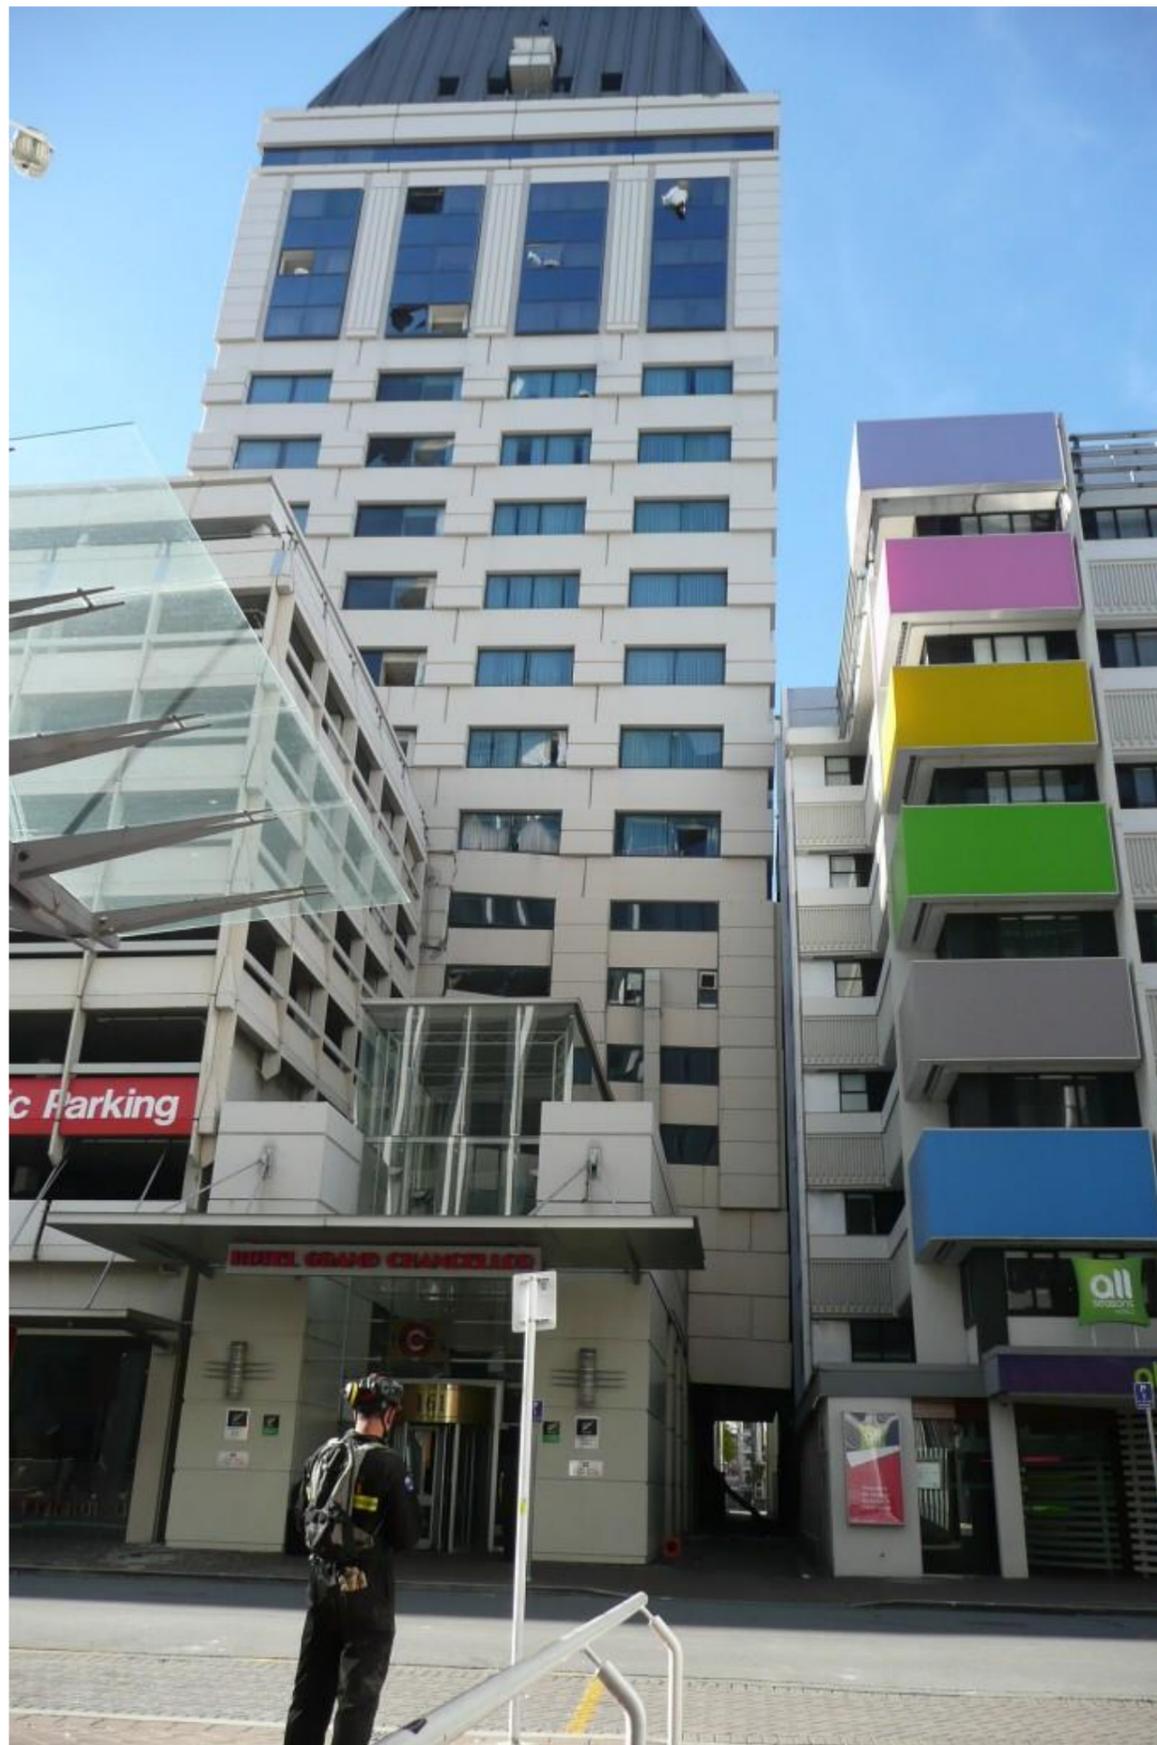
Photo 3 - Southern Elevation - Post February

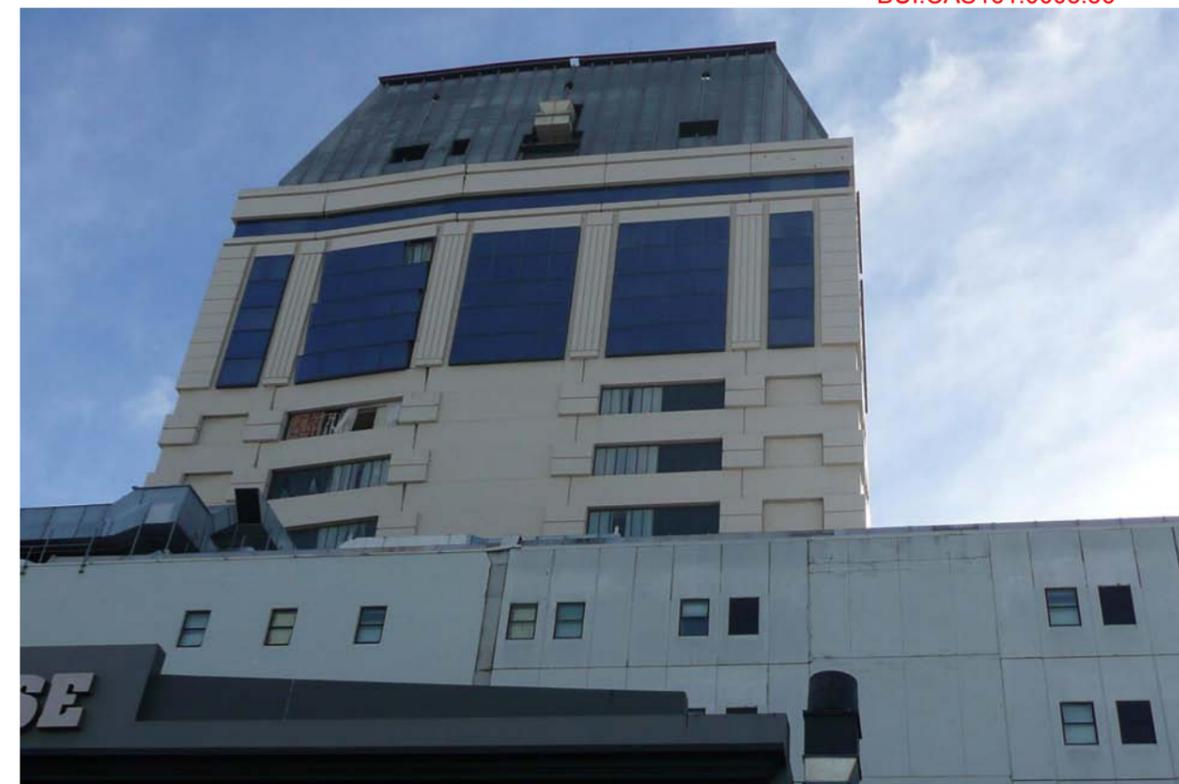
Photo 4 - Eastern Elevation - Post February

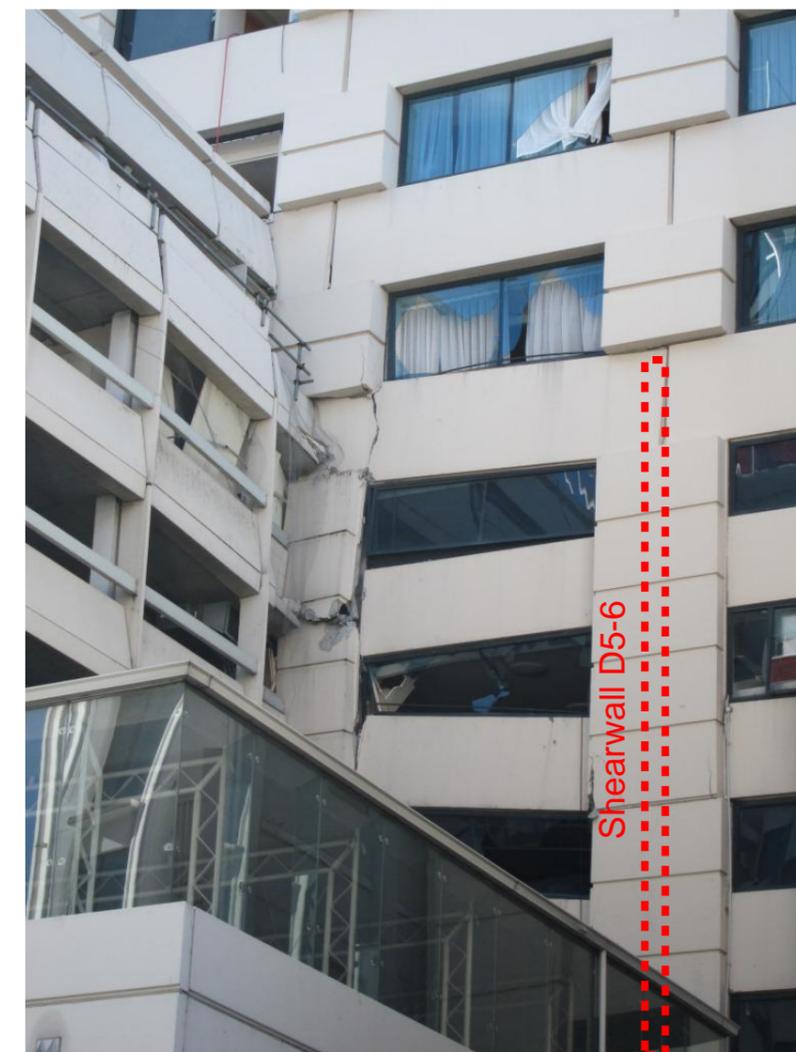
Following the 22 February event, there were media reports that pounding was the cause of the Grand Chancellor failure. While the damage to the southern (Cashel Street) façade has an appearance that could, at first glance, be interpreted as resulting from pounding, this was in fact vertical displacement damage caused as the D5-6 wall failed. [Refer App. C Photograph 5]

Photo 5 - Damage at junction between podium and tower - not related to pounding

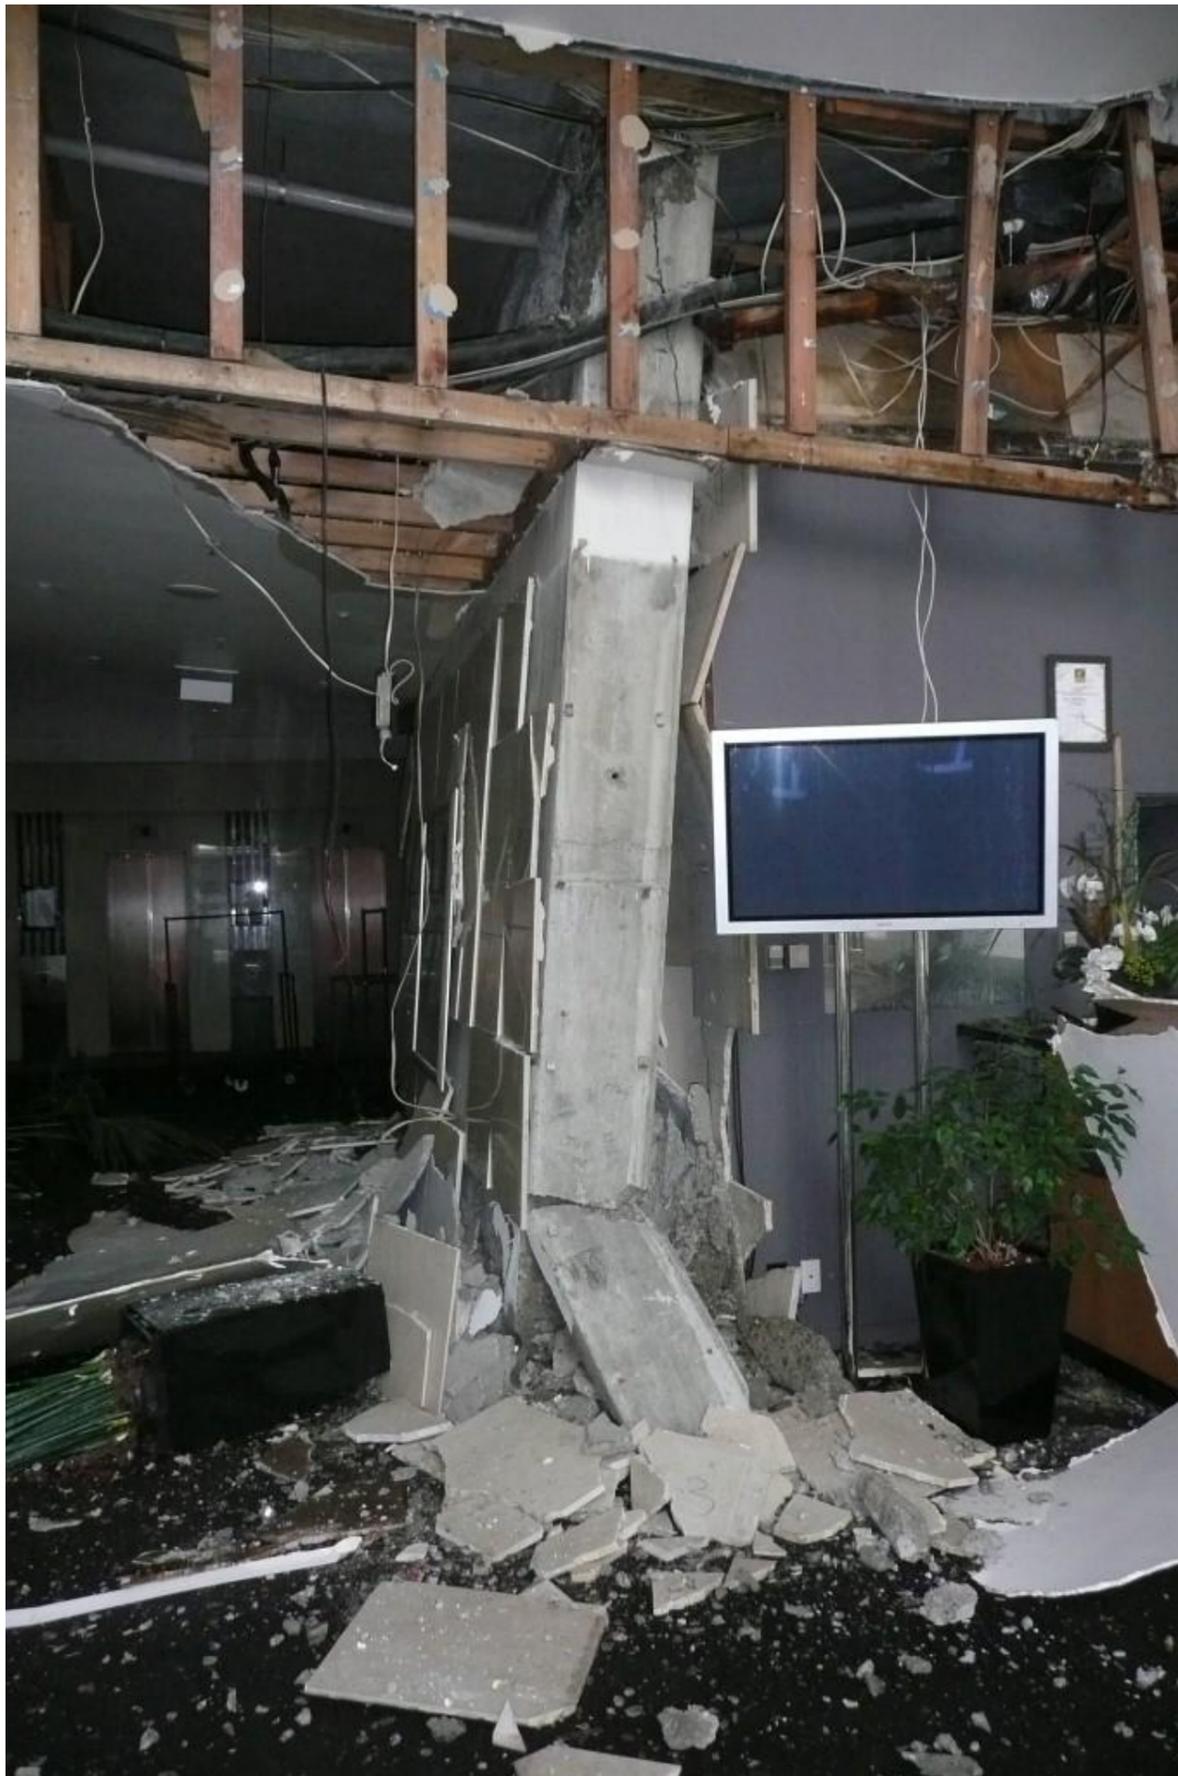
Photo 6 - Shearwall D5-6 - Base Failure

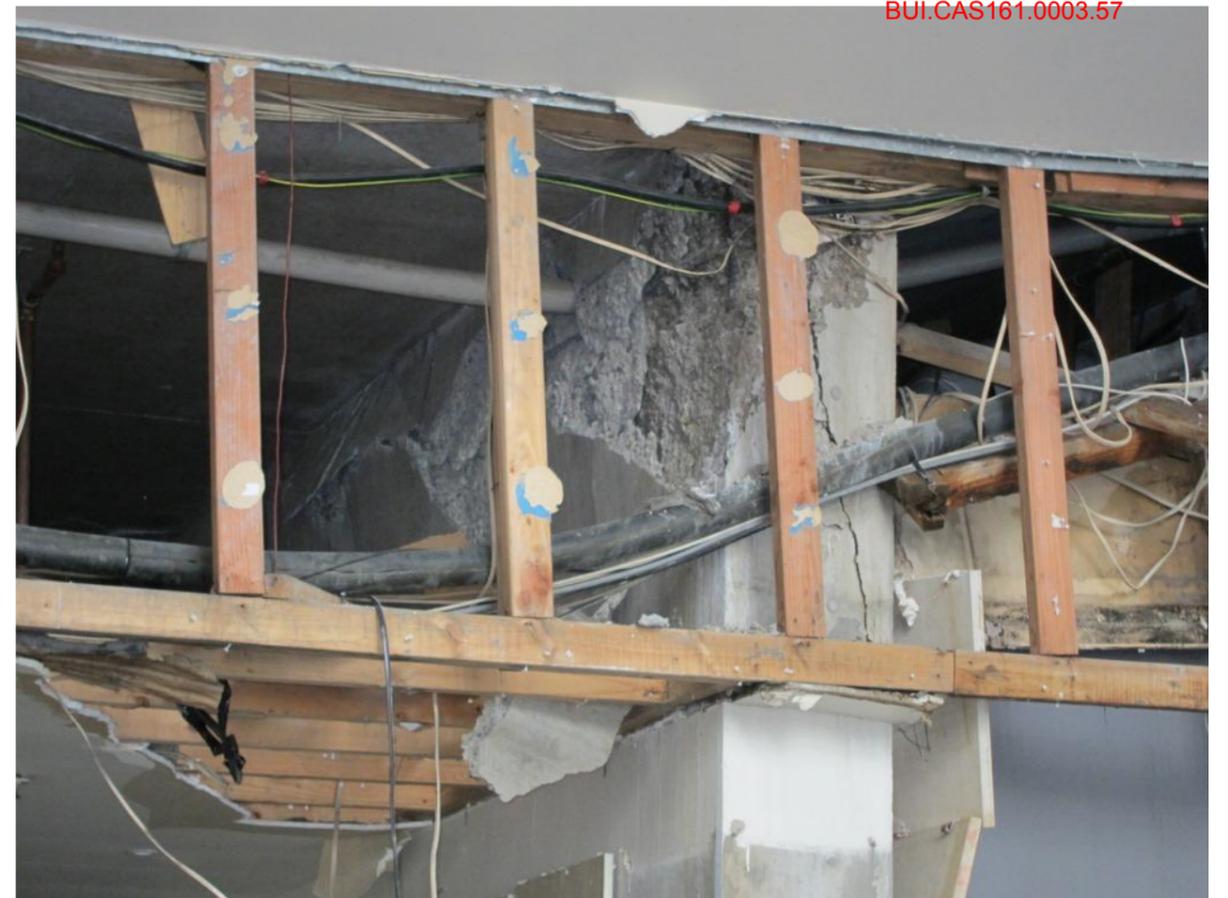
Photo 7 - Shearwall D5-6 - Hingeing at top of ground floor

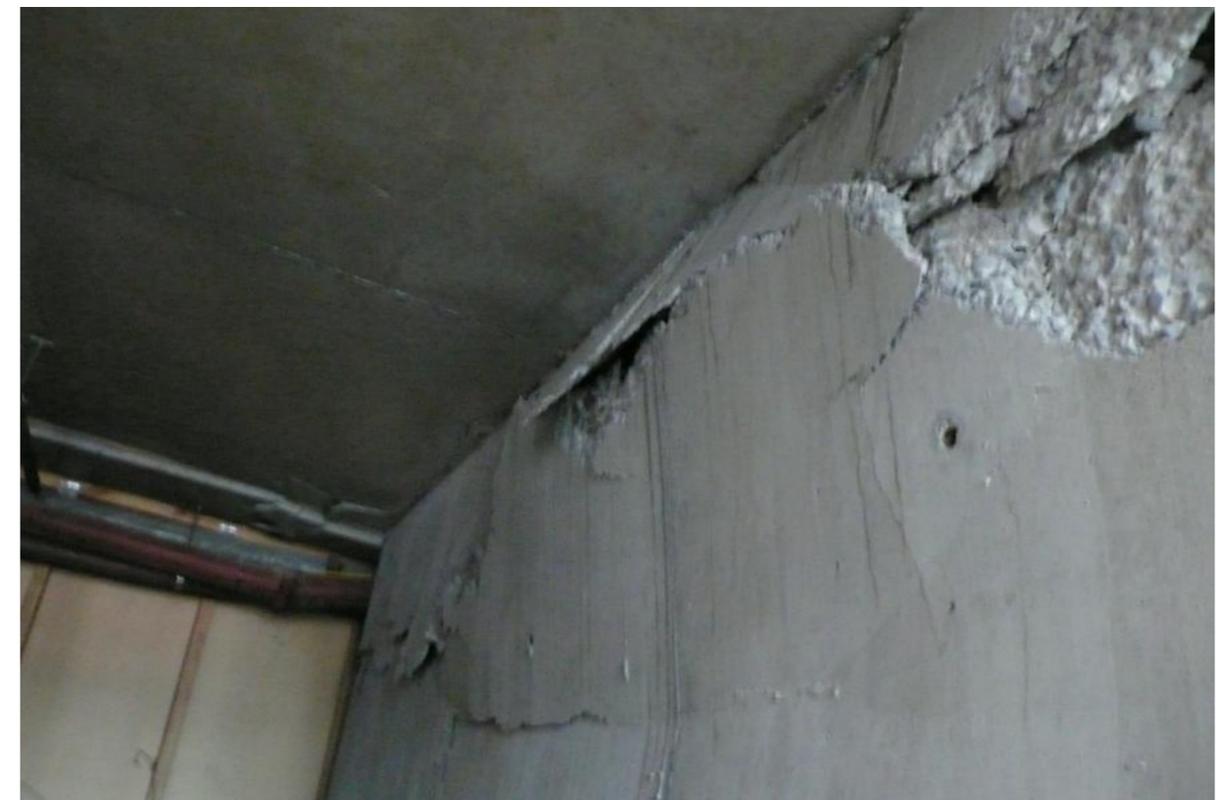
Photo 8 - Shearwall D5-6 - Hingeing at top of ground floor

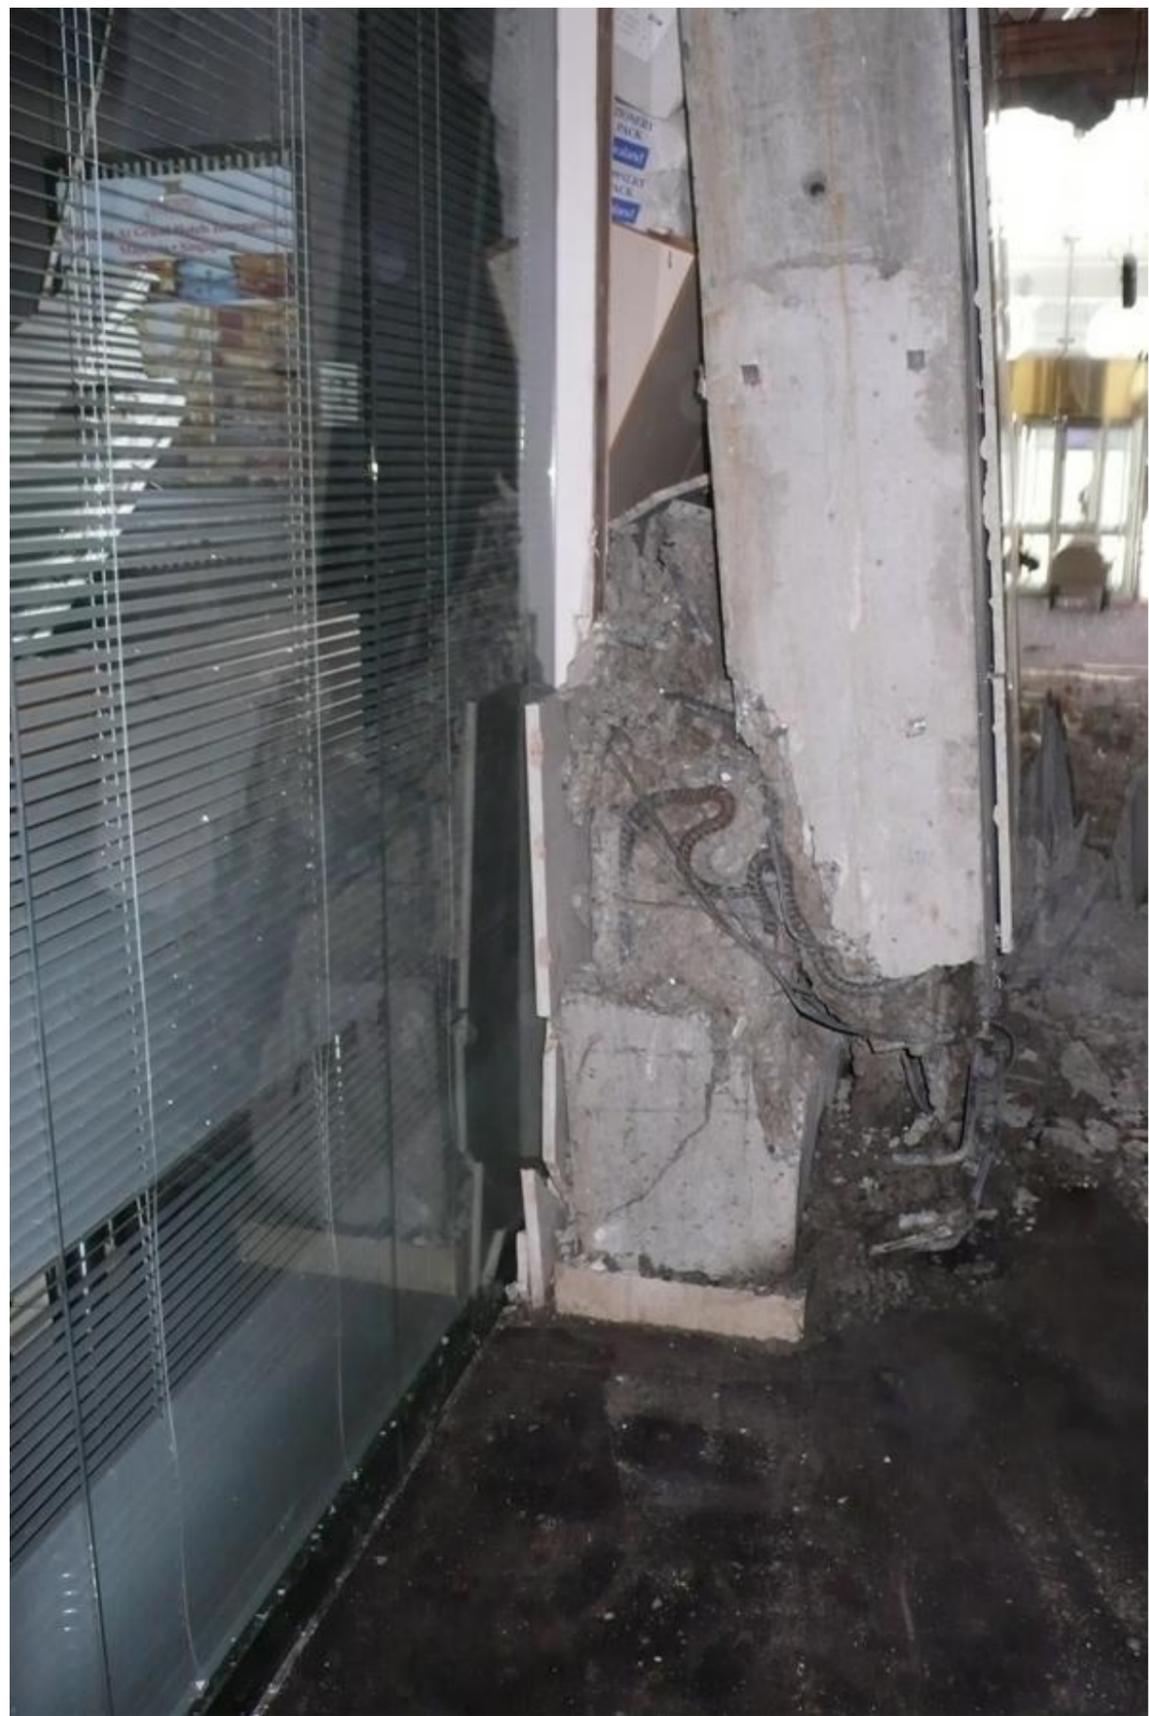
Brittle, transverse failure,
absence of confinement

Photo 9 - Shearwall D5-6 Failure - End View

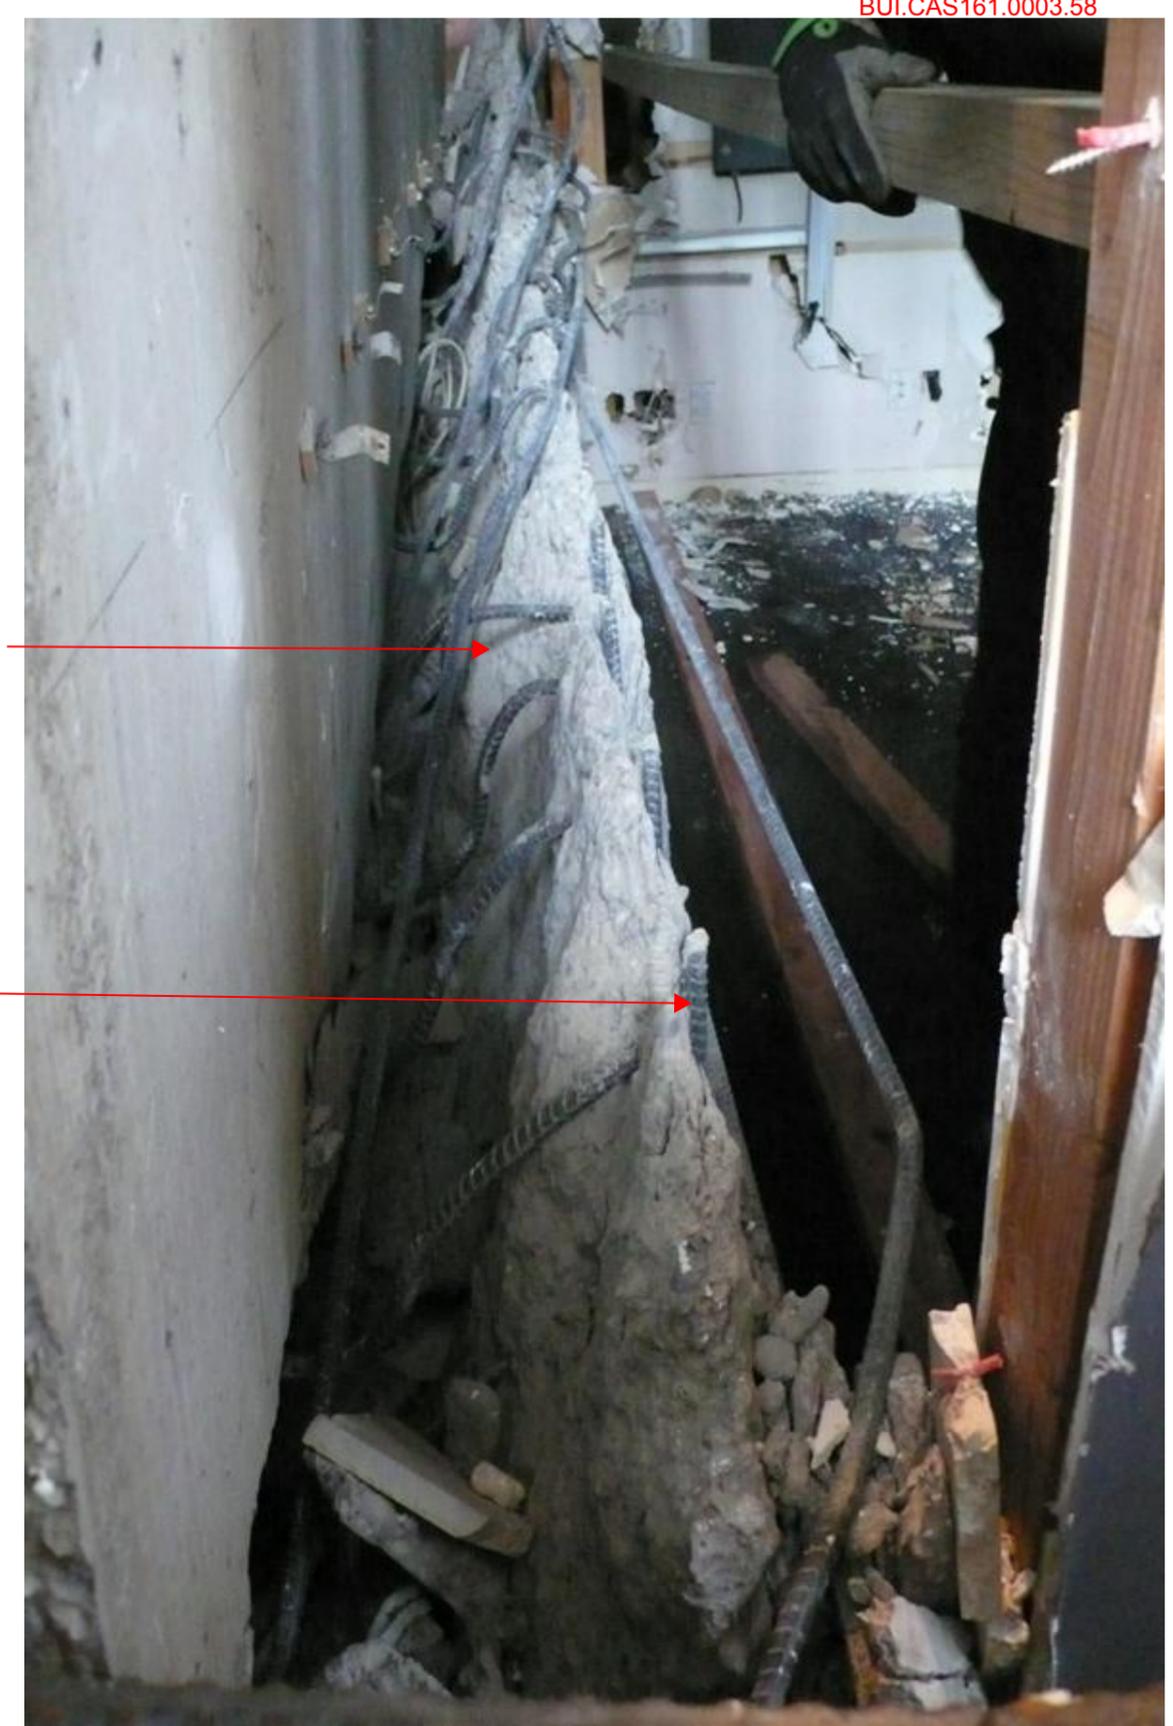
Lapped reinforcing

Photo 10 - Shearwall D5-6 Failure - Close-up

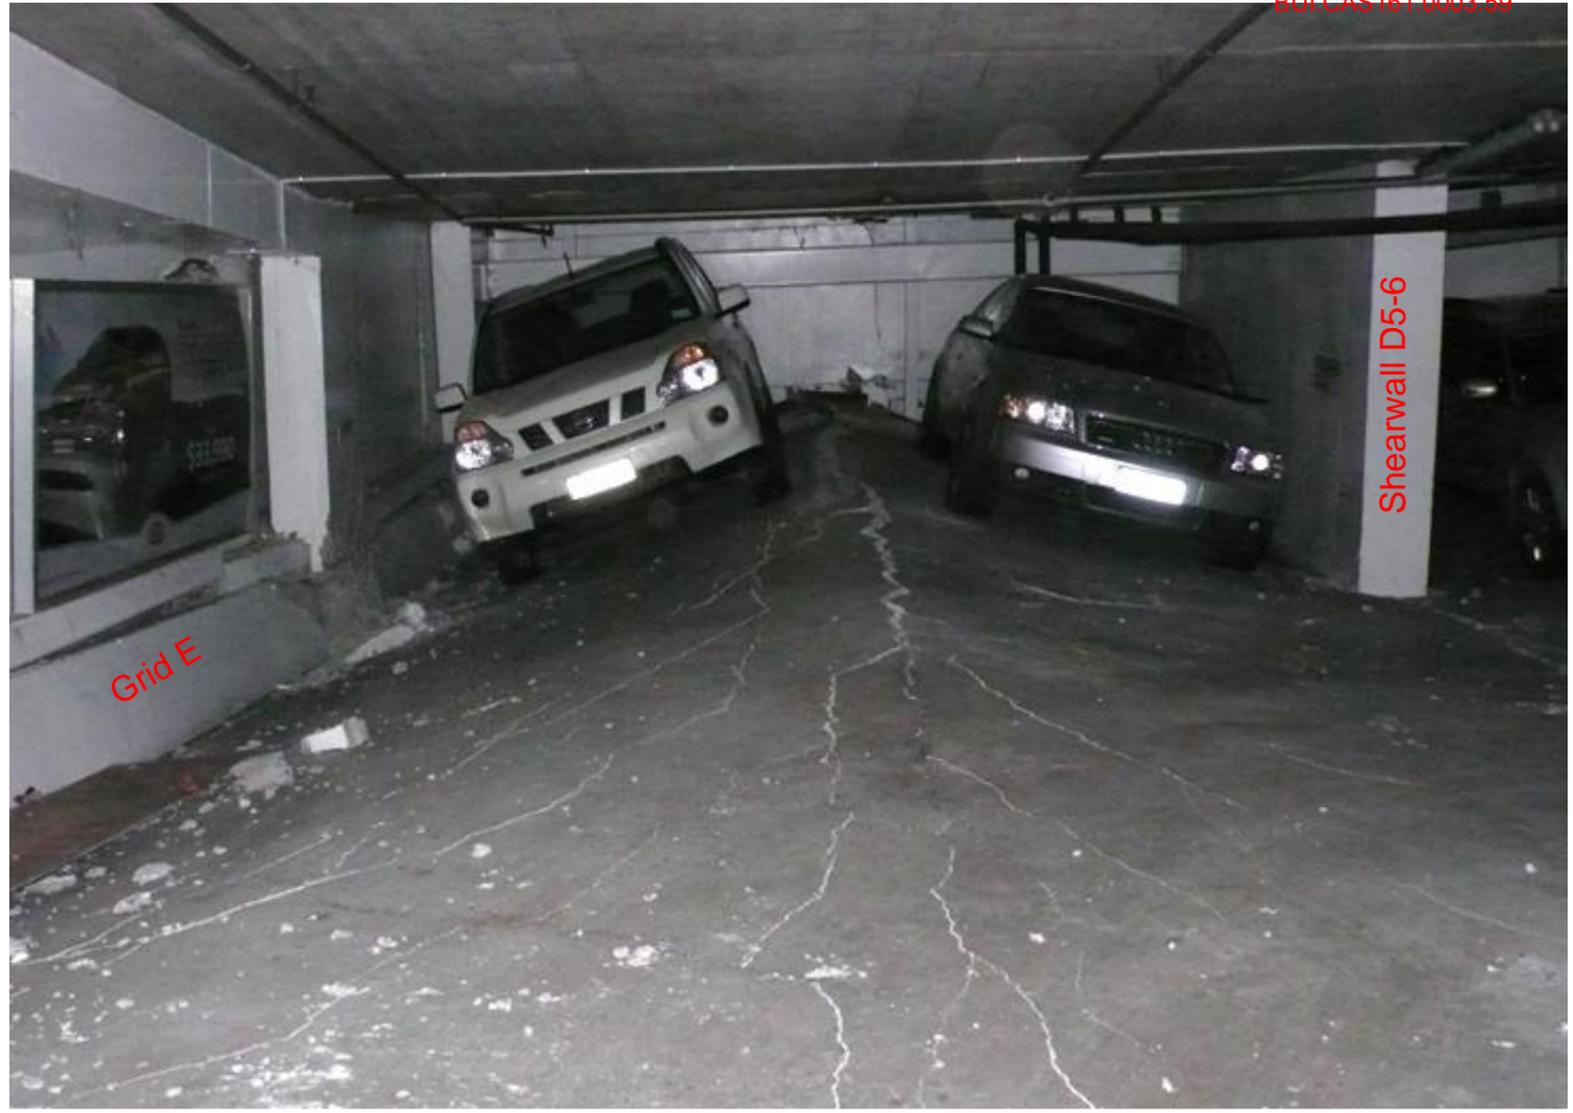
Photo 13 - Folded slab at level 2

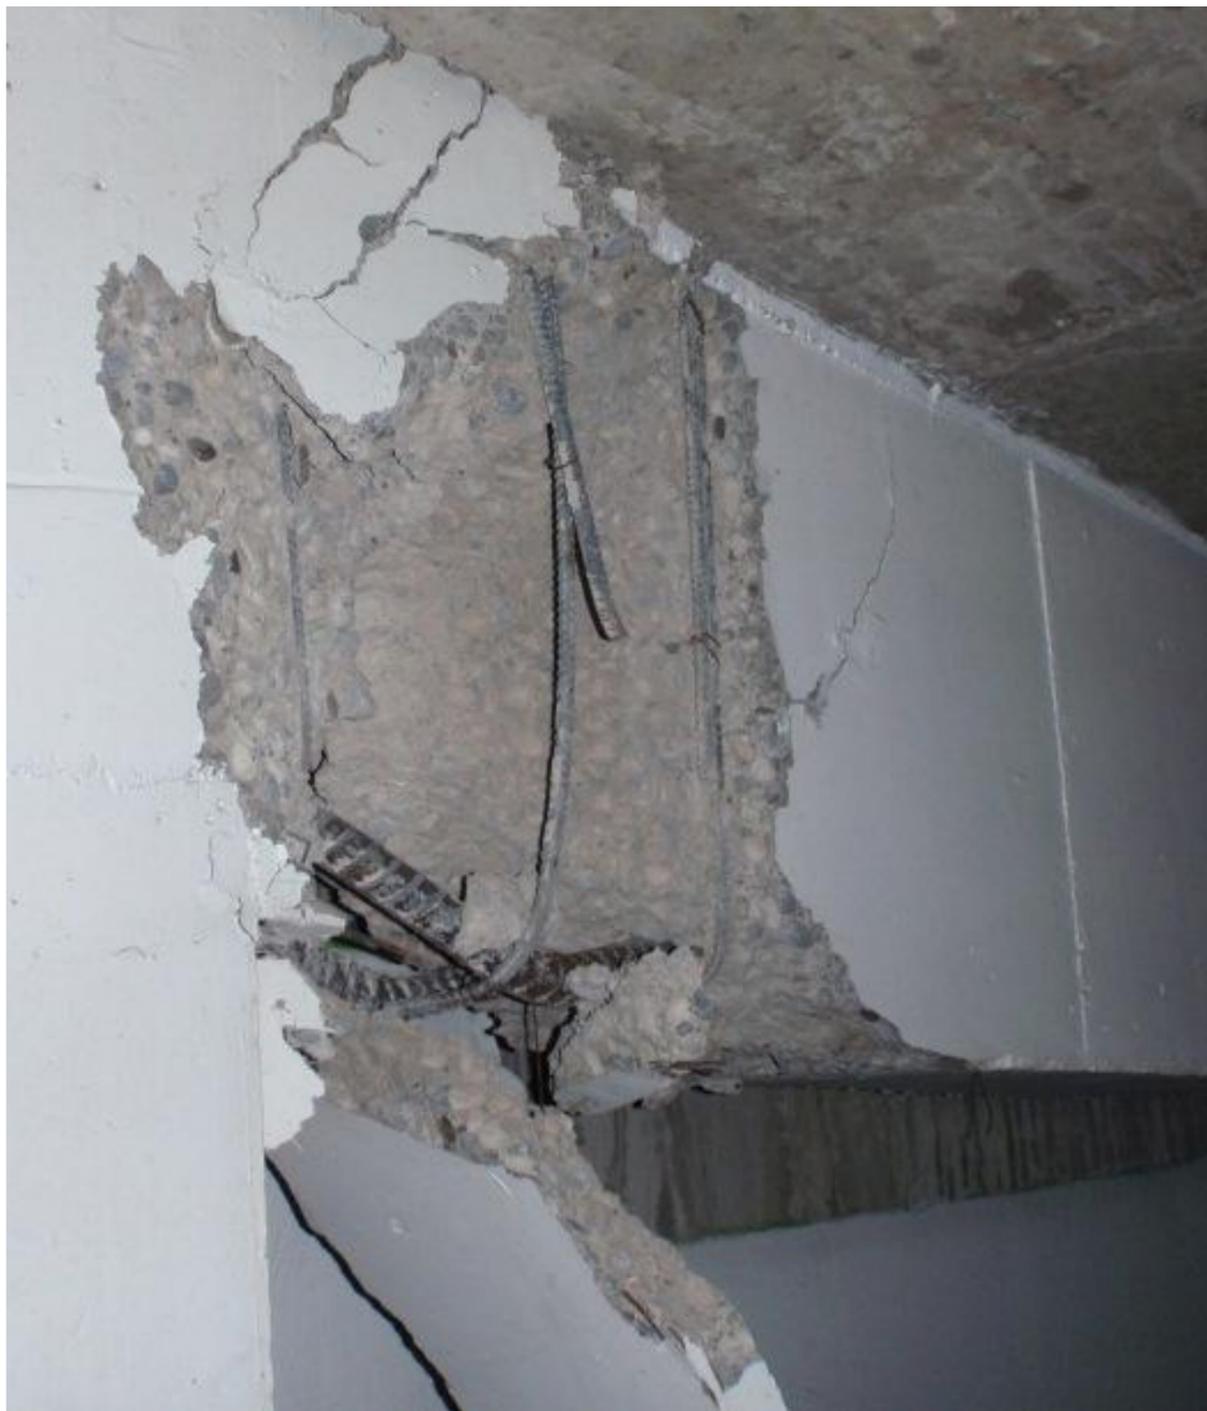
Photo 14 - Hingeing in grid E beams 6-7

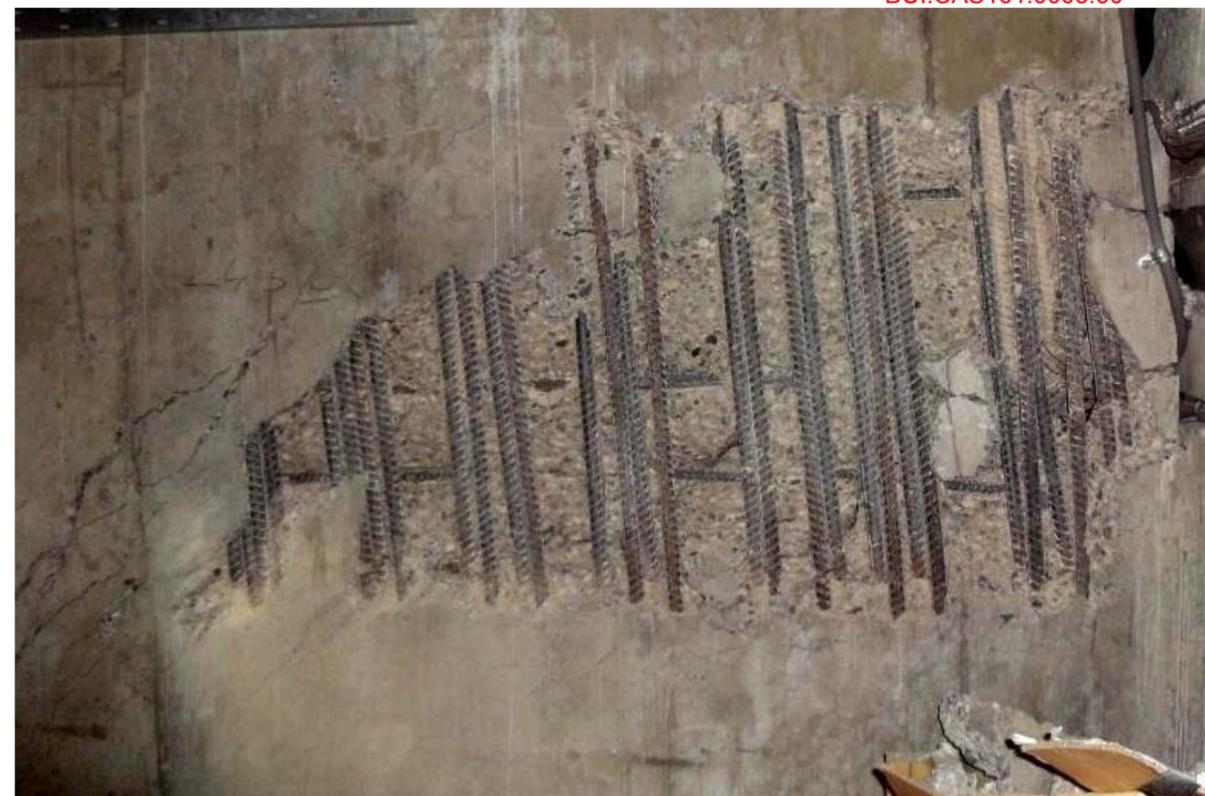
Parallel to the level 12-14 cantilever transfer beams on grids 5 and 6 is a further cantilever beam on grid 8. This beam is also a full floor-to-floor depth between levels 12 and 14 and is an extension of the main spine shear wall on grid 8. This beam supports the hanging column at E8 which, as described in 6.4, experienced a major increase in load as the south-eastern corner of the tower dropped. As the hanger load increased a lap failure initiated in the lapped beam stirrups and the bars slipped by up to 80mm. This mechanism appears to have come close to collapse. *[Refer App. B page 14 & App. C Photographs 15 & 16]*

Photo 15 - Near-lap failure grid 8 cantilever transfer beam

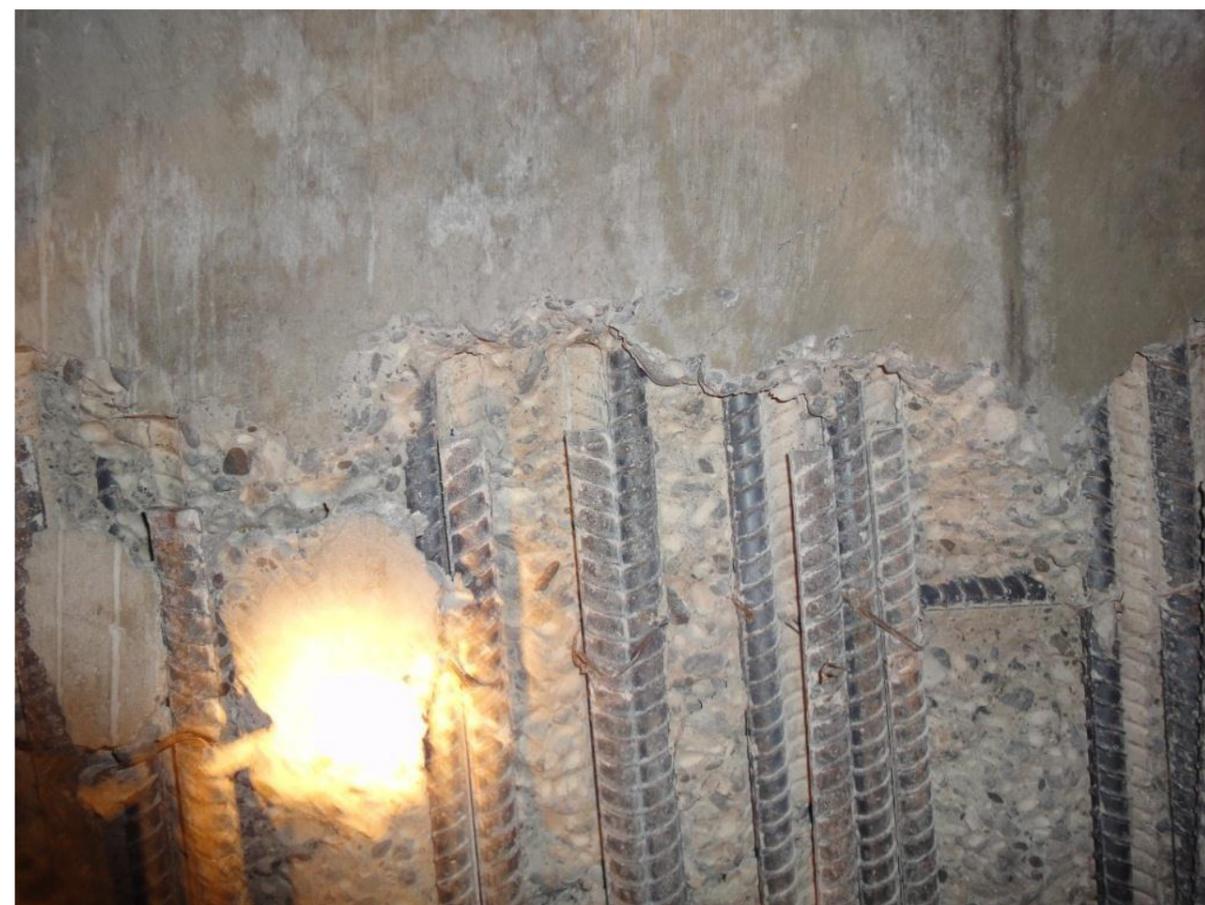
Photo 16 - Near-lap failure grid 8 cantilever transfer beam
