**Christchurch Earthquake
CBD Building Performance Technical Investigation**

**Report on the Structural Performance
of the
Hotel Grand Chancellor
in the
Earthquake of 22 February 2011**

Prepared By:
Dunning Thornton Consultants Ltd

Final: 26 September 2011

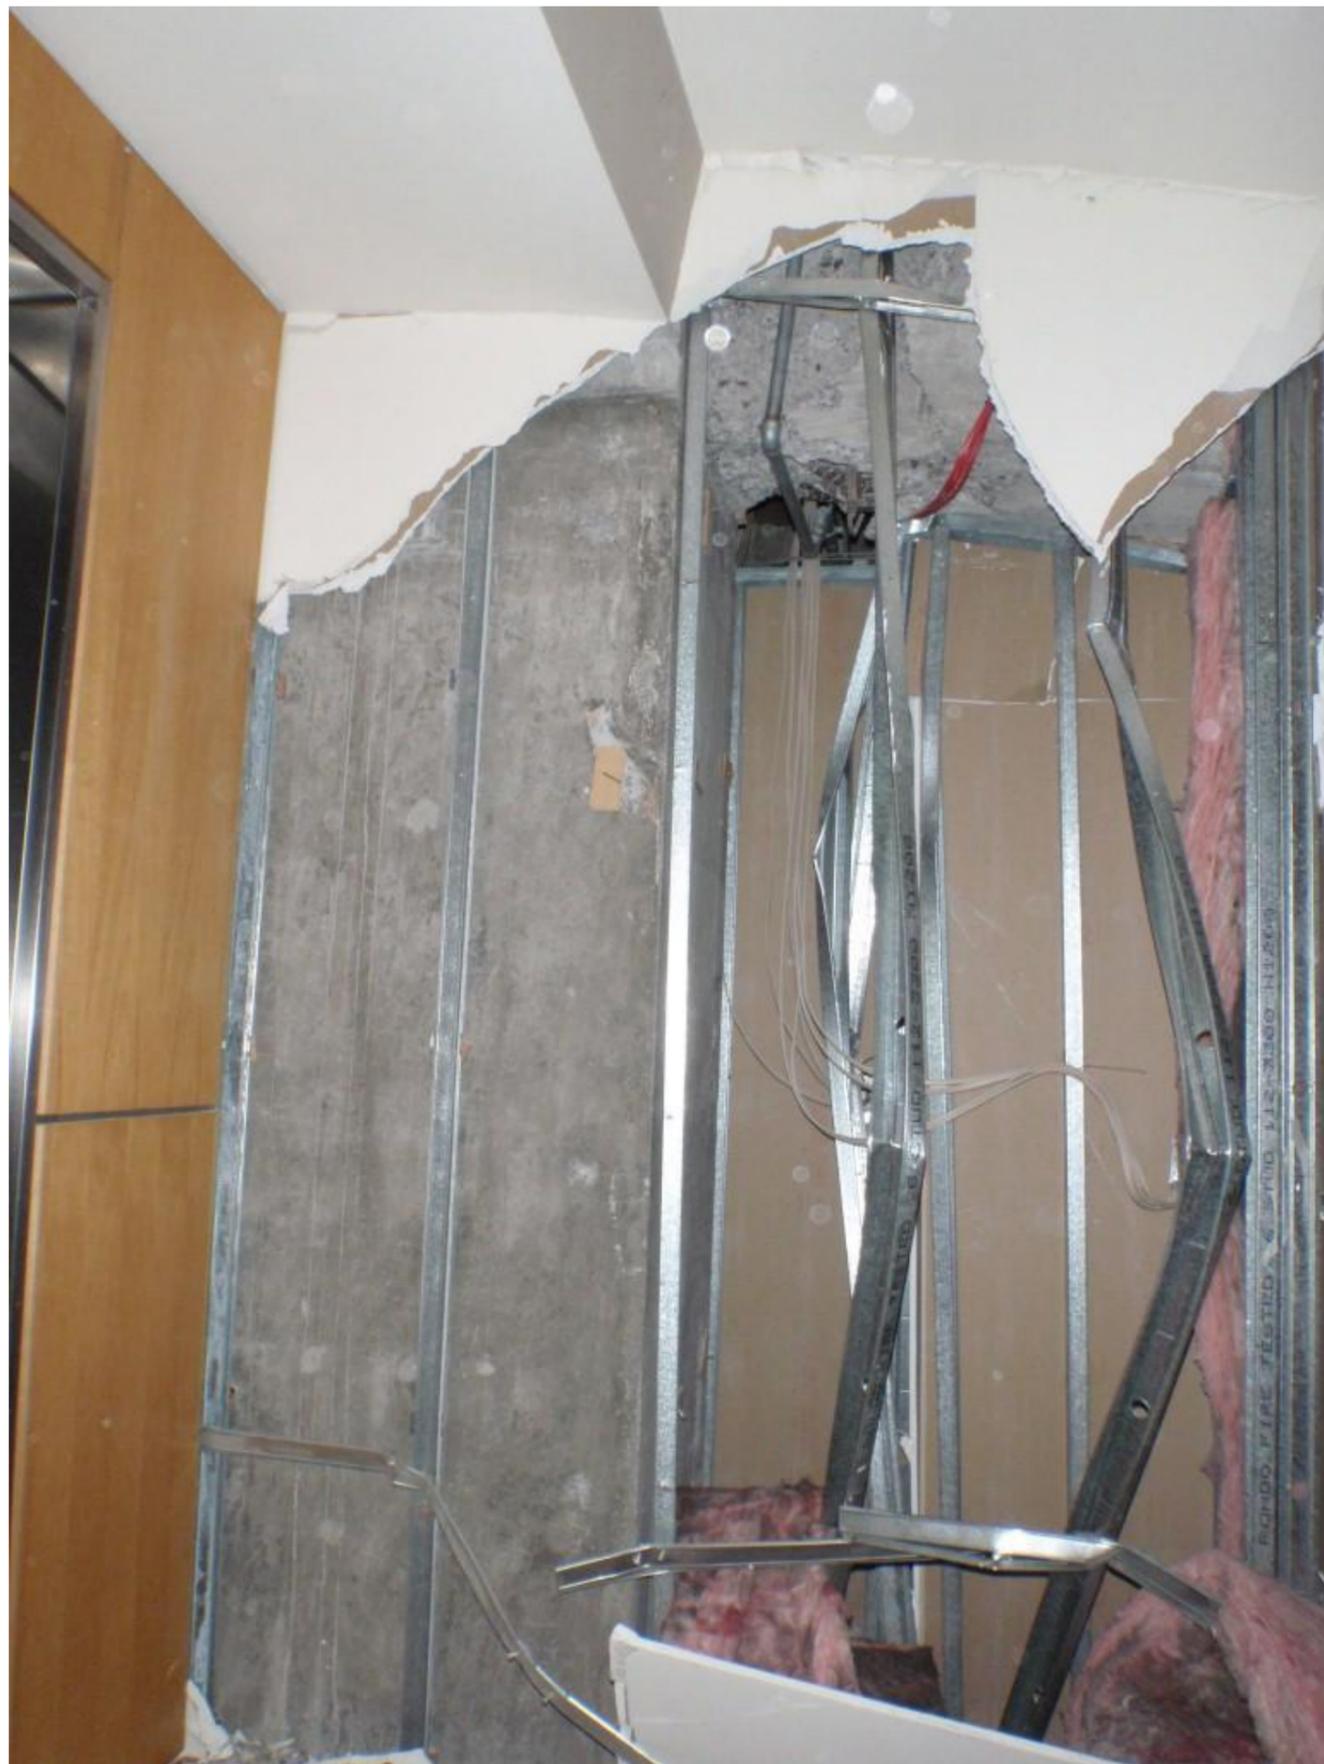
As the upper columns at D5 and D6 dropped, following the shear wall below, these upper tower beams experienced major displacements, well in excess of their expected ductility demands. The beams formed large-rotation hinges at the faces of the columns but the reinforcing did not fracture. *[Refer App. B pages 11 & App. C Photographs 17-19]*

Photo 17 - Hingeing in grid D tower beams

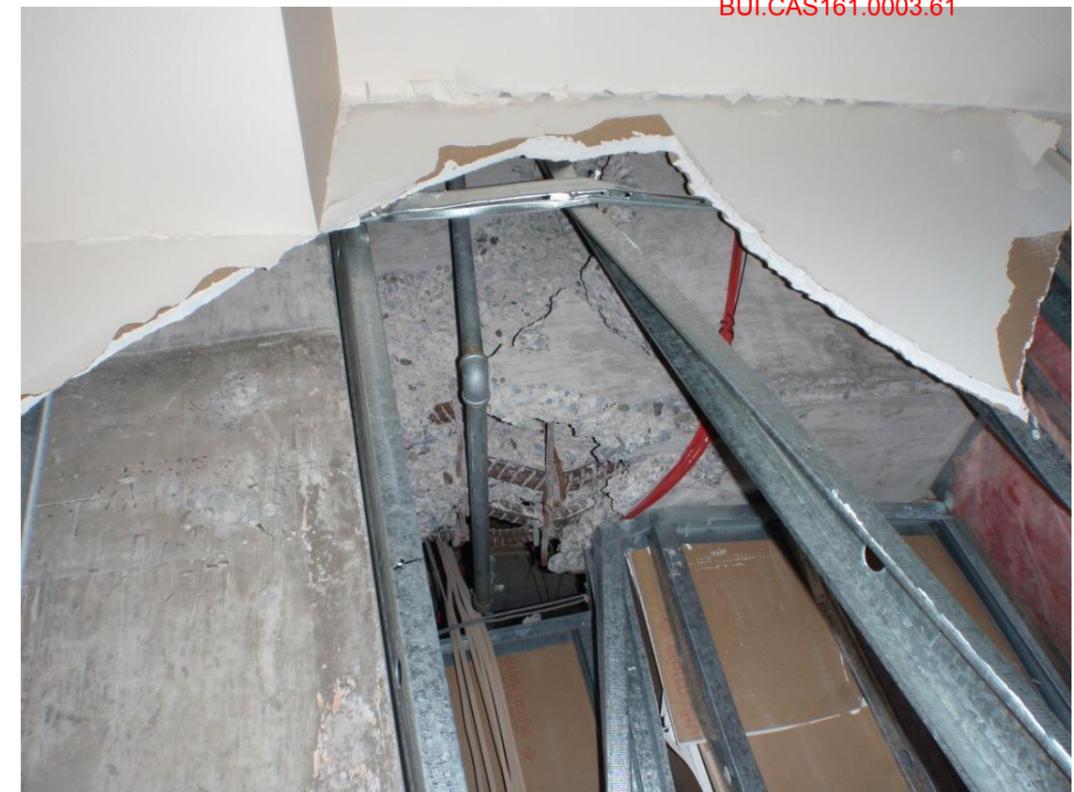
Photo 18 - Hingeing in grid D tower beams

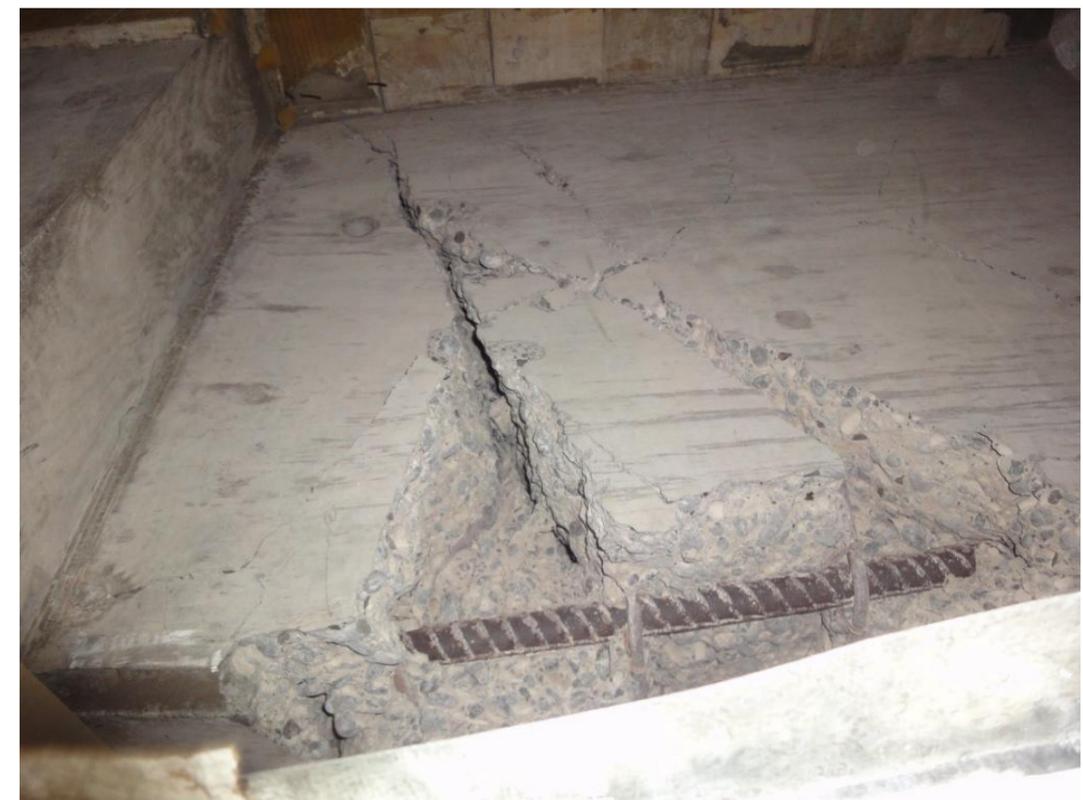
Photo 19 - Hingeing in grid D tower beams

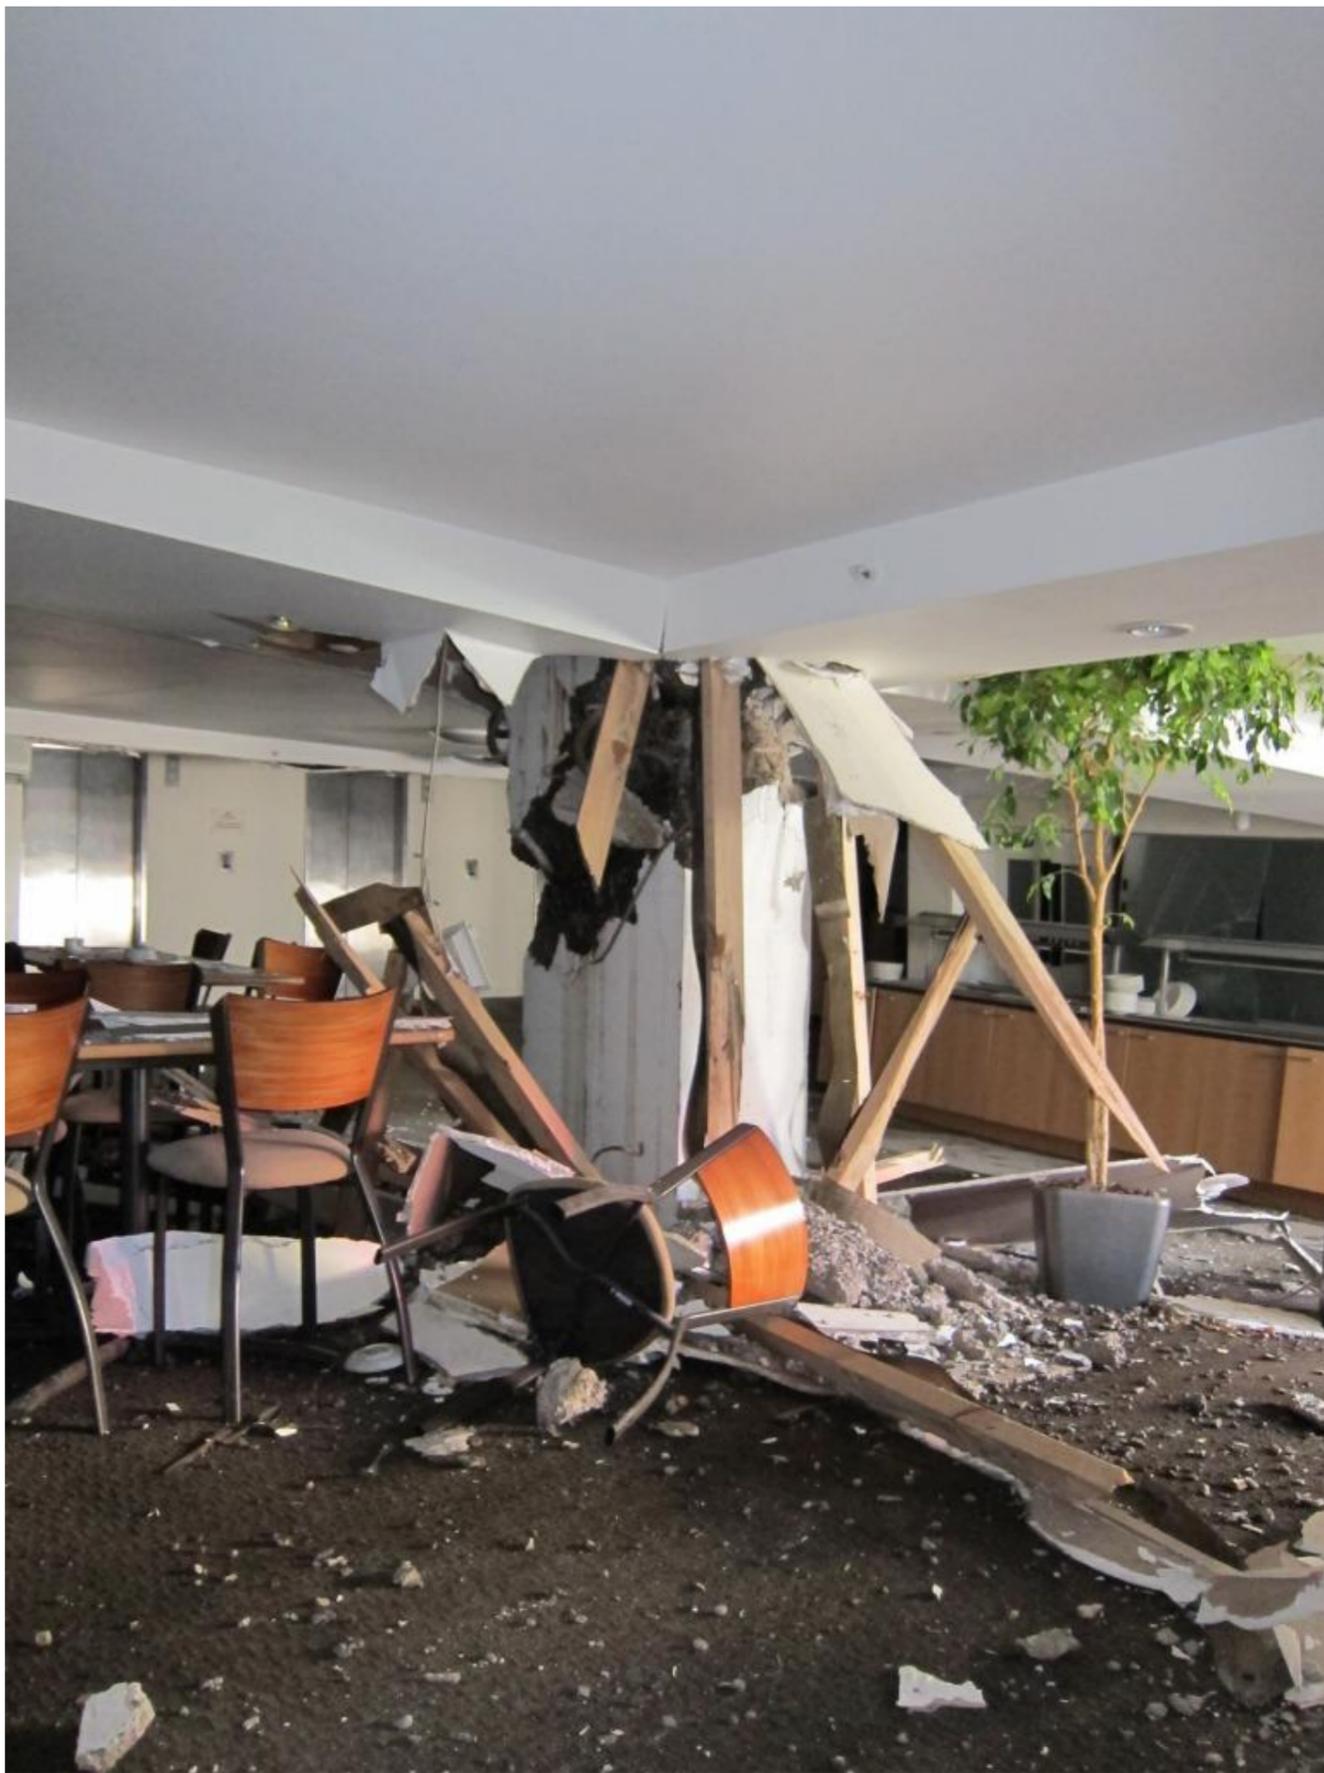
Photo 20 - Crushed columns at level 10, lines 5 & 6

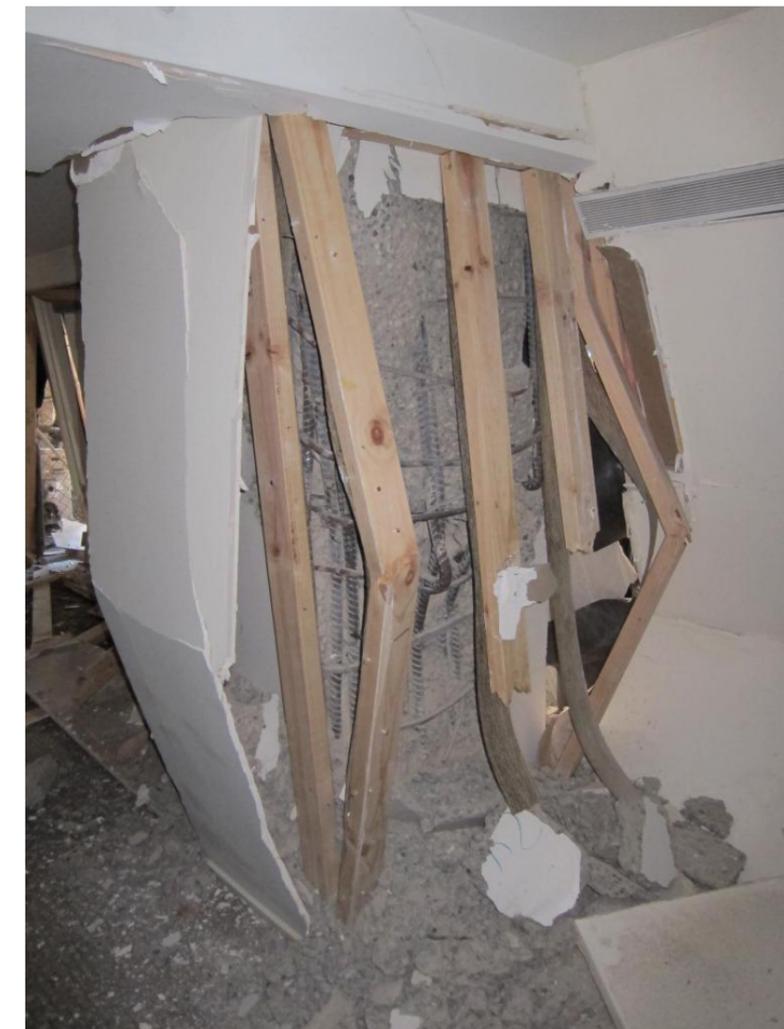
Photo 21 -
Crushed
columns at level
10, lines 5 & 6

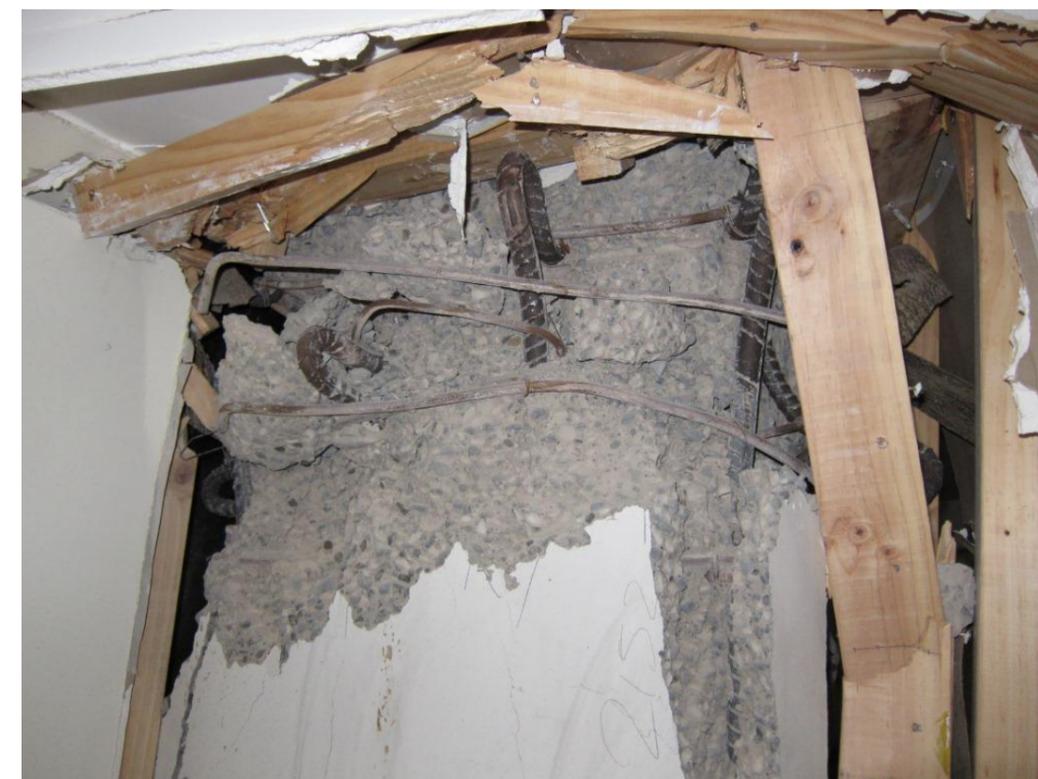
Photo 22 -
Crushed
columns at level
10, lines 5 & 6

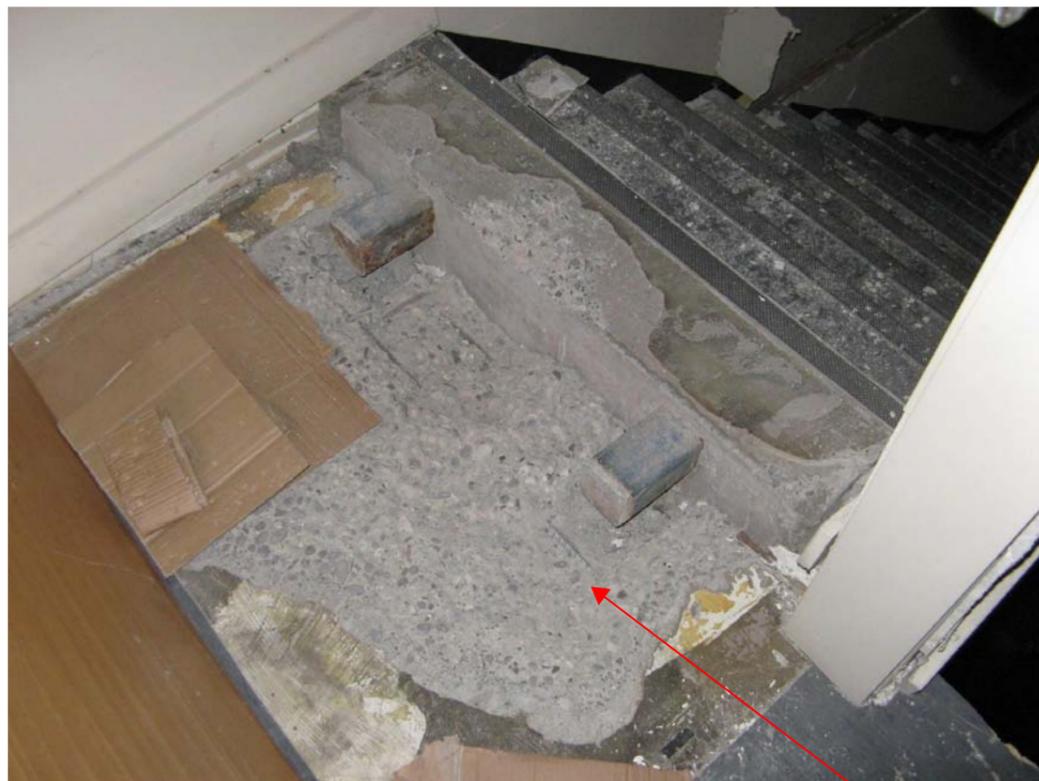
Photo 23 - Top of Intact stair flight

Landing damage

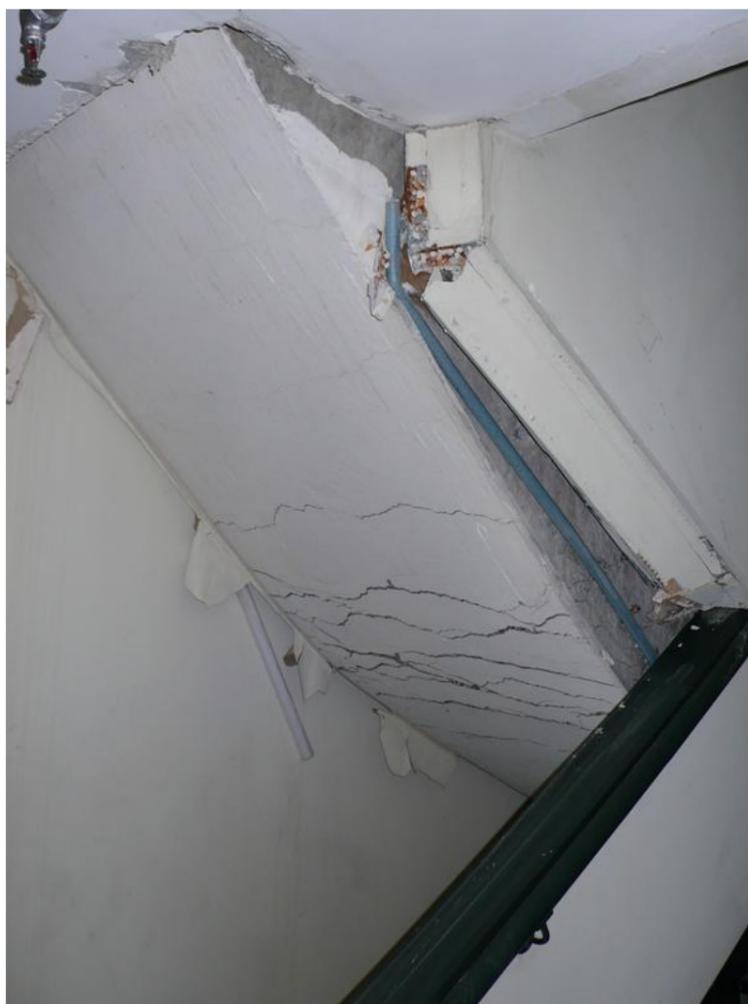
Photo 24 - Highest surviving stair, supporting debris

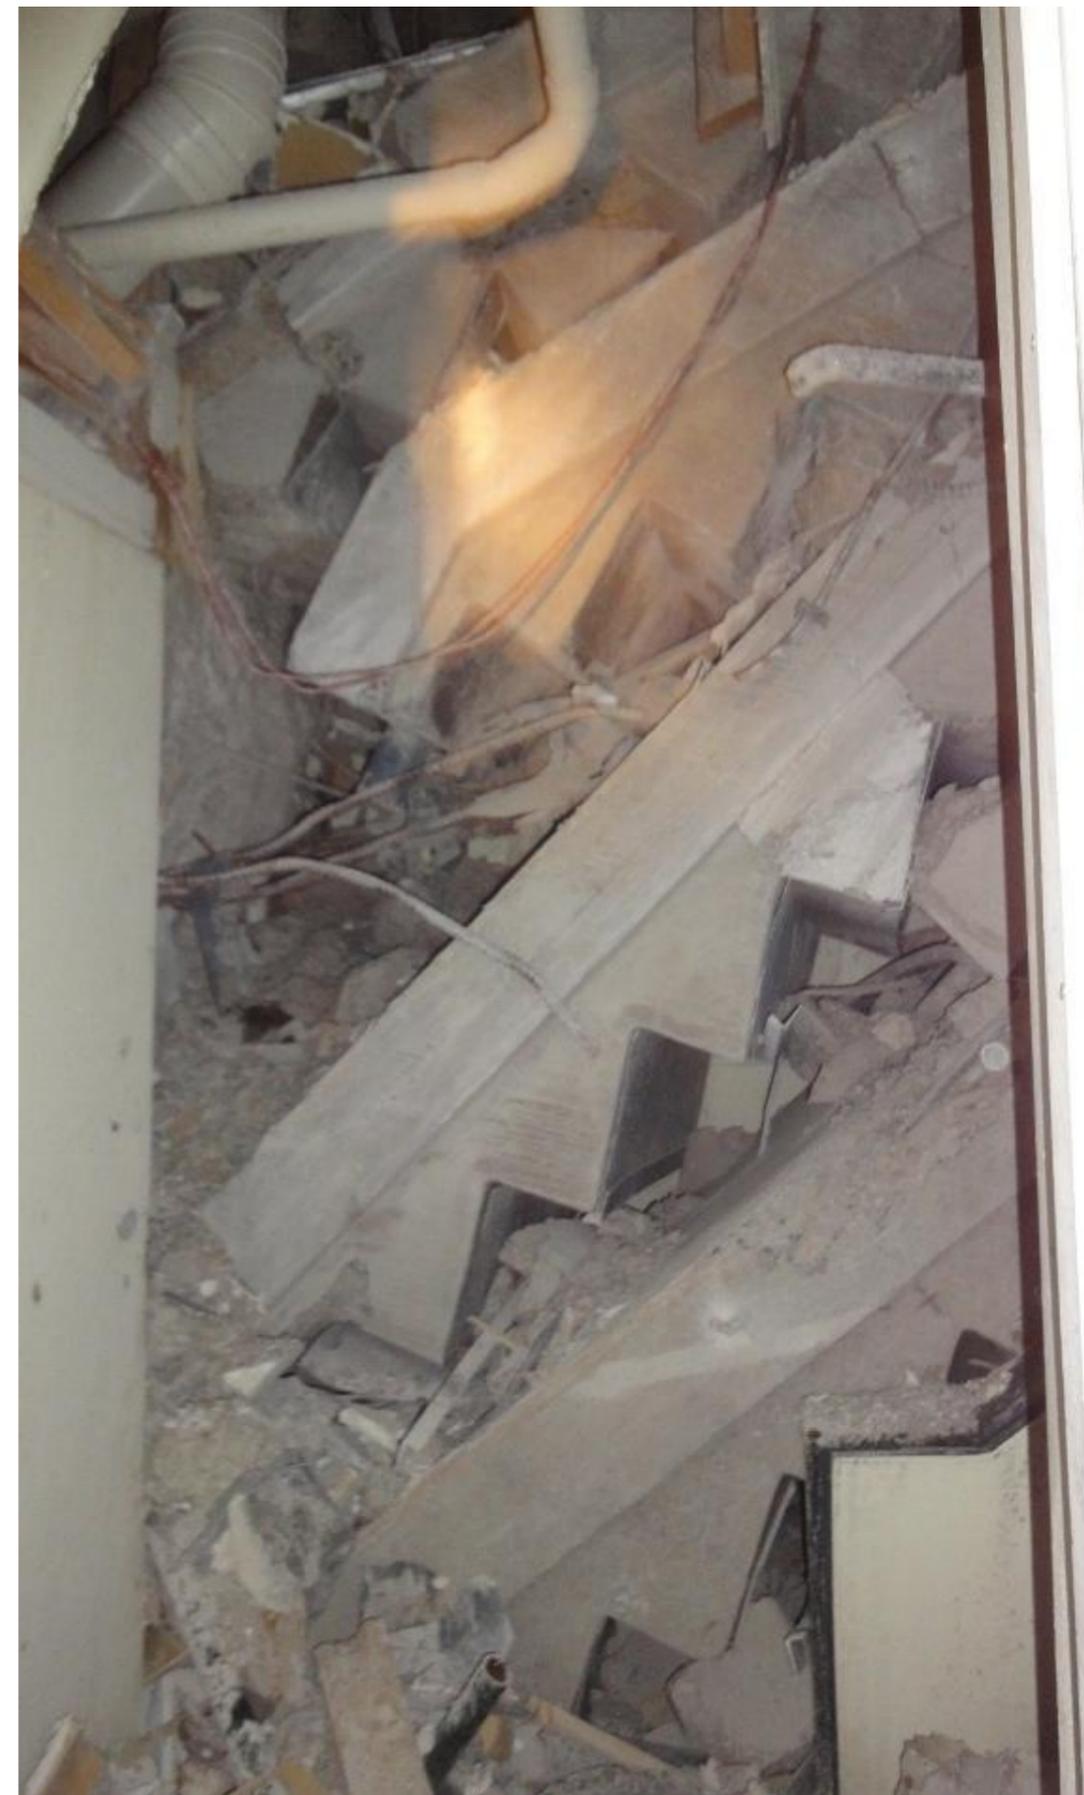
Photo 25 - Stair Debris
