Investigation into the Collapse of the Forsyth Barr Building Stairs on 22nd February 2011

Prepared for Department of Building and Housing (DBH)

By Beca Carter Hollings & Ferner Ltd (Beca)

26th September 2011

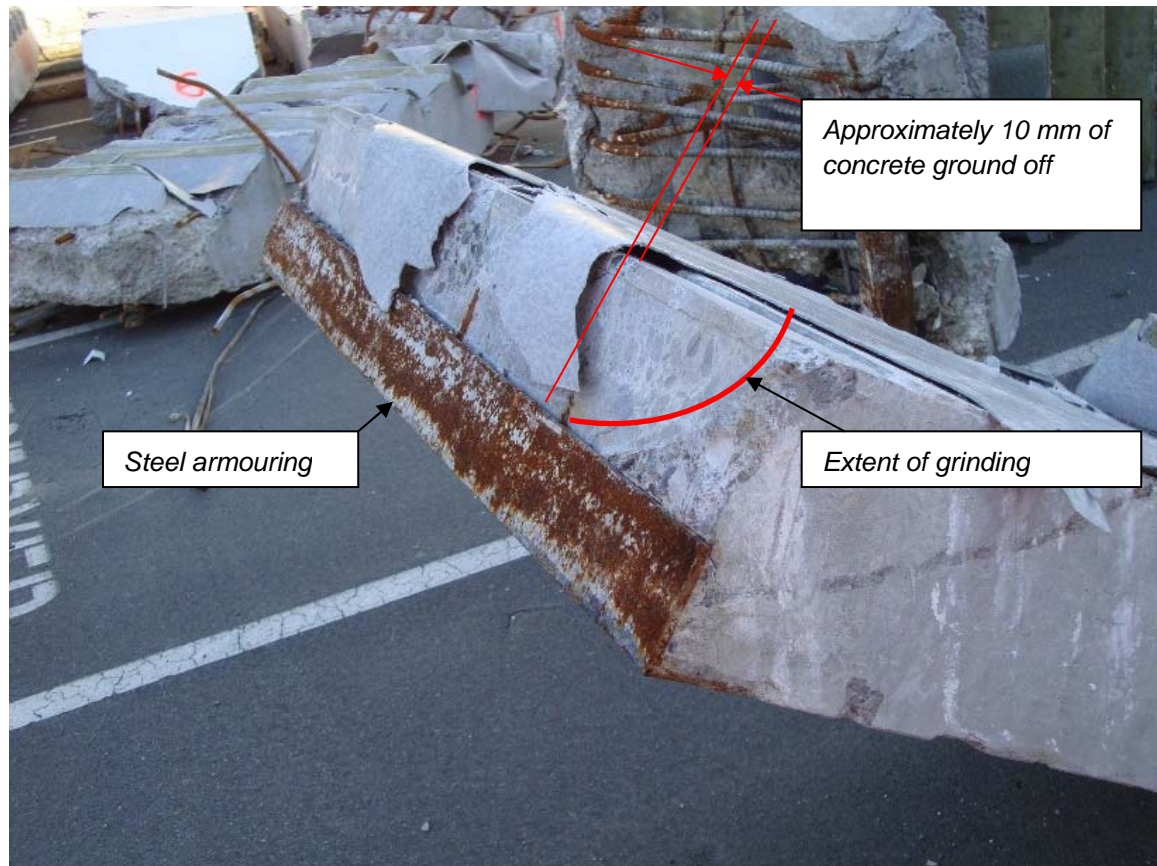
Figure 4.8 : Ground-Back End of Landing in Collapsed Stair Unit

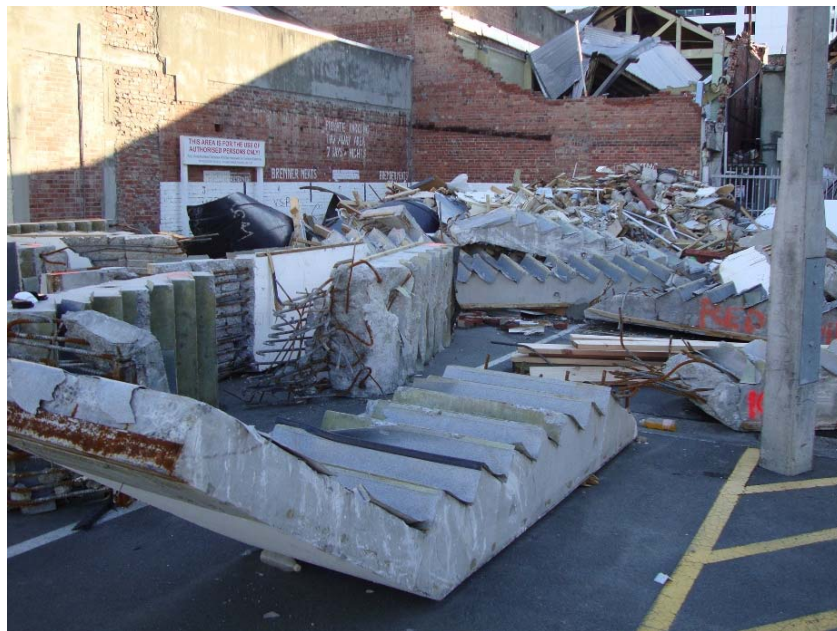
The units that had been removed from the building were available for inspection/testing (refer to Figure 7.1) but it was impossible to judge from which levels they had come. It was also difficult to judge whether or not the damage to these flights caused the collapse or was a result of impact from falling or being hit by other stair units.

Figure 7.1 : Collapsed Stair Units Removed from Stairwell

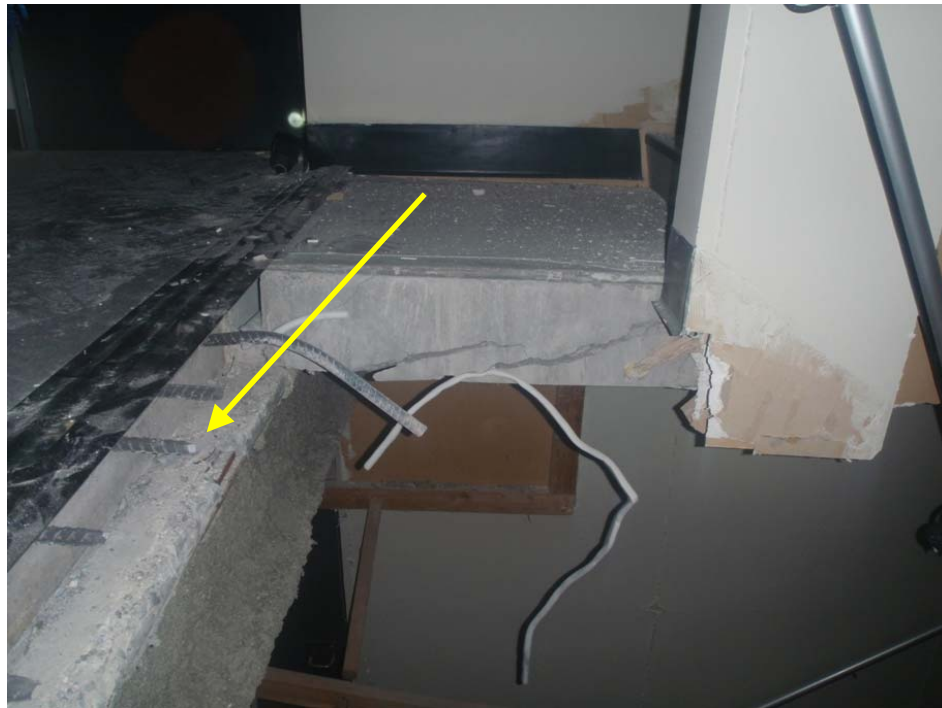
Figure 7.2 : Fractured Top Starter Bars

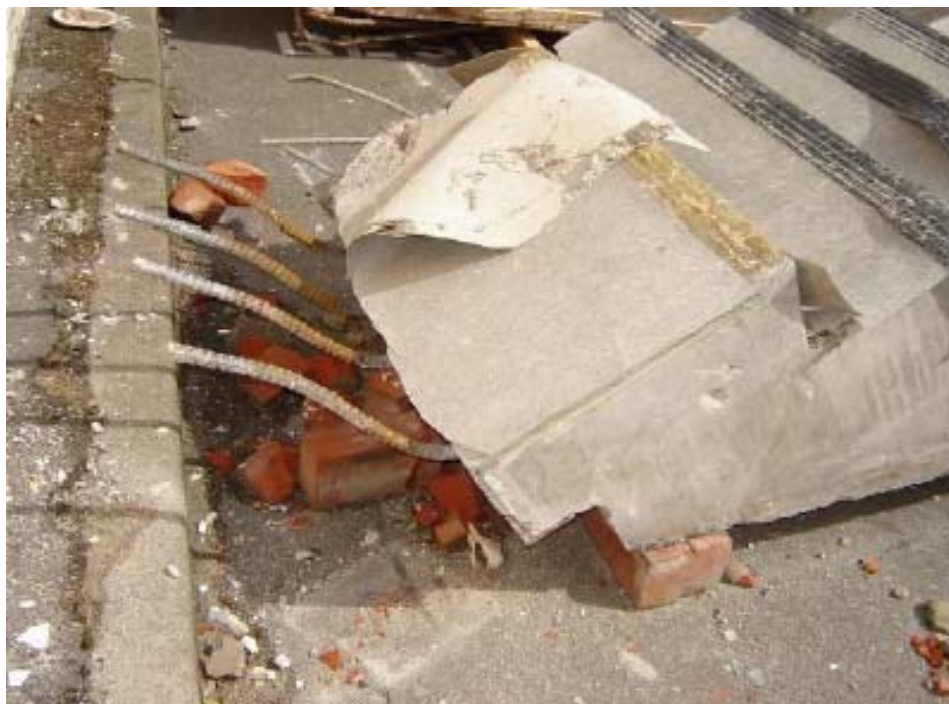
Figure 7.3 : Top Starters Pulled Out

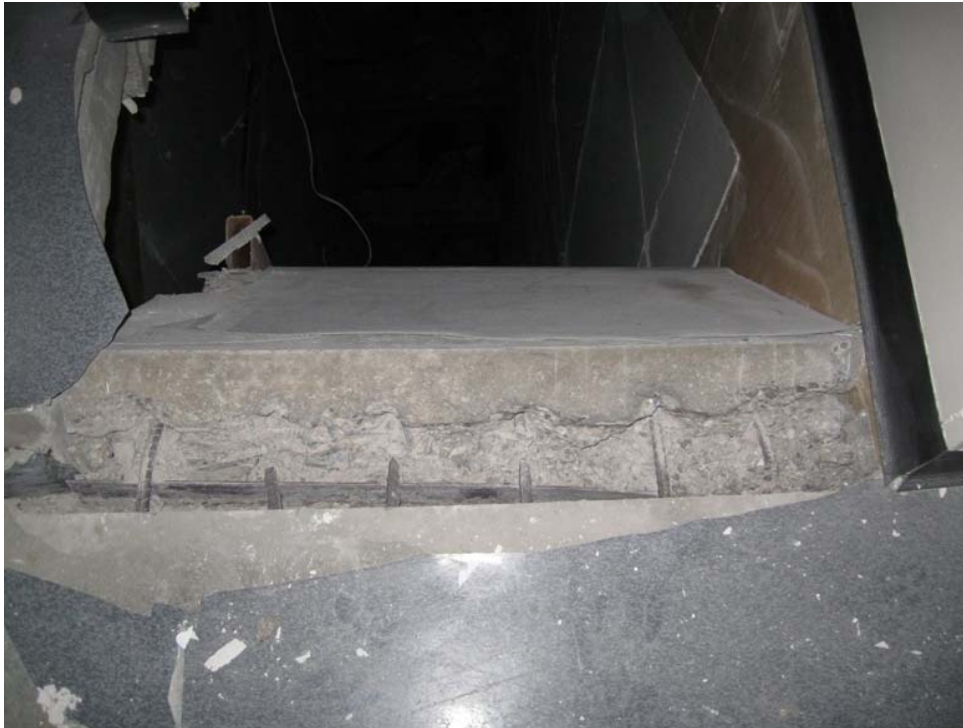
Figure 7.4 : Stair Flight Hanging from Top Starters (photograph taken from the top stair landing looking down the stair shaft).

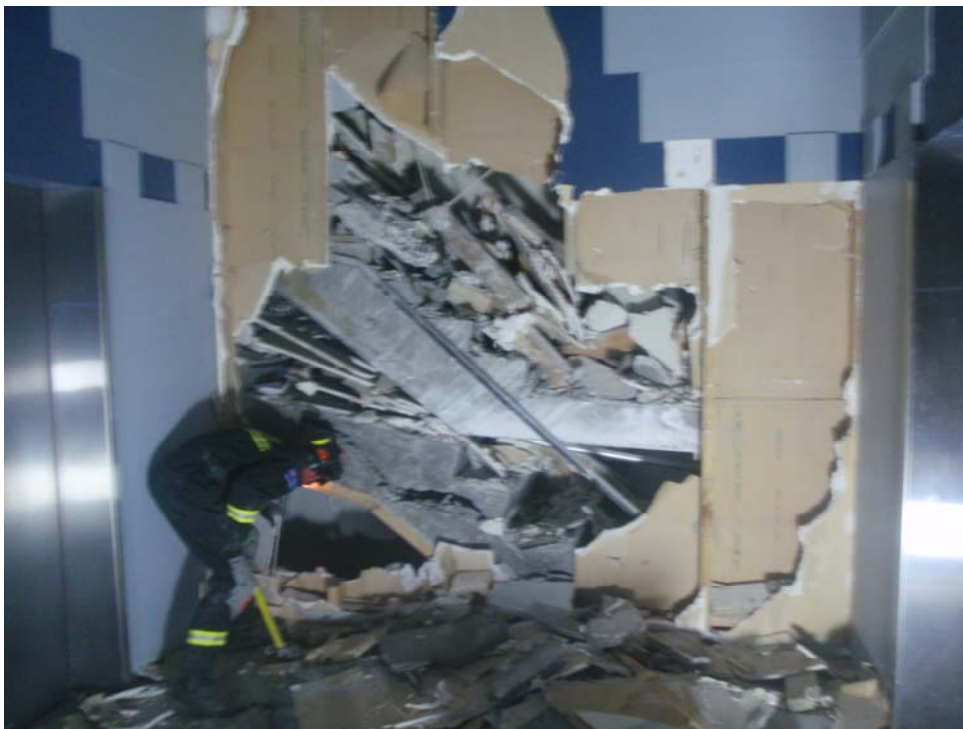
Figure 7.5 : Fallen Stair Flights at the Bottom of the Stairwell

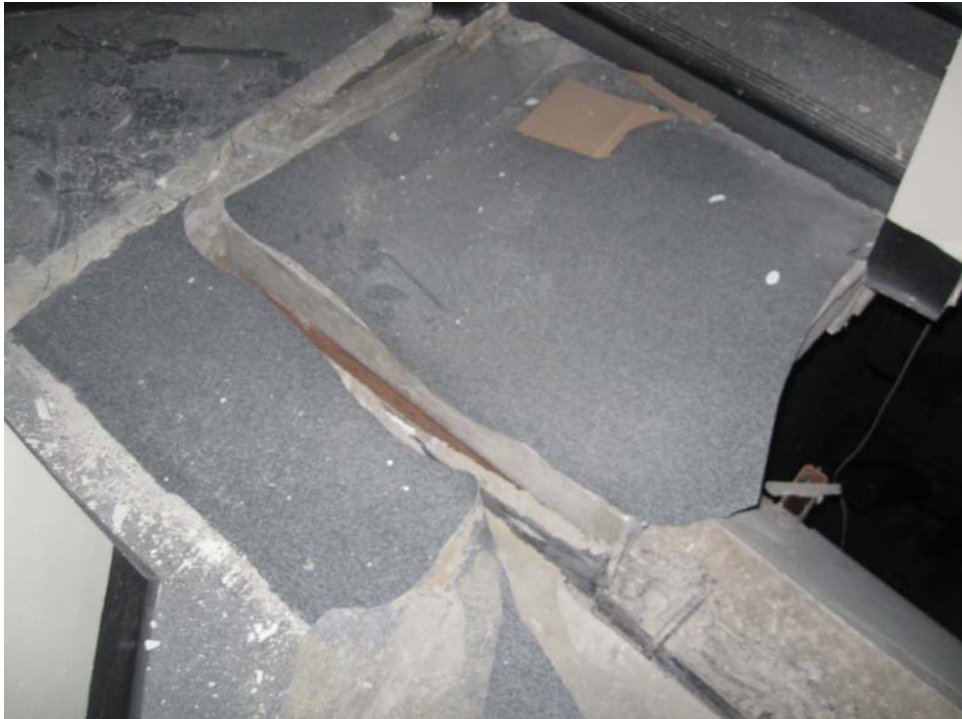
Figure 7.6 : Permanent Displacement at Bottom-Landing Seismic Joint

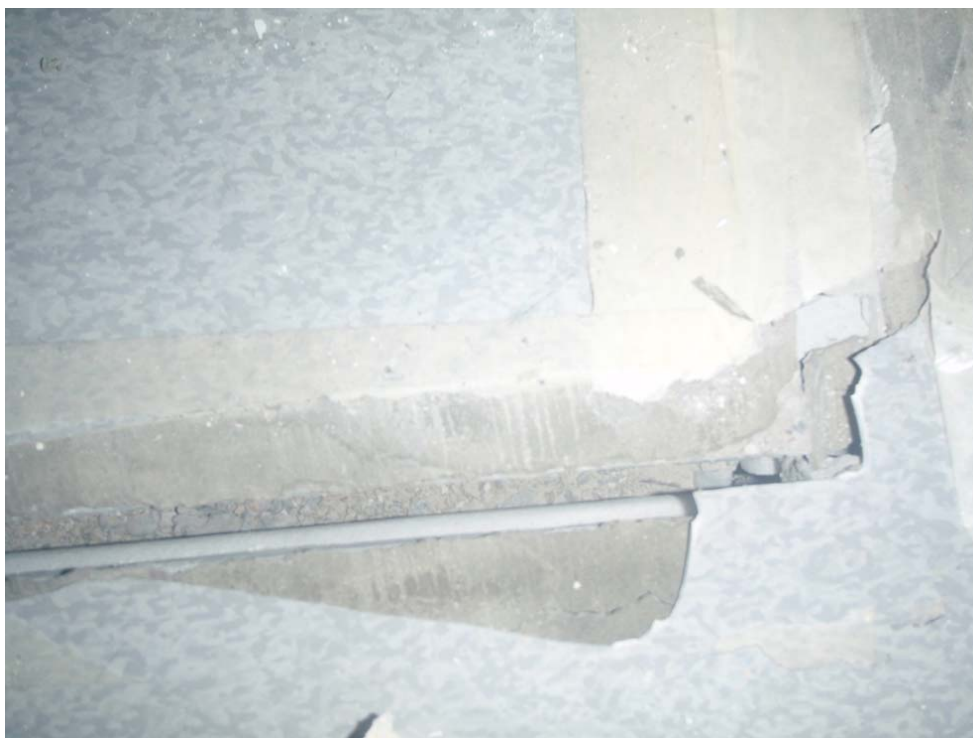
- At least some of the seismic joints are said to have been filled with construction debris, polystyrene packing, and/or mortar. This observation was also made after the 4th September 2010 earthquake. Refer to Figures 7.7, 7.8 and 7.9 (all taken after 22nd February 2011).

Figure 7.7 : Mortar-Filled Seismic Joint

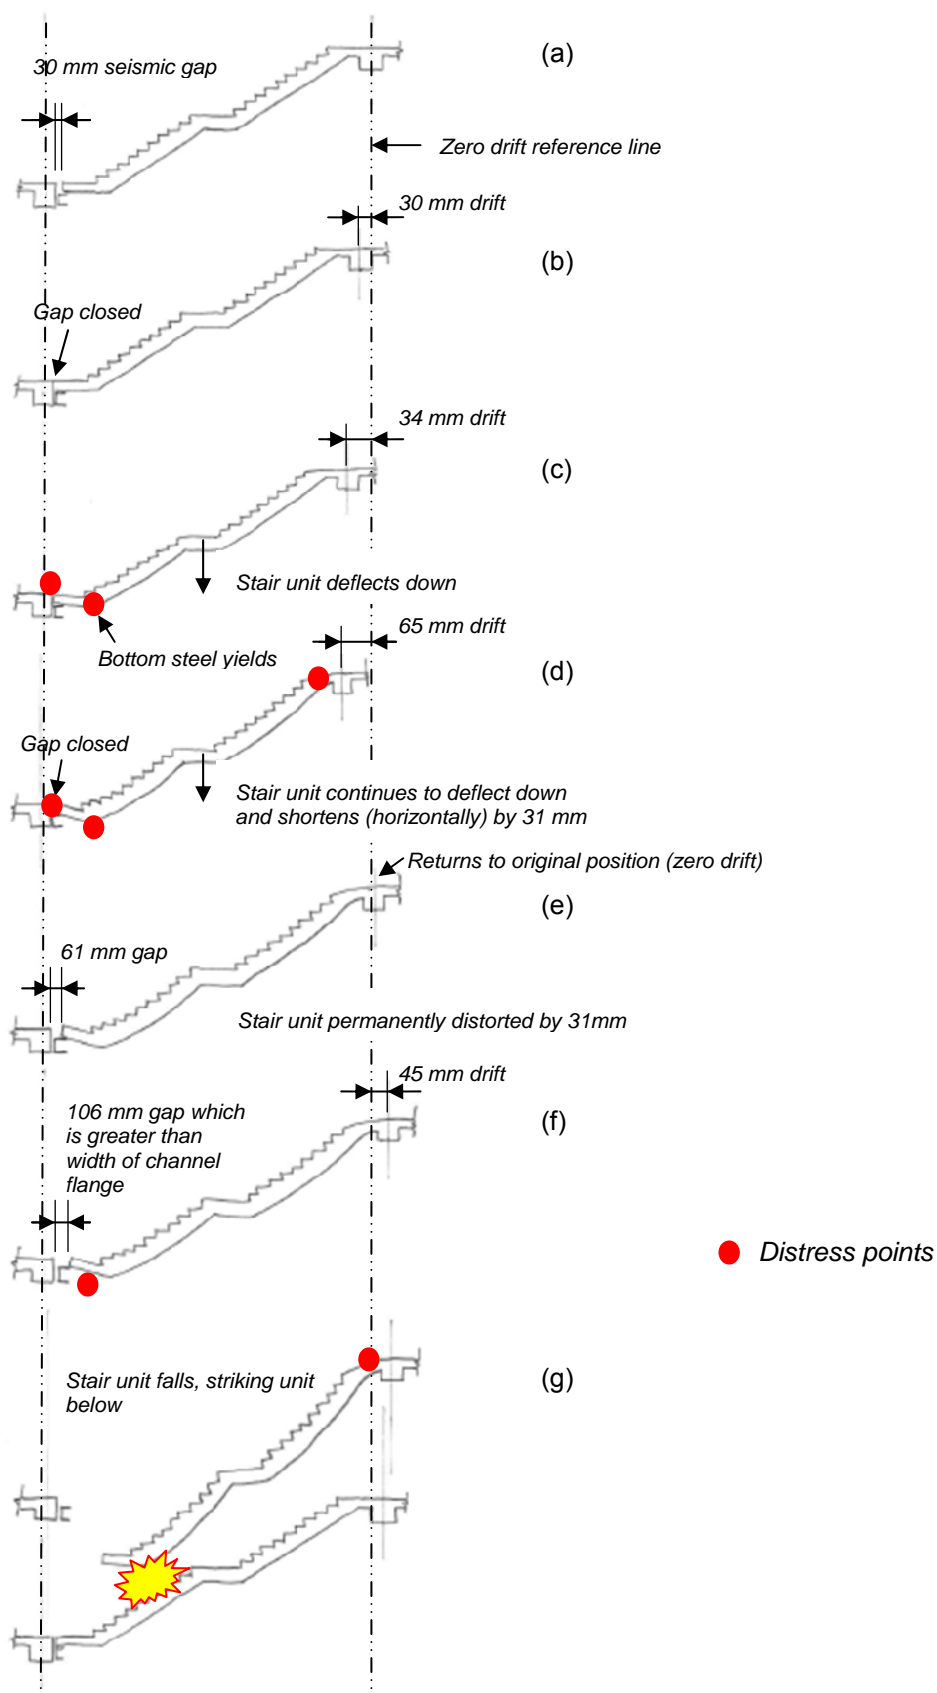
Figure 8.2 : Inferred Collapse Sequence

- When acting as struts, at least some of the units became overloaded and yielded in flexure at to the bottom step/riser. Analyses indicate that yield in this location will occur once inter-storey drifts of the order of 4 mm occur after the stairs become locked between floors (i.e., for drifts exceeding $30 + 4 = 34$ mm). Refer to Figure 8.2(c).

- Yielding can also occur where the top step meets the top landing, but would not cause additional overall shortening of the unit.

- Further inter-storey drift beyond 34 mm causes more flexural yielding, locking in further shortening of the unit.
