STRUCTURAL REPORT

OFFICE BUILDING 249 MADRAS STREET

CANTERBURY REGIONAL COUNCIL

by Holmes Consulting Group, Christchurch

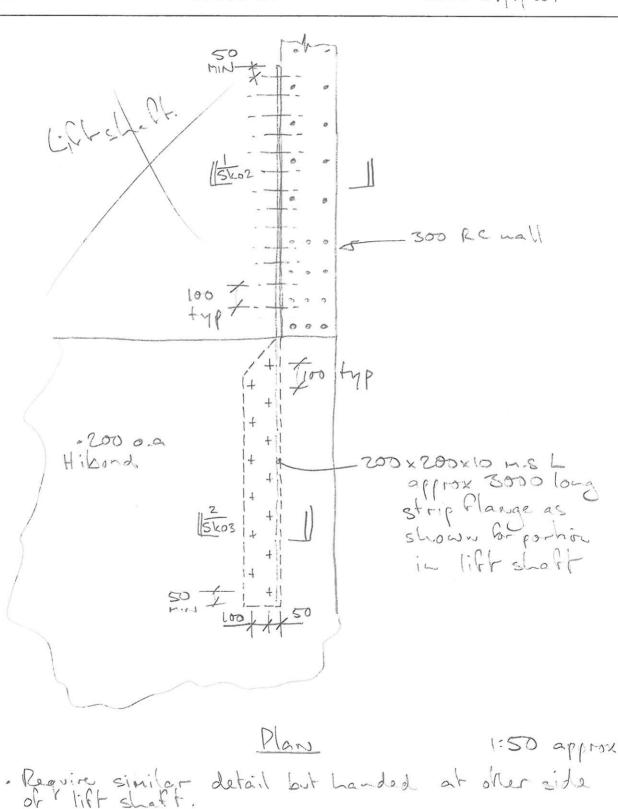
PAGE S/C-01 DATE 31/1/90.

· Detail typical to levels 1 to 5.

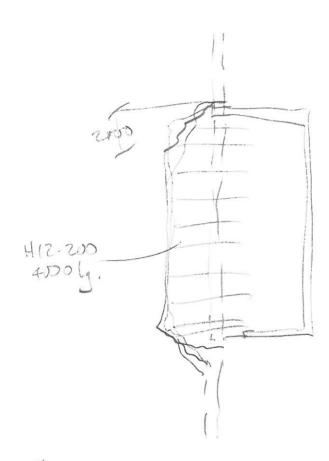
On extrar shear cove

Cutting as shown. ~ get 4000 H12-200 - Vs= 410×4×565 = 927 L.N + 664 wesh over 11.5 ~. Vs=11.5 × 269 × 275 = 851 Lw - plenty already.
