CANTERBURY EARTHQUAKES ROYAL COMMISSION - REQUIREMENT FOR
INFORMATION - RECEIVED 19 SEPTEMBER 2011

Royal Commission of Inquiry into Building Failures Caused by the Canterbury Earthquakes: Requirement for Information

PGC Building – Re-inspection of ground floor window frame gap and second floor partition crack.

Photographic Summary of Primary Damage Observed – 16 Sept 2010

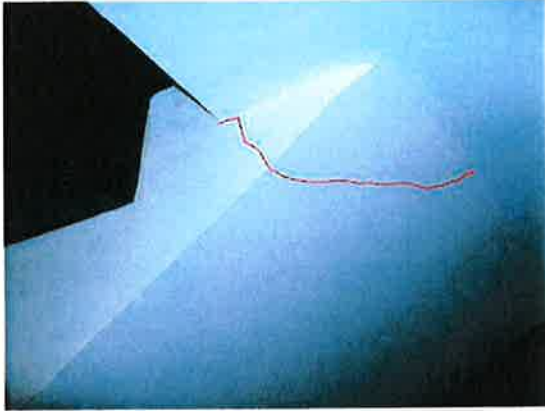
Damaged Item	Example
<p>Photo 001</p> <p>Minor cracking to underside stairs to L1 Typically $\leq 0.2\text{mm}$</p>

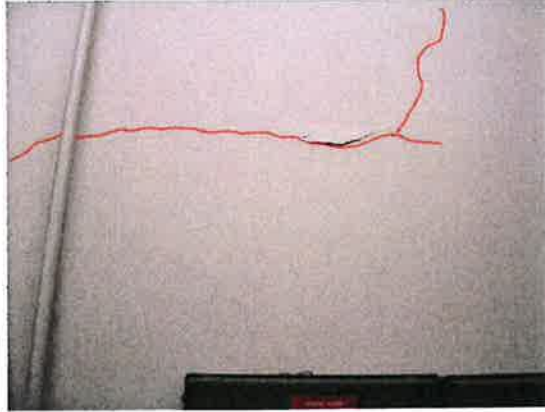
<p>Photo 002</p> <p>Cracking to G floor shear wall Typically $\leq 0.2\text{mm}$</p>

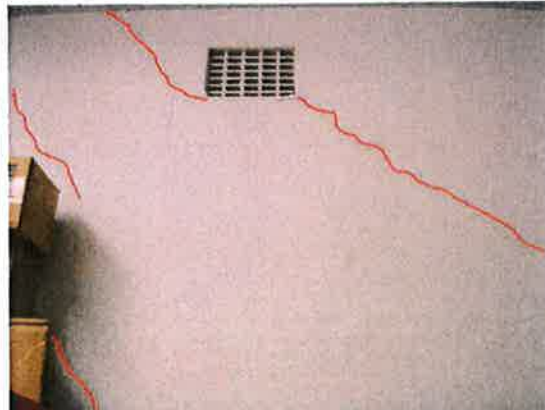
<p>Photo 003</p> <p>Cracking to G floor shear wall Typically $\leq 0.2\text{mm}$</p>

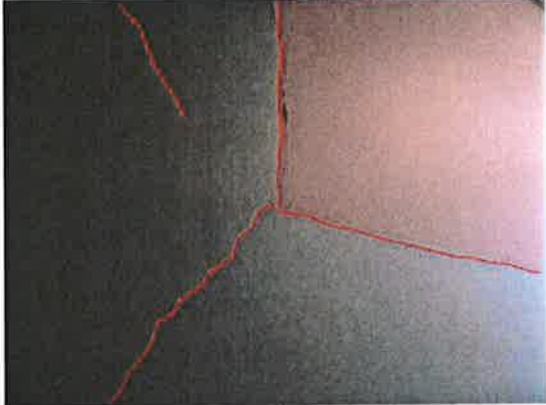
Damaged Item	Example
<p>Photo 004</p> <p>Cracking to G floor shear wall Typically $\leq 0.2\text{mm}$ Shaded area is Gib infill</p>

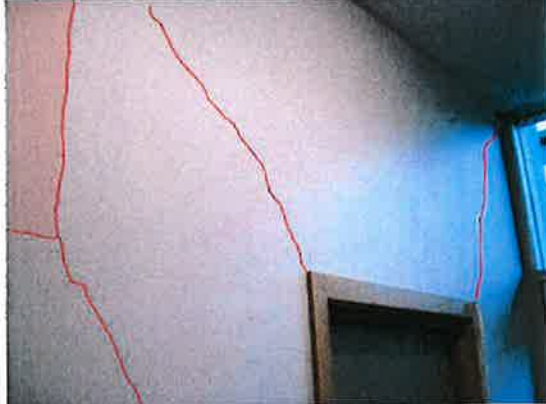
<p>Photo 005</p> <p>Cracking to G floor shear wall Typically $\leq 0.2\text{mm}$ Shaded area is Gib infill</p>

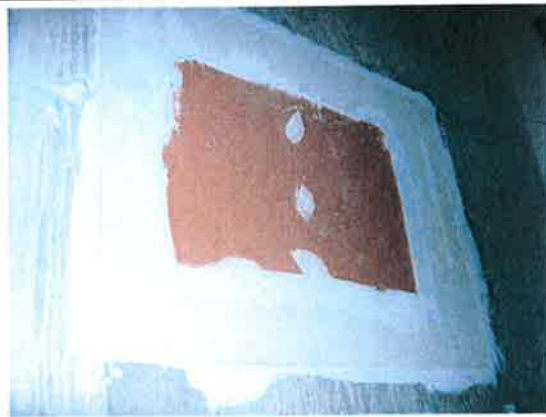
<p>Photo 006</p> <p>Rear of shear wall showing Gib infill Plantroom</p>

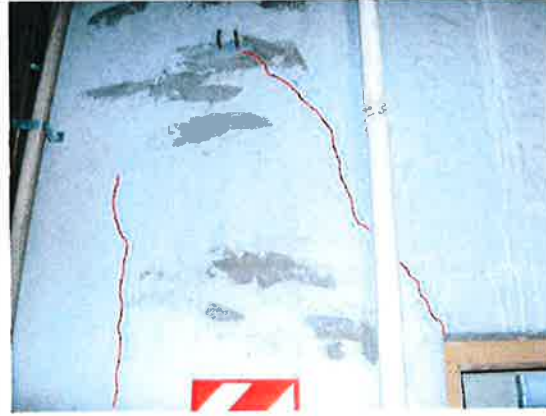
<p>Photo 007</p> <p>Cracking to G floor shear wall Typically $\leq 0.2\text{mm}$ Plant room</p>

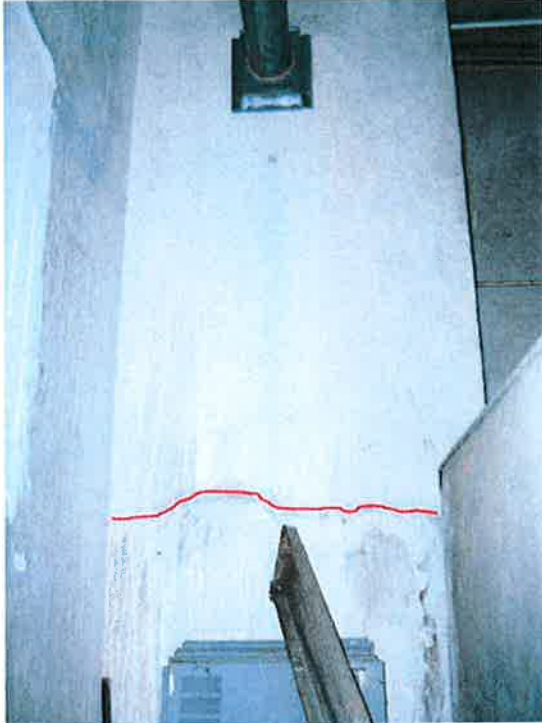
Damaged Item	Example
<p>Photo 008</p> <p>Horizontal cracking to G floor shear wall Typically $\leq 0.3\text{mm}$ Plant room</p>

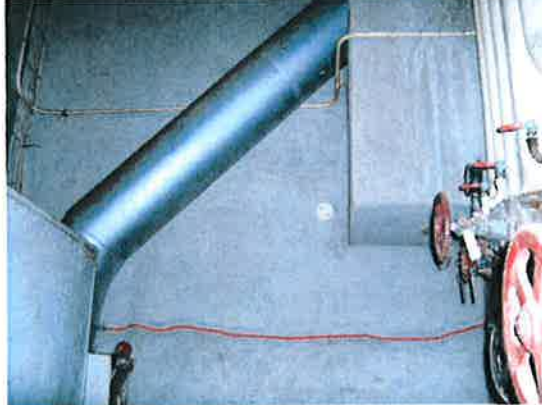
A photograph of a light-colored concrete wall in a plant room. A horizontal crack is visible, extending across the width of the wall. The crack is highlighted with a red line. A metal pipe is visible at the top of the wall, and a wooden beam is leaning against the wall below the crack.
<p>Photo 009</p> <p>Horizontal cracking to G floor shear wall Typically $\leq 0.3\text{mm}$ Plant room</p>

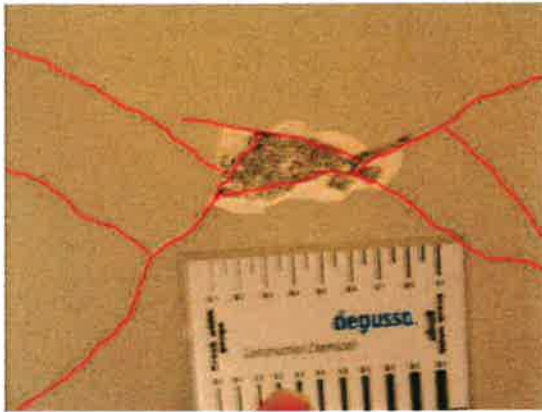
Damaged Item	Example
<p>Photo 011</p> <p>Cracking to L1 shear wall Typically $\leq 0.2\text{mm}$</p>

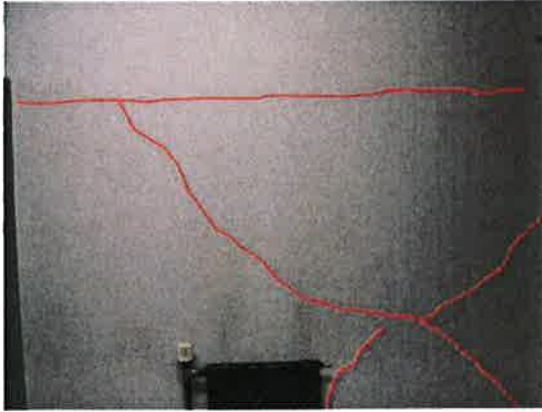
A photograph of a light-colored wall with several red lines drawn over it to indicate cracks. A ruler is visible in the foreground for scale.
<p>Photo 012</p> <p>Cracking to L1 shear wall Typically $\leq 0.2\text{mm}$</p>

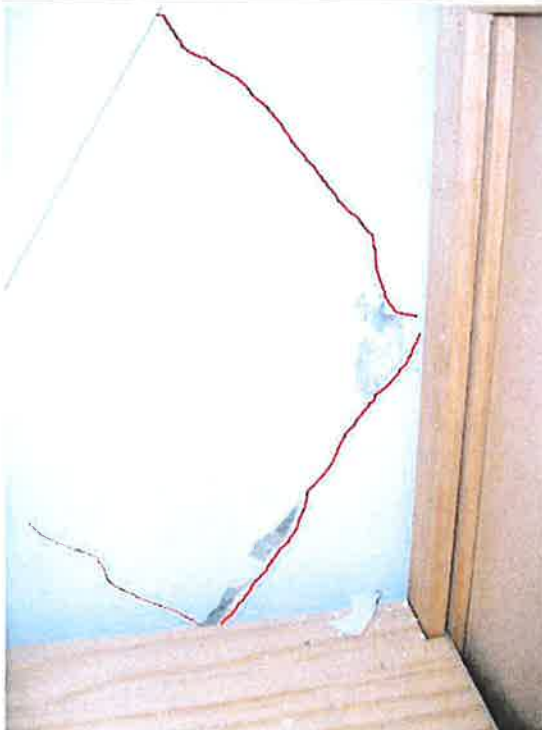
As illustrated in the photographic record the cracking to the shear walls was predominantly on the Ground and First Floors and were generally 0.2-0.3mm. The largest of the cracks was located on the E-W shear wall at the south of the lift core (refer photographs 013-017 in the attached document) and were 0.2-0.6mm.

A photograph of a wall with several red lines drawn over it to indicate cracks.
<p>Photo 013</p> <p>Cracking to L1 shear wall in storeroom Crackwidths between 0.2mm – 0.6mm At Lift Core Wall</p>

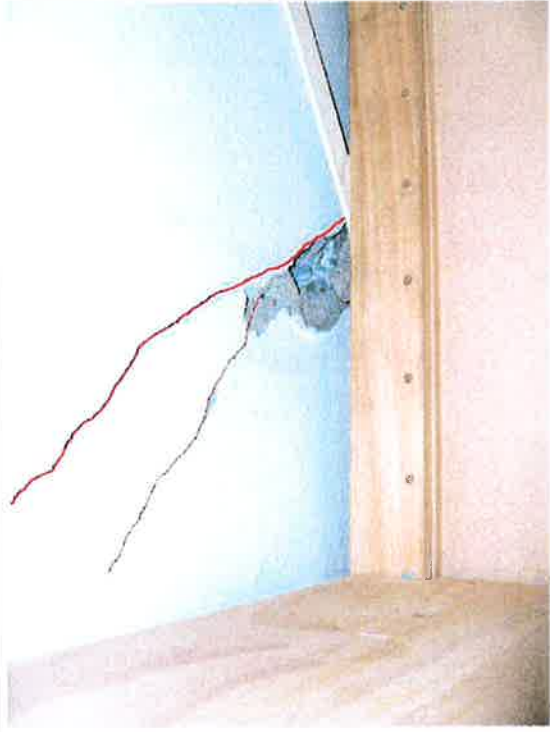
Damaged Item	Example
<p data-bbox="231 293 352 322">Photo 014</p> <p data-bbox="231 376 679 488">Cracking to L1 shear wall in storeroom Crackwidths between 0.2mm – 0.6mm At Lift Core Wall</p>

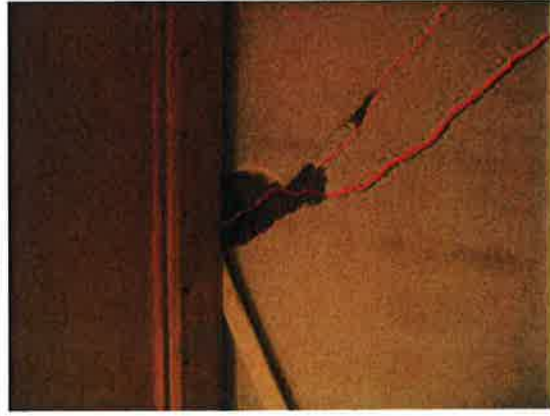
<p data-bbox="231 1473 352 1503">Photo 016</p> <p data-bbox="231 1556 679 1668">Cracking to L1 shear wall in storeroom Crackwidths between 0.2mm – 0.6mm At Lift Core Wall</p>

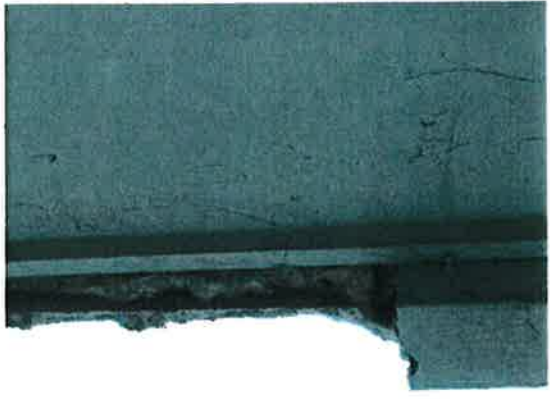
Damaged Item	Example
<p data-bbox="231 291 359 324">Photo 017</p> <p data-bbox="231 369 686 481">Corrosion induced cracking/spalling of spandrel panels Typical panel damage shown</p>
