# CHRISTCHURCH CITY COUNCIL

BUILDING - 605 COLOMBO STREET

SEISMIC RISK BUILDINGS - SURVEY

**Notices under the Building Act 2004 not to use or occupy your building and to repair your building  
605 Colombo Street**

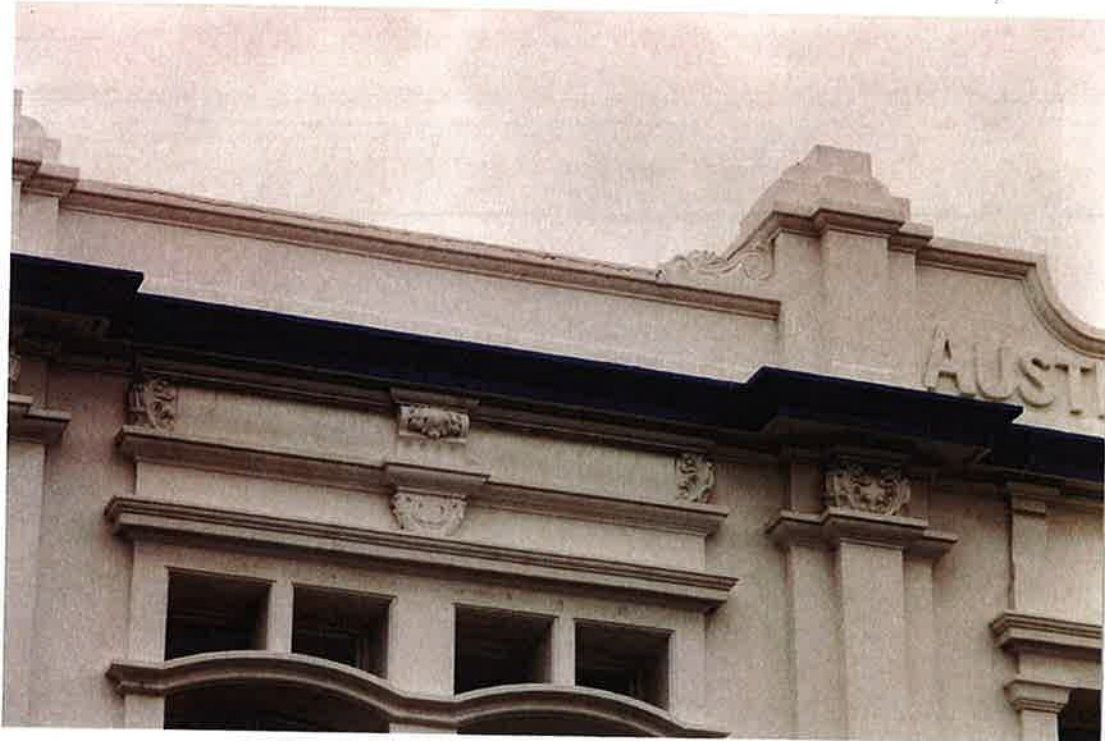
Parapet: ~1.0m cracked top, "spiky" blocks (see photo)  
Chimney: .....  
Cornice: heavy ~400mm o/H

Heavy Parapet - note crack along top of parapet cap.
