**Canterbury Earthquakes Royal Commission**  
**Te Komihana Rūwhenua a te Karauna**

**617 Colombo Street, Christchurch**

The Royal Commission is currently examining the failure of the building at 617 Colombo Street (the Building).

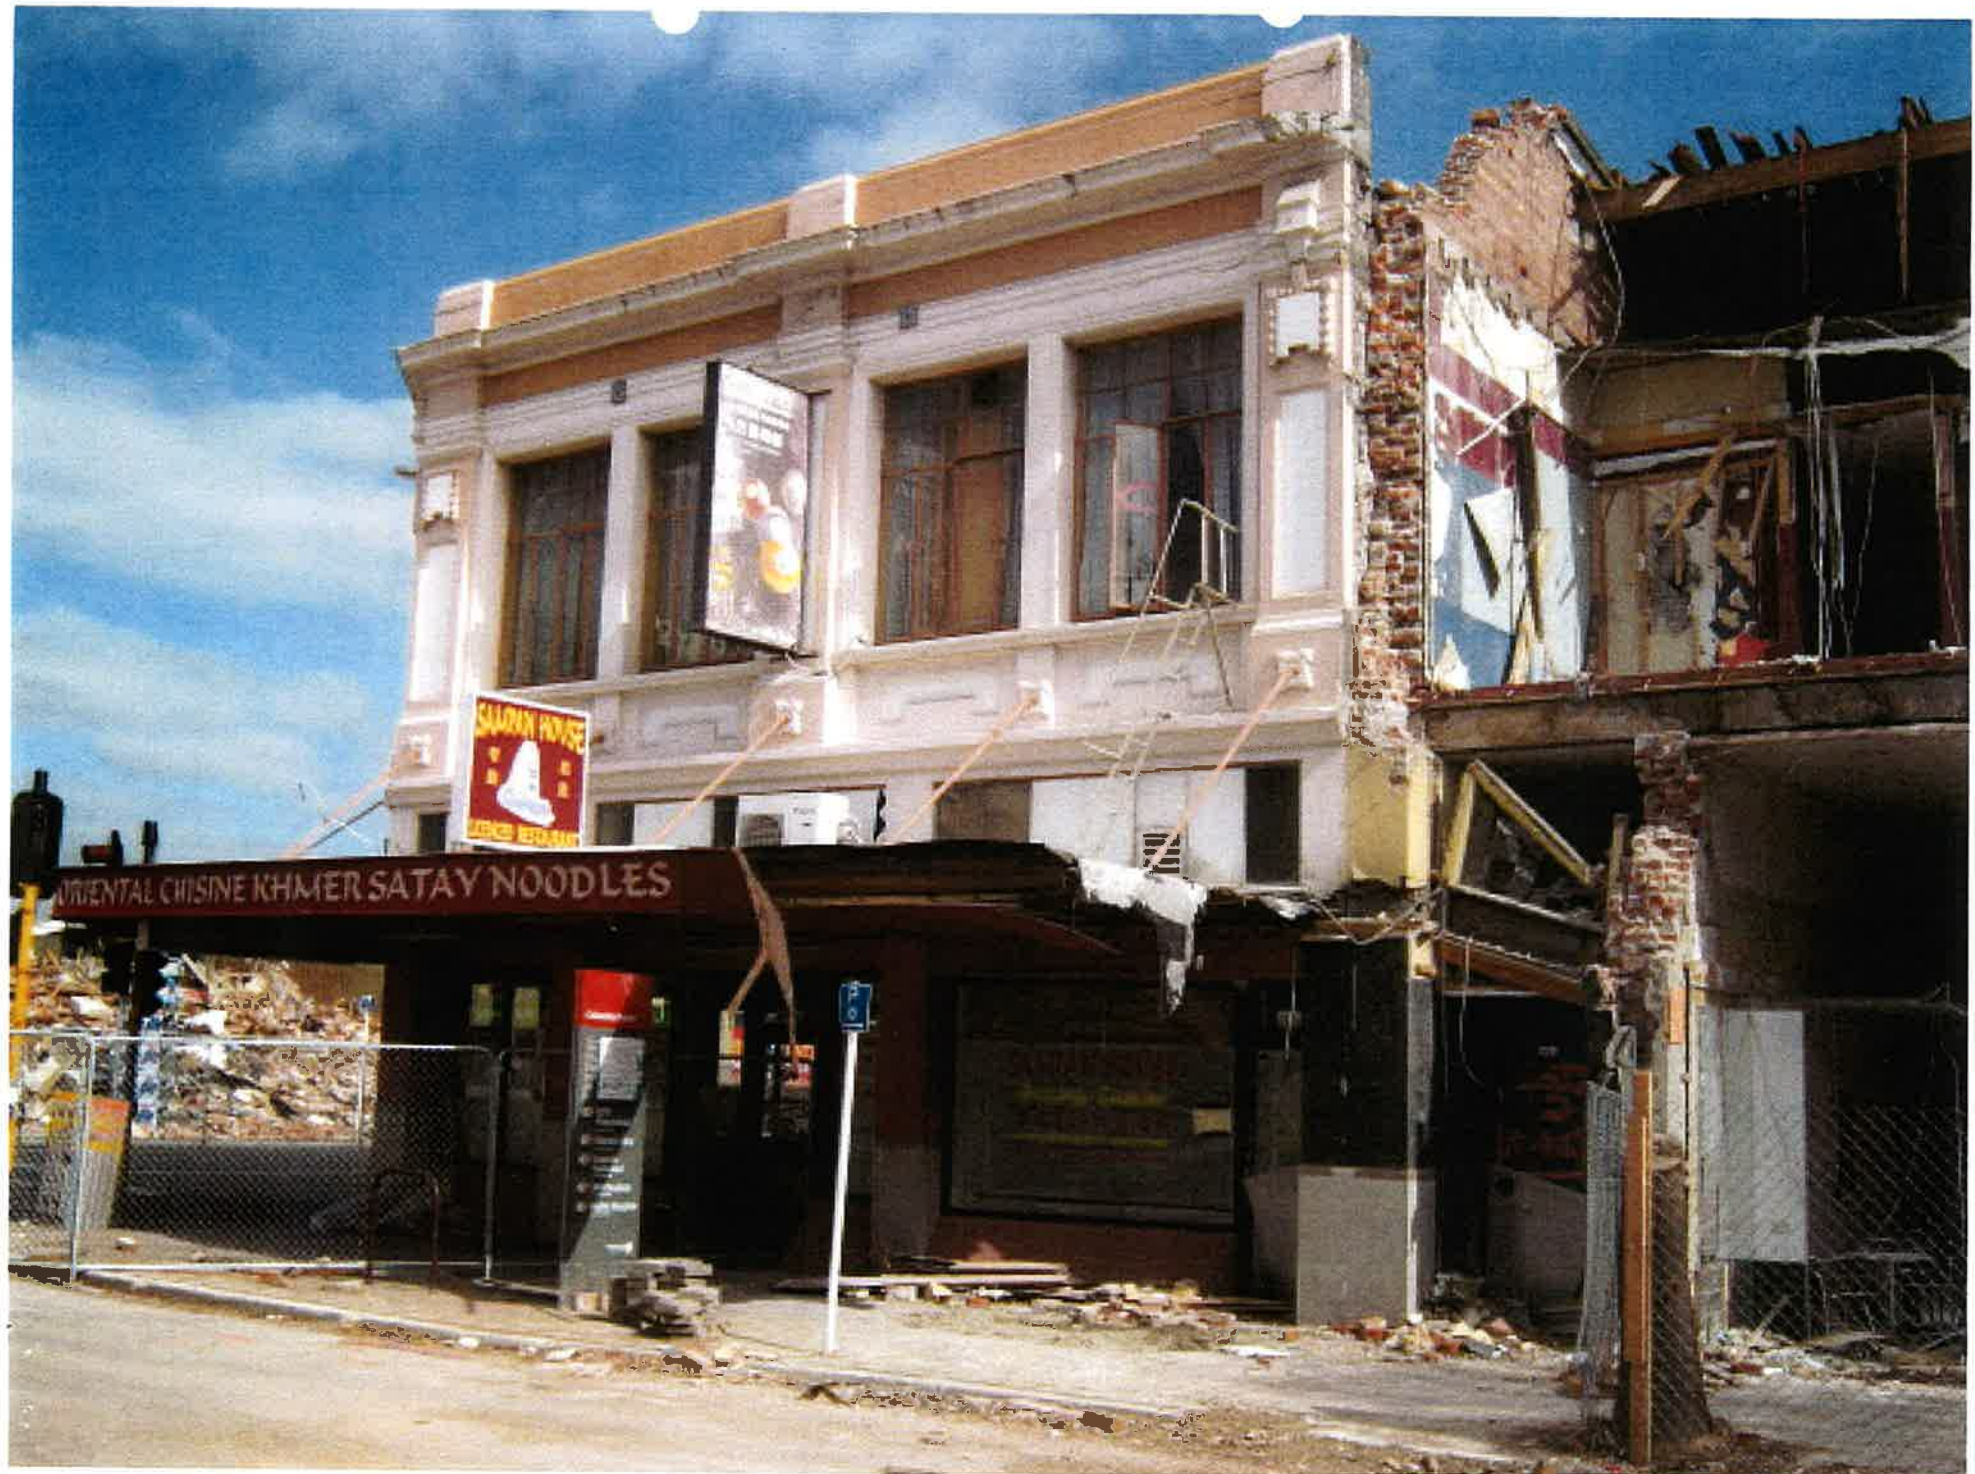
We also **attach** a photograph taken of the building after the 22 February earthquake. This photo is in the building file and has been sent to the Royal Commission. The photograph shows the part of 617 Colombo Street which has collapsed. It is possible that this part of the building was referred to as 623 Colombo Street, and this correlates with the rapid assessment forms completed, as the front façade of what is referred to as 623 Colombo Street has collapsed onto the street, while Sampan House has minimal damage.
