**Canterbury Earthquakes Royal Commission**  
**Te Komihana Rūwhenua a te Karauna**

**617-625 Colombo St**

The Royal Commission is inquiring into the building failure of the building that was located at 617-625 Colombo St, in particular 625 Colombo St, the failure of which resulted in the death of a pedestrian.

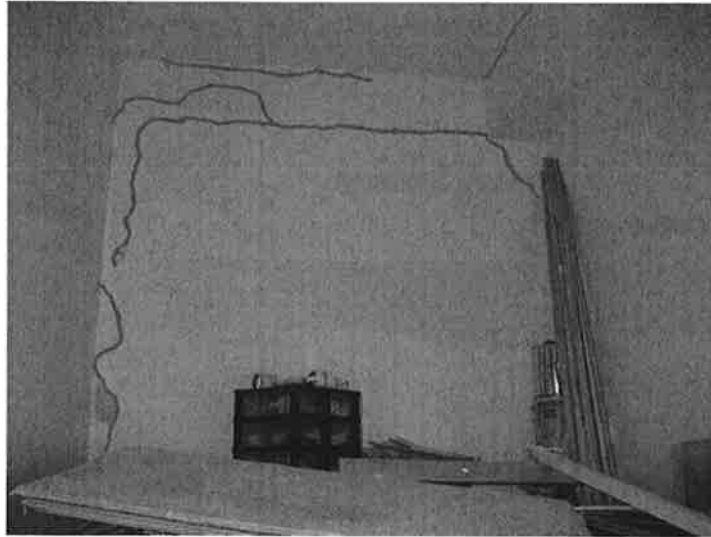
Cracking was observed below the stairs adjacent to the restaurant area, caused by in-plane racking of new reinforced blockwork walls.

**Photo 1: Cracking in wall**

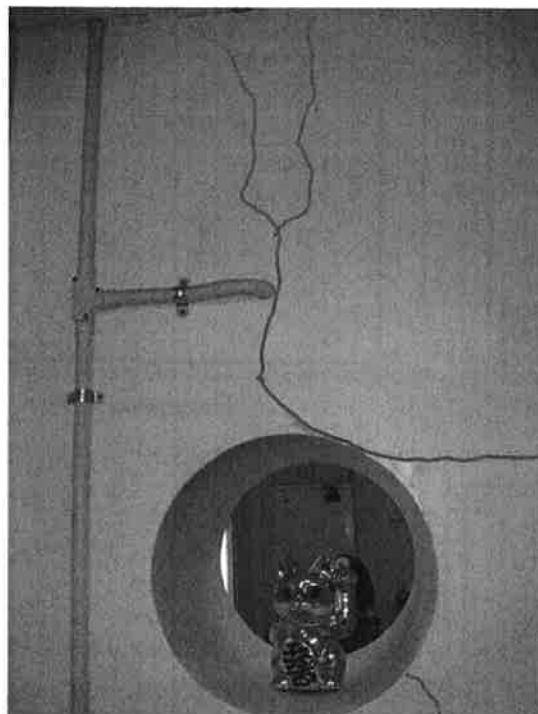
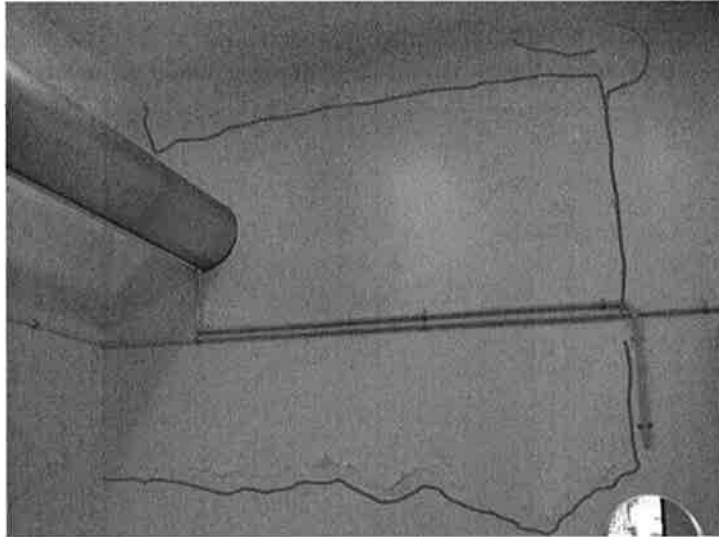
Cracking was observed in the new reinforced blockwork wall between restaurant serving area and rear kitchen. The photographs show cracking to both sides of wall.

**Photo 2: Cracking in wall**

**Photo 3: Cracking in wall**

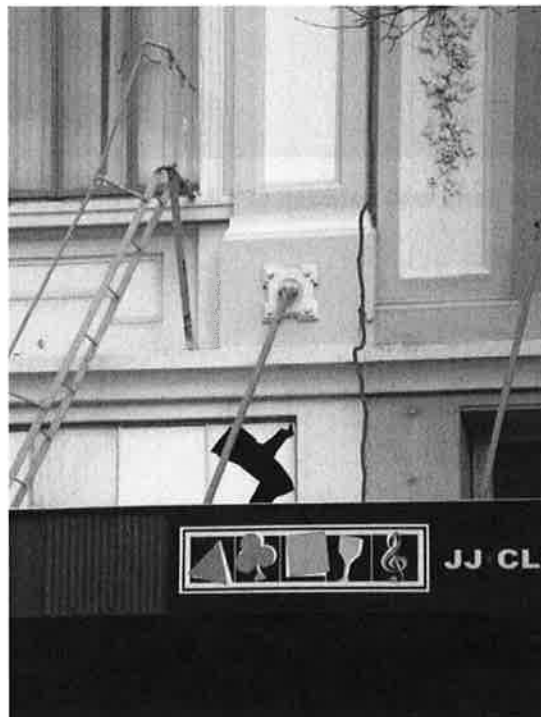
A crack was observed at the joint between 619 and 625 Colombo Street at first floor level.

**Photo 4: Crack between buildings**

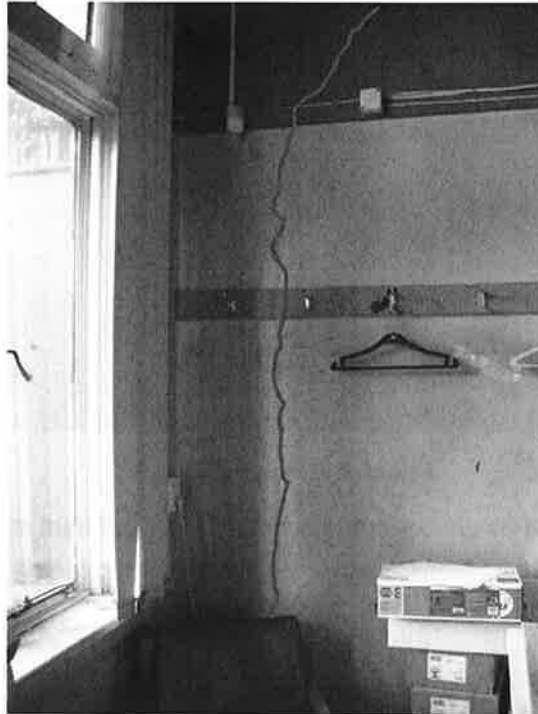
A crack in the party wall (taken from 627 Colombo), first floor level at the front of the building. This cracking could not be observed on the opposite side of the wall due to the presence of wall linings.

**Photo 5: Crack in first floor party wall between 623 & 627 Colombo Street (taken within 627)**

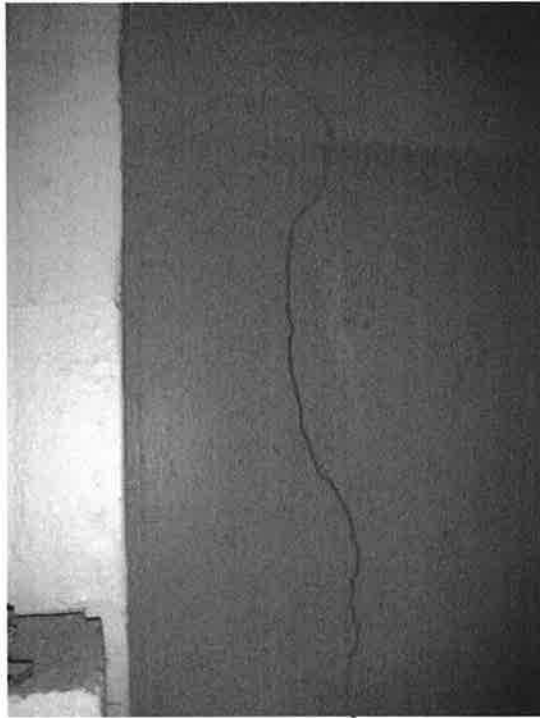
Cracking was observed at the first floor level in party wall, possibly caused by loading from new perpendicular wall within 625 Colombo Street. This cracking could not be observed on the opposite side of the wall due to the presence of wall linings.

**Photo 6: Crack in first floor party wall between 623 & 627 Colombo Street (taken within 627)**

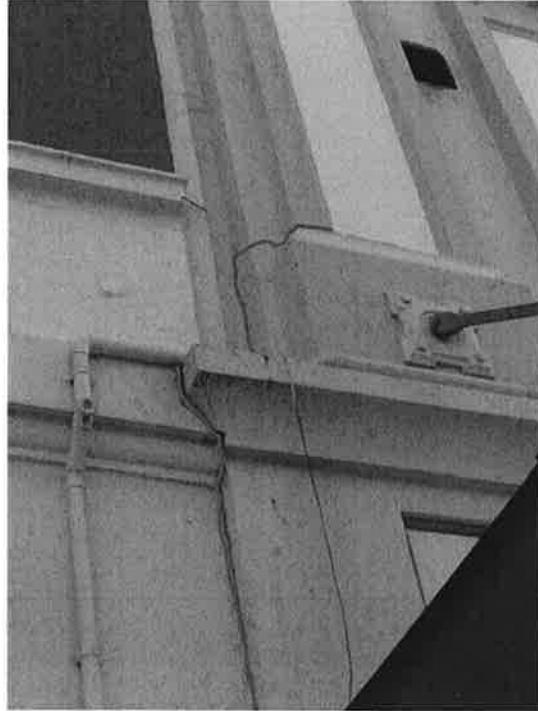
No observed or reported structural damage within building. Cracking was observed at the joint between 617 Colombo and 143 Tuam Street however.

**Photo 7: Cracking at joint between 617 Colombo Street & 143 Tuam Street**

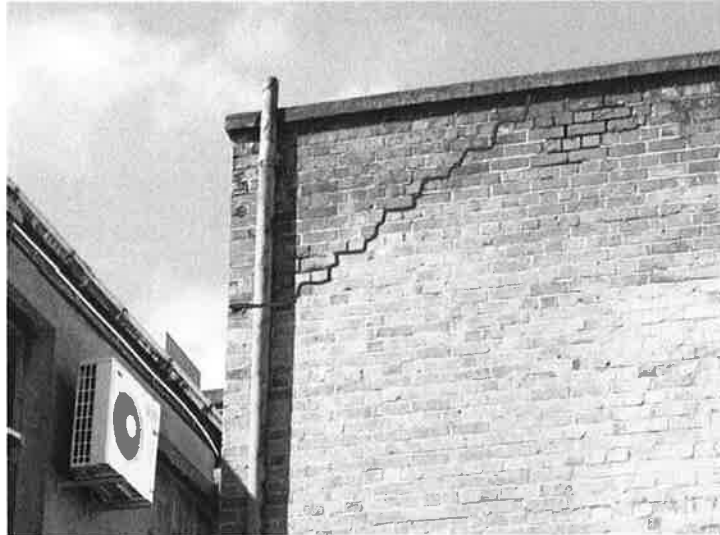
Cracking was observed within masonry parapets at the corners of the building with the Southwest parapet being partially collapsed.

**Photo 8: Masonry crack at NE parapet**

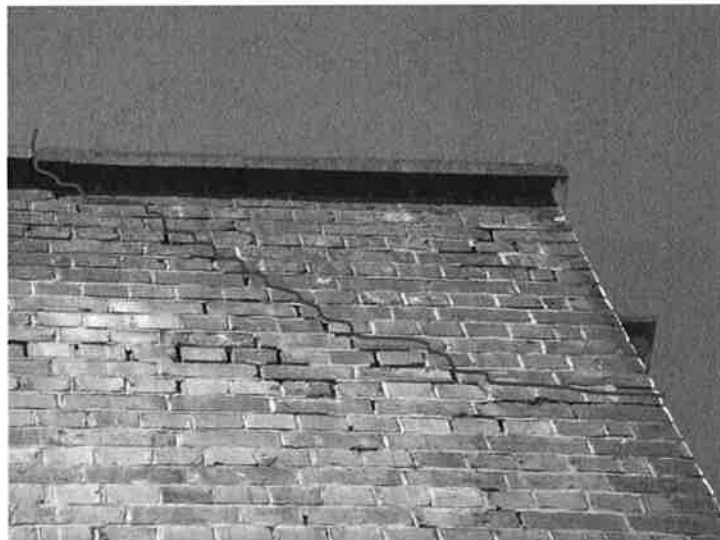
**Photo 9: Masonry crack at NW parapet**

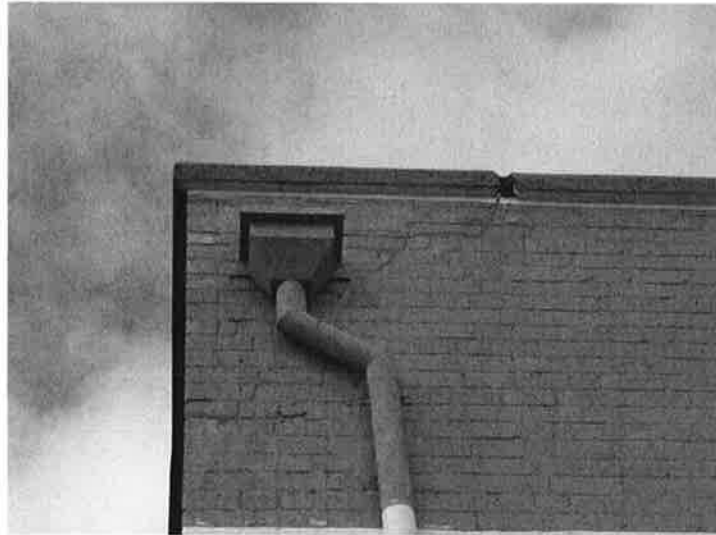
**Photo 10: Masonry crack at NW parapet**

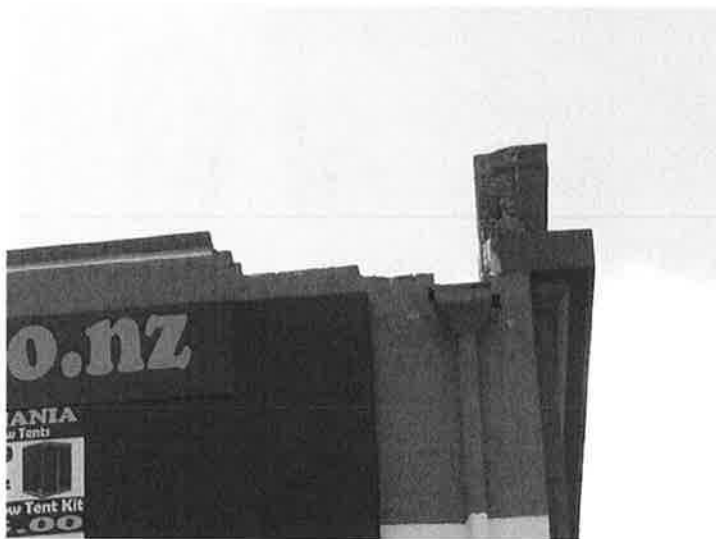
**Photo 11: Partial collapse of SW parapet following aftershock**

We also noted that attention should be given to stabilising the parapets of 143 Tuam Street for public safety purposes.

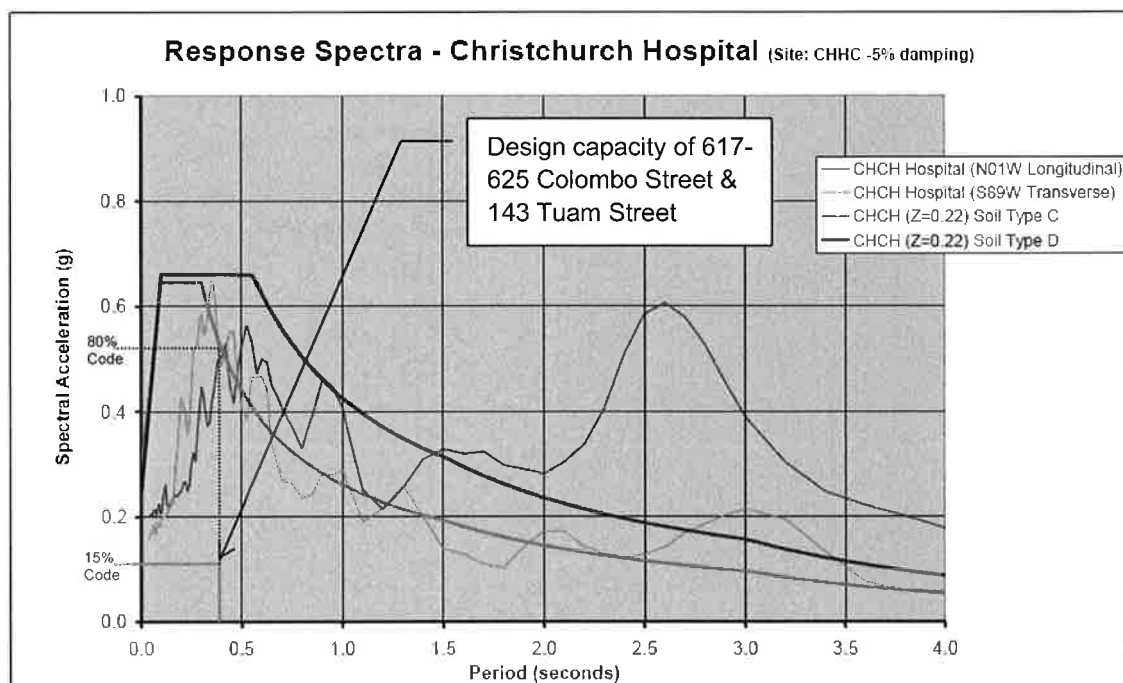
**Figure 1 – Comparison of recorded shaking with at Christchurch Hospital with NZS1170 design 1/500 year modal response spectra for both class C and D soils**

Preliminary processing of the shaking was recorded during the 4 September 2010 earthquake on a strong motion instrument located near Christchurch Hospital, approximately 1.0km to the West of these buildings. The data indicates that there was about 80% of the shaking prescribed in the current earthquake design standard (NZS1170.5:2004) for the Ultimate Limit State (ULS) for a building with an assumed period of around 0.4 seconds for a 1/500 year return period earthquake. Refer to Figure 1 where the recorded shaking is compared with the level of shaking assumed in the design of a modern building designed in accordance with the current Building Standard (the appropriate design curve is labelled CHCH (Z=0.22) Soil Type D).

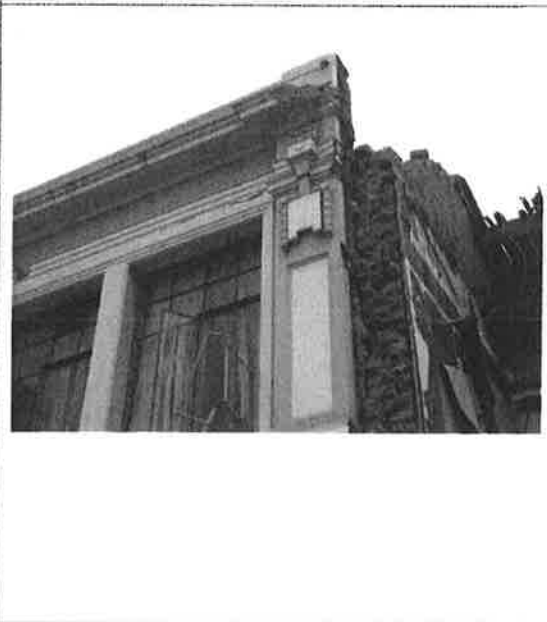
Photo 3 – Wall between 617 & 623 Colombo St

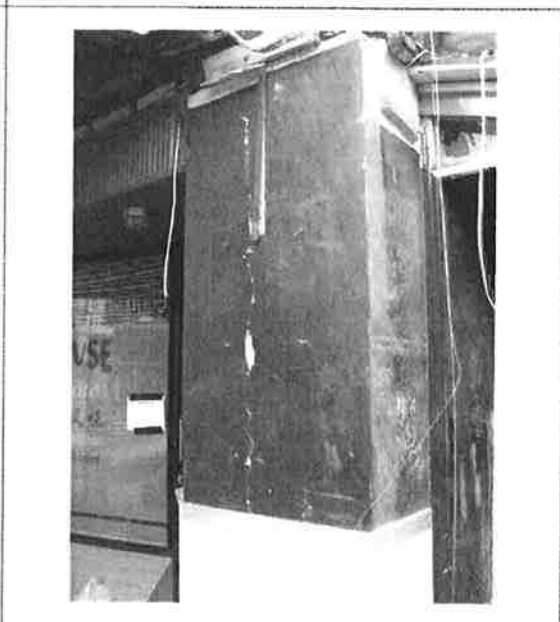
Photo 4- Cracked column between buildings

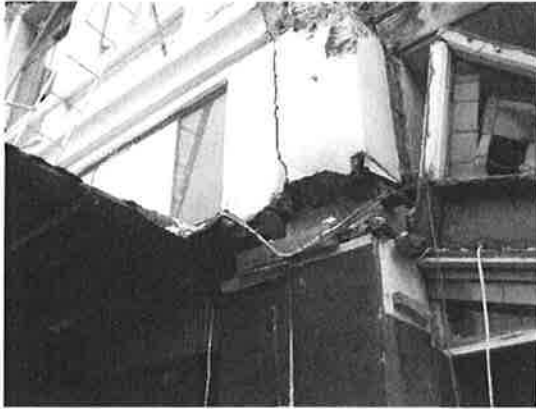
Photo 5- Crack at party wall interface.

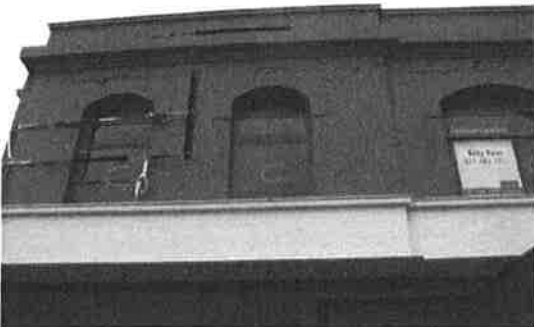
Photo 7- Damaged parapet 143 Tuam Street

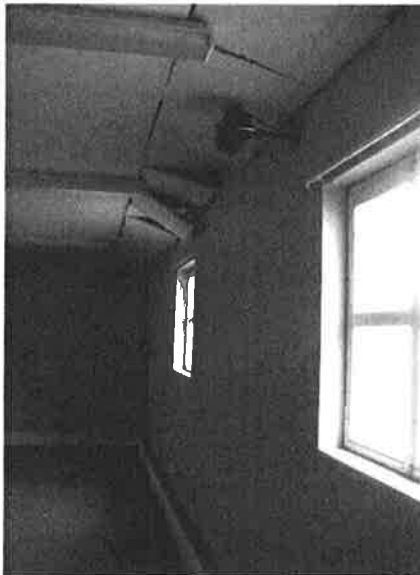
Photo 8 – Damaged tiles from fallen debris
