STRUCTURAL REPORT ON
TRADES HALL, GLOUCESTER STREET,
CHRISTCHURCH

JOB NO. 51172

STRUCTURAL REPORT

TRADES HALL

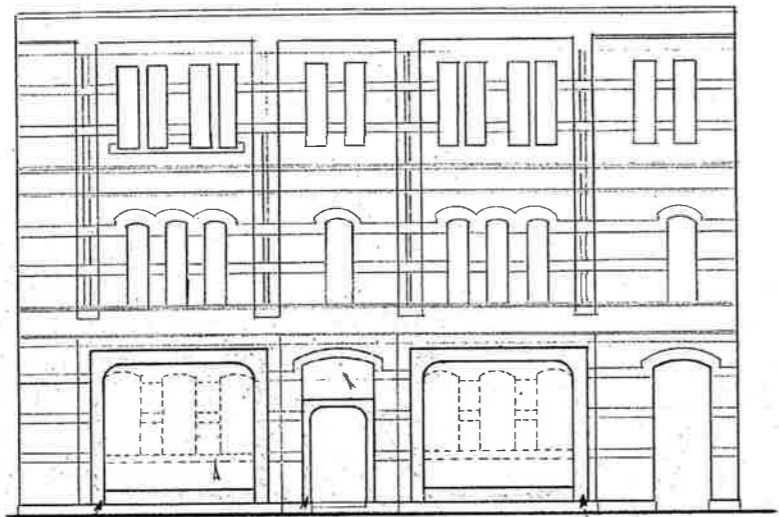
North Elevation
 Existing brickwork to be removed shown dotted
 Fill void above new frame with brickwork to match existing

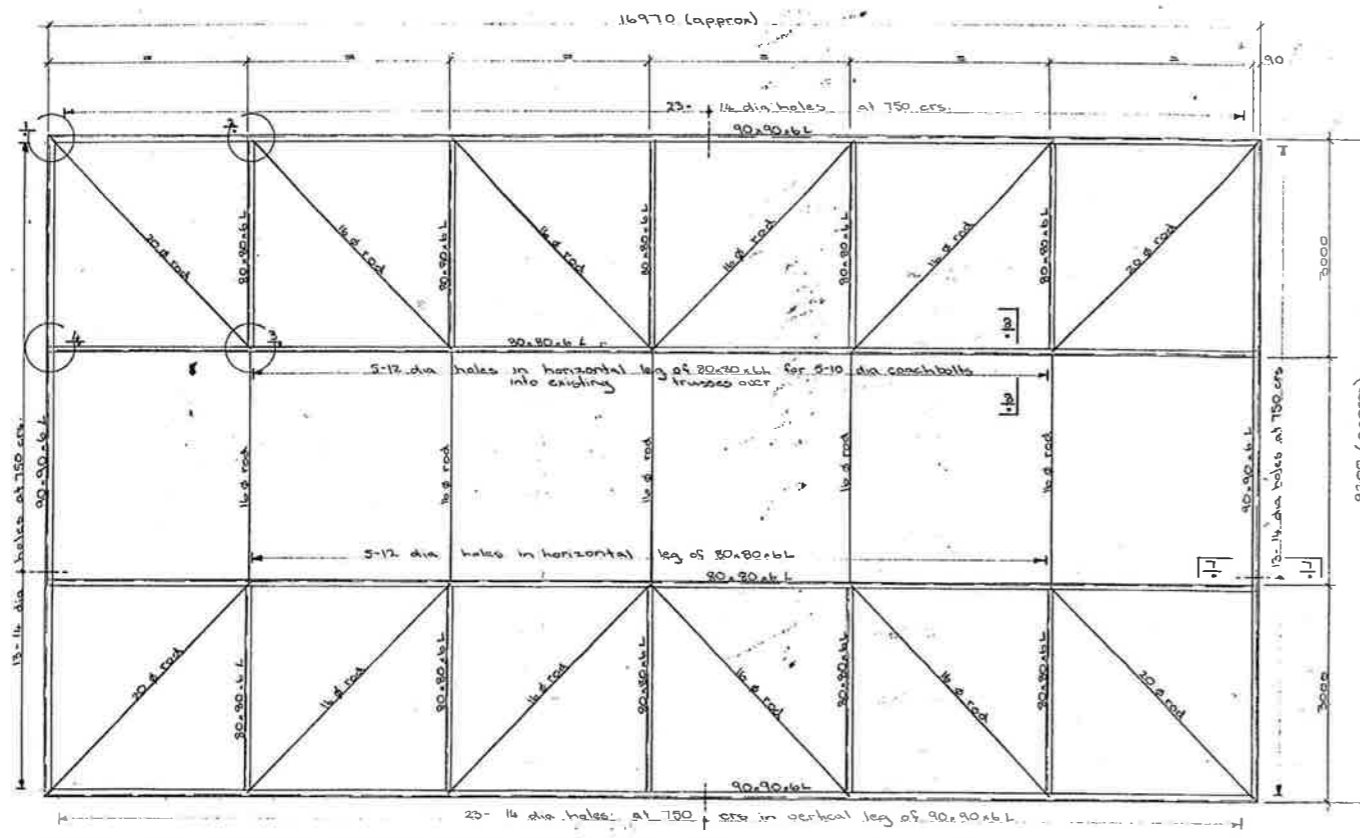
TRUSS FOR SECOND STOREY REAR BLOCK (to underside of existing ceiling)

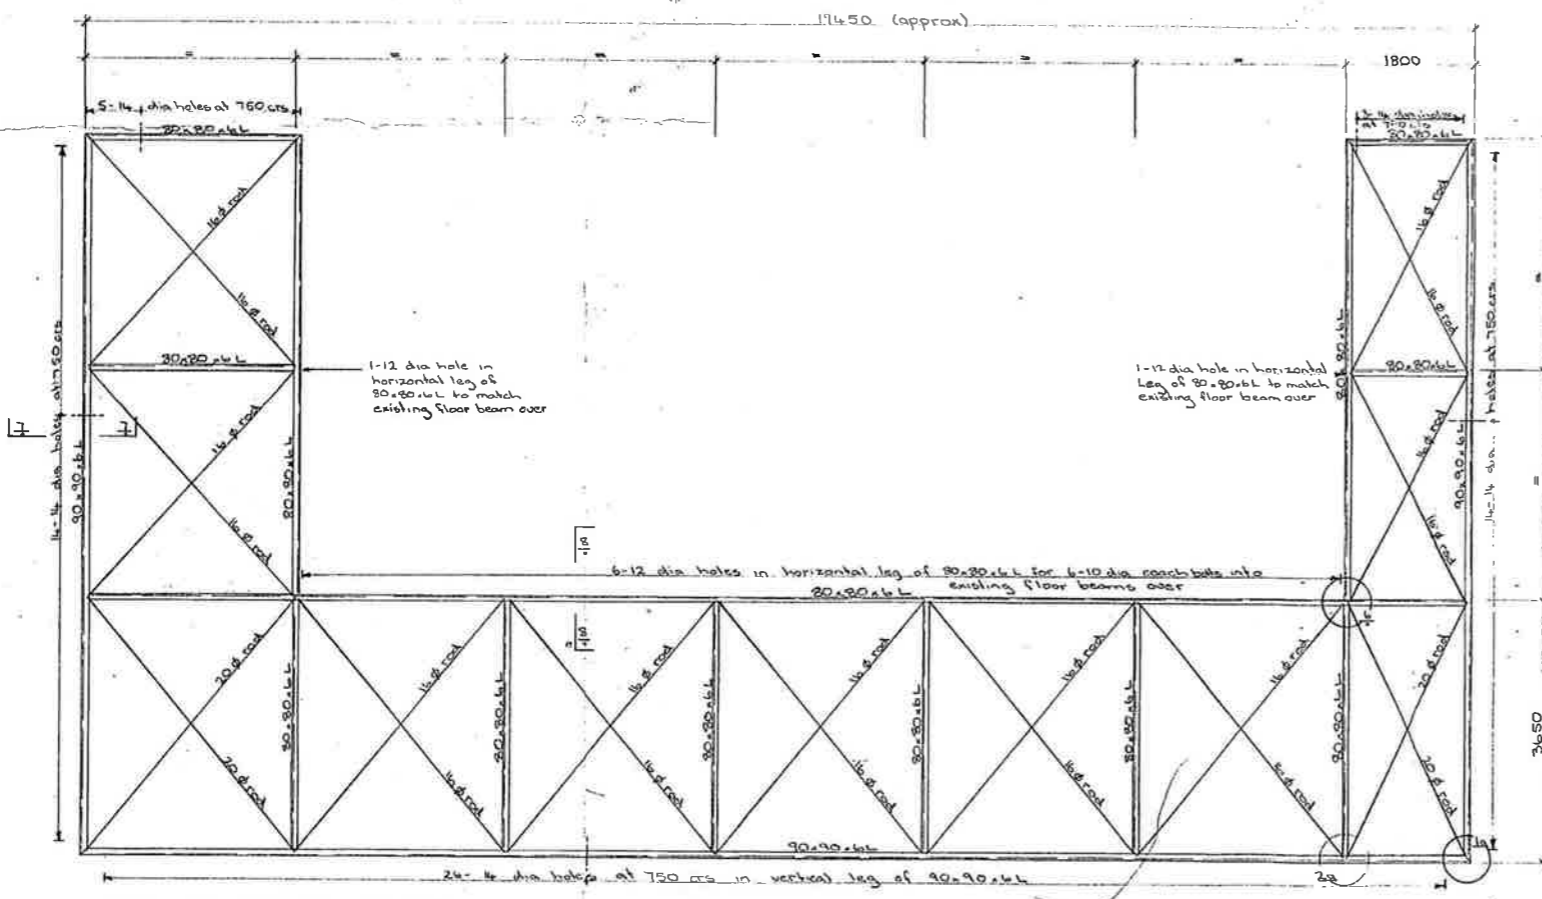
TRUSS FOR SECOND STOREY FRONT BLOCK (to underside of existing ceiling)

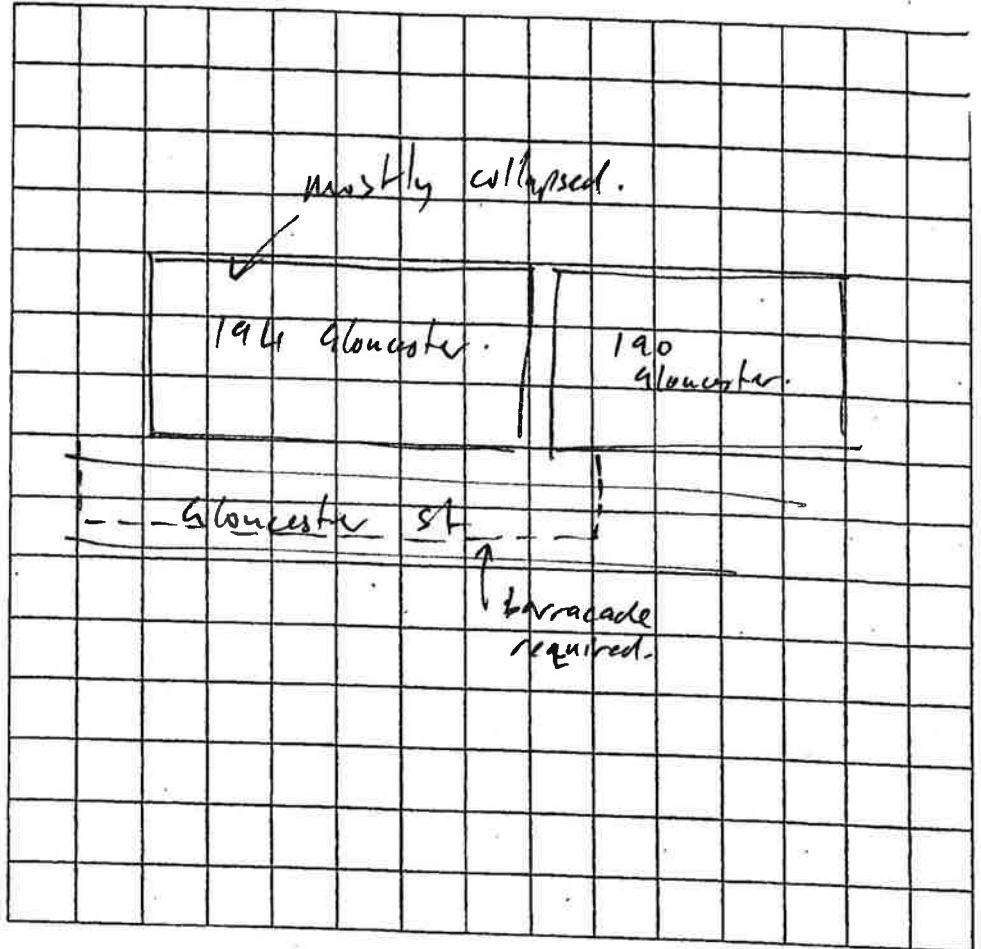
Sketch (optional)
Provide a sketch of the entire
building or damage points. Indicate
damage points.

Recommend that the building be demolished
urgently.
