Christchurch Eq RAPID Assessment Form - LEVEL 2

The 123 Mort

91A Cashel St.

91 Cashel Street – Earthquake Damage Assessment

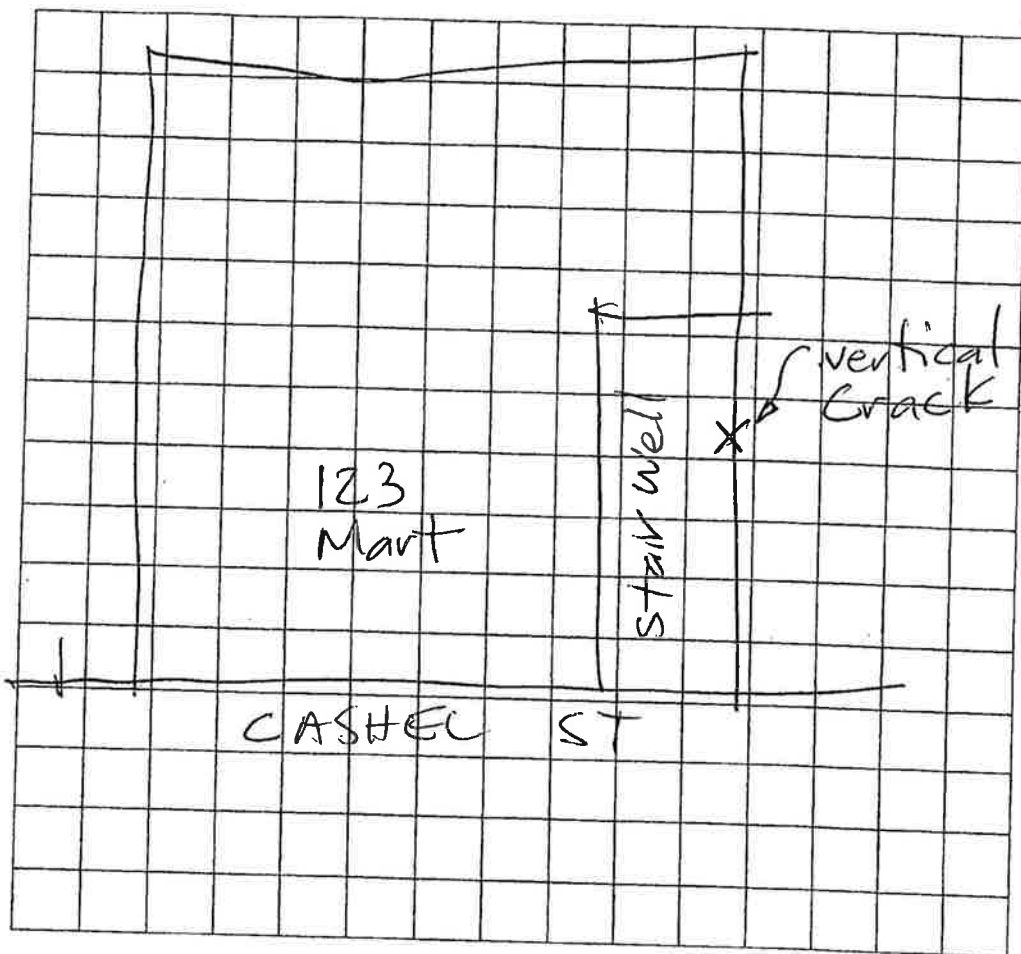
General Comment *vertical crack the full height of external wall in staircase*

check by engineer - hairline crack in structural wall

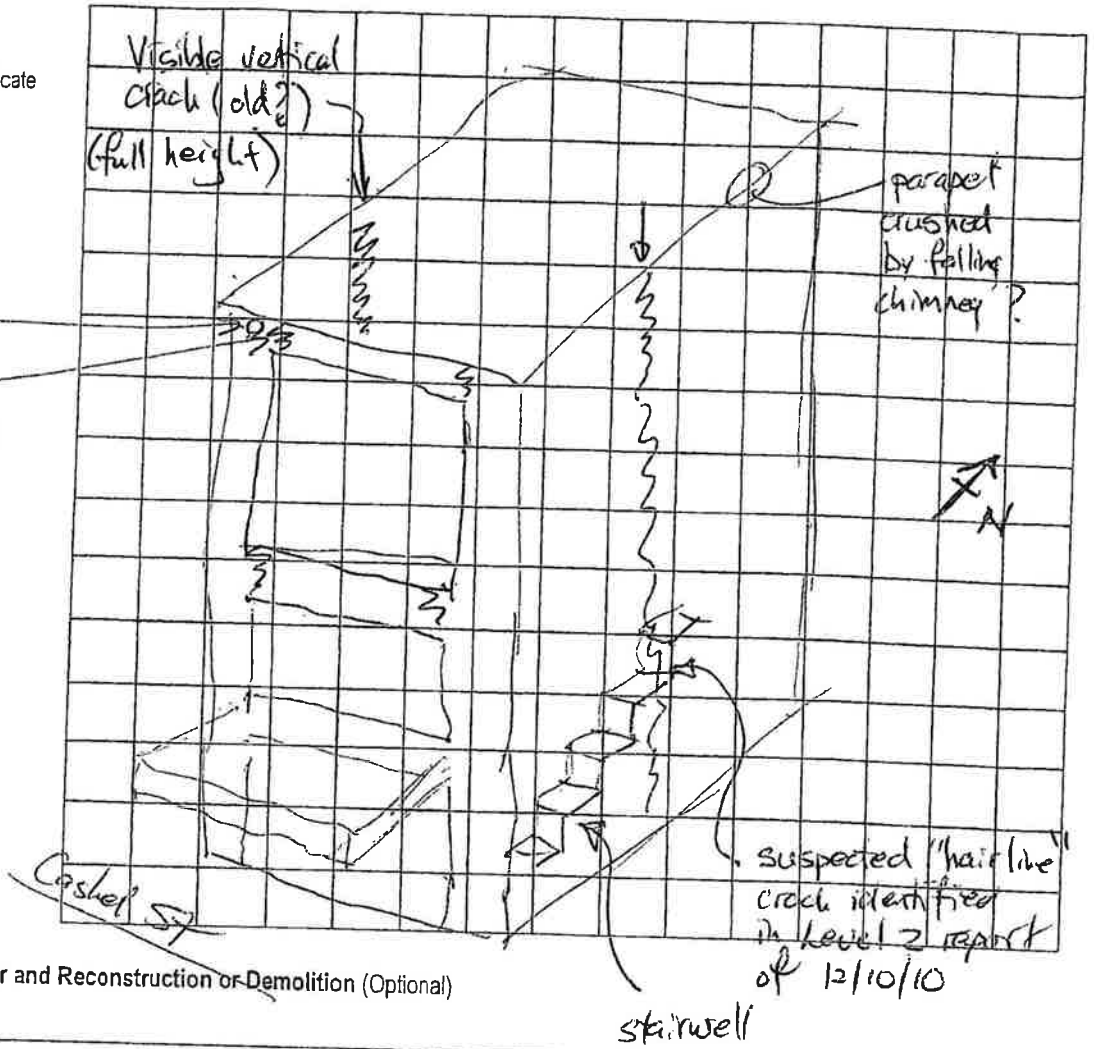
General Comment Request was to inspect vertical crack in stairwell east side ^{well}, but not accessible (previous level).
 Noted, vertical crack in west wall similar location to inferred east wall.
 Other cracks in street frontage at joint between walls and horizontal members.
 Brickwork exposed beneath plaster (a lot of work to find these exposures, so examine photos carefully). How building ~~from~~ works structurally not clearly understood and requires further study.

exposed face brick (see photo) cracks (see photo)

Called to inspect "hairline" crack in stairwell, but could not gain access.
 Phone contact for access given as Tracy Brough Ph 355 9566
 Suspect mechanism for this crack same as crack observed on opposing side of bldg.

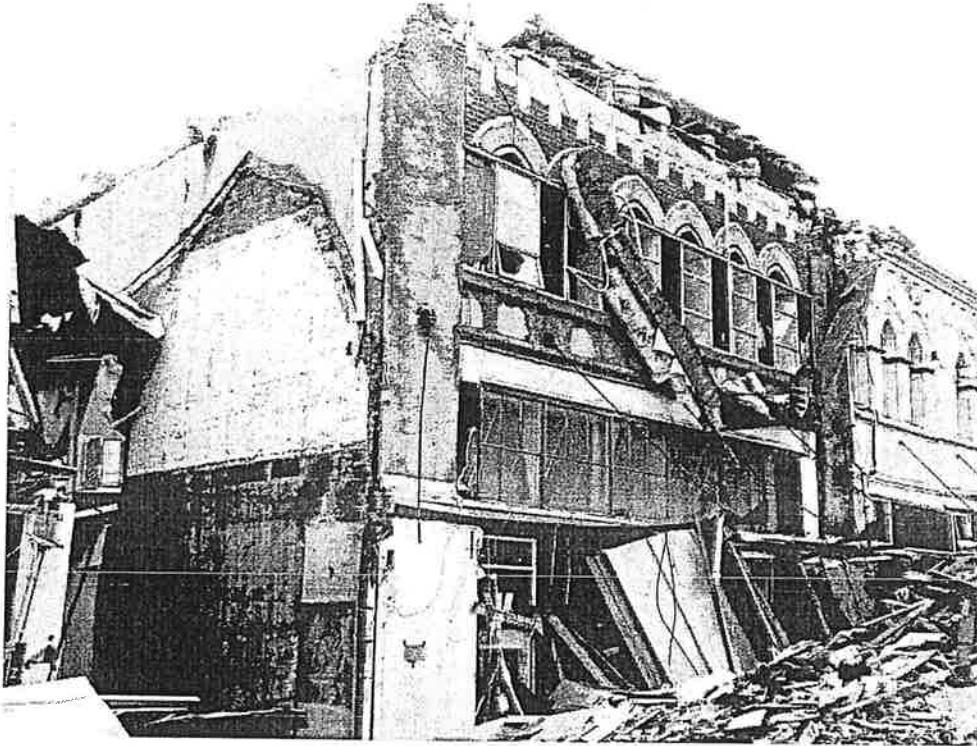
The building has sustained severe damage, most notably the complete loss of the third storey walls to the west, south and east elevations and subsequent loss of support to the roof. Refer Photos 1 and 2 following. The Cashel Street (south) glazed façade and canopy have also been destroyed. Significant damage is also visible to the spandrels on this facade due to overstress and pounding with the building to the east. Refer Photos 3 and 4 following.

Photo 1: Southwest corner of building show loss of 3rd floor, façade glazing and canopy.

On the basis that the building is unstable, unsafe to approach or enter, presents a public safety risk and is not economic to repair, we recommend that this building should be demolished.

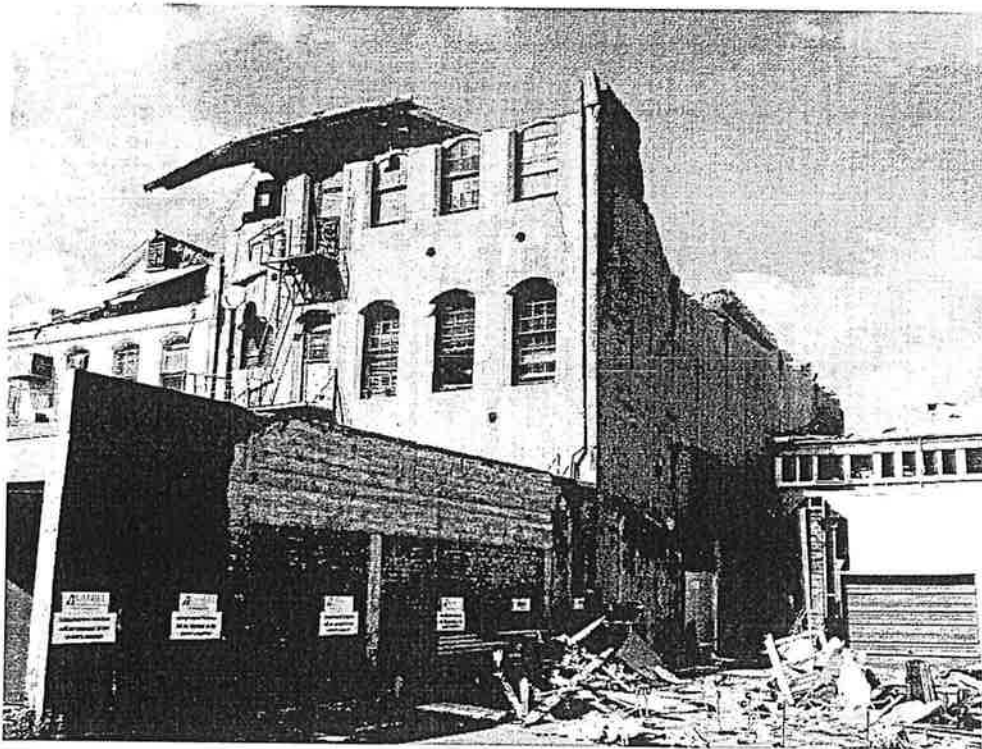
The third storey wall on the north elevation has failed above the window level. At least part of this wall has fallen outward with significant damage visible to the eastern side of the single storey extension at the rear of the building.

Photo 2: Northwest corner of building showing only remaining 3rd floor walls and roof.

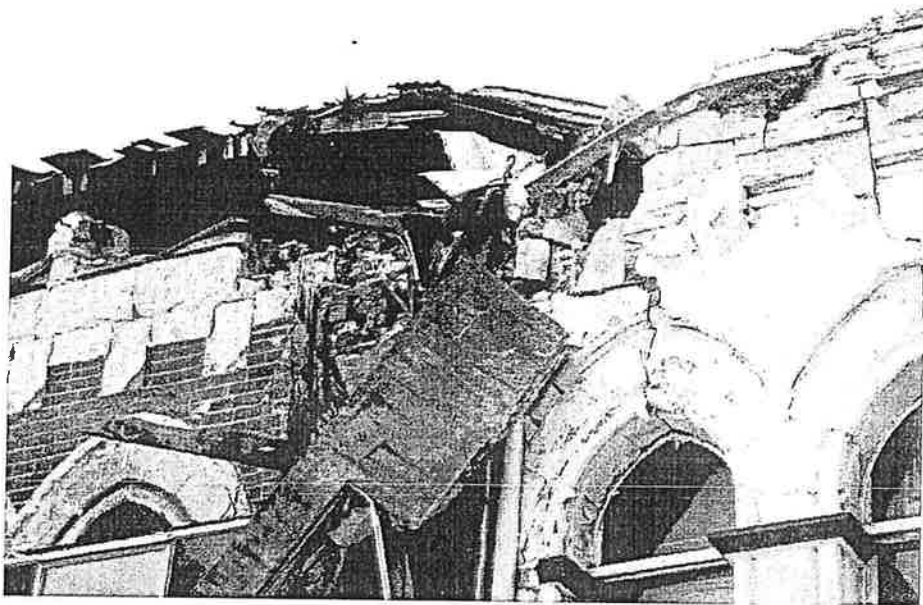
Photo 3: Pounding damage with adjacent building at 2nd floor

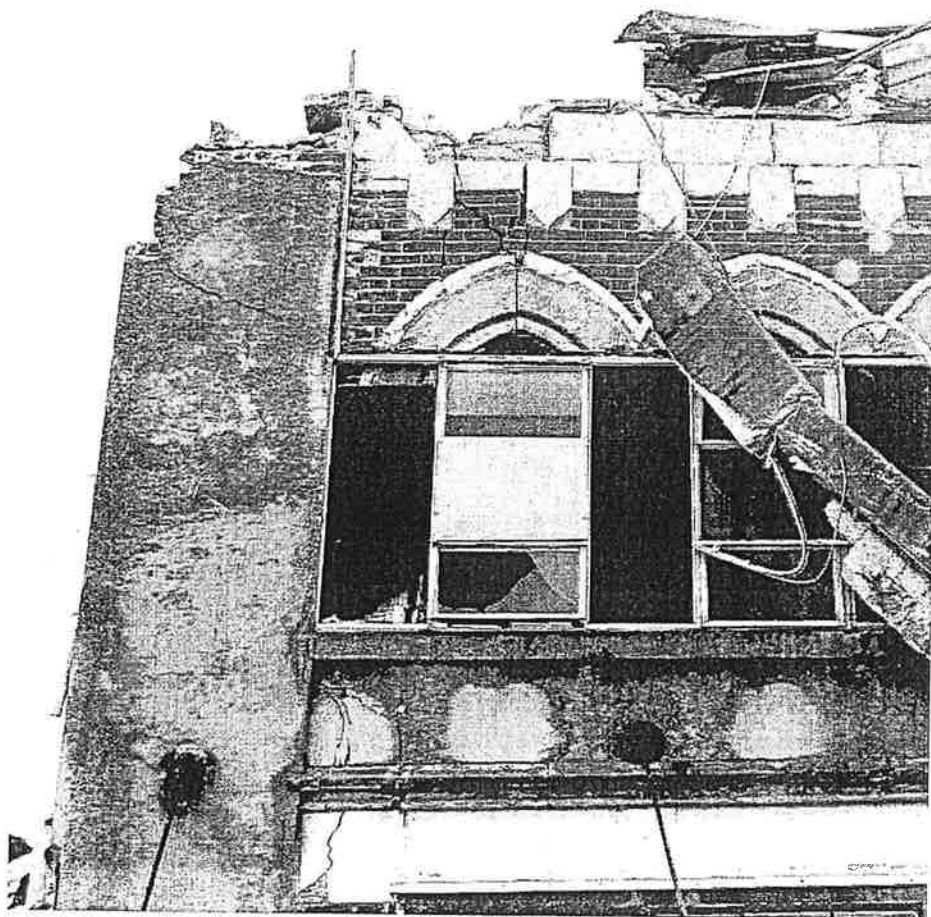
We believe that the damage visible to the spandrels on the south elevation and the collapse of the building to the west has severely reduced the lateral load resisting system of the building in the east-west direction.

Photo 4: Damage to 1st floor and 2nd floor spandrels

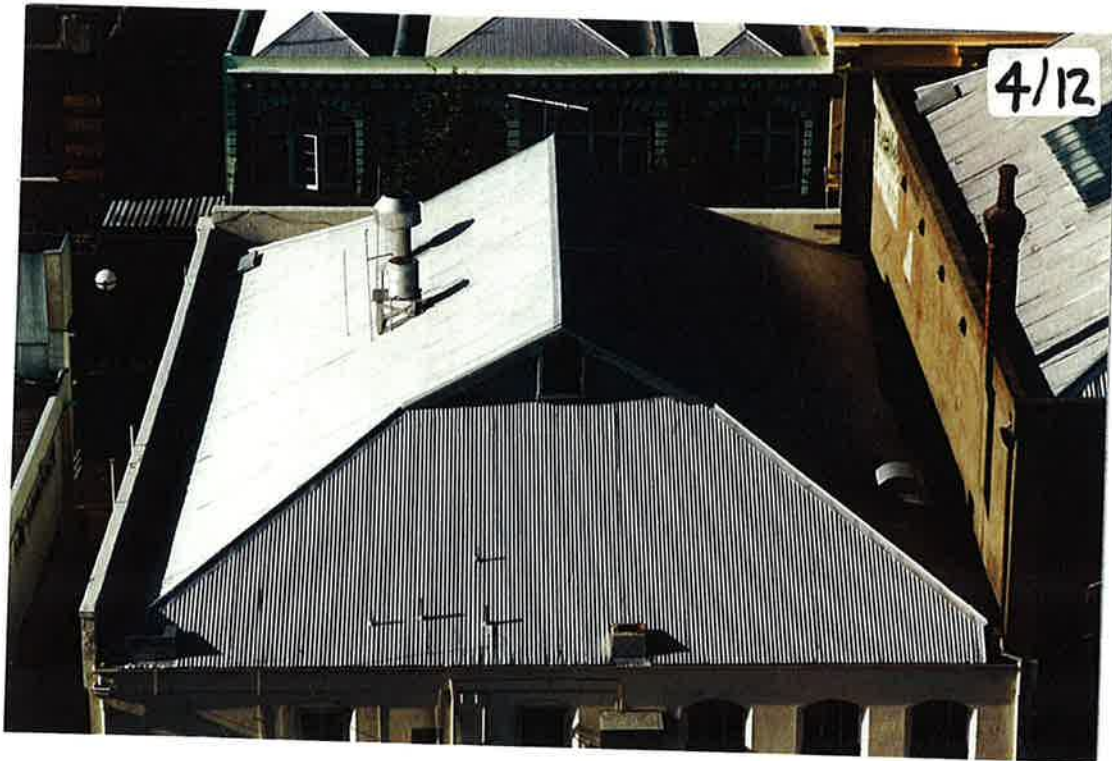
4/12. Parapet on Alley and Mall Elevations.

Comments: Hazards: the parapet seems likely to topple (in an earthquake) onto heavy pedestrian traffic below.
