Christchurch Eq. RAPID Assessment Form - LEVEL 1

Building Name Ballantynes

Address 43 Lichfield St

**RE: POST EARTHQUAKE SITE INSPECTION TO THE ANDERSON BUILDING AT
 BALLANTYNES, LICHFIELD STREET, CHRISTCHURCH**

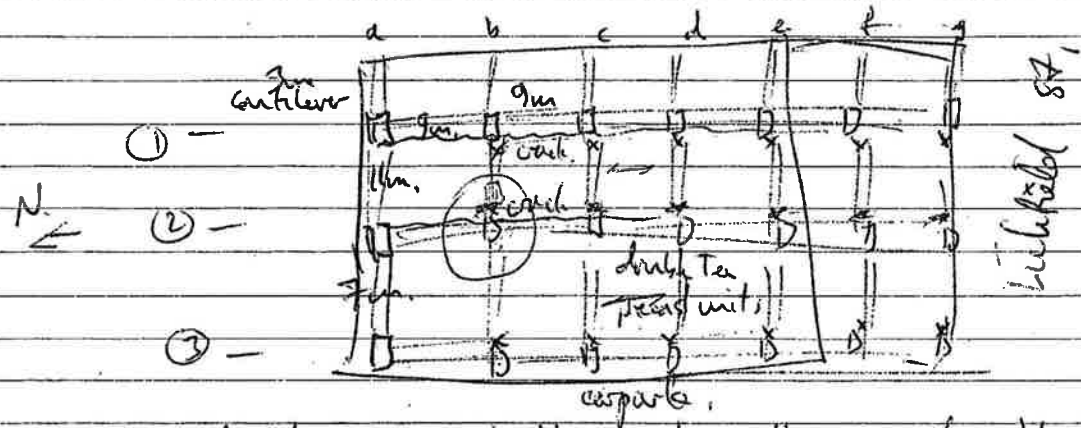
double T precast floor units with 3 (unreinforced) topping
 spanning 9m.

Typical floor crack along lines 1 & 2 adjacent to
 large beams

Level 2
 E-W
 x Beams above 1st level have flexural crack Grids 1
 & 2 - some cover concrete on col line 3 spalled.
 Cover concrete on ramp ^{into end} spalled beam contacts and
 end supports dislodged g3 & 3.
 Floor ^{concrete} spalled Grid g severely damaged

Level 2 floor III shows severe crack 2m from
 Grids 1 to 2 with flexural/shear crack to E-W beams
 2m from Grids 1 & 2 lines 6 & 7
 Other flexural cracking of beams at col lines
 d e & g

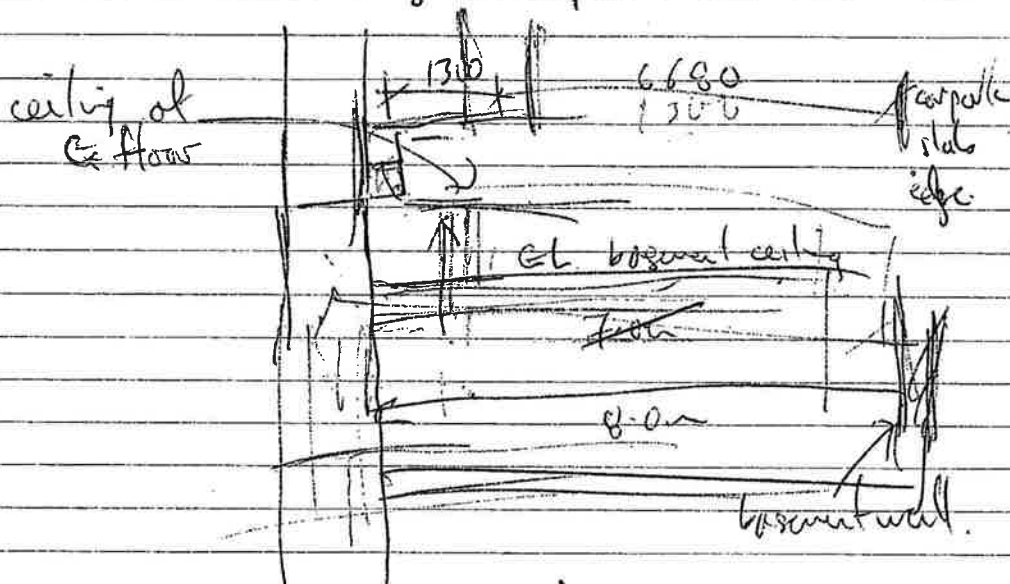
6.68 to edge of carpark slab

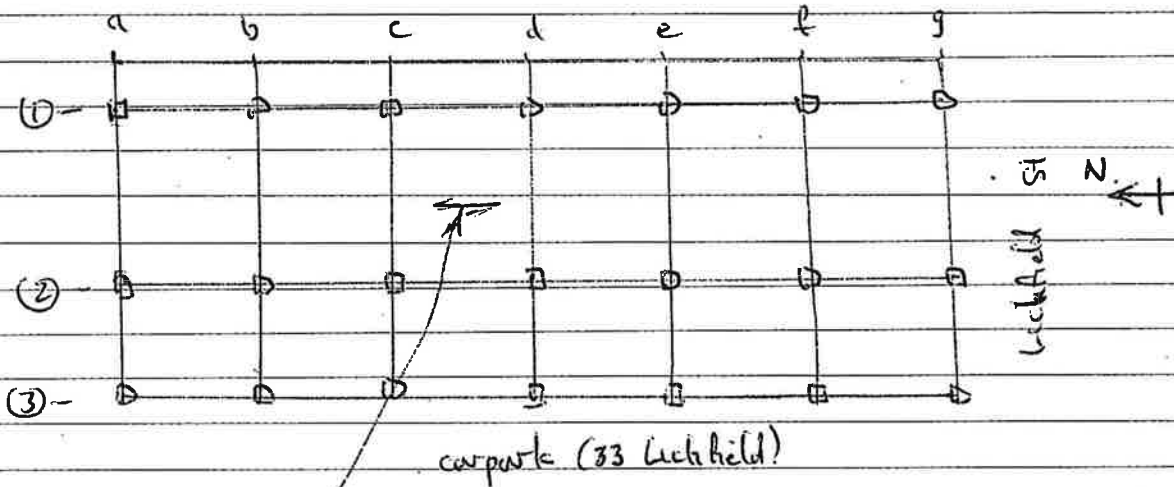
double T precast floor units

Topping to TT units has full depth cracking along lines 1 & 2 weathered cracks with no visible topping mesh - possibly fully fractured - reduced diaphragm capacity in N-S

Second carpark level TT show severe crack 2m from Grids 1 → 2 with flexural/shear crack to E-W beams approx 2m from Grids 1 & 2 lines b & c. Other beams show flexural cracking of beams at col. face d e f g

First carpark level: Cover concrete, on ramp lower end beam corbels and end supports, dislodged
Ferra concrete spandrel. Grid g severely damaged - hazard for Lichfield St.

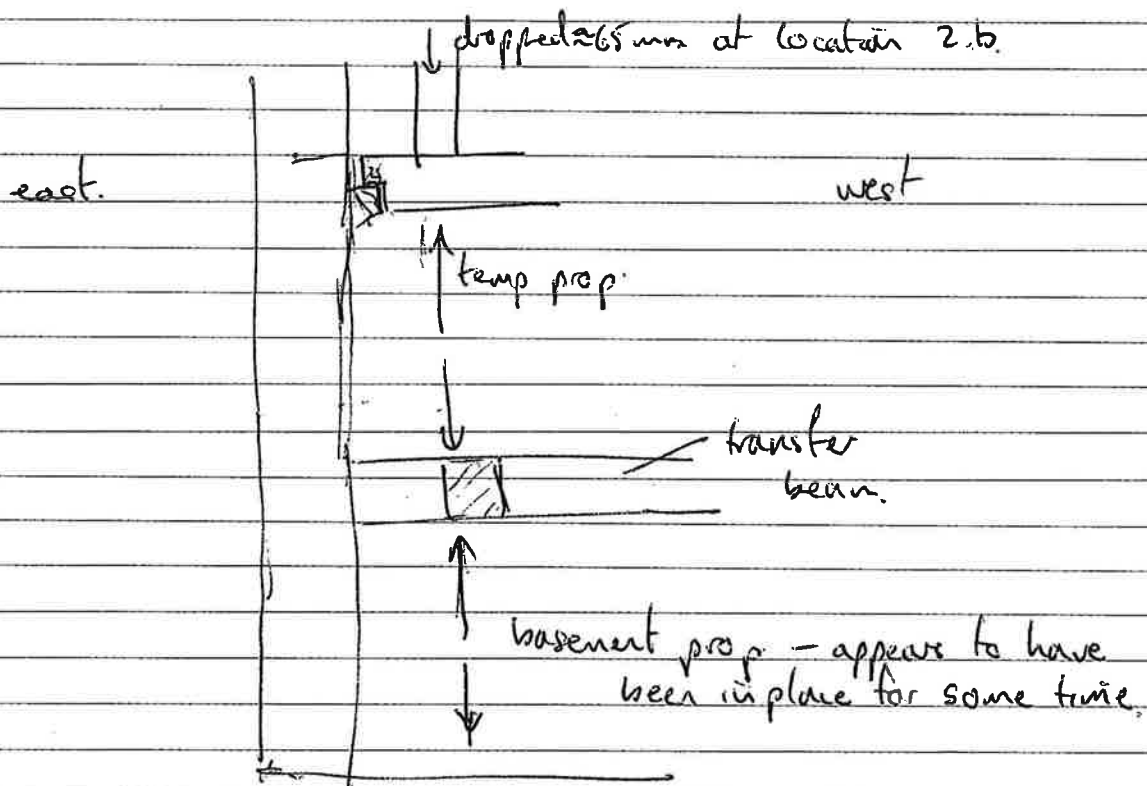
Ponding of water on carpark at location 2.b and beam cracking at this location consistent with position of corbel damage & propping.

Propping secures vertical load path for building
