Canterbury Earthquakes Royal Commission**Komihana a te Karauna hei Tirotiro i ngā Whare i Horo i ngā Rūwhenua o Waitaha**

391/391A Worcester Street, Christchurch

9 September 2011

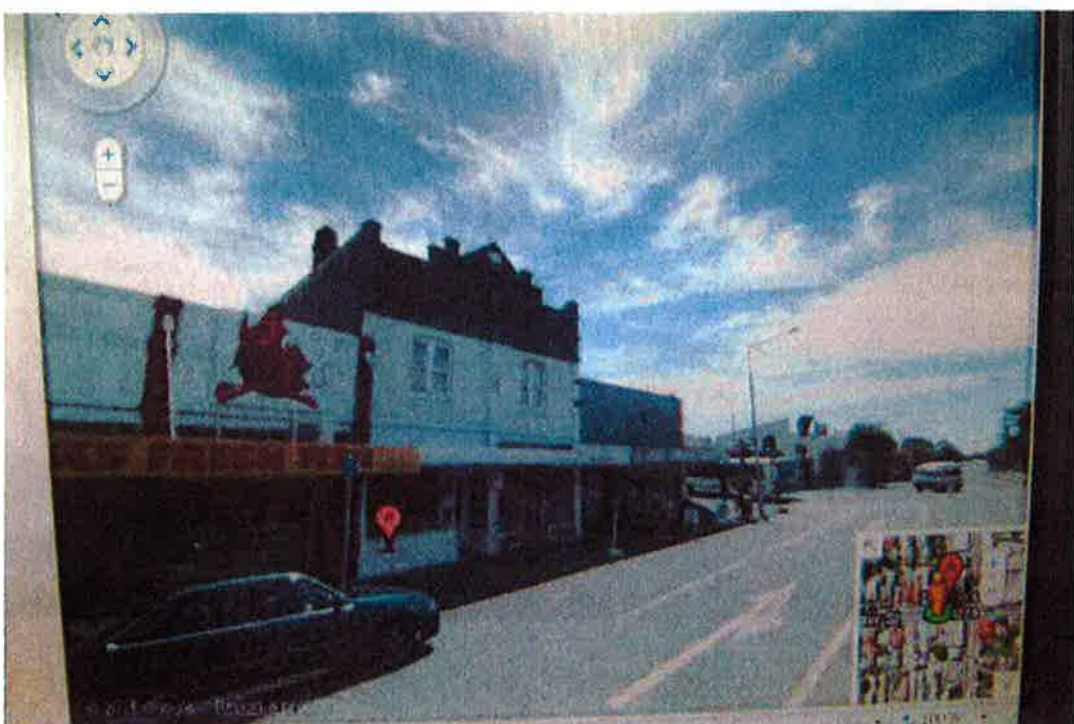
from Google Street View
or competitors

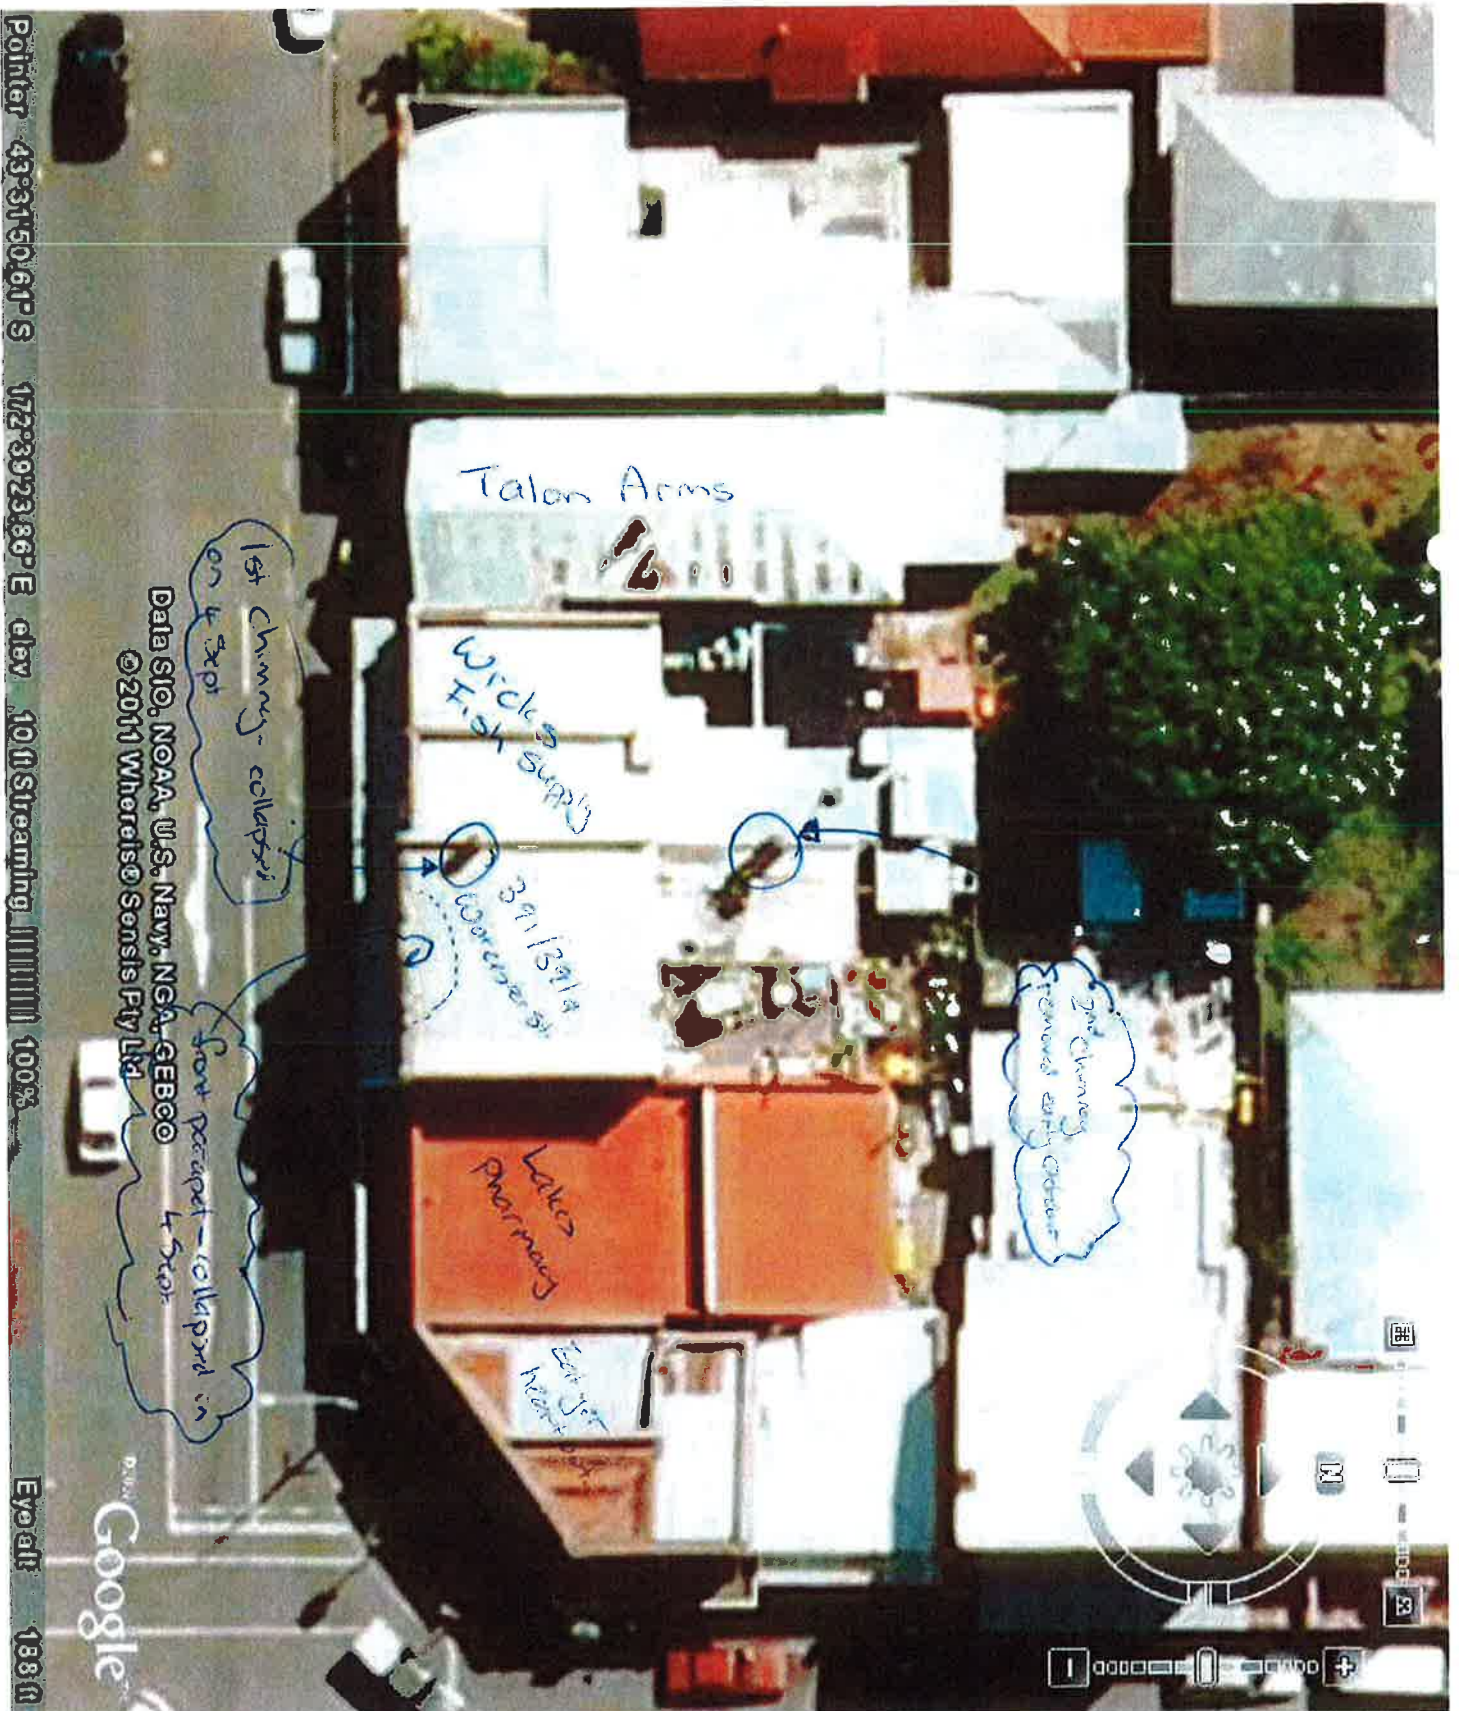
upper chimney that
fell in the first earthquake

This parapet cap was
existing when we arrived
on site

This eastern parapet was lowered, and
covered with a flashing

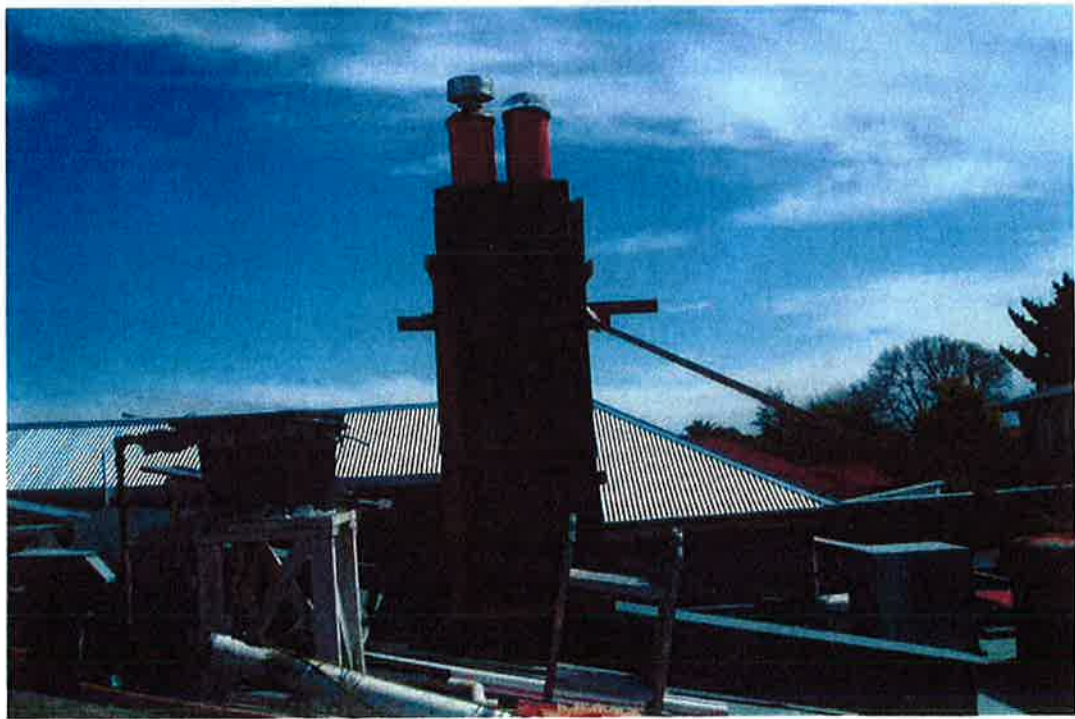
30 September 2010
Bracing of 2nd (lower level) chimney
in preparation for removal

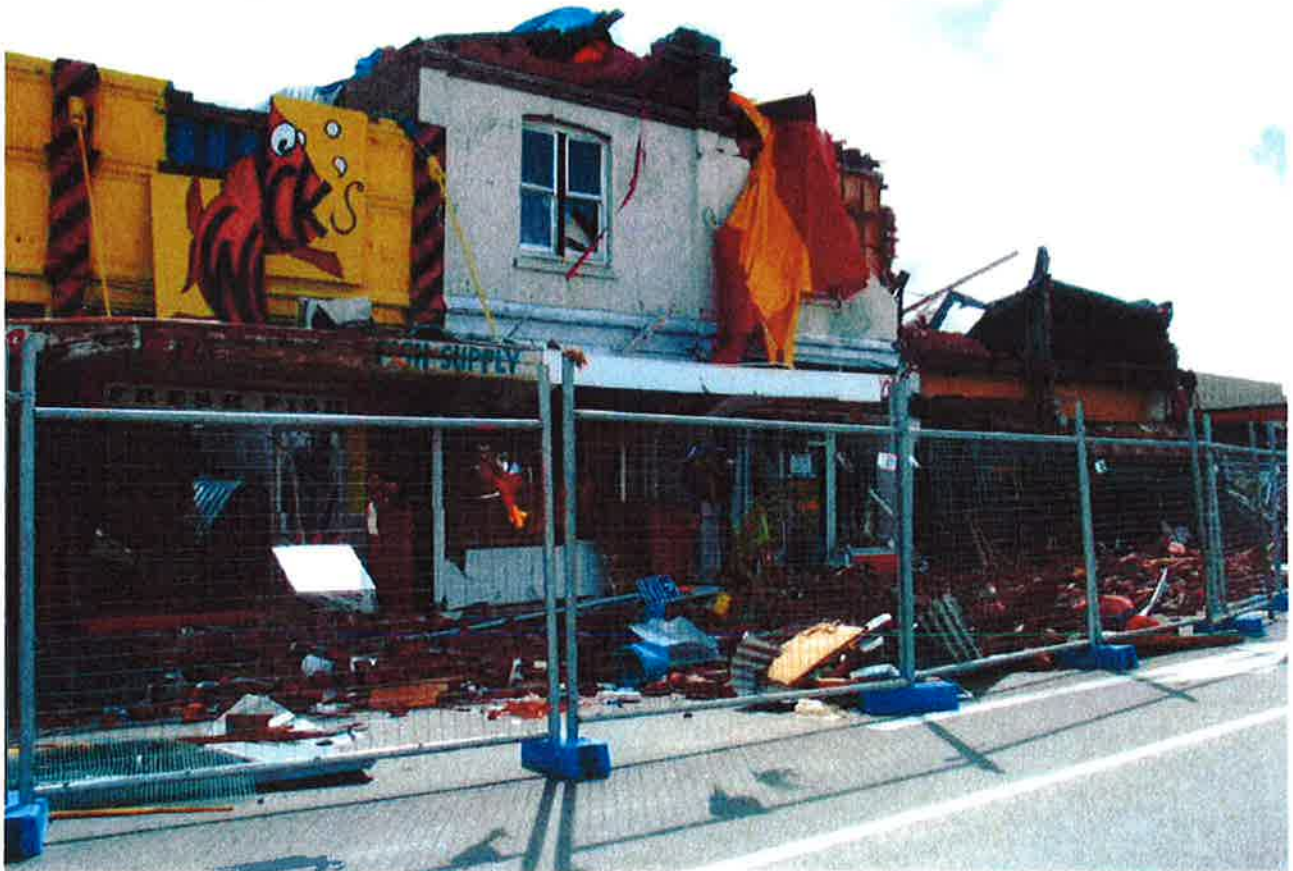
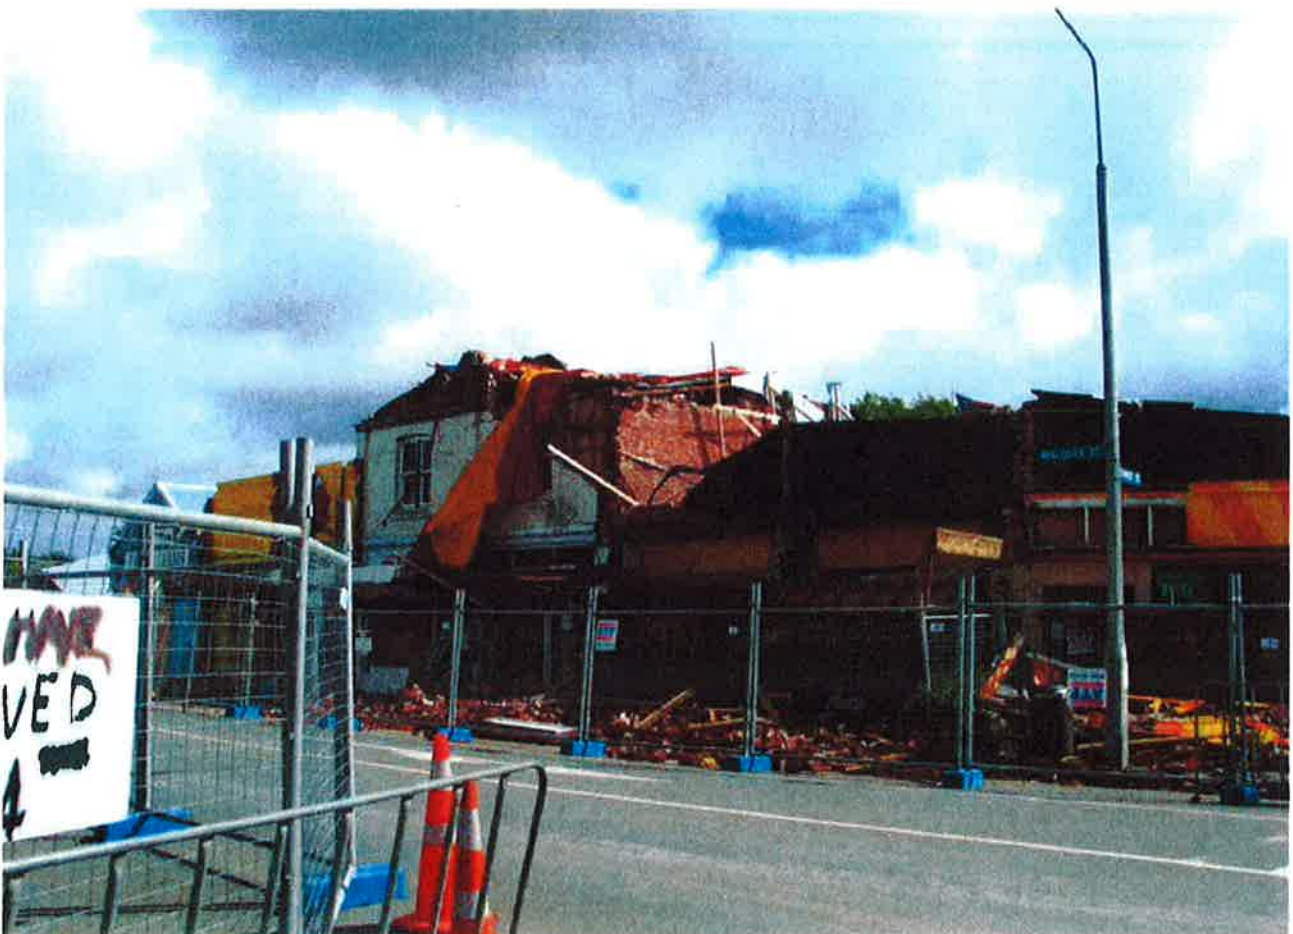
taken 8 March 2011
