STRUCTURAL REPORT

**OFFICE BUILDING
249 MADRAS STREET**

CANTERBURY REGIONAL COUNCIL

January 1990

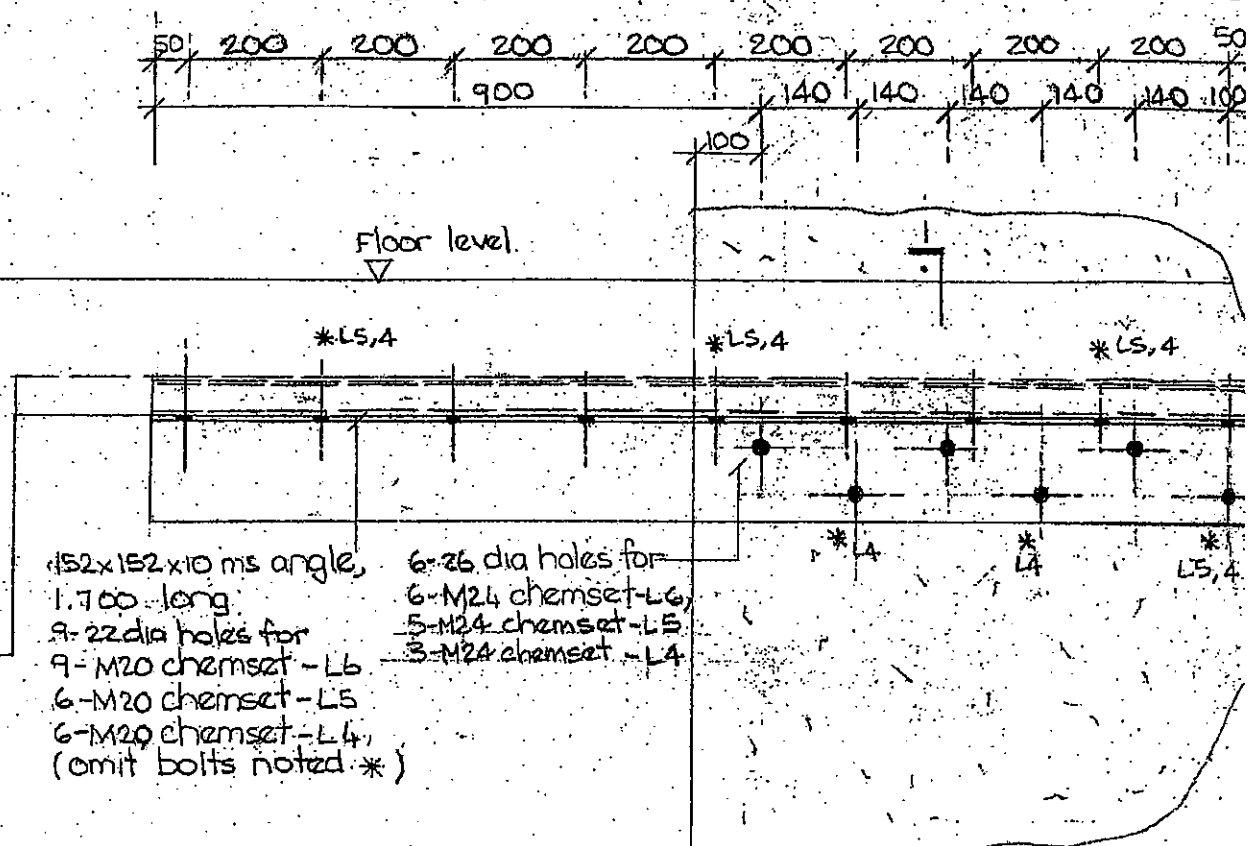
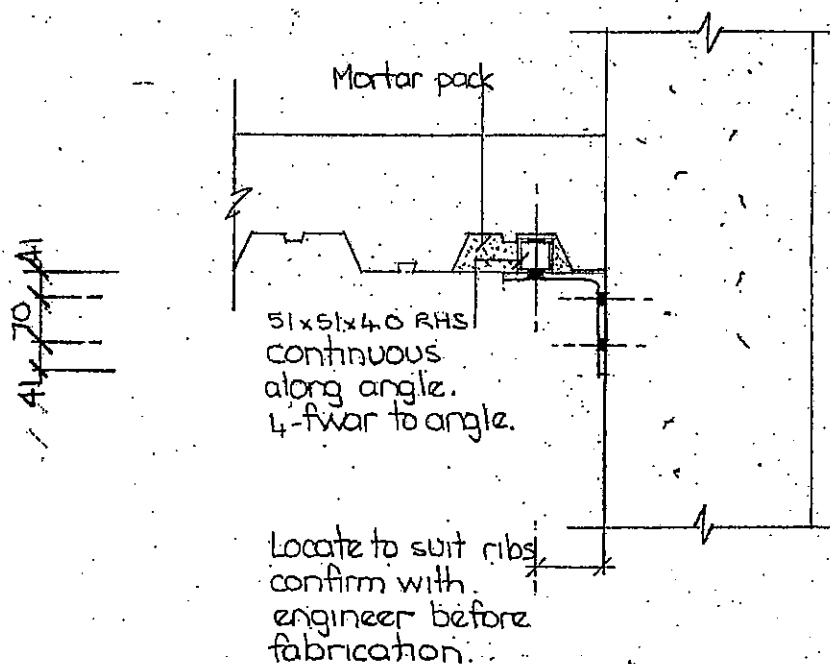
WALL TIE TO SLAB. GRID LINES D, 4/5
LEVELS 4-6.

An area of concern however has been discovered in the connections of the structural floor diaphragm to the shear walls. While this is not a concern on the coupled shear wall to the south of the building, connections to the walls at the North face of the building are tenuous, due to penetrations for services, lift shafts and the stairs, as detailed on the drawings.

The result of this would be that in the event of an earthquake, the building would effectively separate from the shear walls well before the shear walls themselves reach their full design strength.

The proposed remedial work, if required, would consist of a total of two ties per floor, tying the walls to the floor diaphragm.

The agreed maximum tie load is 300 kN per tie. We understand that this load would be reduced on lower floors in accordance with the "Parts and Portions" section of NZS 4203:1984.

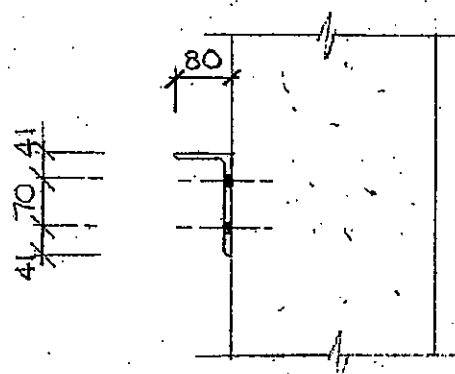
PAGE	CD3
SECT	WALL TIES
FILE	3608
DATE	10/10/91

WALL TIE TO SLAB.
GRID LINES D/E, 4/5.
LEVELS 4-6

7-26 dia holes for
7-M24 chemset - L6
5-M24 chemset - LS
4-M24 chemset - L4

12x 152x 152x 10 ms angle
2.690 long
10-22 dia holes for
10-M20 chemset - L6
8-M20 chemset - LS
6-M20 chemset - L4
(omit bolts noted *)
