20 December 2011

Canterbury Earthquakes Royal Commission
PO Box 14053
Christchurch Mail Centre
Christchurch 8544

91A Cashel Street, Christchurch

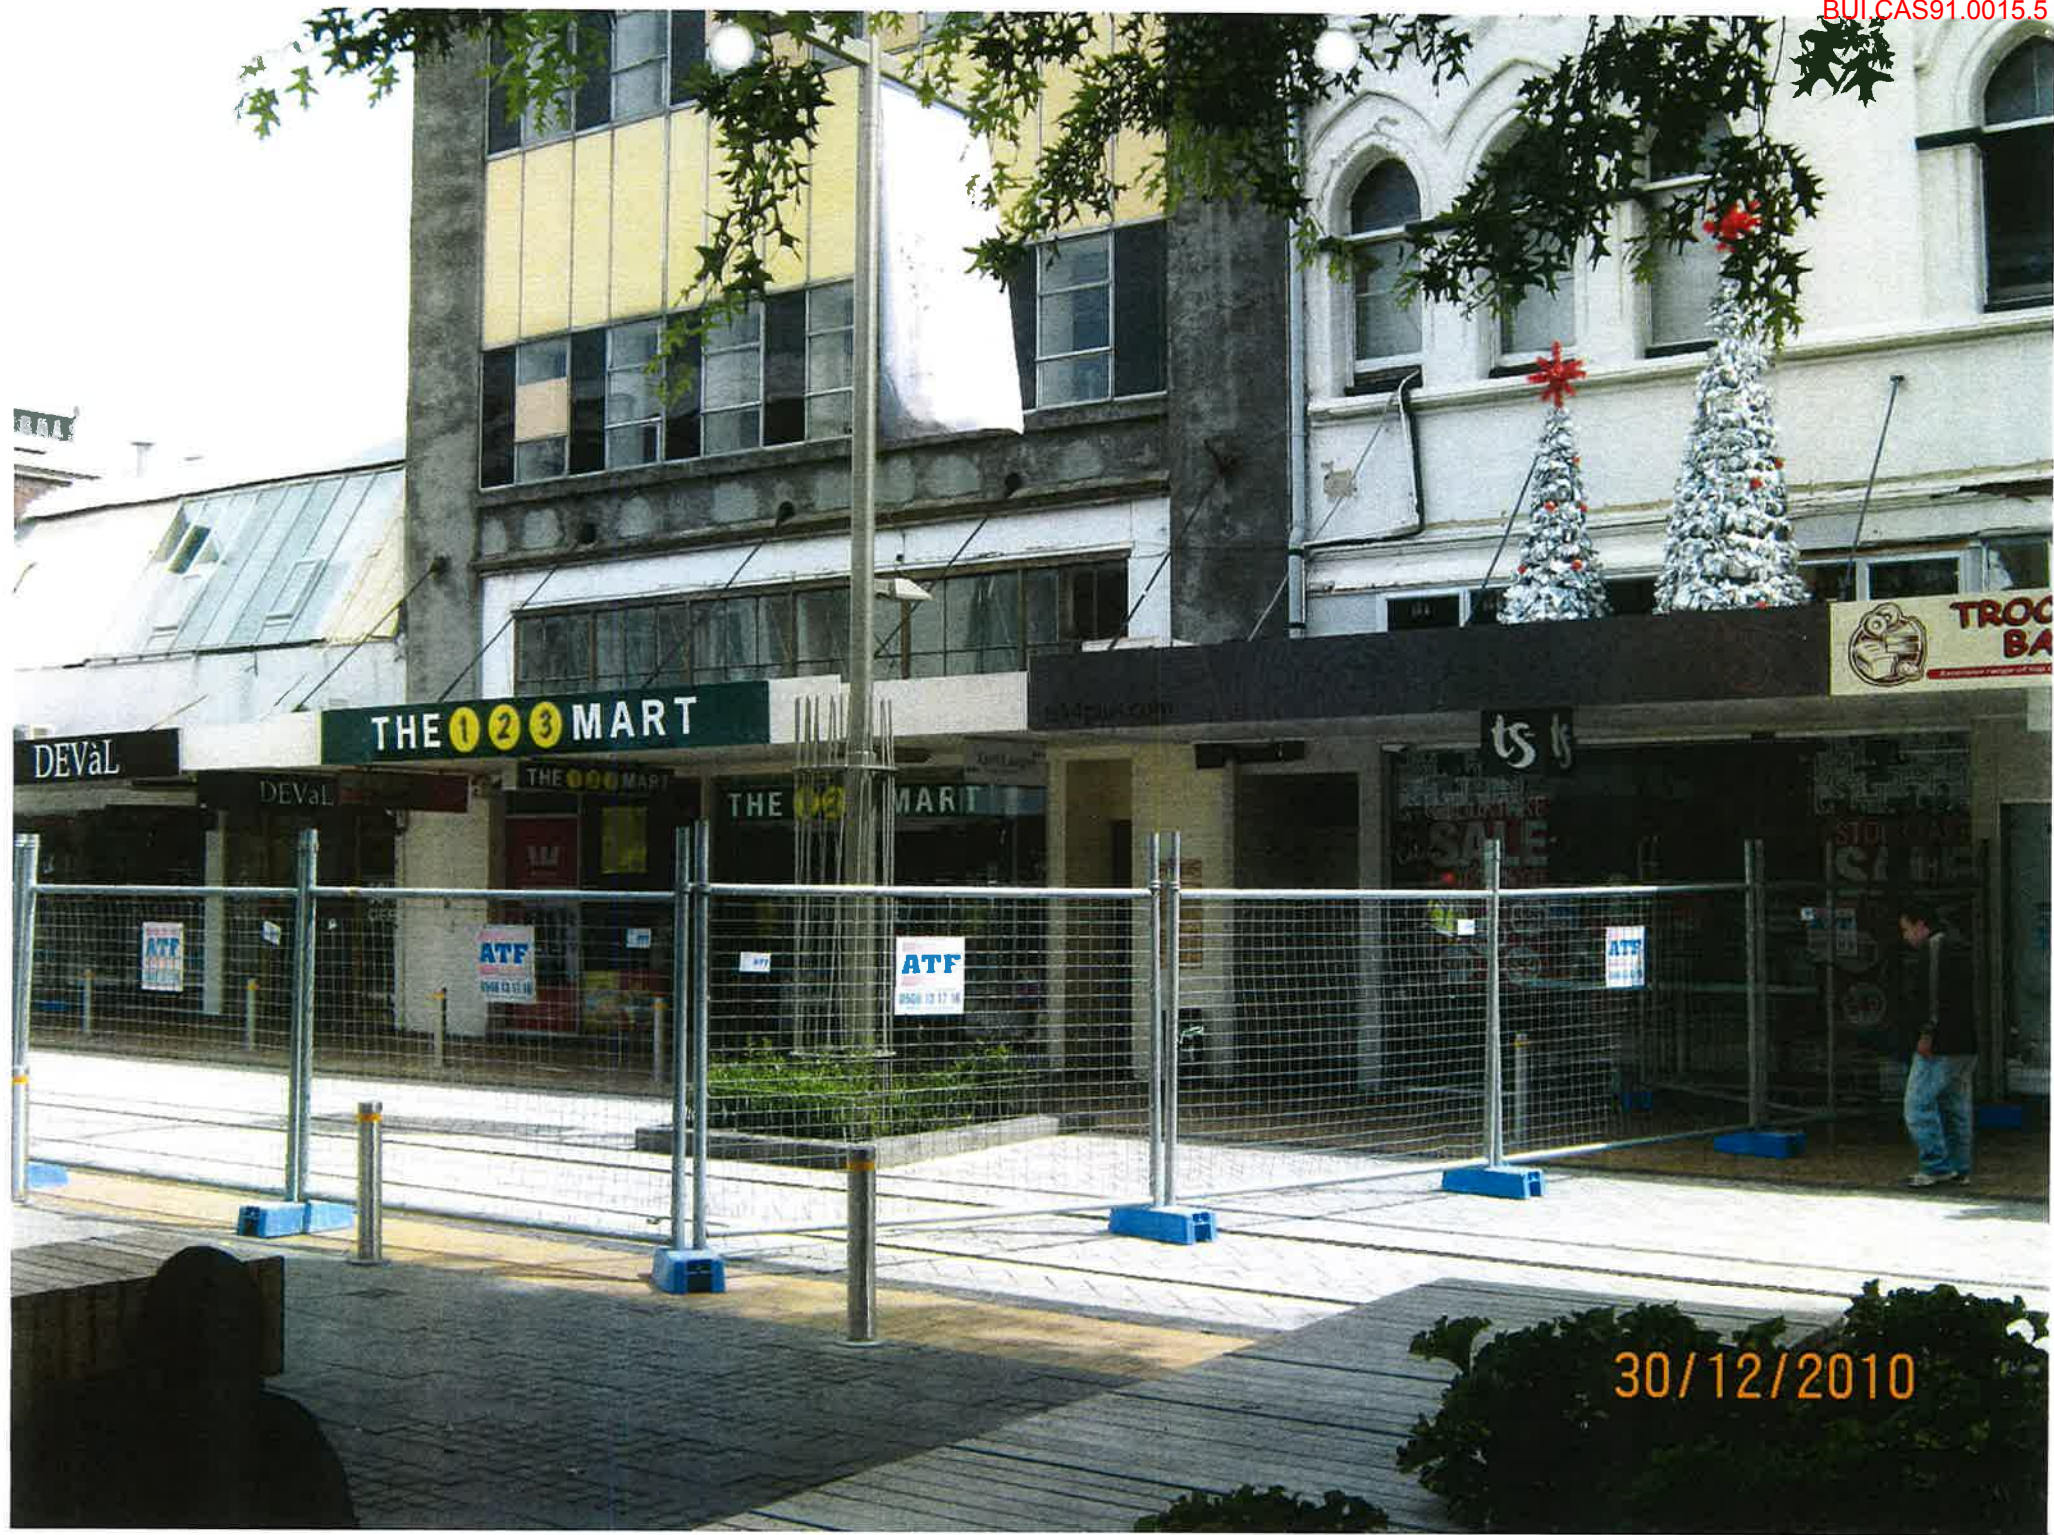
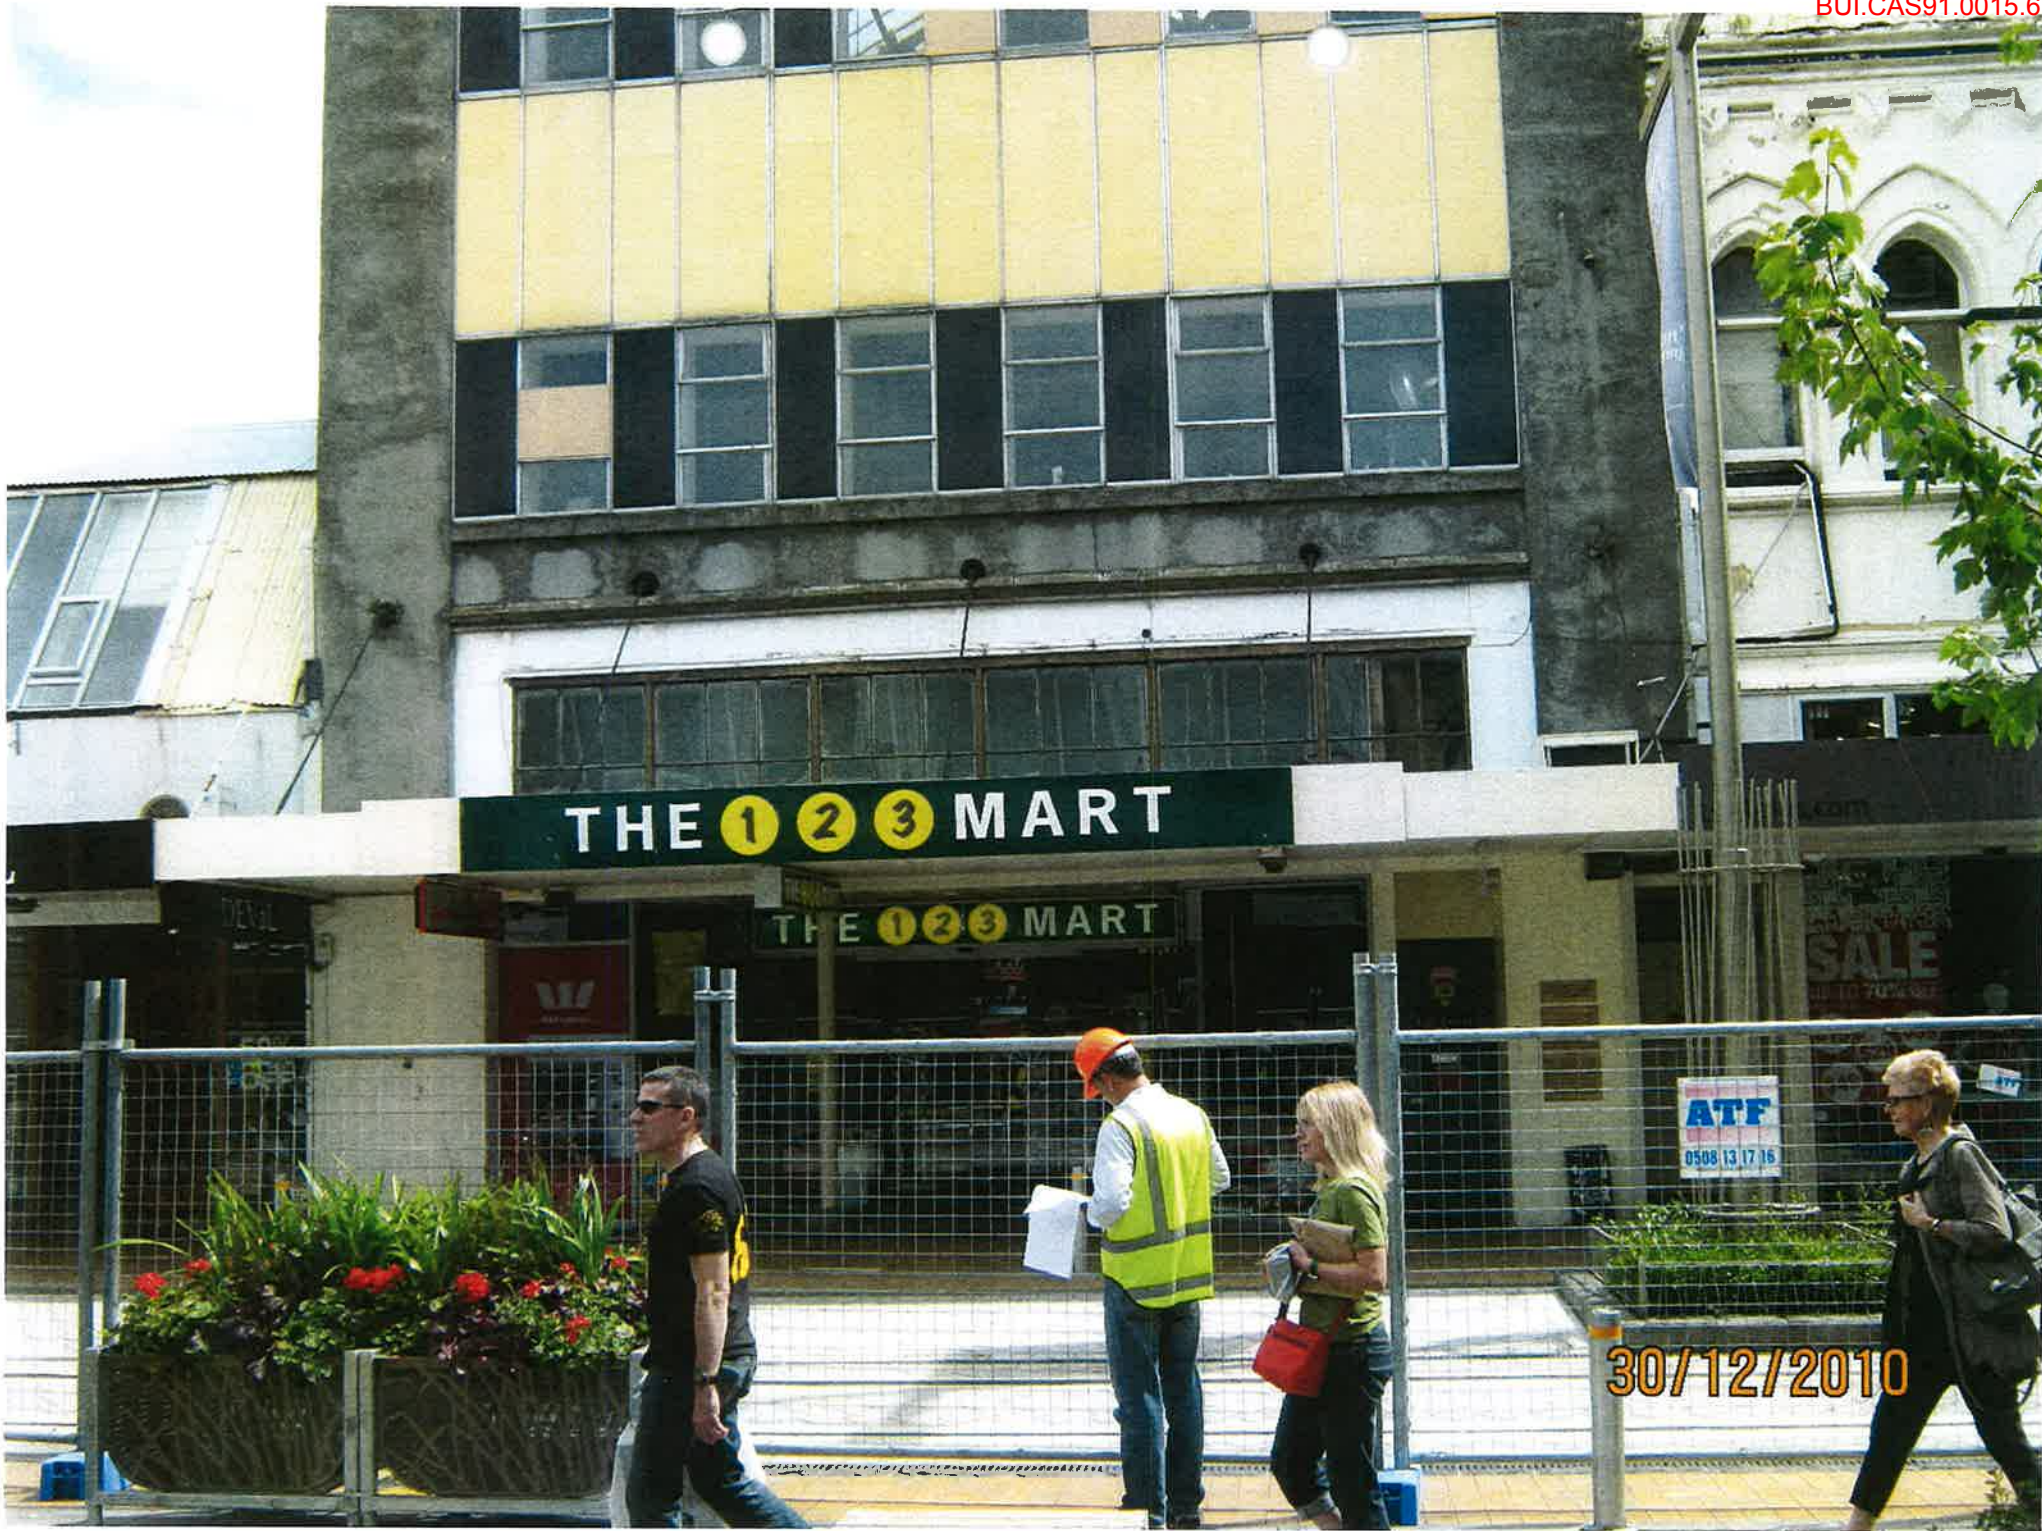
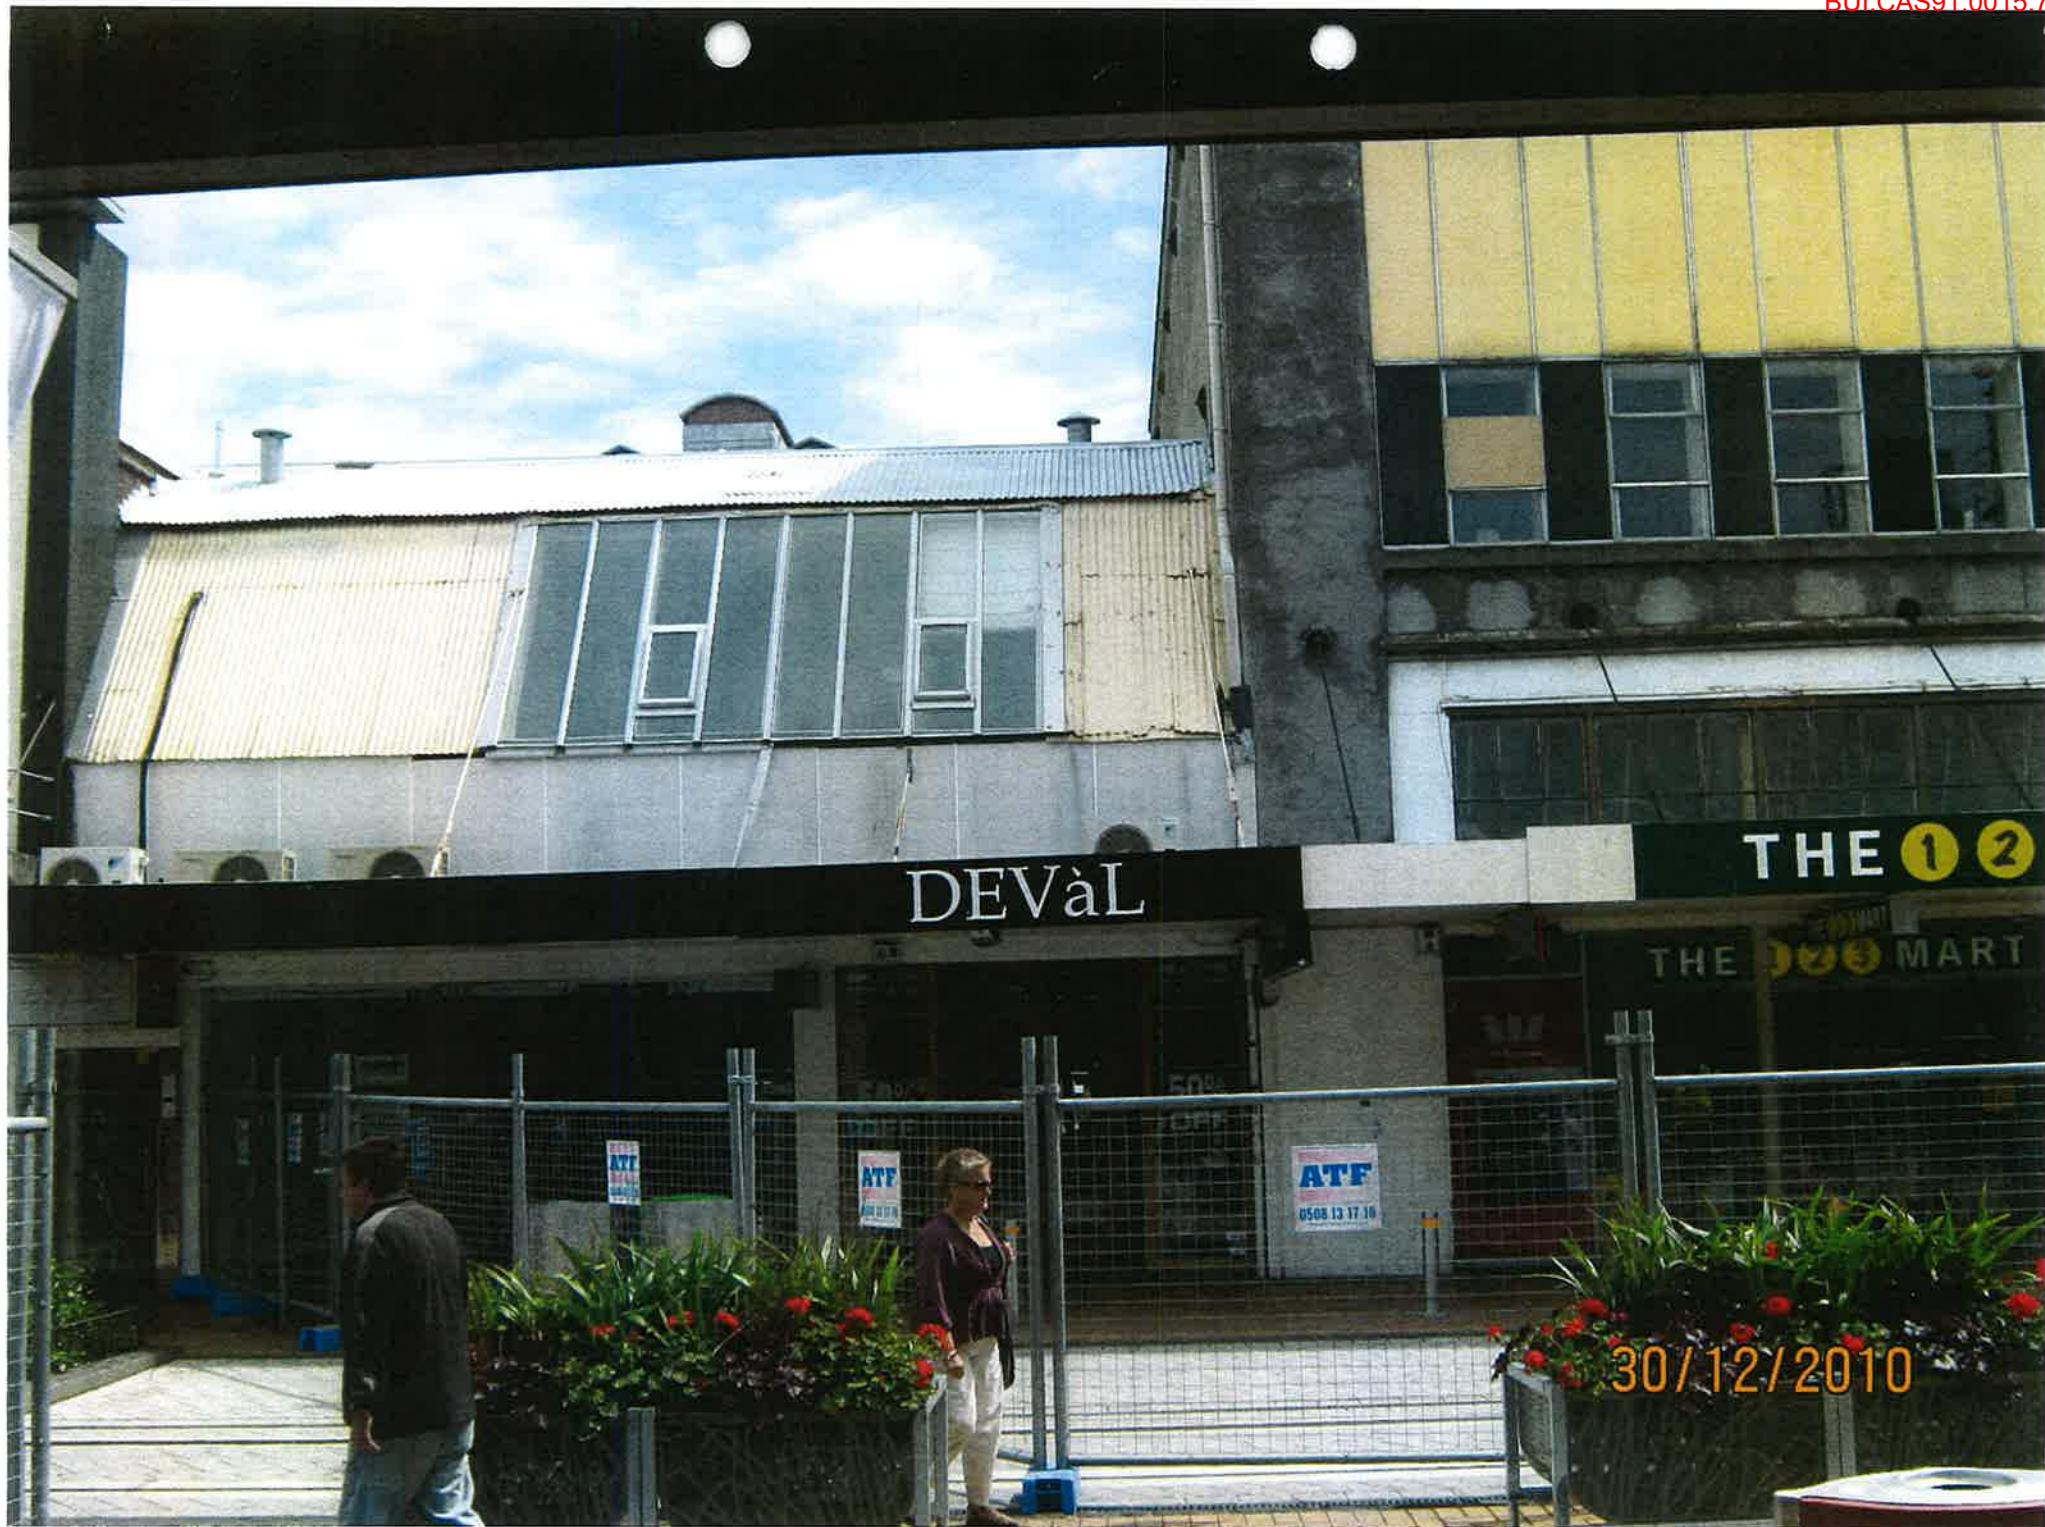
30/12/2010

The Council does have a record of photos taken of the cordon dated 30 December 2010 (**attached**). The Council also has a map of the cordons as at 4 February 2011, and it appears that the cordons had been removed by then (**attached**).

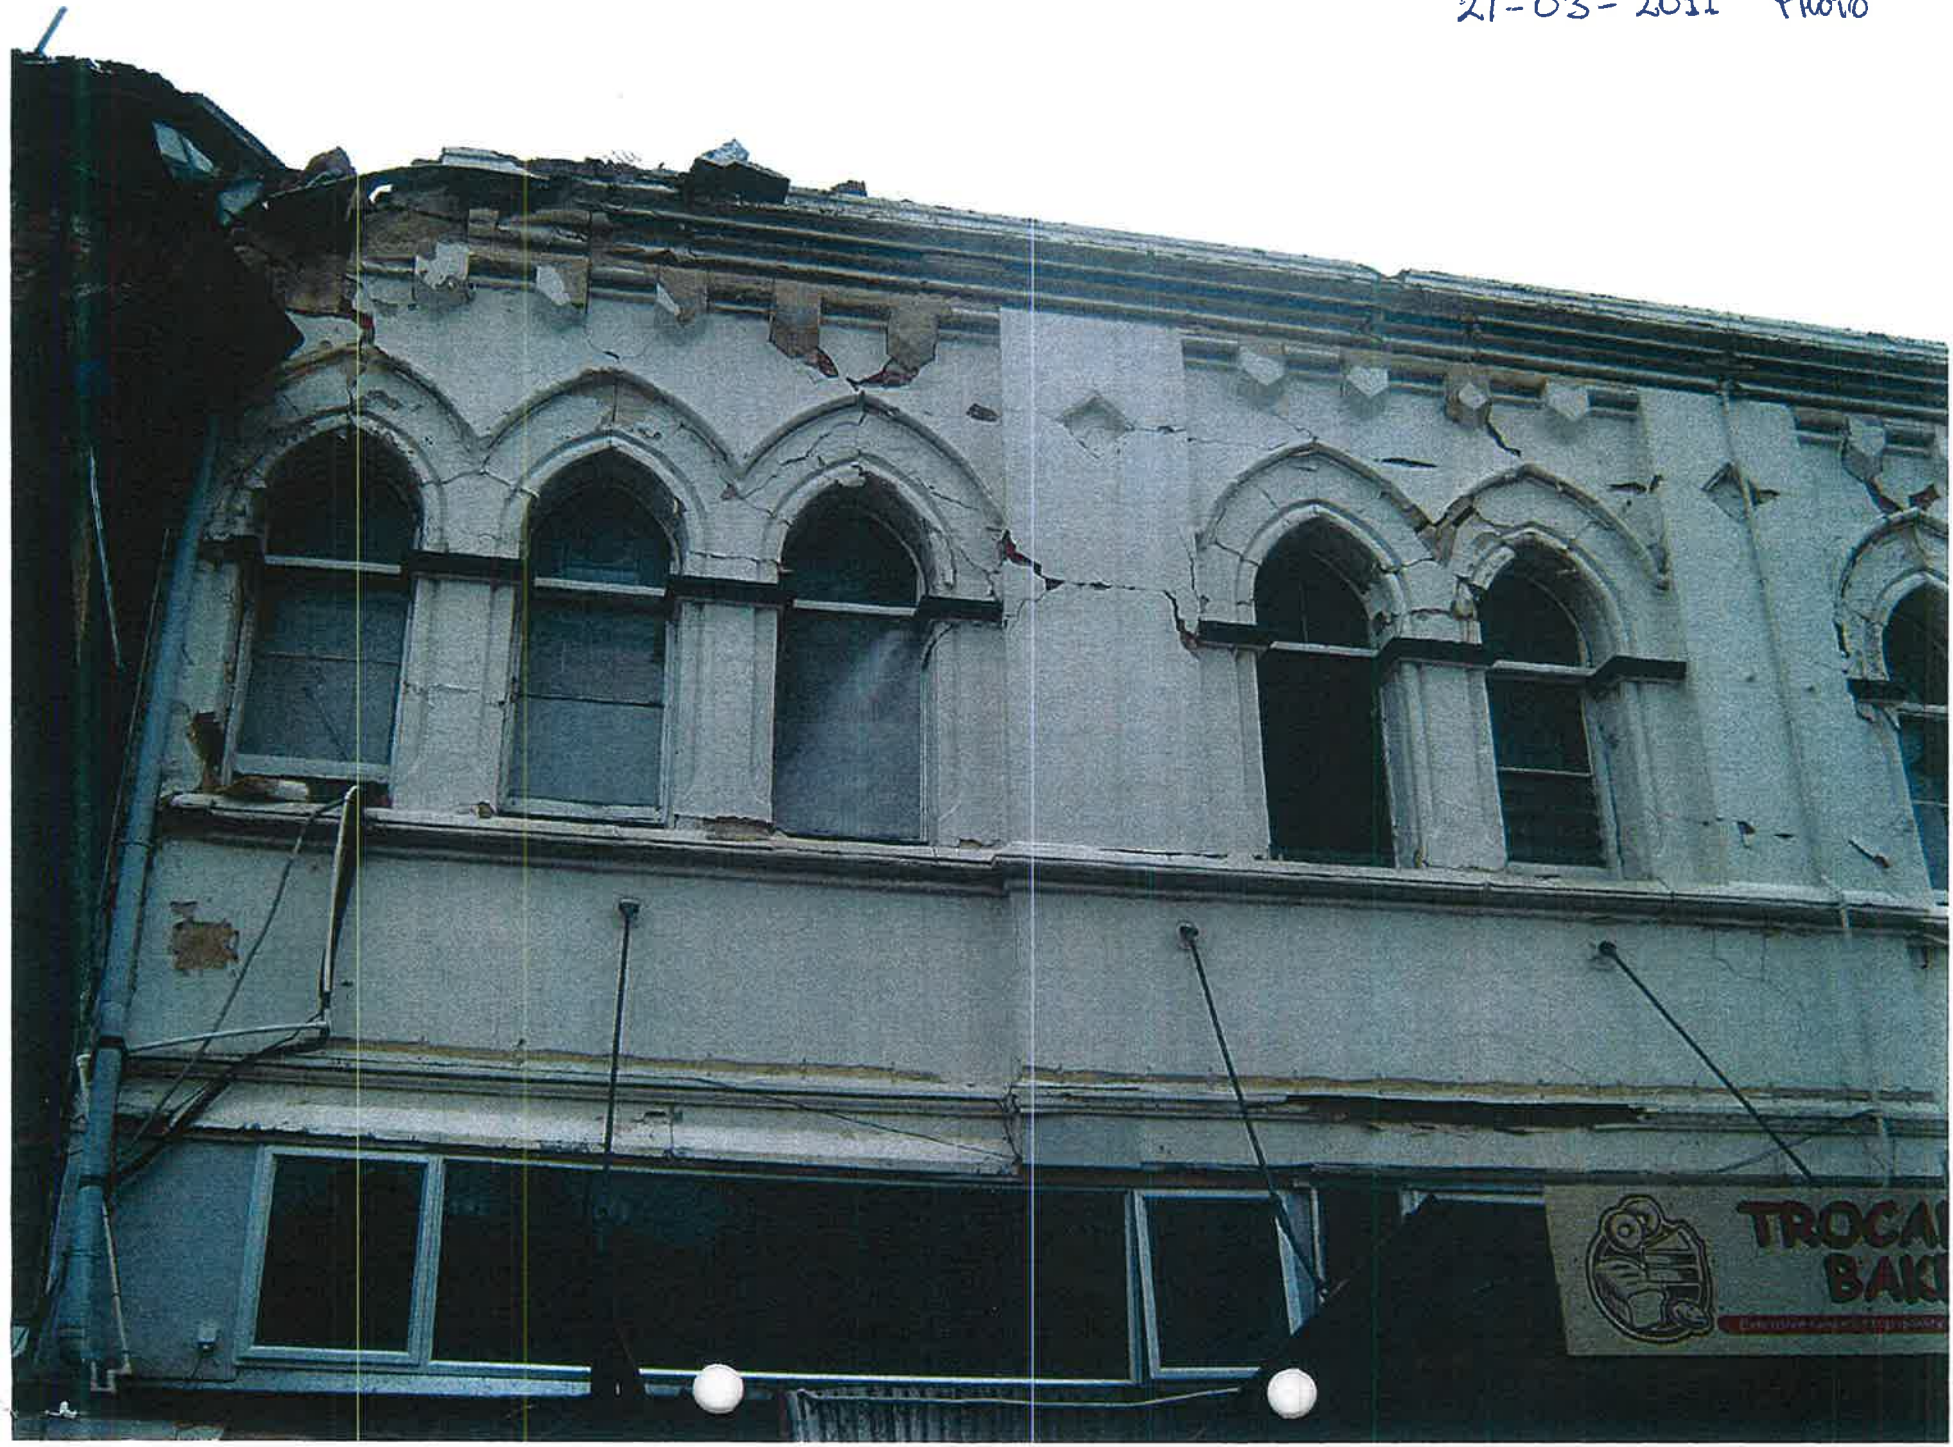
21-03-2011 PHOTO

The photograph of the building taken on 21 March 2011 after the 22 February earthquake shows the parapet damaged but in position (**attached**). This photo seems to confirm the parapet had been secured.
