**INDEPENDENT ASSESSMENT ON EARTHQUAKE PERFORMANCE  
OF  
32 Cathedral Square  
The Press**

**FOR  
Royal Commission of Inquiry into building failure  
caused by the Canterbury Earthquakes**

**Report prepared by Peter C Smith and Jonathan W Devine of  
Spencer Holmes Ltd**

**December 2011**

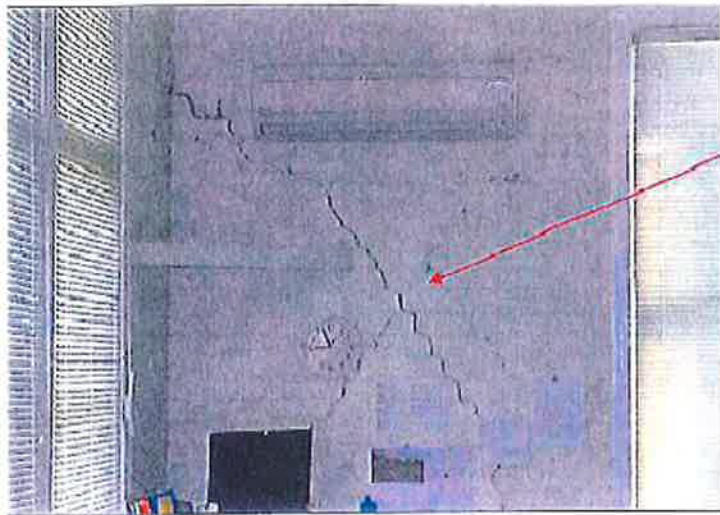
**Damage:**

**Diagonal shear cracking to the internal exposed brickwork.**

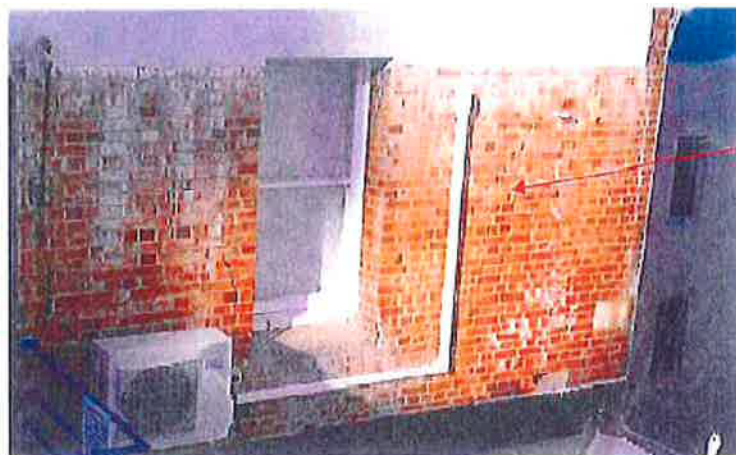
**Damage:**

**Diagonal shear cracking to the external exposed brickwork.**
