5 Earthquake Effects on Site and Building

6888 Ch-ch EQ CBD Building Performance Investigation

Hotel Grand Chancellor - Final 26 Sept 2011

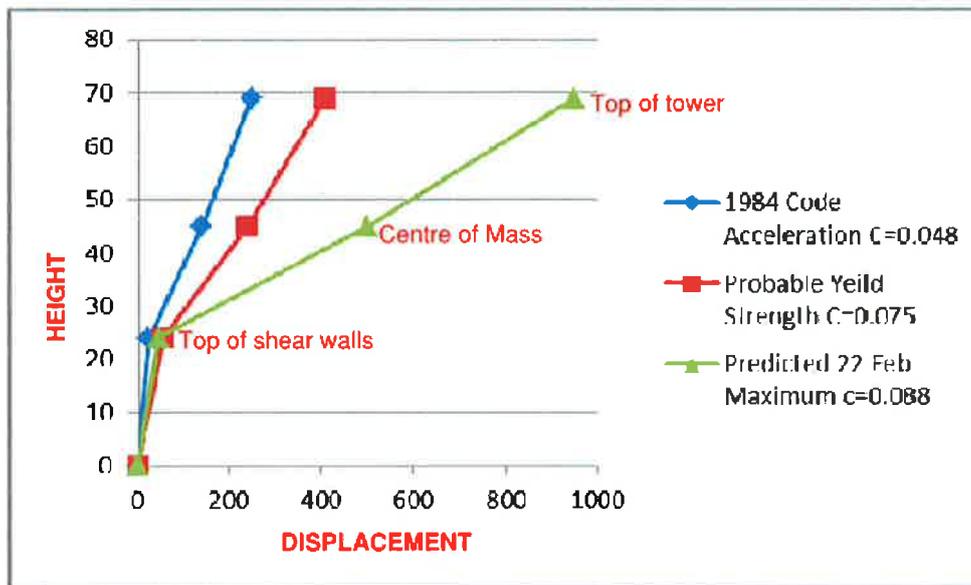
Fig.7

This response (ignoring the failure) is similar to what is implied by the 1984 loadings code (NZS4203:1984). While the initial accelerations and displacements for a 3 second period structure were higher in the February event than implied by the code, as the structure yielded and softened the demands were similar.

If the damage resulting from the wall collapse is disregarded then the observed damage is generally consistent with the ductility demand. While the extent of cracking is perhaps less than expected in the upper tower beams, this may be explained by the limited number of strong motion cycles, maybe only 2 or 3.

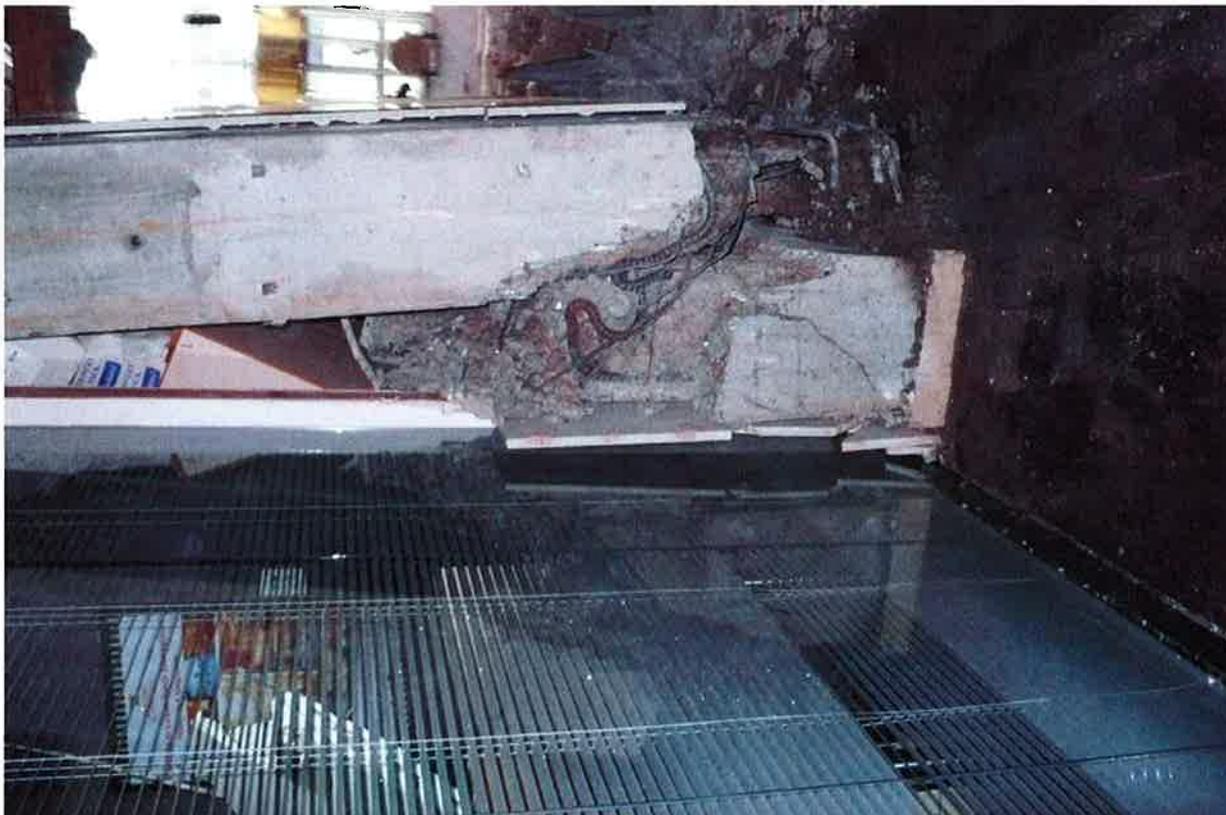
Photo 9 - Shearwall D5-6 Failure - End View

- The wall central (web), vertical reinforcing had a lap just above ground floor level although the primary (at the ends of the wall) reinforcing bars were not lapped until the first floor. In a situation where the compression block/neutral axis extends beyond the confined area the web reinforcing effectively becomes primary reinforcing. NZS 3101:1982 did not permit lapping of primary reinforcing within the end/hinge zone (lower portion) of a shear wall. Part of the reason for this is that within a zone of ultimate concrete strain the end of the reinforcing bars can cause stress raisers within the concrete.

- Even without the addition of vertical acceleration loads, it is highly probable that the conditions for wall failure existed, when subject to severe shaking,

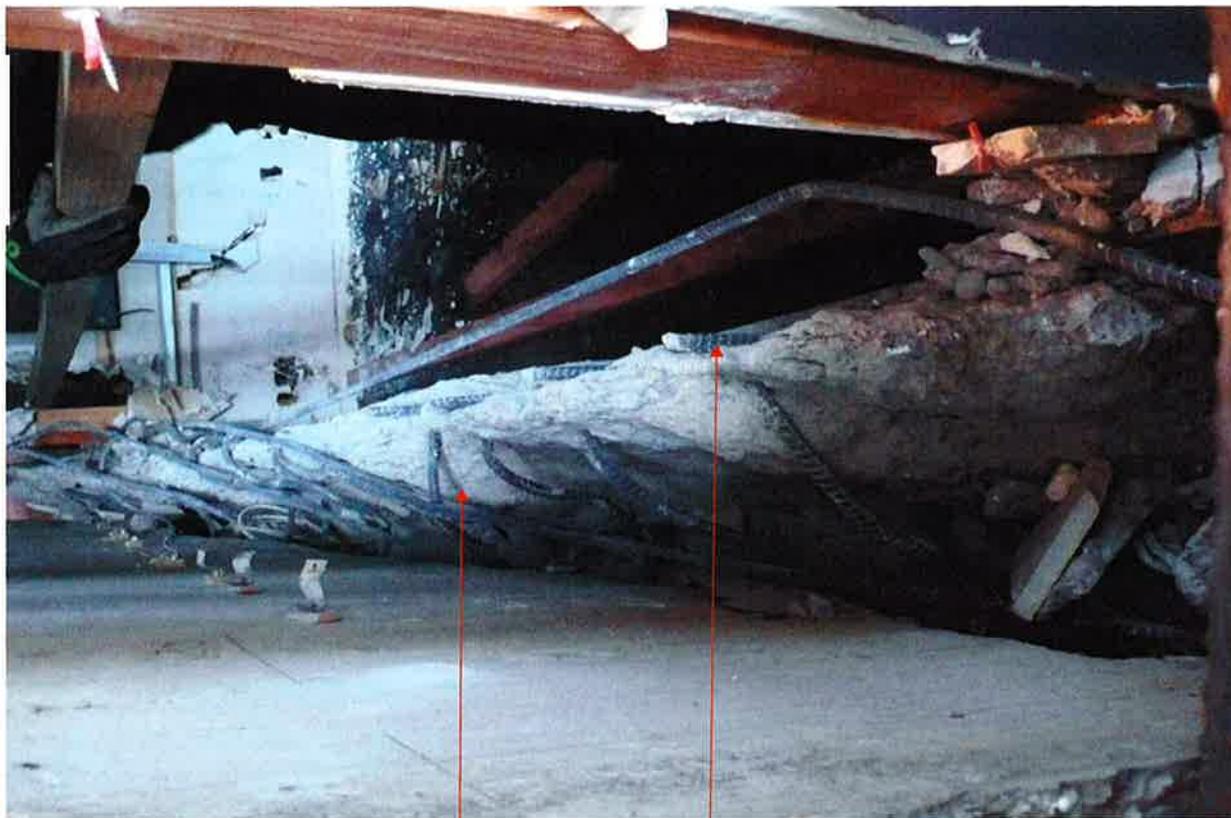
Photo 10 - Shearwall D5-6 Failure - Close-up

- It is likely that the diagonal failure plane initiated immediately behind the small confined zone, at the top of the lapped bars, possibly encouraged by a tension yield crack and/or by stress raisers at the top of the web laps. This is consistent with photographic evidence that shows the top of the failure plane coincident with the top of the lap bars. [Ref App C Photo 10]

Of the factors listed above that contributed to the brittle failure of the wall, it is the lack of effective confinement that is considered to be the critical factor. Adequately detailed confinement provides concrete (an inherently brittle material) with ductility, which is an ability to withstand post-elastic strains. In many respects, and in retrospect, the actions on wall D5-6 can be likened to those on a highly loaded concrete column.

Brittle, transverse failure,
absence of confinement

Lapped reinforcing

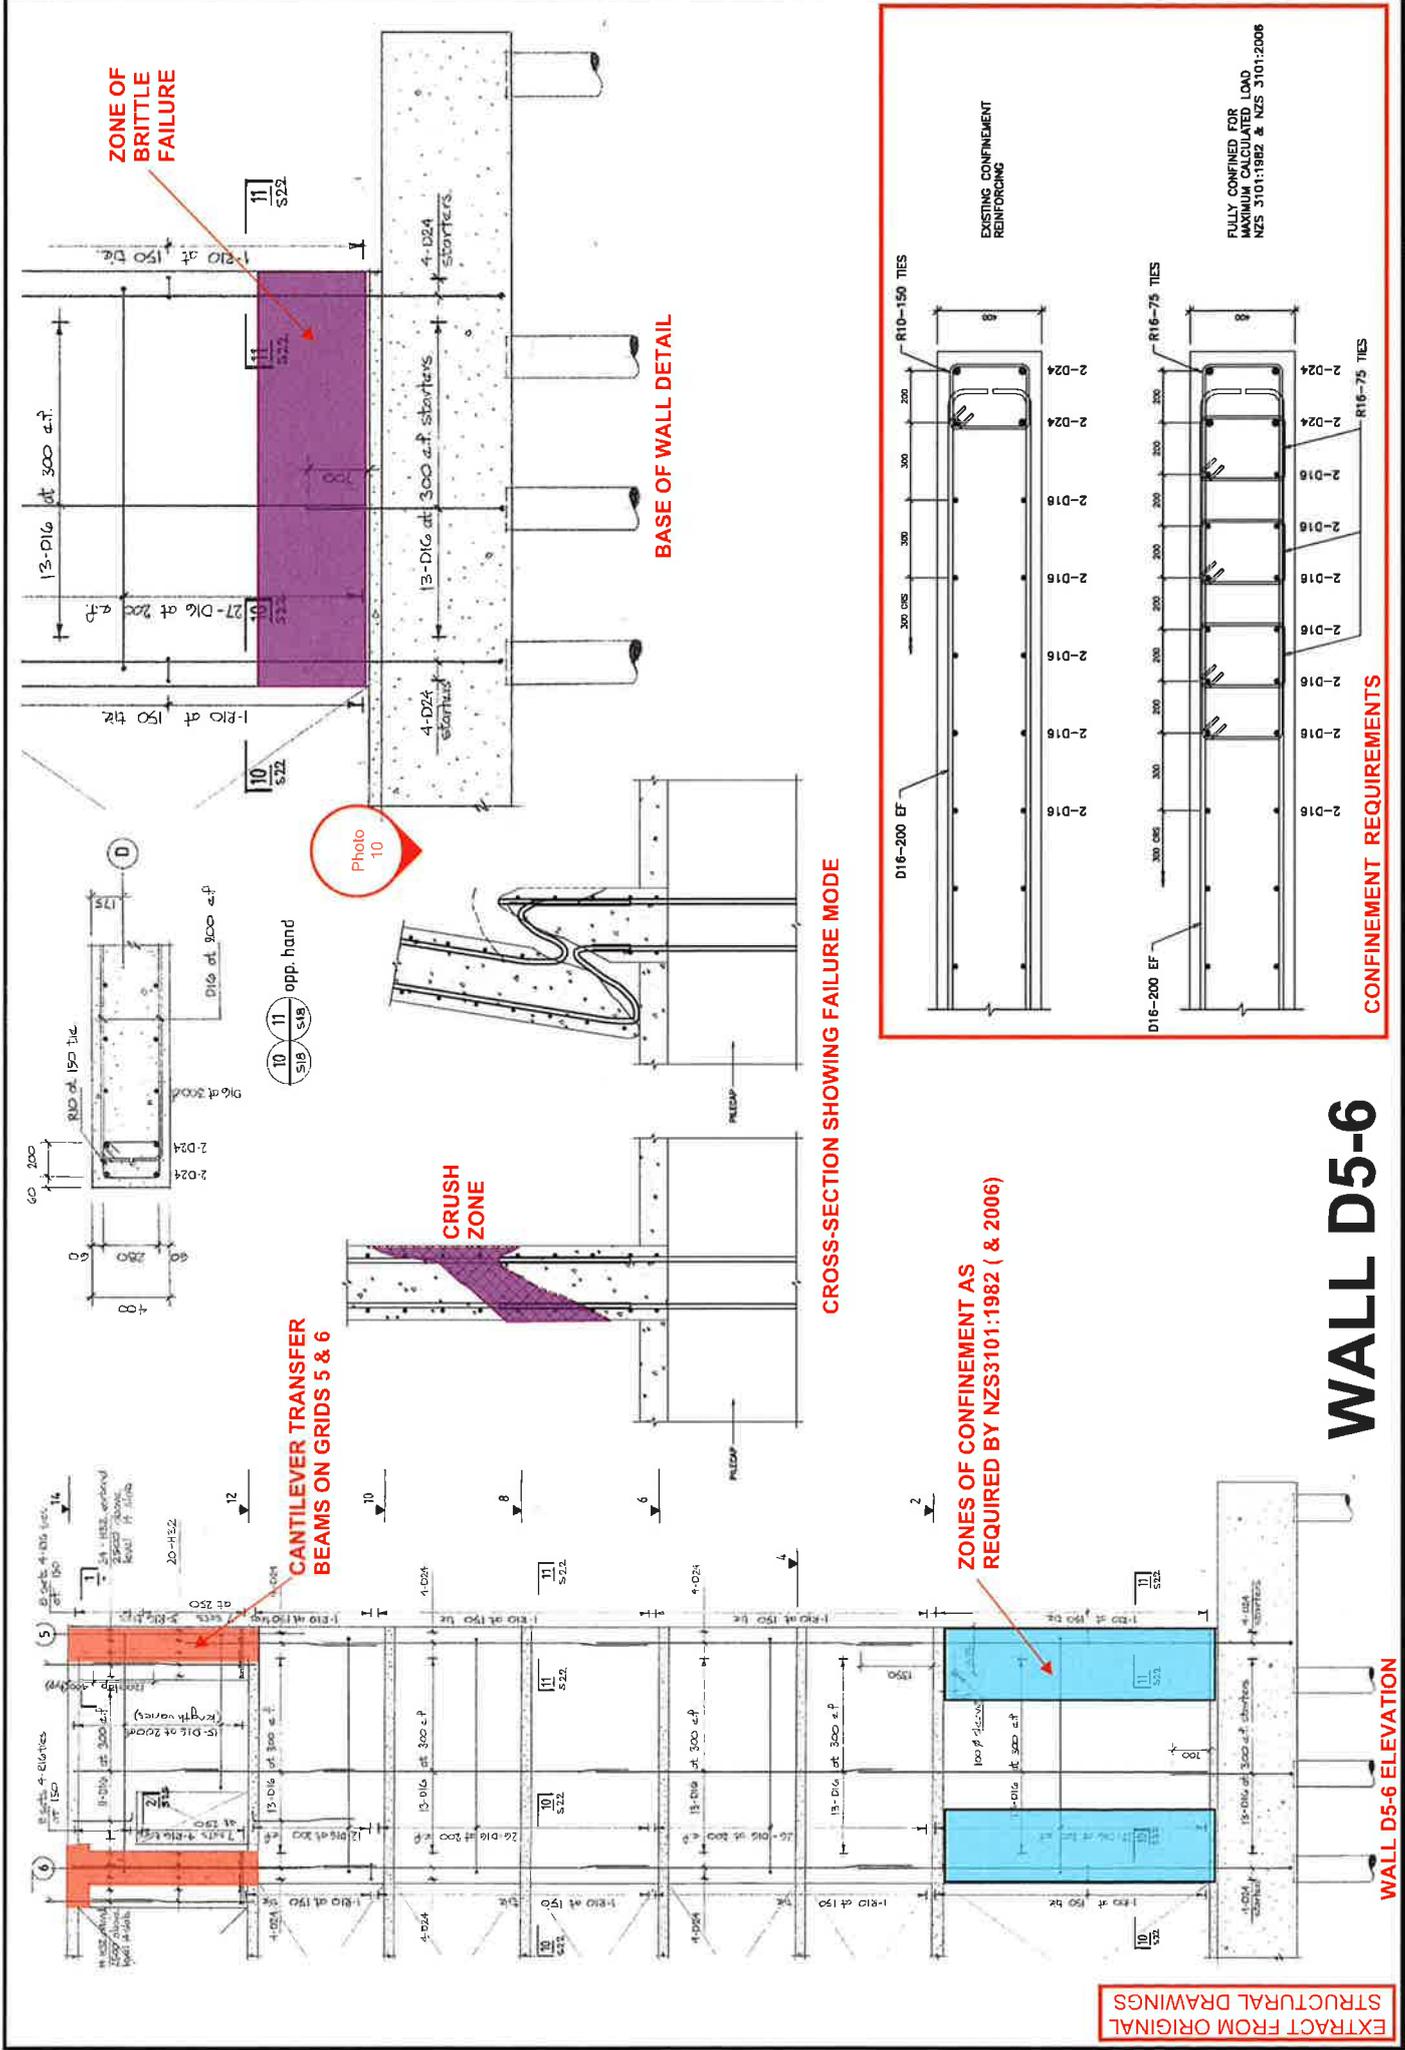
EXTRACT FROM ORIGINAL STRUCTURAL DRAWINGS

ZONE OF BRITTLE FAILURE

CRUSH ZONE

ZONES OF CONFINEMENT AS REQUIRED BY NZS3101:1982 (& 2006)

FULLY CONFINED FOR MAXIMUM CALCULATED LOAD NZS 3101:1982 & NZS 3101:2006

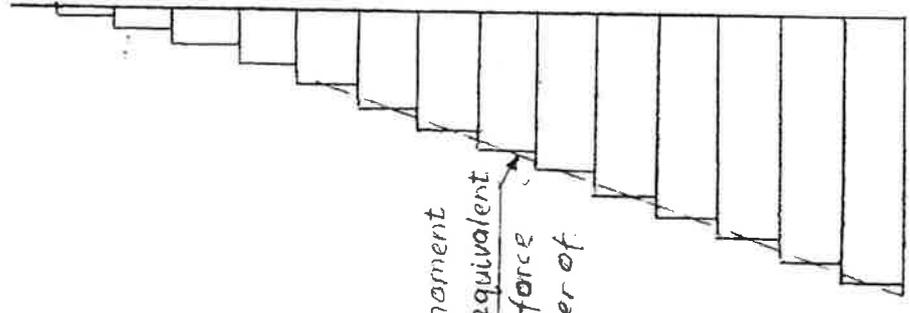
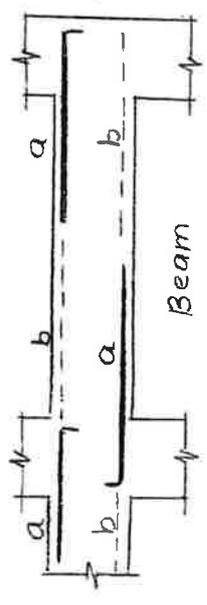
Sketch 3

Bending moment due to cantilever portion of floor at one level $\pm 3,500 \text{ kNm}$, This is equivalent to a shear of the order of 1,000 kN. Hence the strength to deflect to the East is reduced by 1,300 kN, and the strength to deflect to the West is increased by 1,300 kN.

This could be compensated by increasing strength for Eastward deflections, but this has not been done.

To balance strengths would require more reinforcement in zones "a" than in zones "b", but this has not been done.
