**IN THE MATTER OF ROYAL COMMISSION OF INQUIRY INTO BUILDING  
FAILURE CAUSED BY CANTERBURY EARTHQUAKES**

**STATEMENT OF EVIDENCE OF STEPHEN JAMES MCCARTHY IN RELATION TO 194  
GLOUCESTER STREET**

**DATE OF HEARING: 15 FEBRUARY 2012**

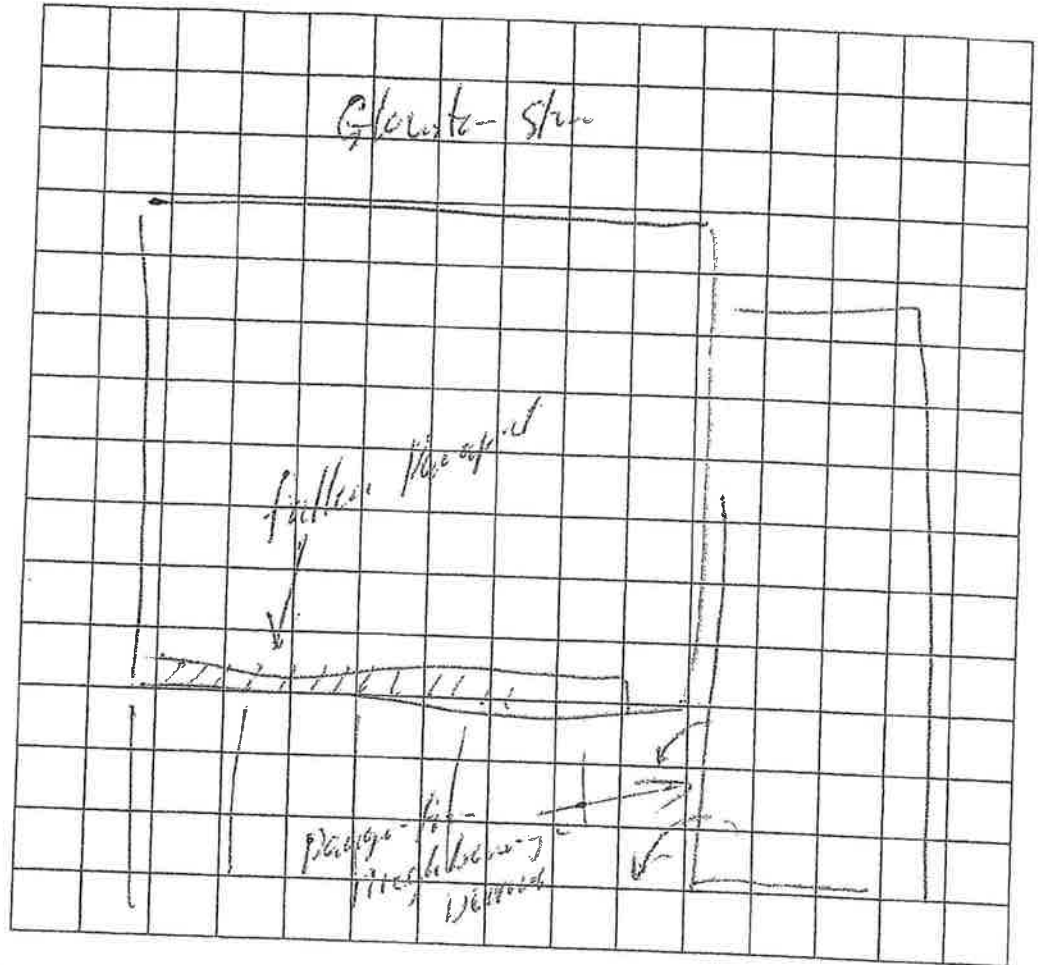
**Sketch (optional)**

Overall Hazards / Damage	Minor/None	Moderate	Severe	Comments
Collapse, partial collapse, off foundation	<input checked="" type="checkbox"/>	<input type="checkbox"/>	<input type="checkbox"/>	<p>Previous notice states "TIPPING HAZARD AT REAR - NO ACCESS THROUGH BACK DOORS TO GARAGE TARD"</p> <p>SOME MINOR CRACKING TO SIDE WALL</p> <p>PART OF ROOF PARALLEL WITH BEEN REPAIRED</p>
Building or storey leaning	<input checked="" type="checkbox"/>	<input type="checkbox"/>	<input type="checkbox"/>	
Wall or other structural damage	<input type="checkbox"/>	<input checked="" type="checkbox"/>	<input type="checkbox"/>	
Overhead falling hazard	<input type="checkbox"/>	<input checked="" type="checkbox"/>	<input type="checkbox"/>	
Ground movement, settlement, slips	<input checked="" type="checkbox"/>	<input type="checkbox"/>	<input type="checkbox"/>	
Neighbouring building hazard	<input type="checkbox"/>	<input checked="" type="checkbox"/>	<input type="checkbox"/>

Should be able to be repaired

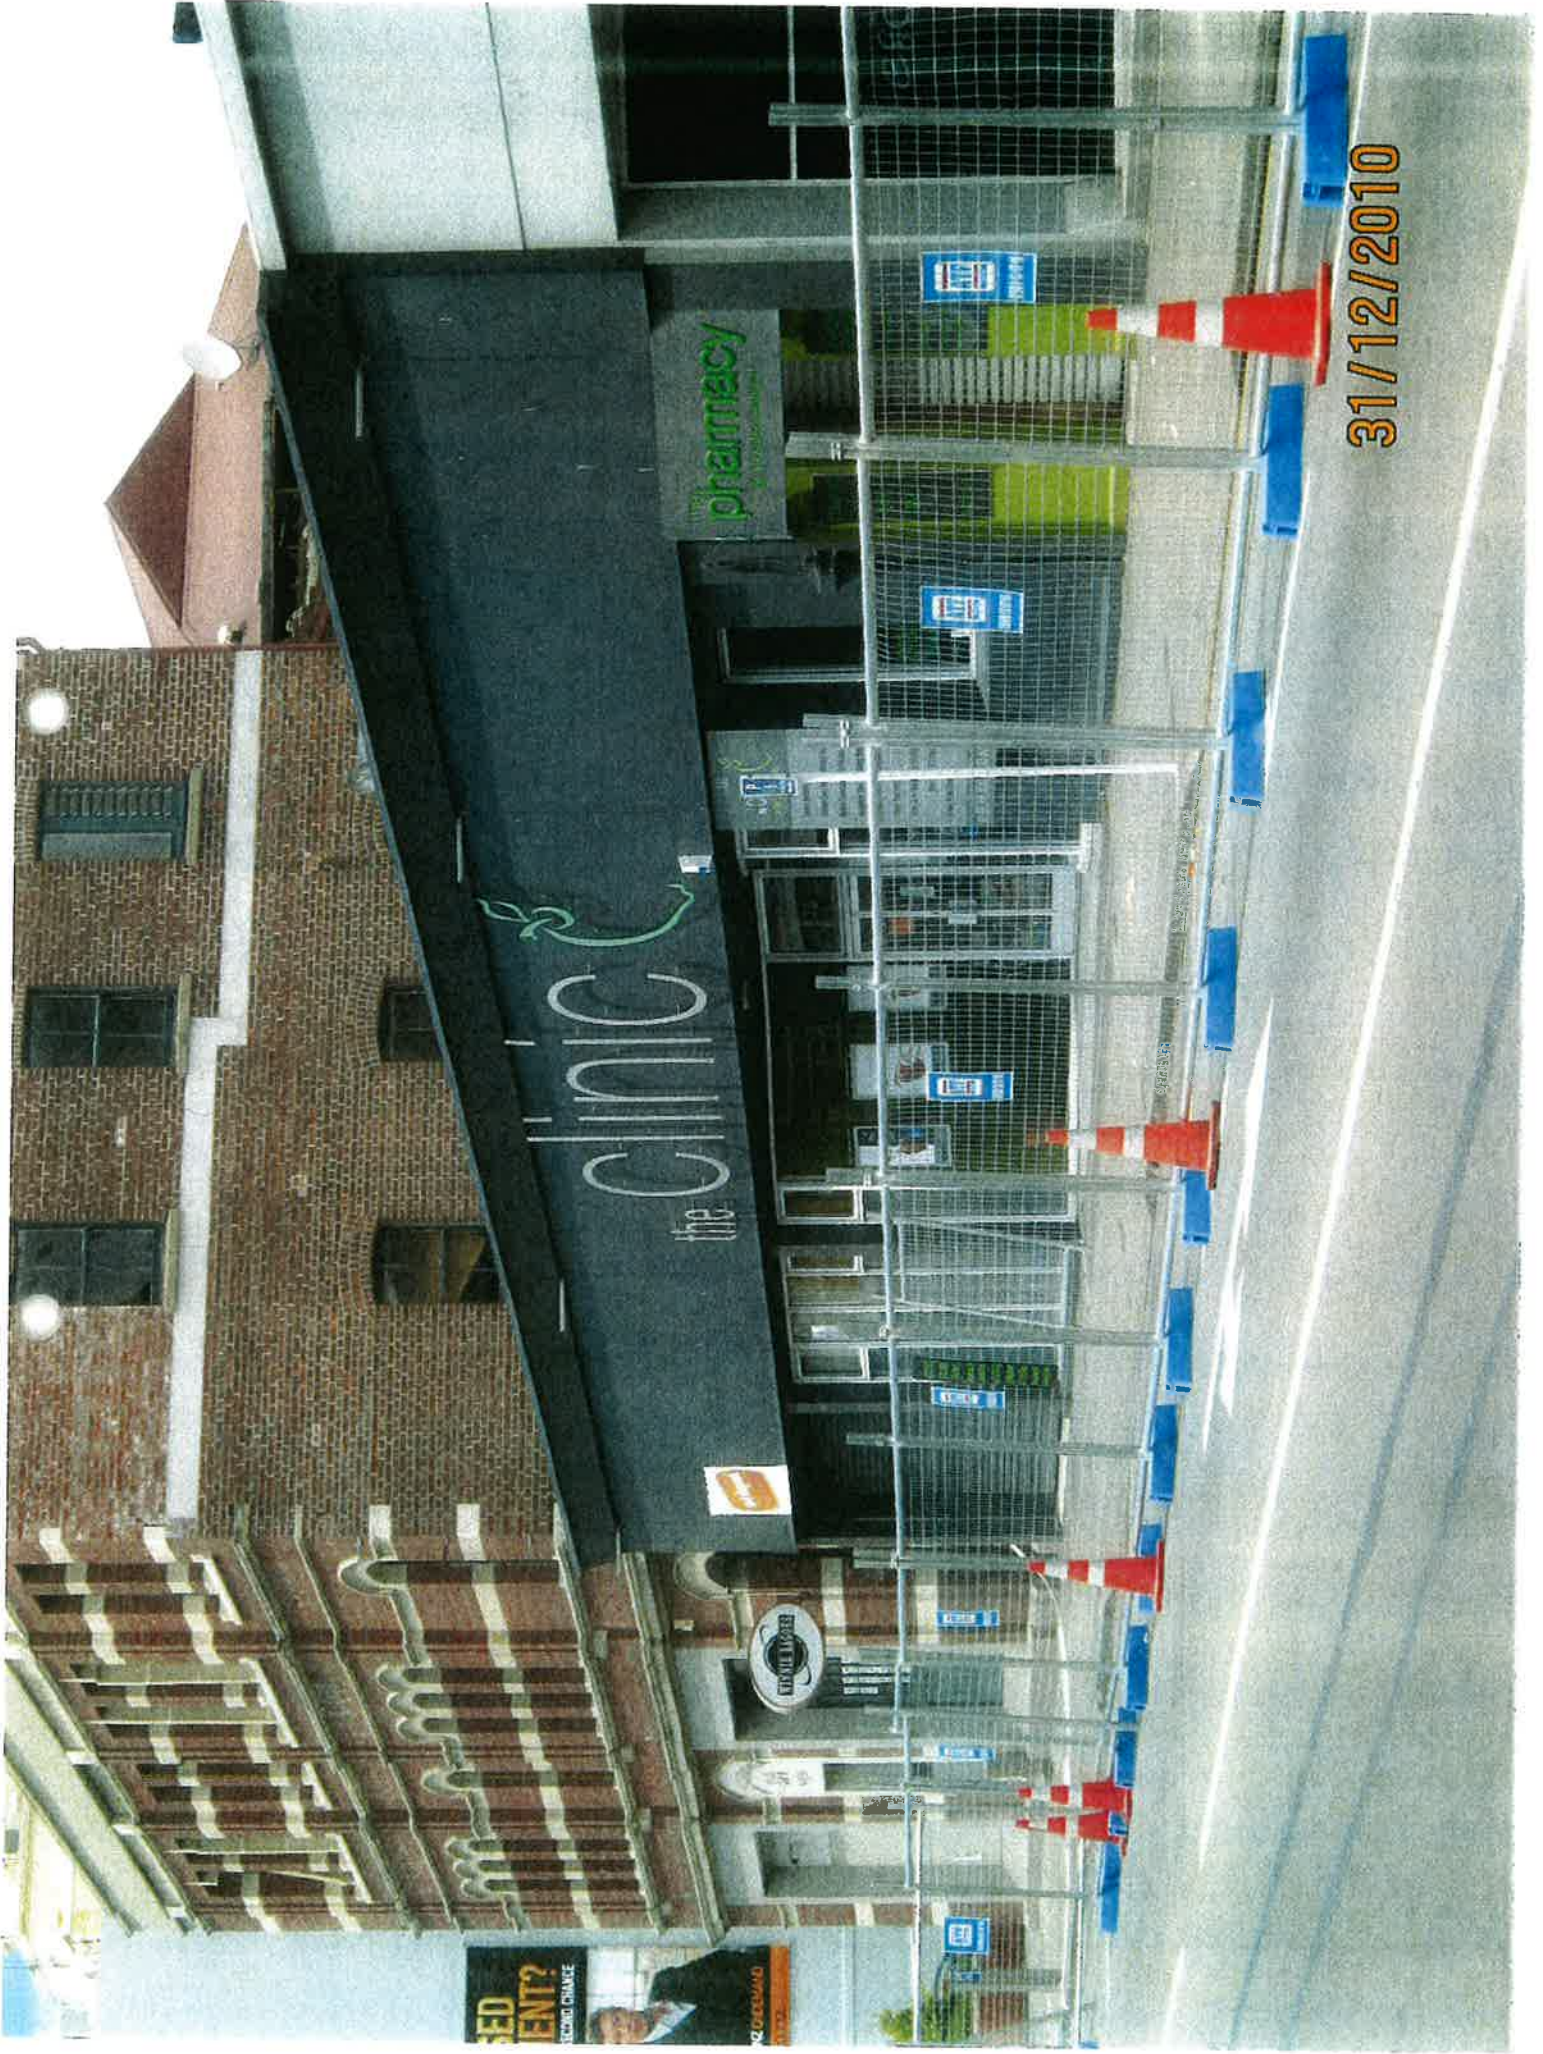
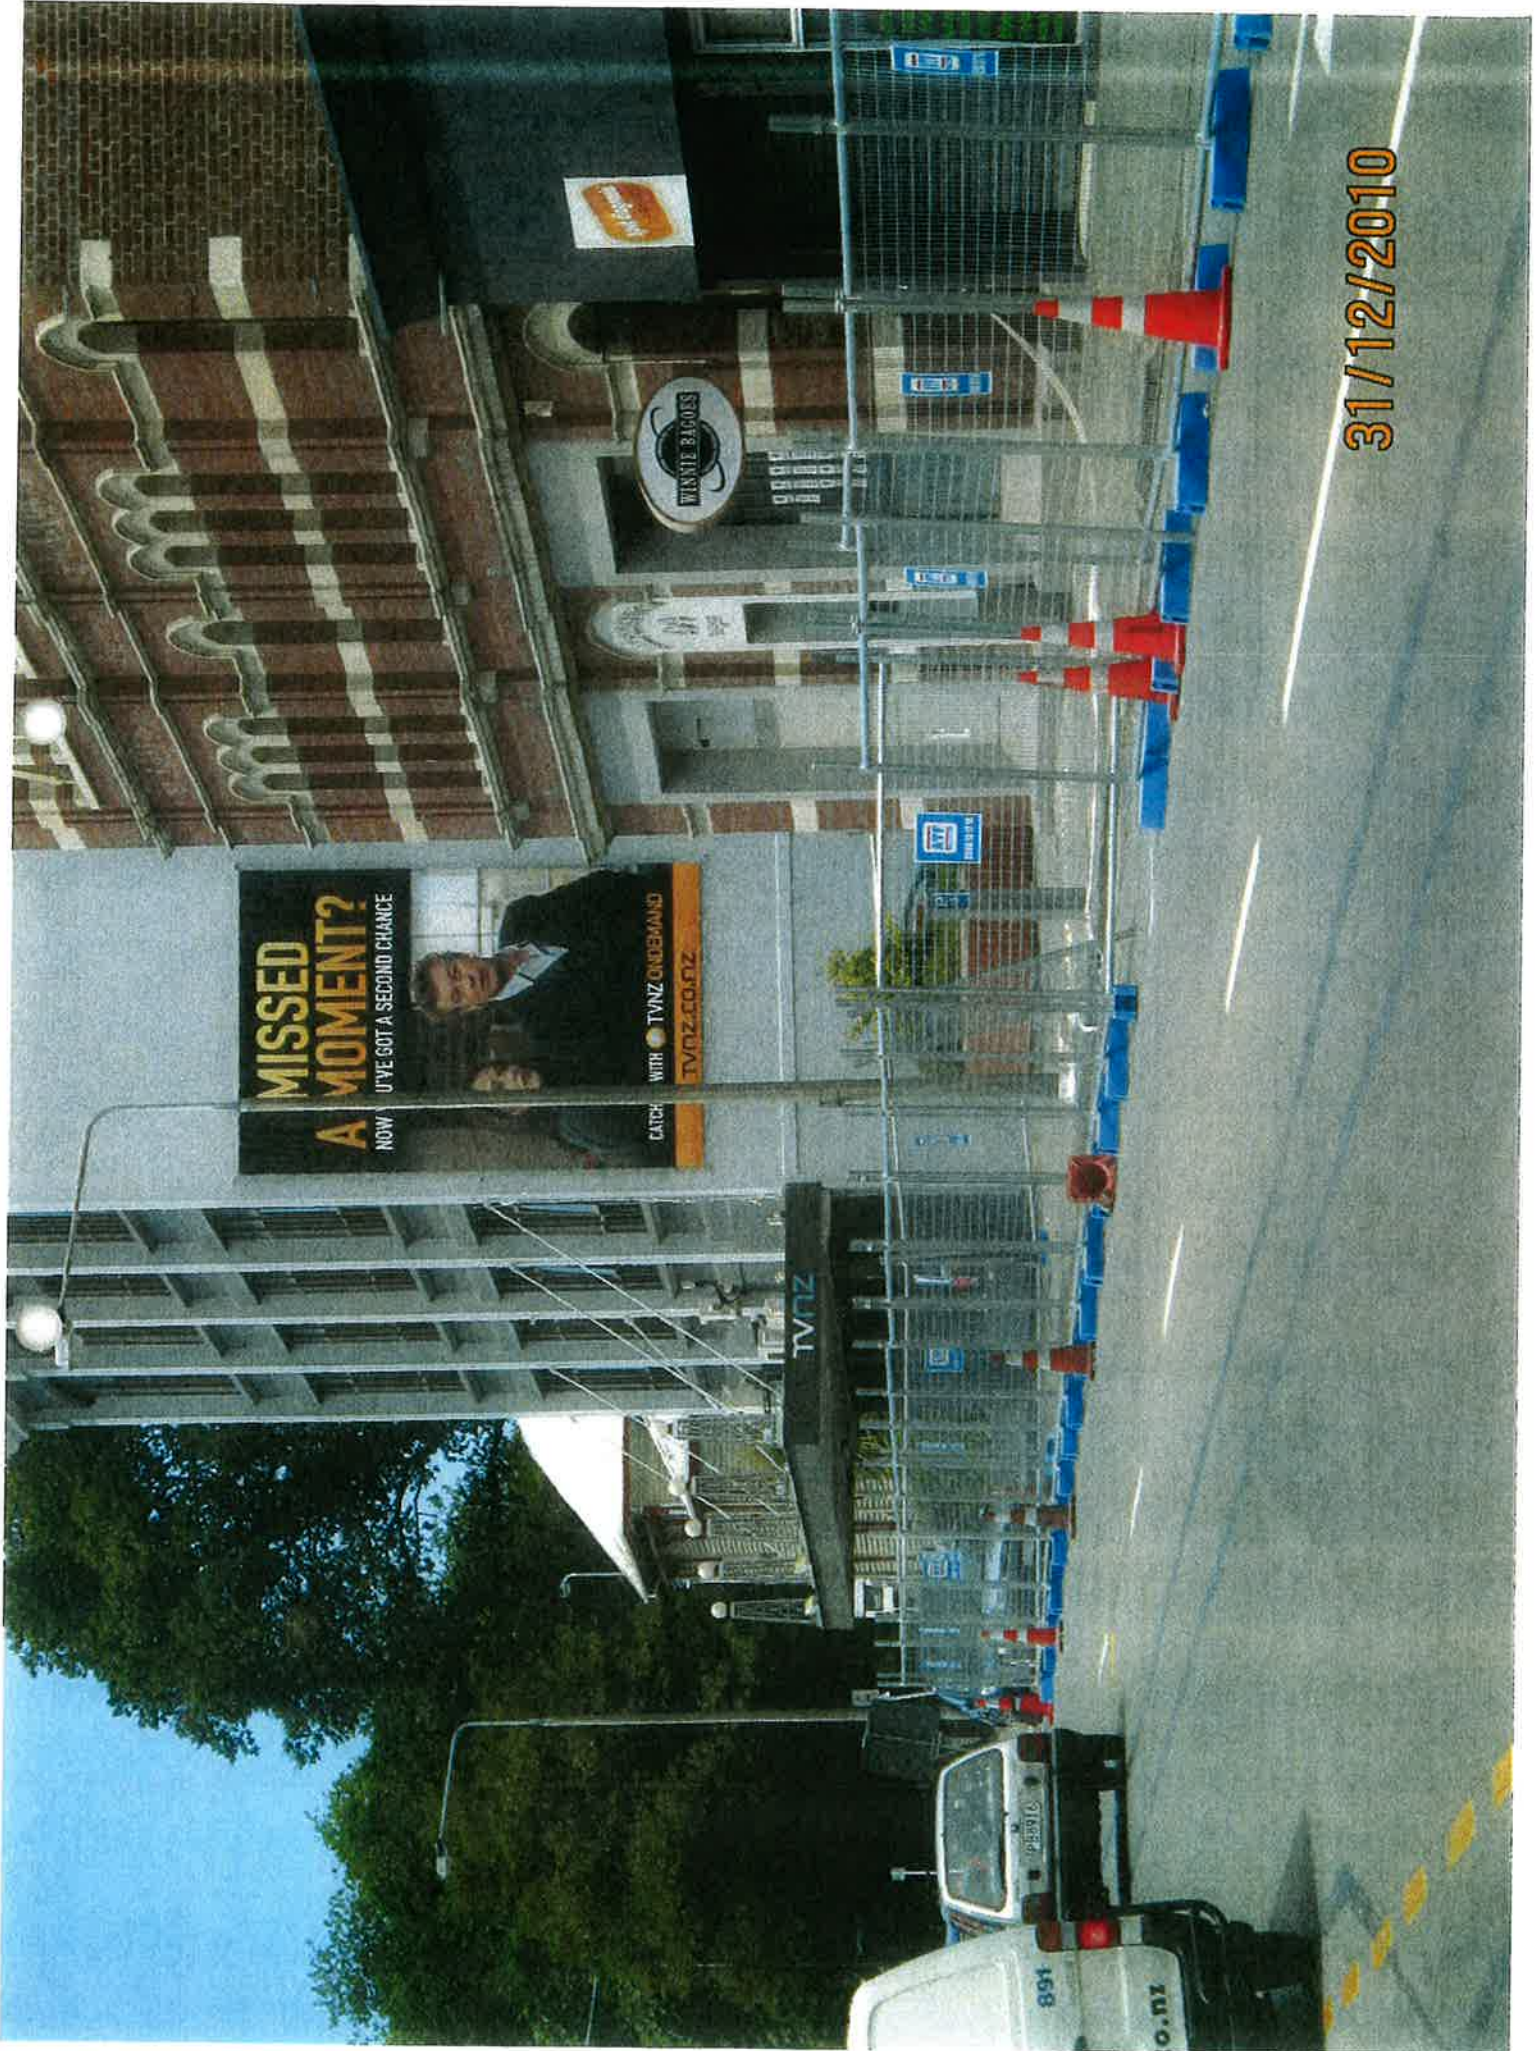
31/12/2010

12. A USAR Damaged Building Reconnaissance Report dated 27 December 2010 at 10.15am stated that an engineering assessment was required but additional cordon/fencing was not required (**BUI.GLO194.0012.38**). A further USAR Damaged Building Reconnaissance Report dated 27 December 2010 at 12.00pm states that the west parapet has fallen and that the top north west window was loose by 6 inches (**BUI.GLO194.0012.39**). This report recommended that an engineering assessment and cordons/fencing were required. Cordons were in place on 31 December 2010 as shown by the attached photographs (**Annexure "A"**).

21. The USAR Damaged Building Reconnaissance Report of 27 December 2010 at 12.00pm notes that a cordon is urgently required. The photographs taken on 31 December 2010 indicate that the cordon was in place by this date (**Annexure**
