**IN THE MATTER OF ROYAL COMMISSION OF INQUIRY INTO BUILDING
FAILURE CAUSED BY CANTERBURY EARTHQUAKES**

**STATEMENT OF EVIDENCE OF STEPHEN JAMES MCCARTHY IN RELATION TO 91
CASHEL STREET**

DATE OF HEARING: 24 JANUARY 2012

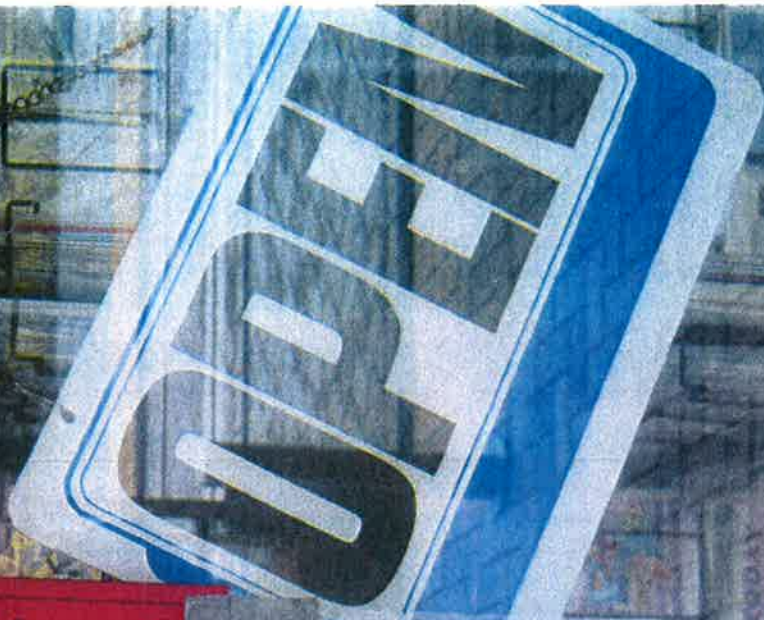
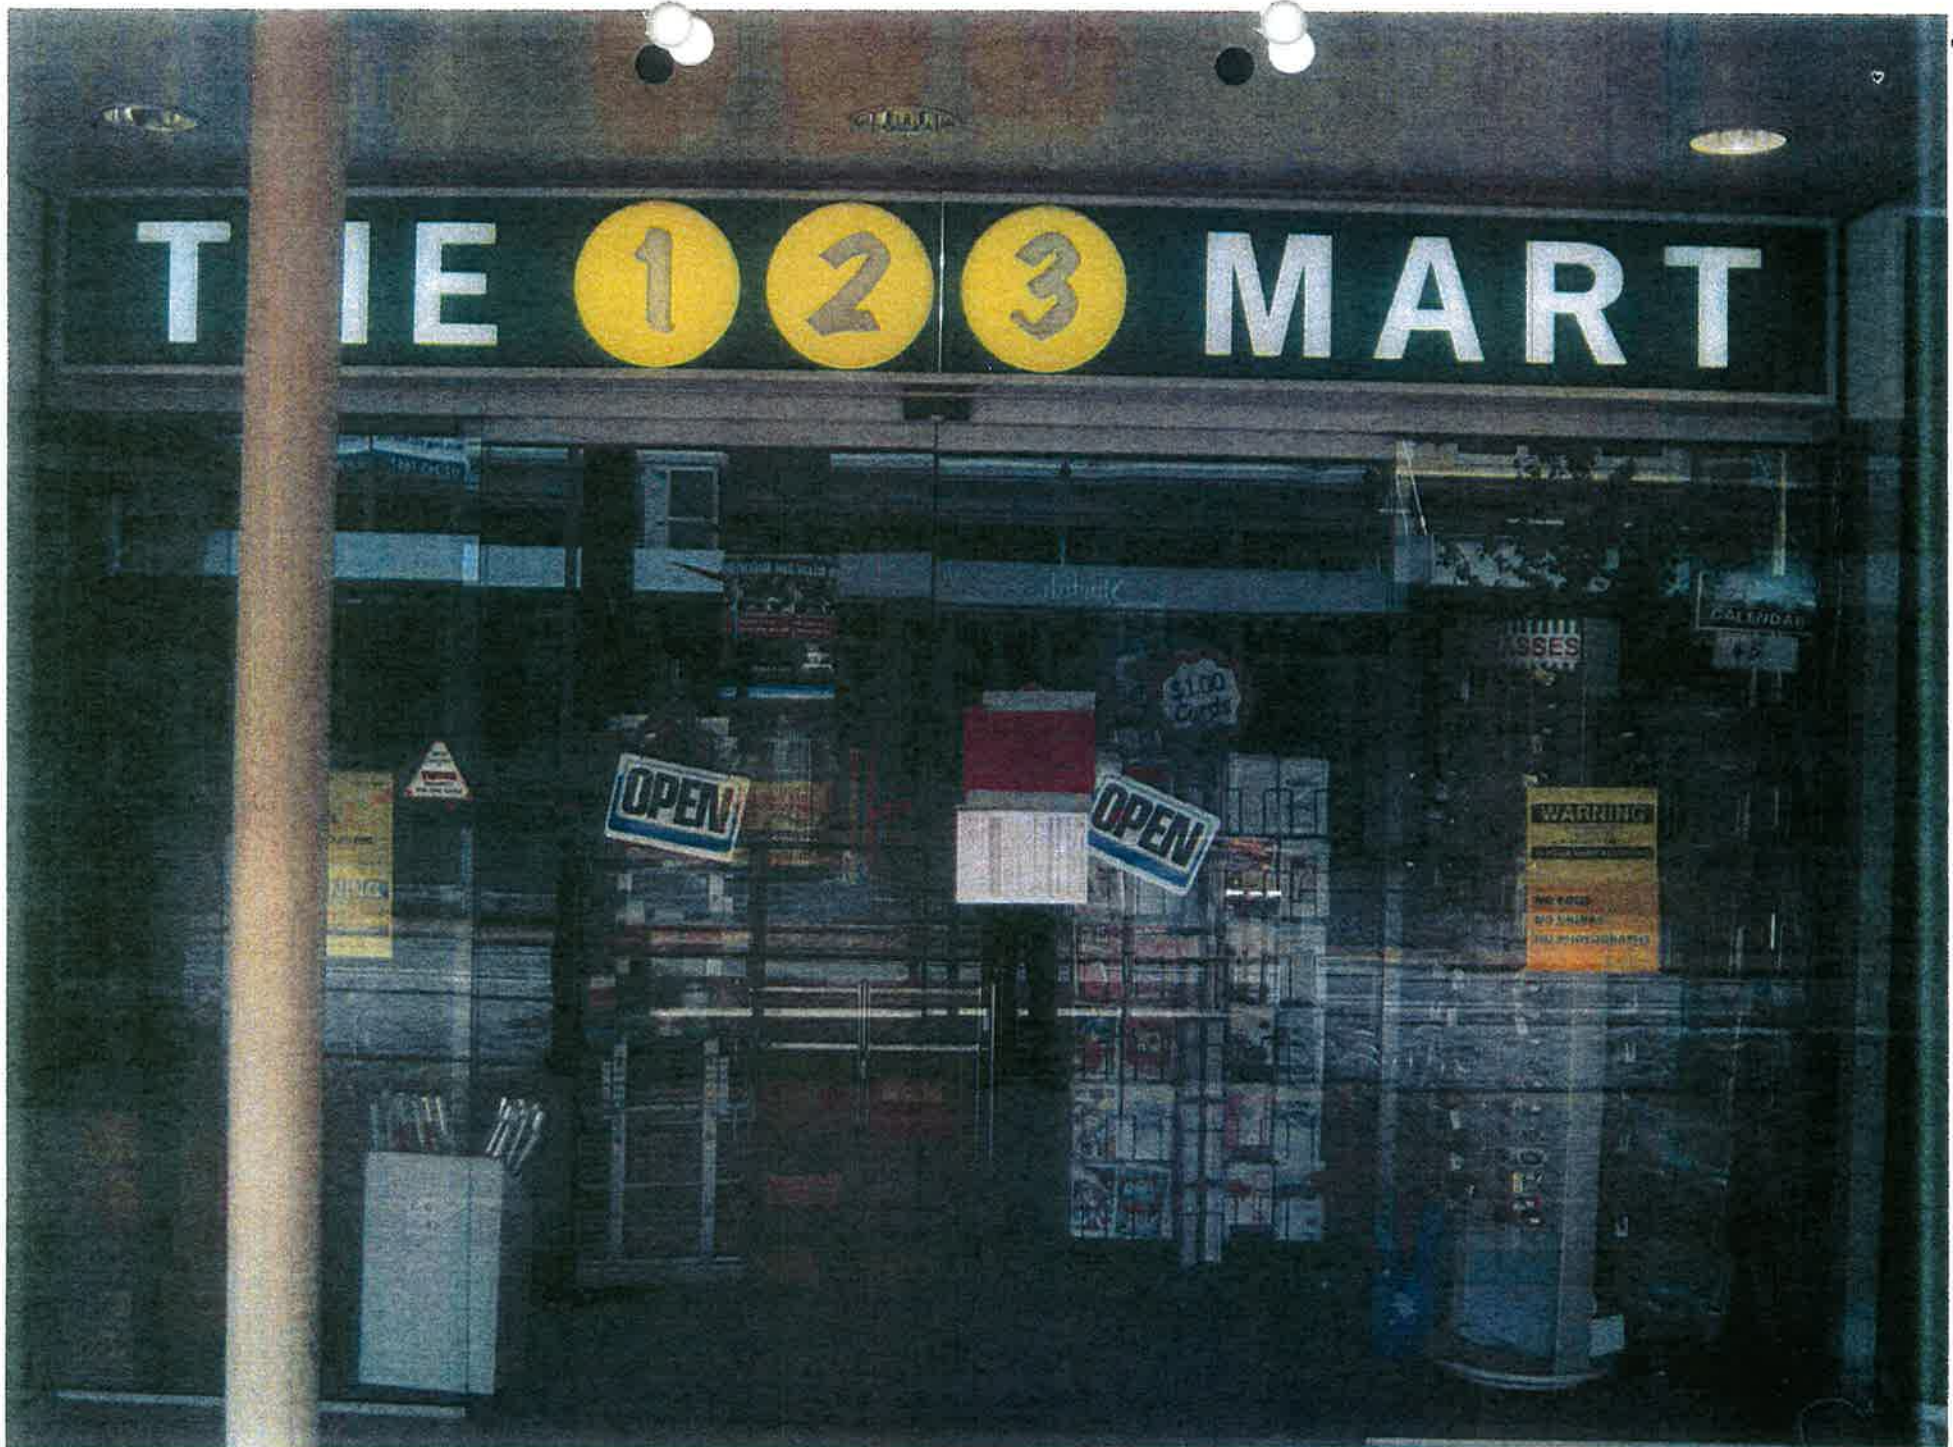
"B"

10. On 26 December 2010, a Level 1 rapid assessment was carried out (**BUI.CAS91.0019.57**). It appears that the “restricted use – yellow” assessment category was initially ticked on the form, but this was later changed to “unsafe – red” and a Building Act notice was issued on 27 December 2010 (**BUI.CAS91.0019.60**). A red placard was fixed to the building on 28 December 2010 as recorded in the photographs attached as **Annexure “B”**.
