# Canterbury Earthquake Royal Commission Hearings - 17 Jan 2012

## Seismic Performance of the Hotel Grand Chancellor : Findings and Recommendations

**Stefano Pampanin**

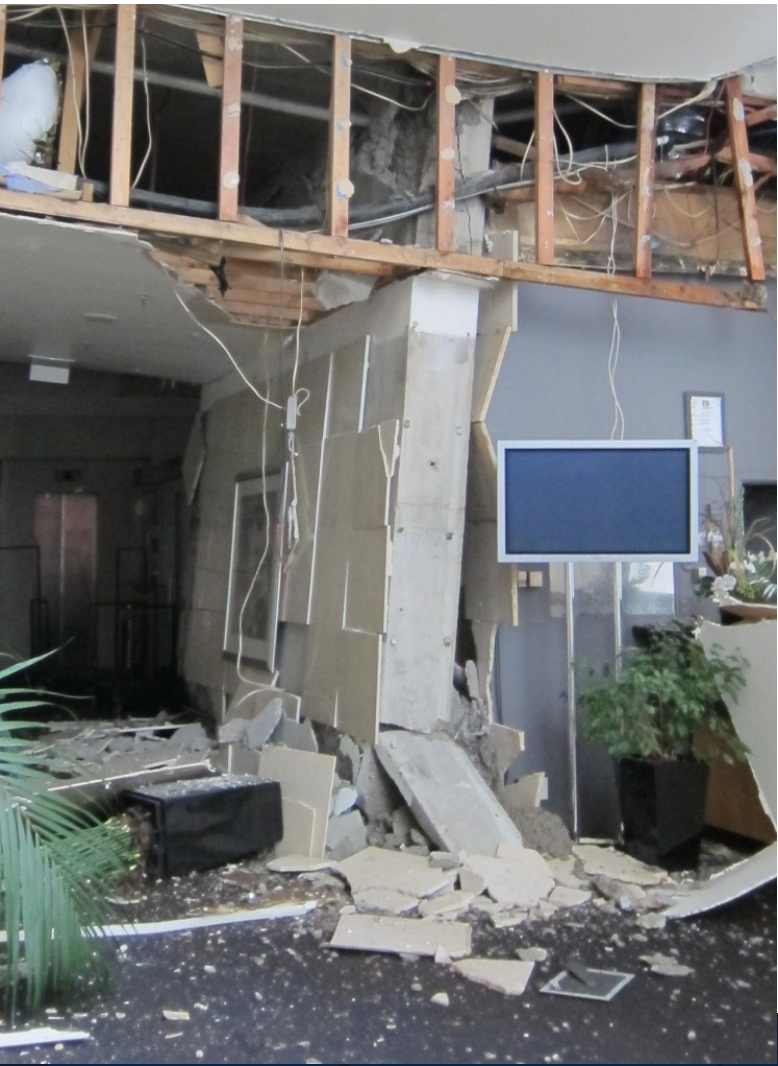
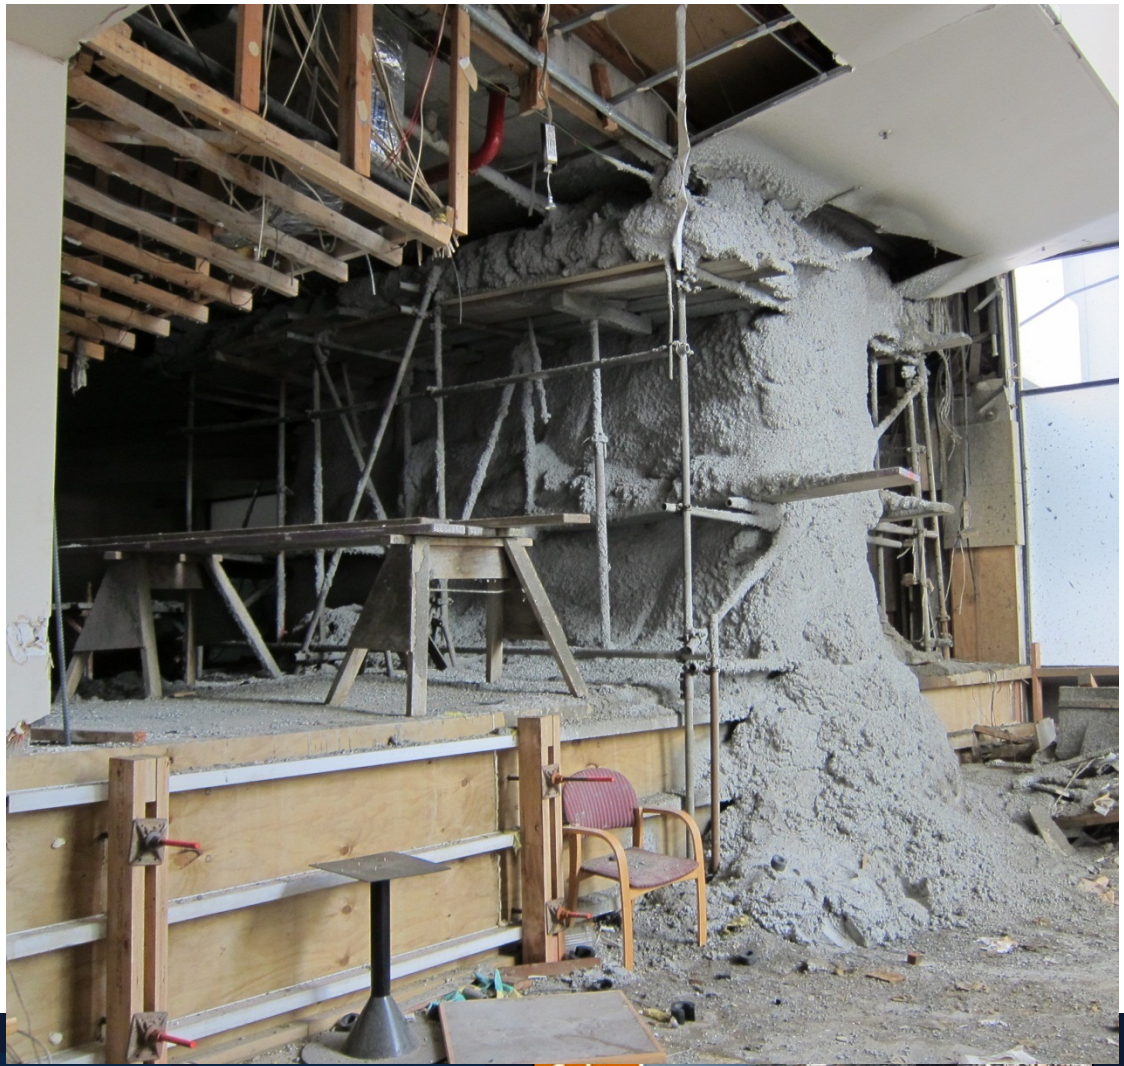
# Structural wall jacketing/shoring

Rapid engineering assessment decisions for repair and temp. stabilisation – led by Dr David

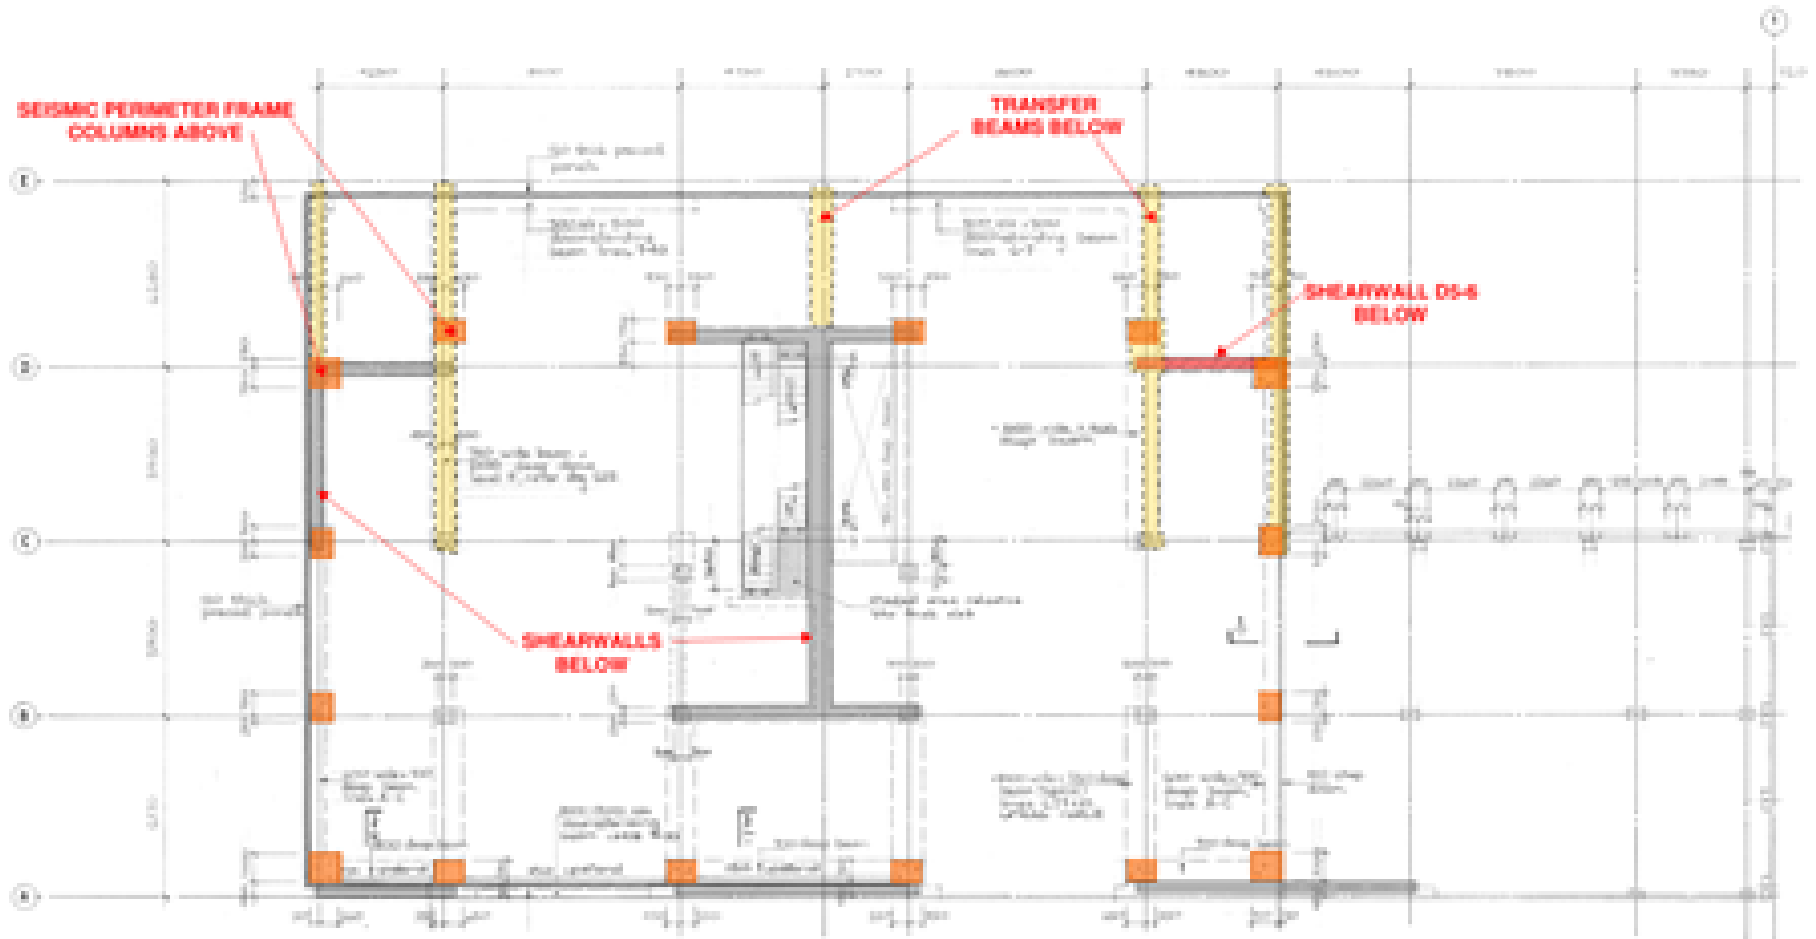
# Global Behaviour

**NOTE: LEVEL 14 IS THE TRANSFER FLOOR WHERE THE SEISMIC RESISTING SYSTEMS CHANGE FROM SHEARWALLS BELOW TO MOMENT RESISTING FRAMES ABOVE.**

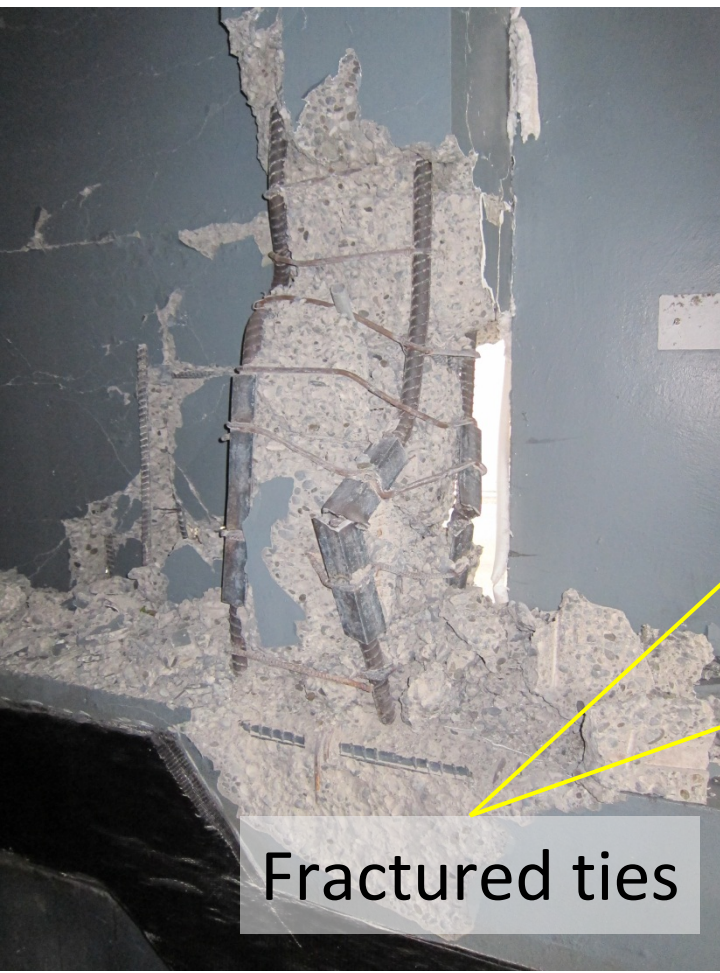
# Boundary confining steel

Fractured ties

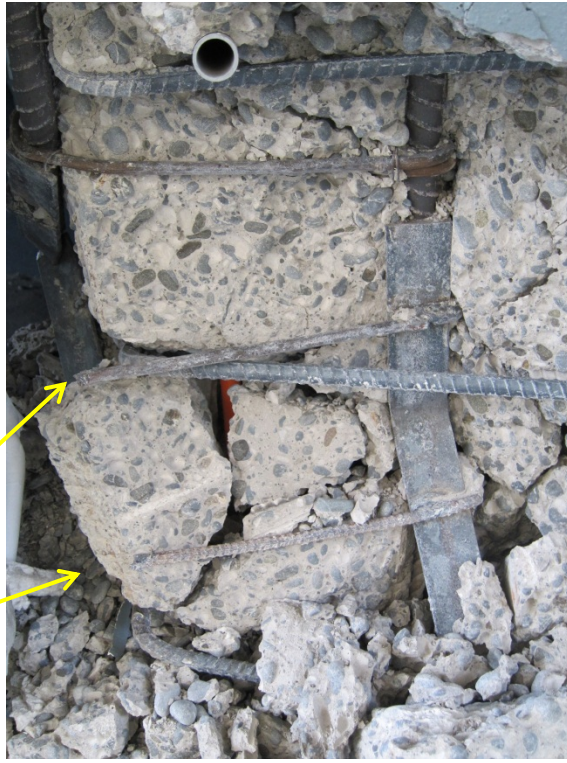
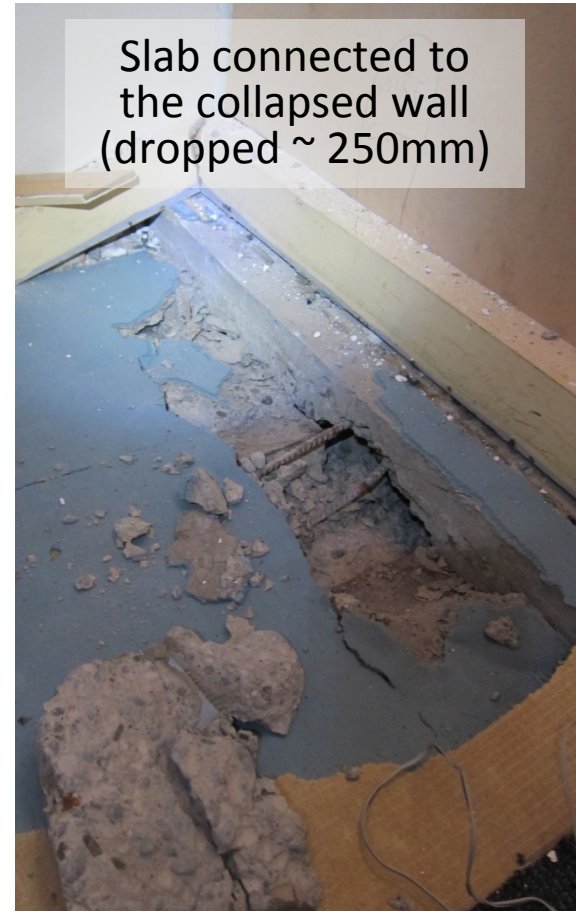
Slab connected to the collapsed wall (dropped ~ 250mm)

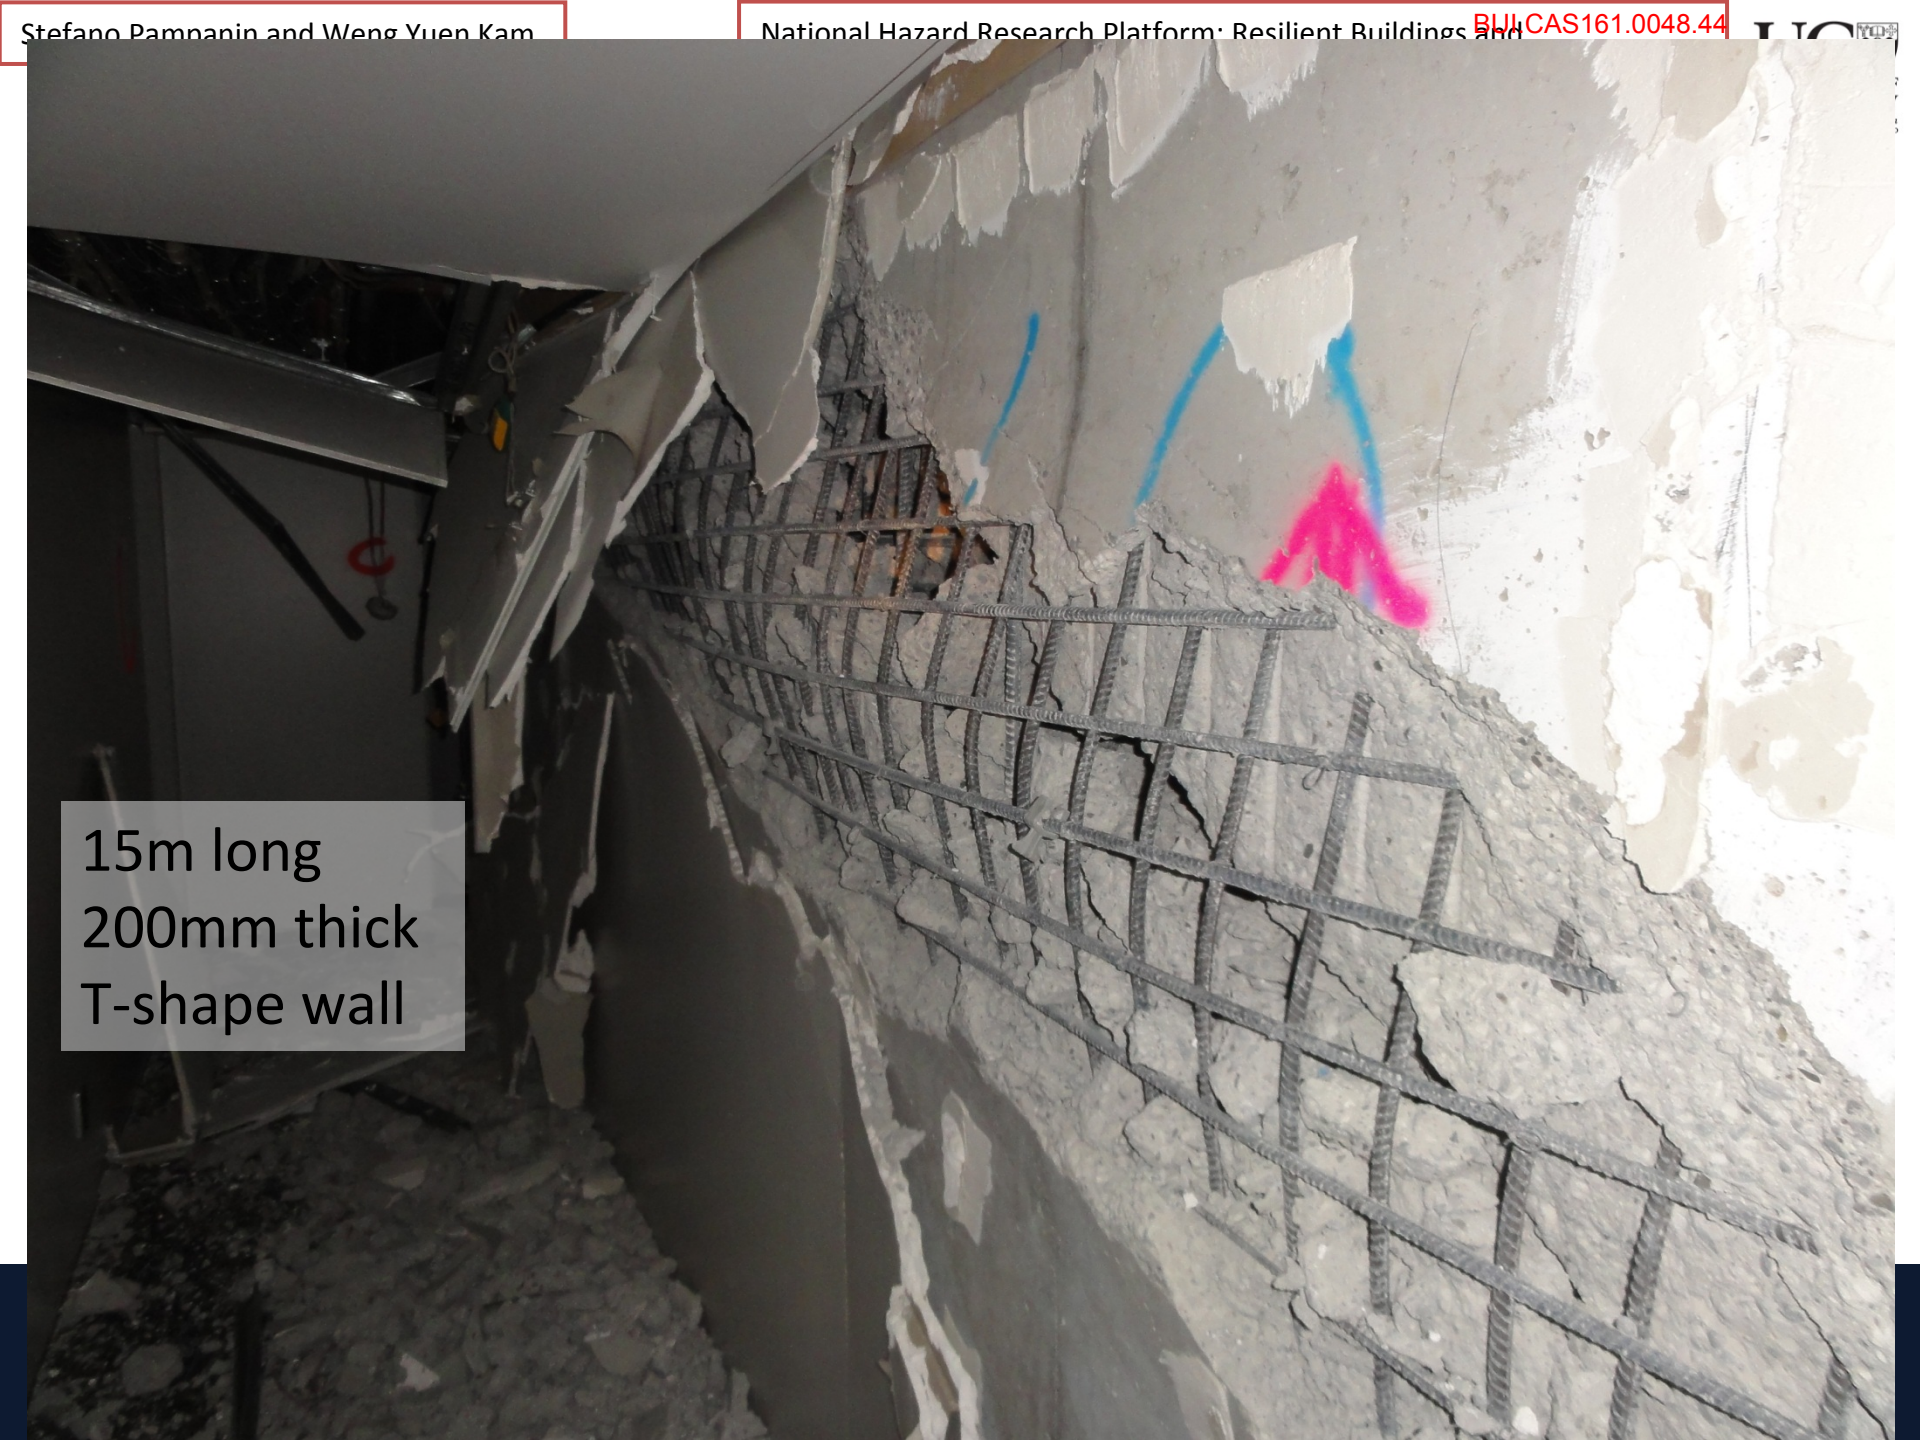
15m long  
200mm thick  
T-shape wall
