Brief of evidence of Martin Laurence Crundwell

3. In October 2010 I was directed by Council staff to inspect the staircase at 91A Cashel Street. I attempted to complete this inspection on 14 October. A Council "Enforcement Team Notices Coversheet" provided to me set out my instructions for the inspection **[WIT.CRU.0001.7]**.

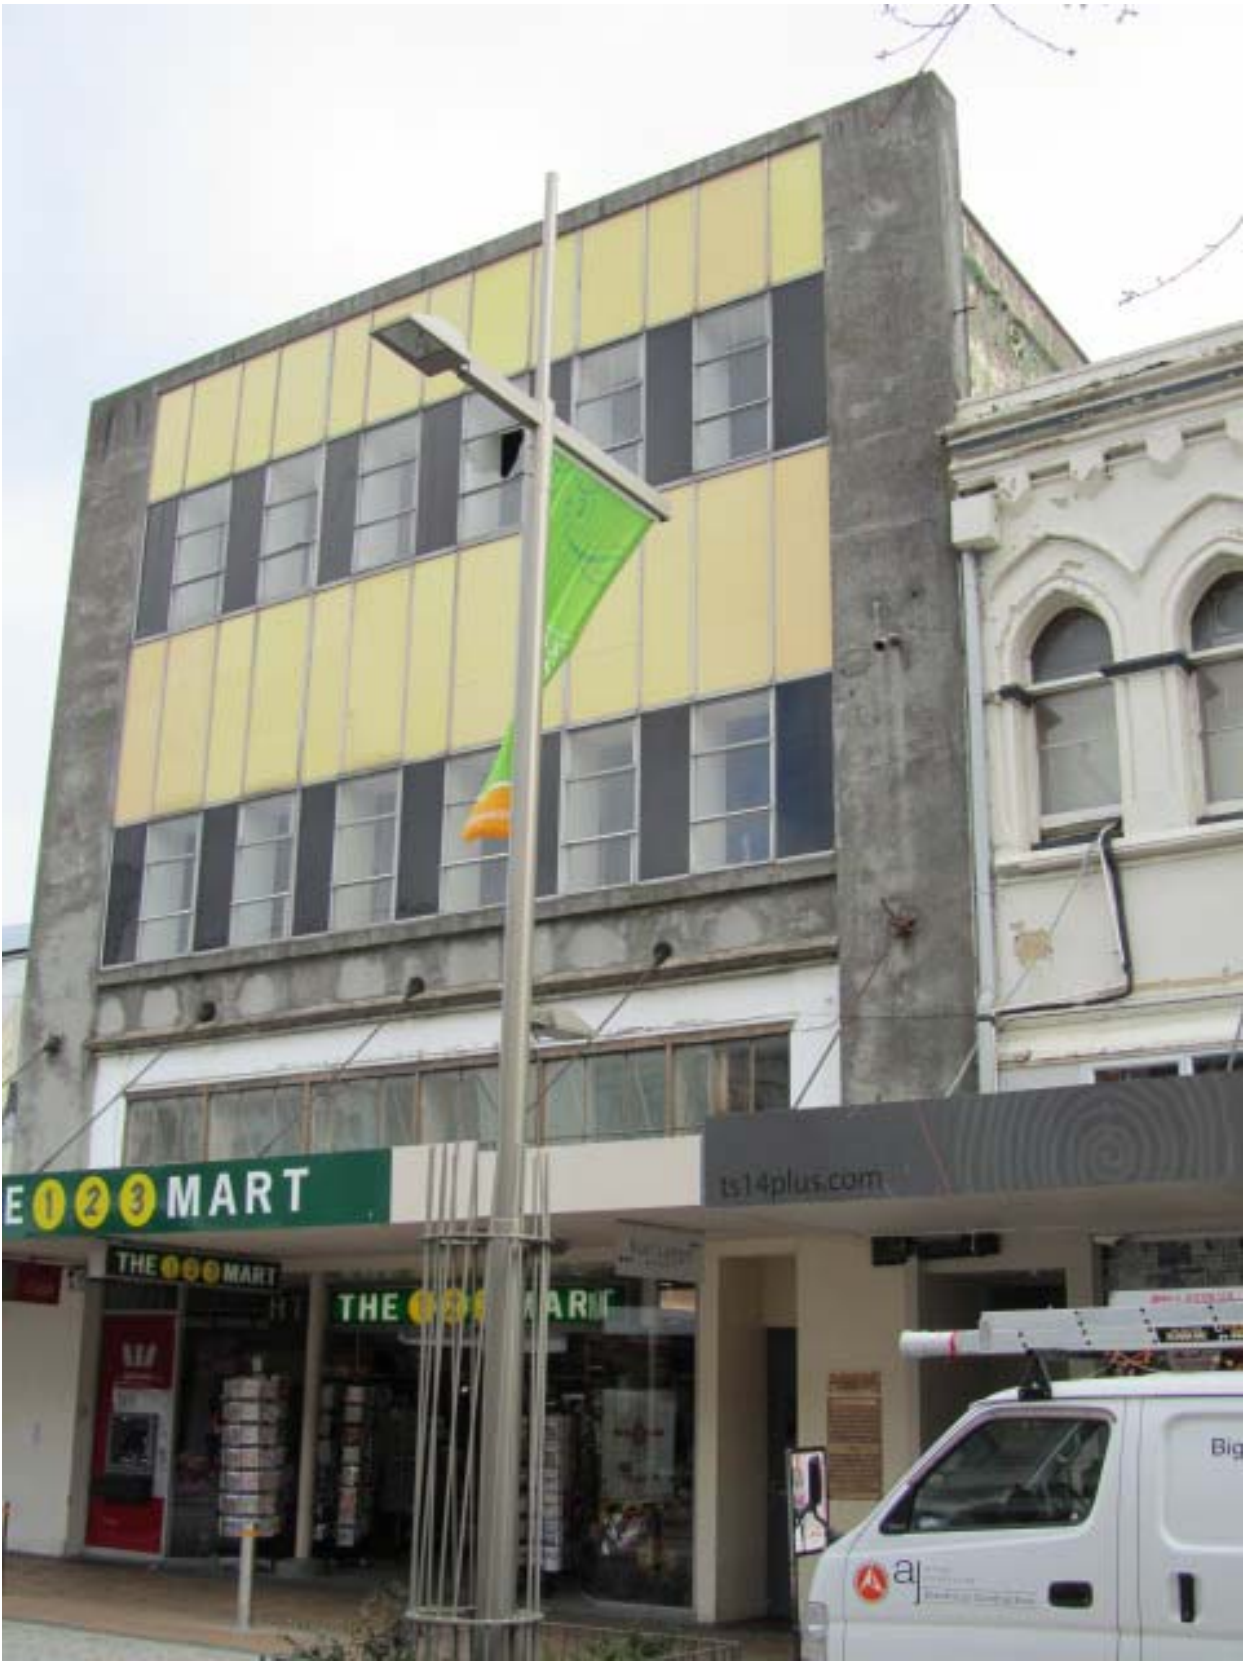
8. I took a series of photographs on site [WIT.CRU.0001.8 - 20]. These indicate that I carried out a visual inspection of the exterior.
9. The photo sequence begins with the Cashel Street frontage [WIT.CRU.0001.9] where the building presented as concrete. I observed an inset glazing facade that masked the structural form of the building. The apparent span of beams behind the facade at second floor level and capping the building at roof level implied the existence of units such as concrete beams perhaps similar to the one supporting the shop front canopy.

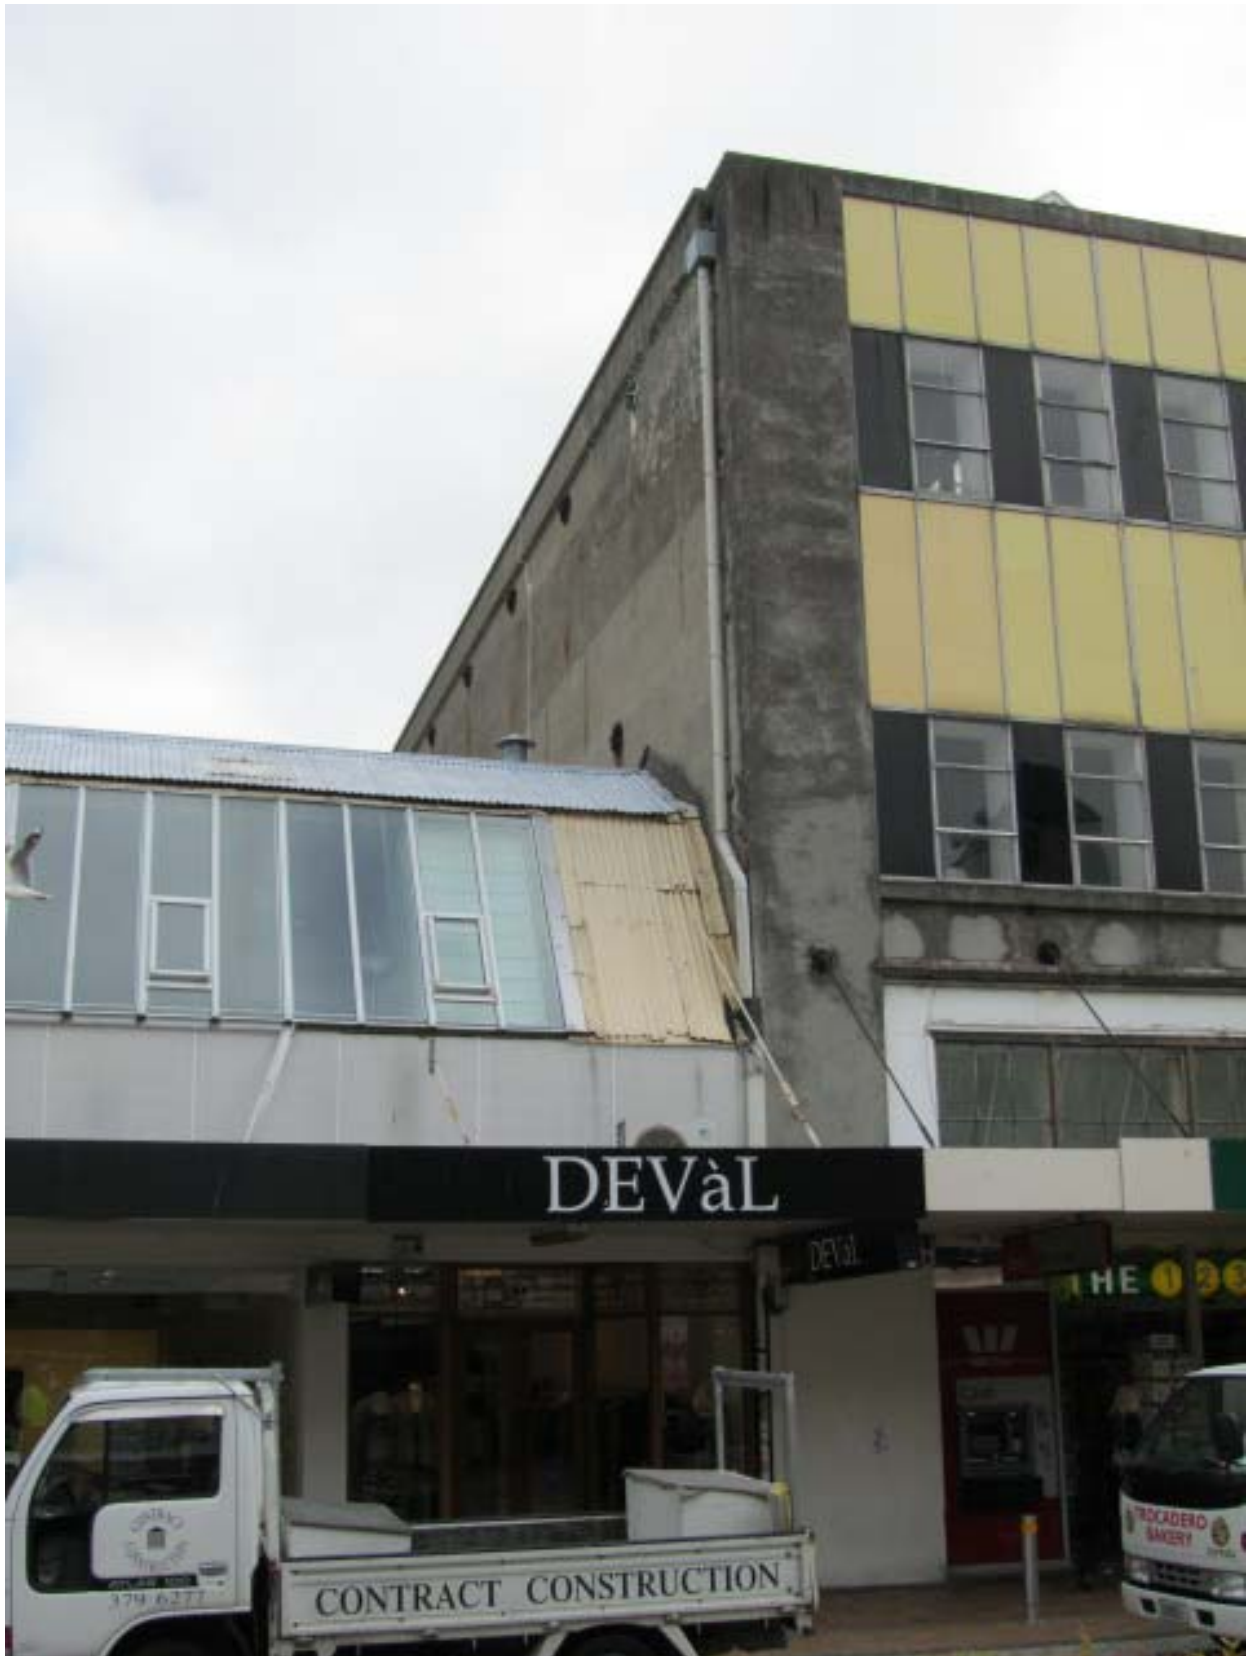
10. The first two site photos [WIT.CRU.0001.9 and .10] covered the eastern and western sides of the building, where I discovered an old vertical crack in the western side wall. This did not present as a crack resulting from horizontal earthquake displacement.

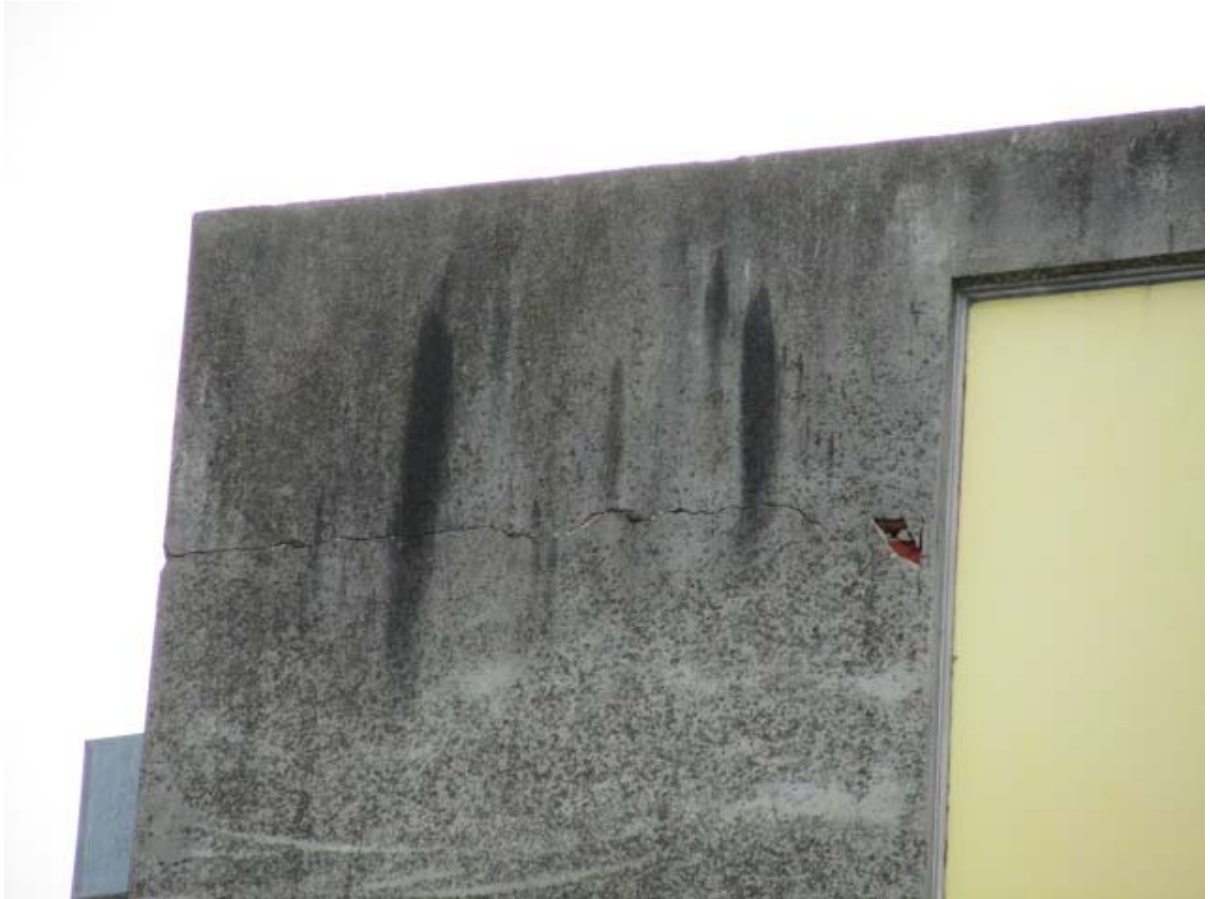
11. I believe that I then returned to studying the front of the building. I found an exposure of brickwork on the front face of the building [WIT.CRU.0001.11] and so determined that the building was at least partially unreinforced masonry with a plaster finish.

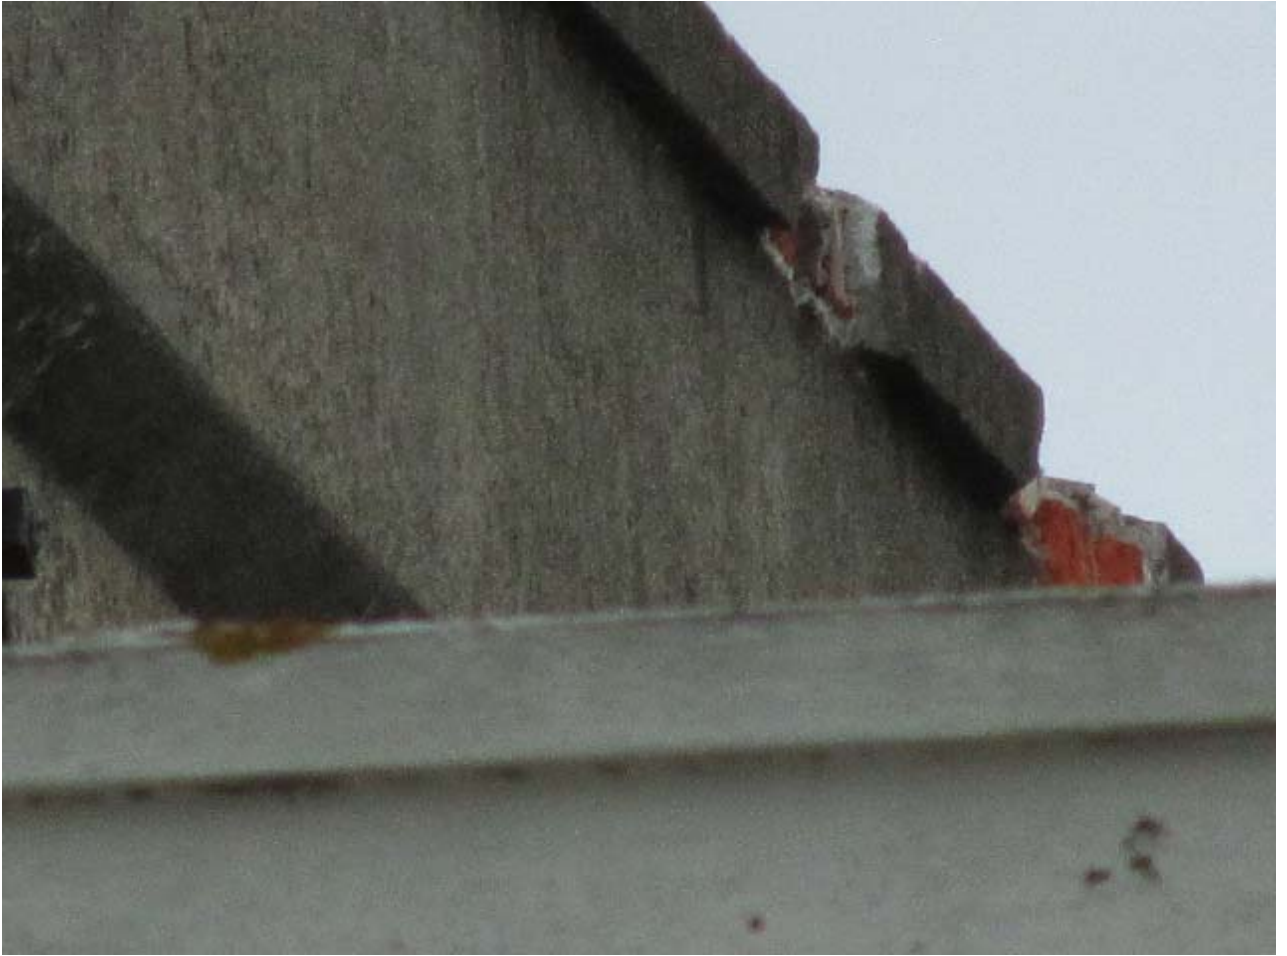
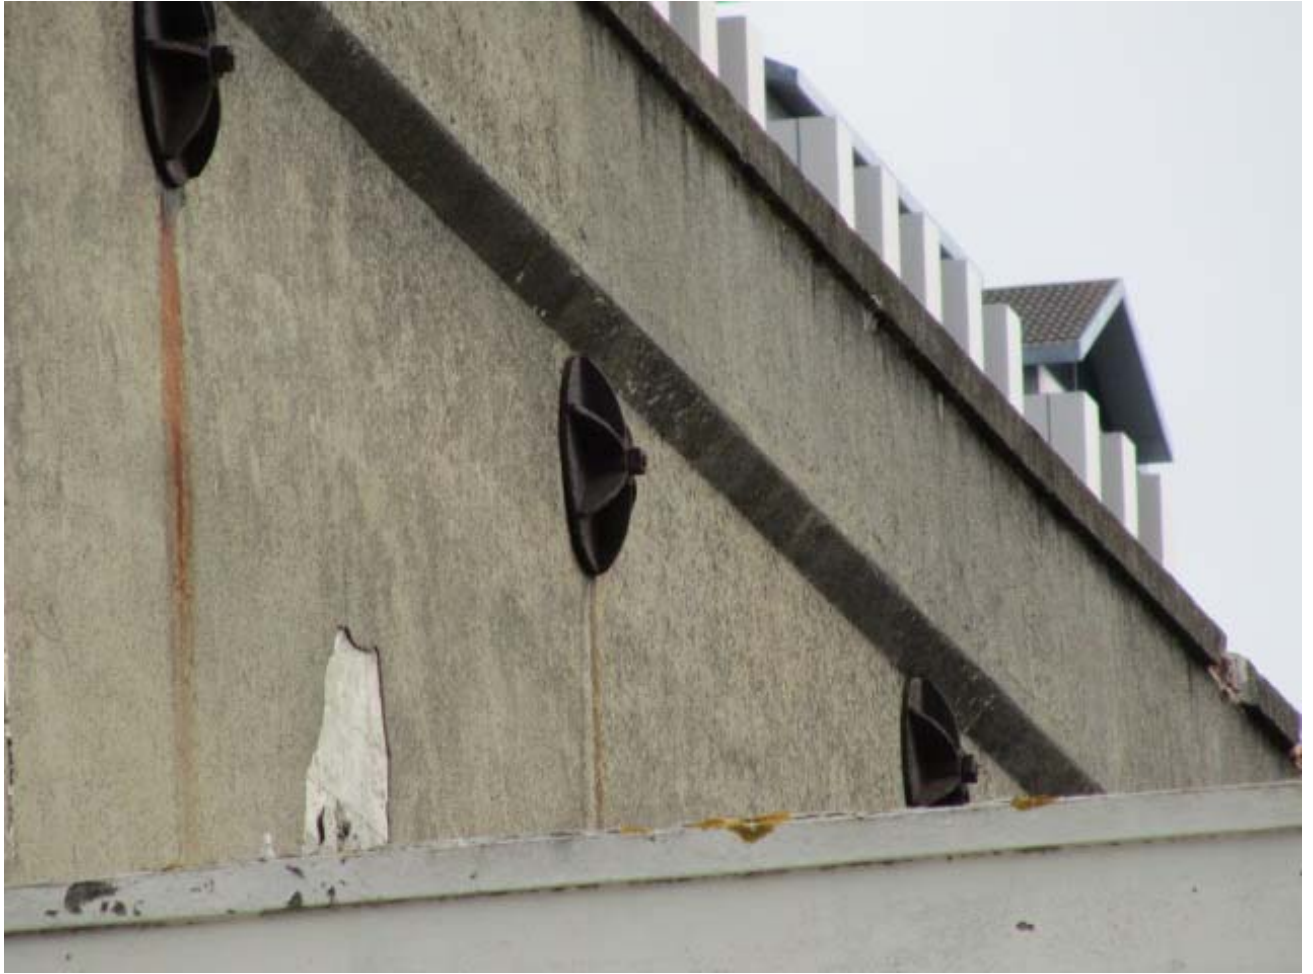
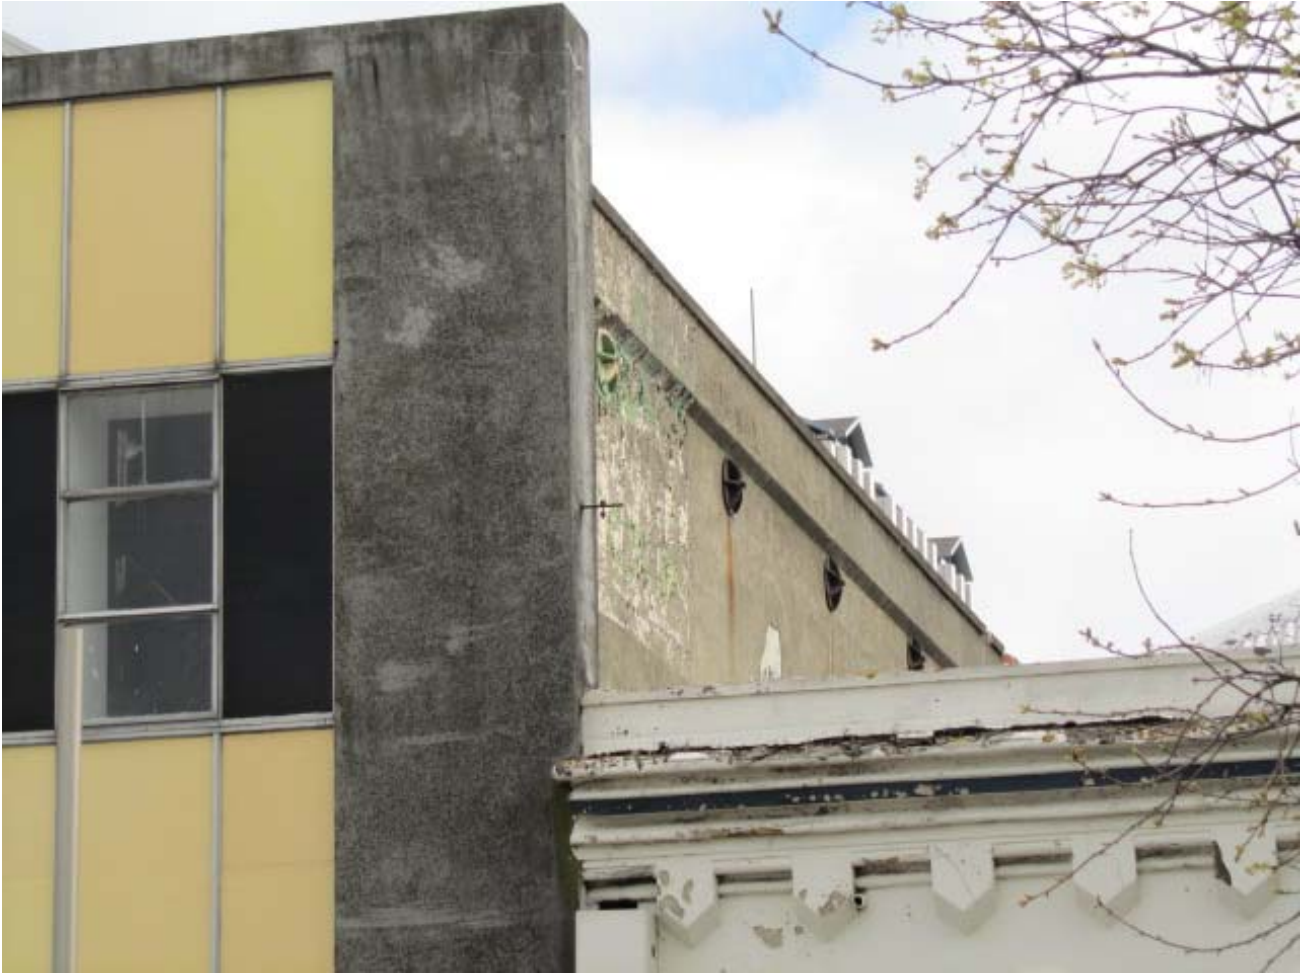
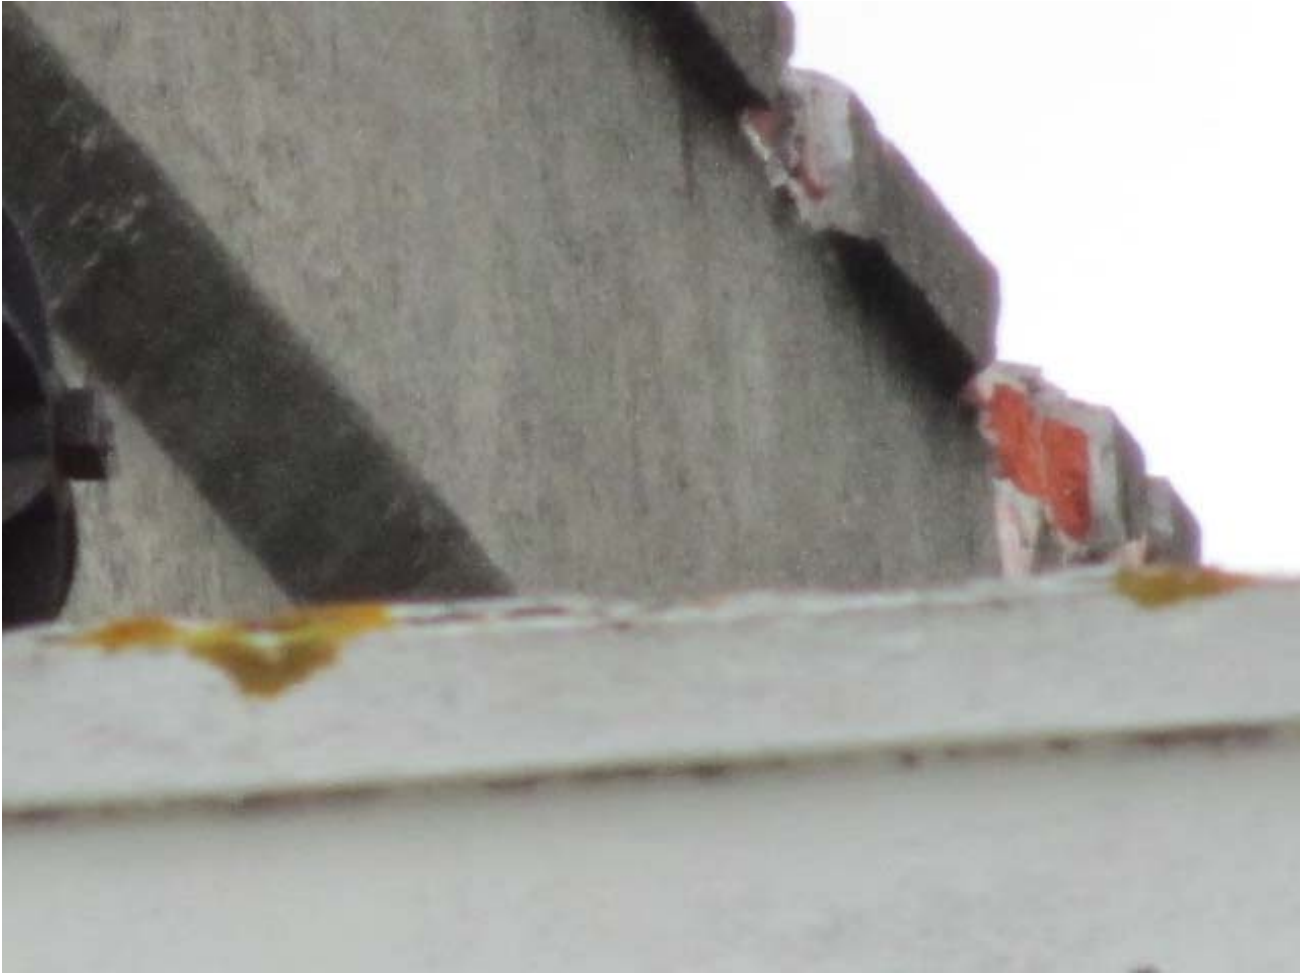
15. From the building on the opposite side of the street we were able to gain a better view of the eastern wall [WIT.CRU.0001.12 - 15]. Here I discovered exposed brickwork on the edge of a parapet toward the rear of the building. But even with the camera on full zoom I could still see no crack in the side wall.

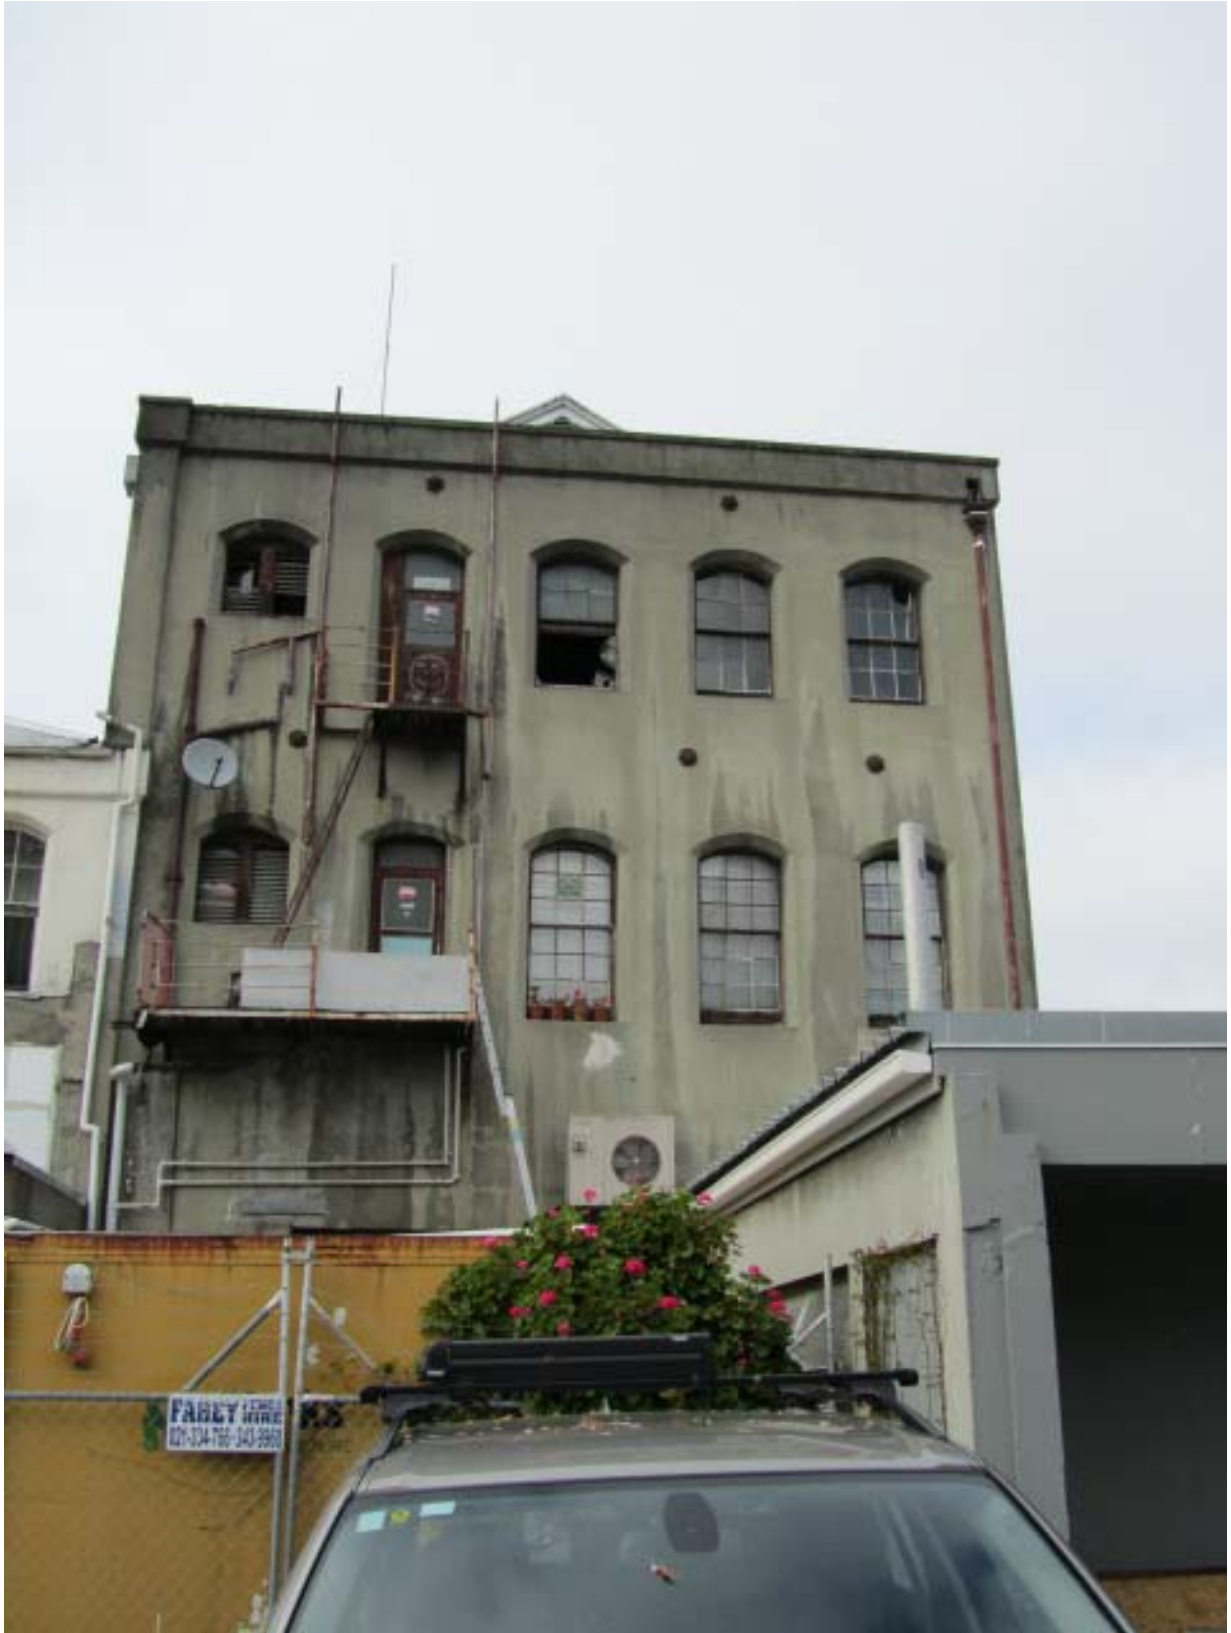
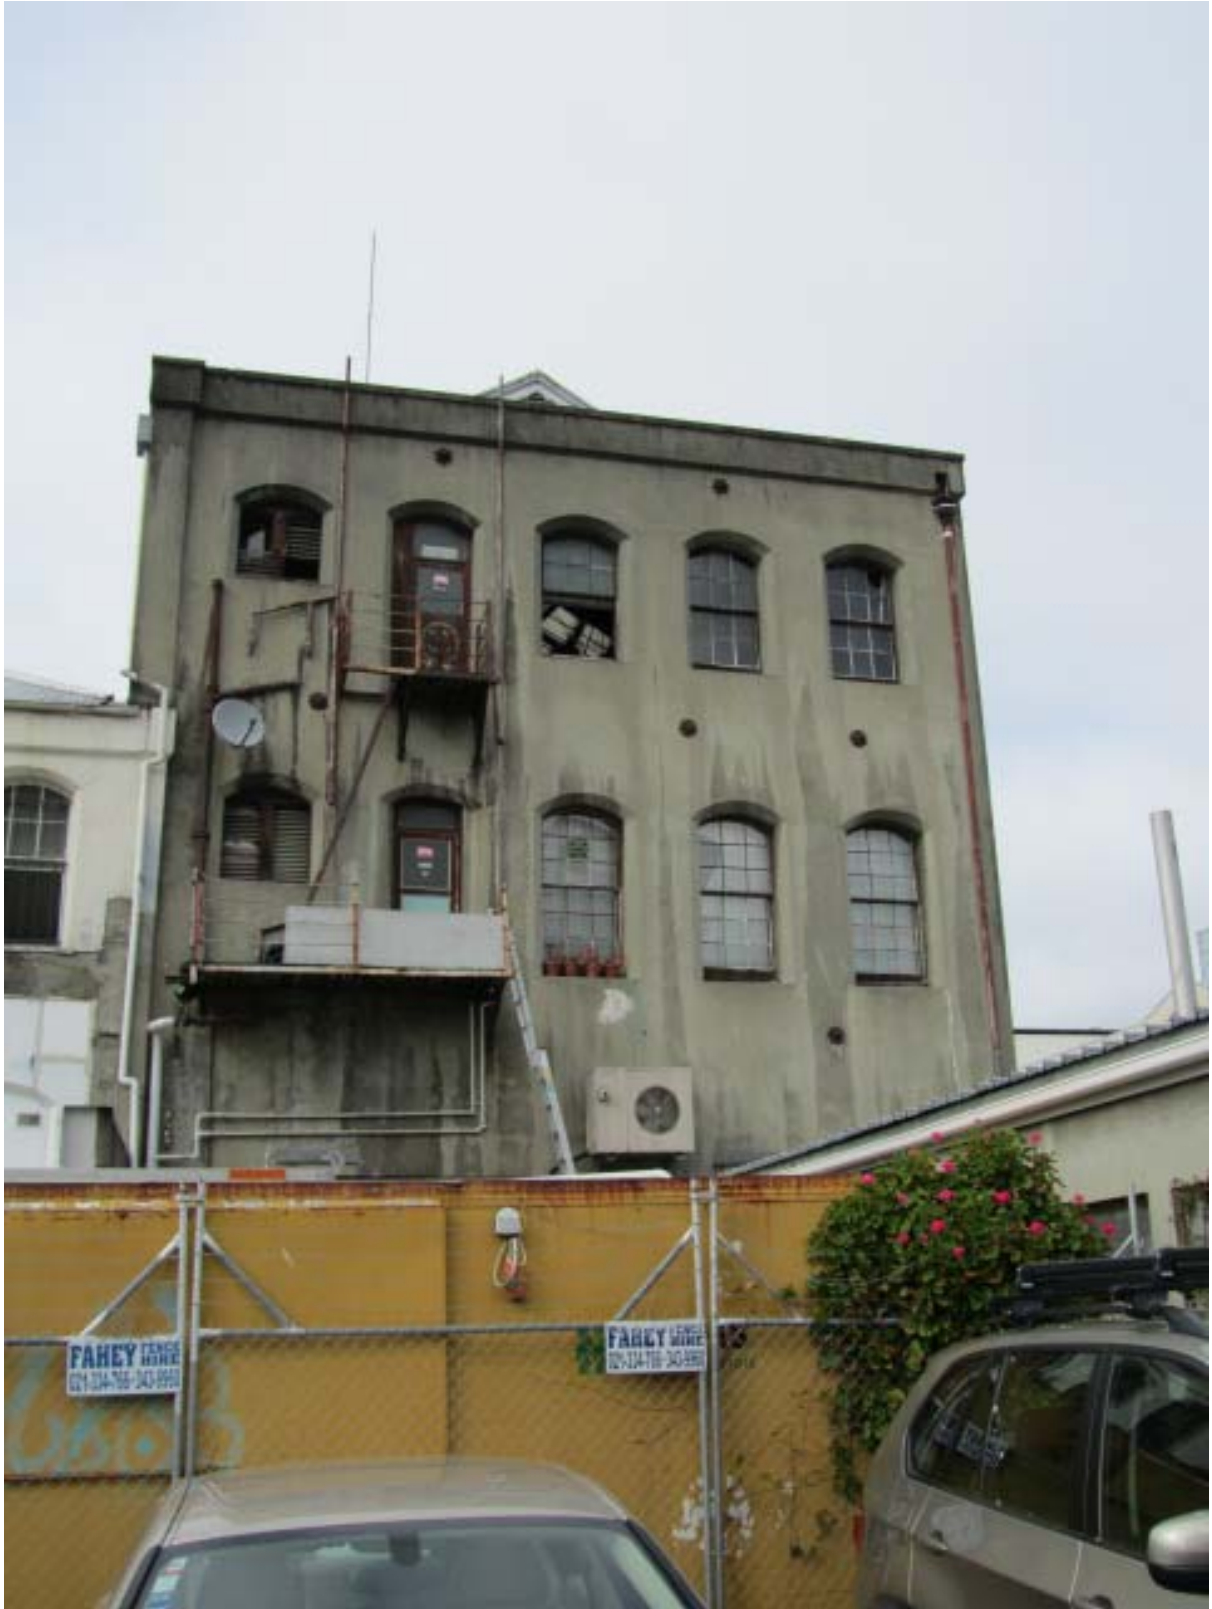
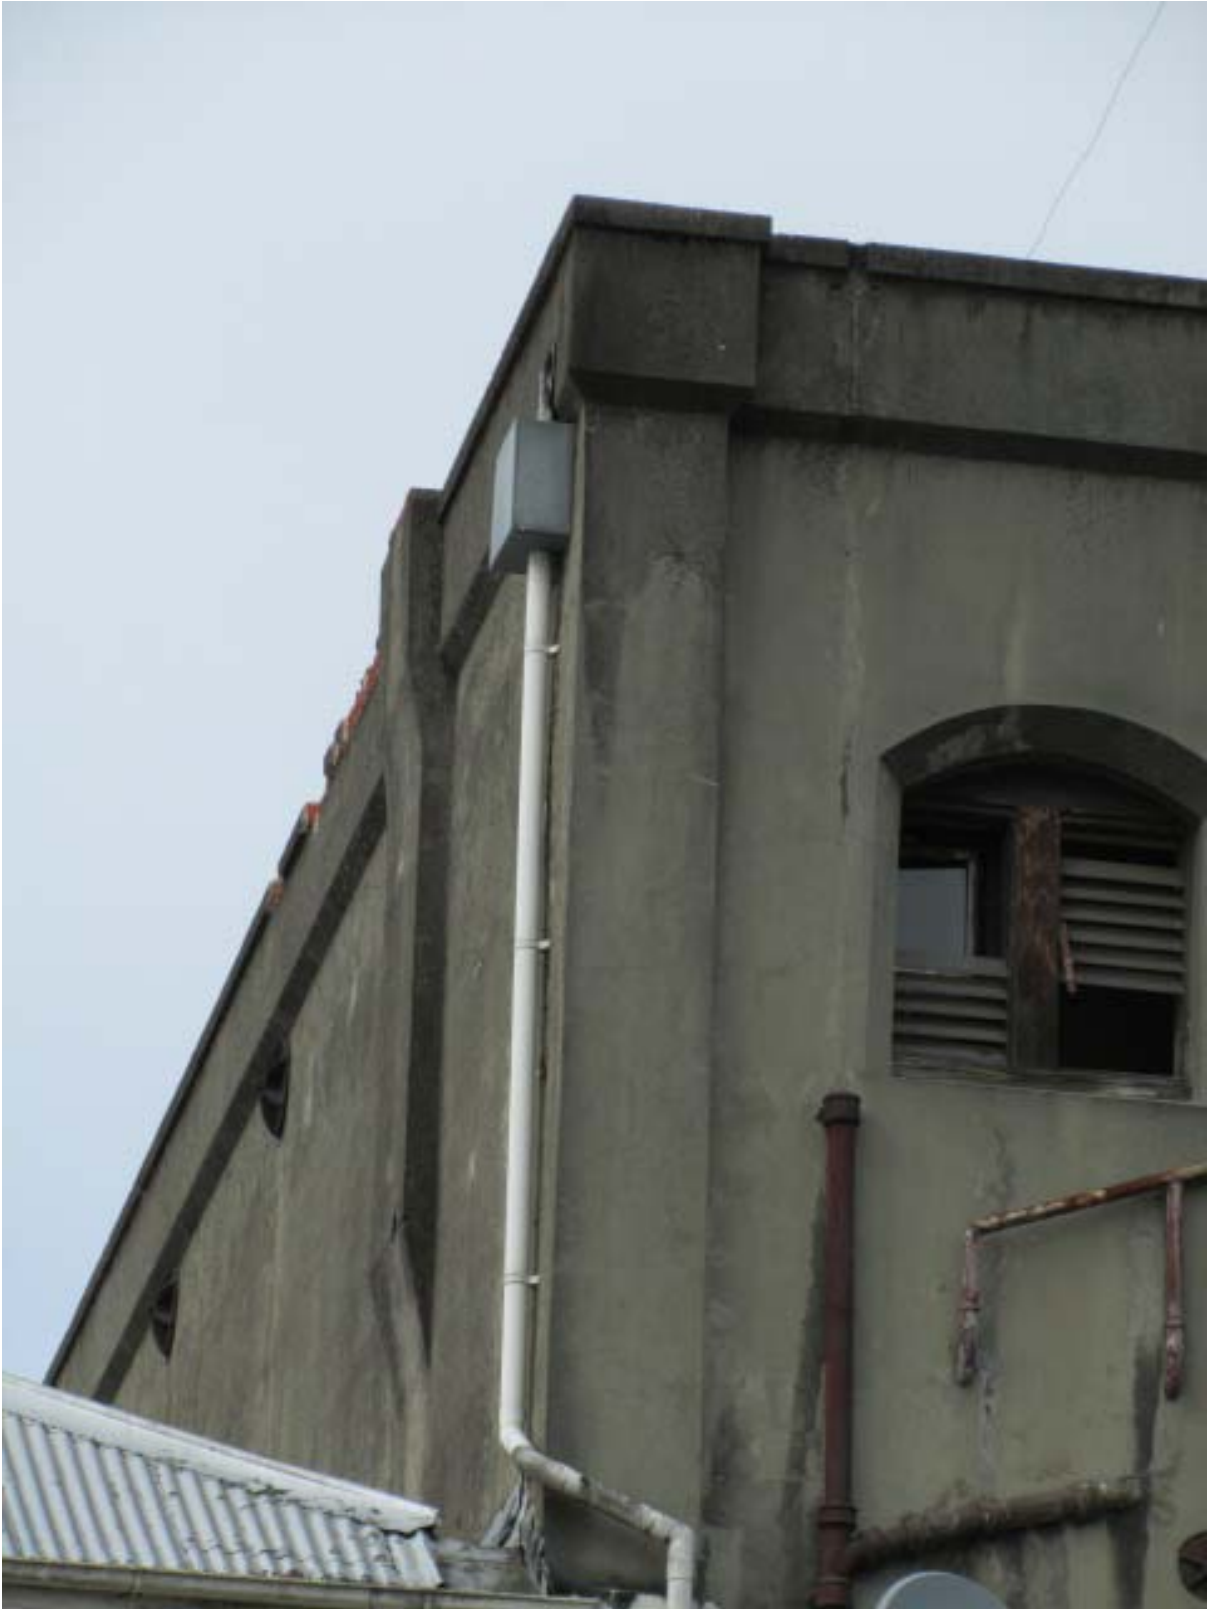
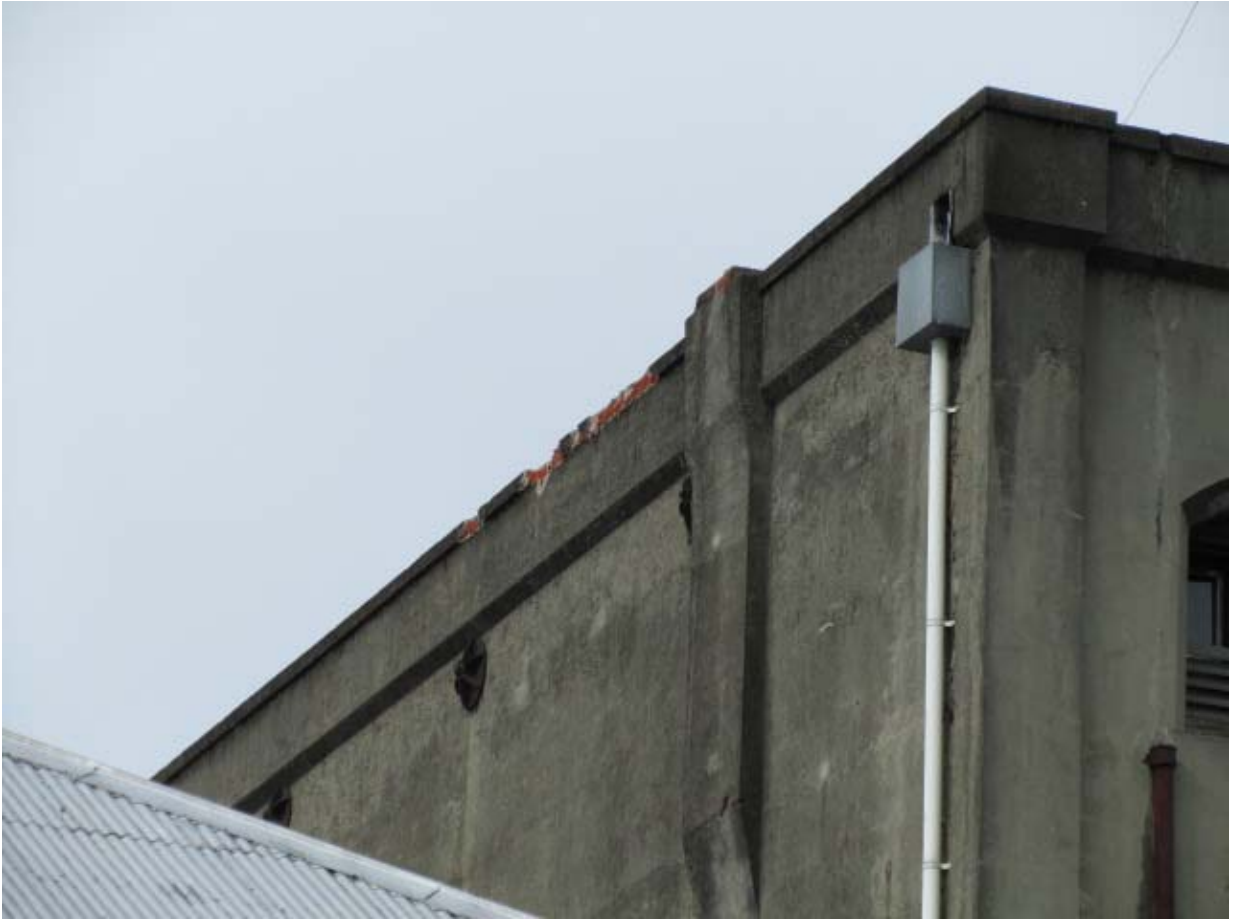
16. In order to check the same wall from the rear of the building, the 123 Mart employee showed us through the store to the rear of the building, and from the carpark I observed the north and eastern walls [WIT.CRU.0001.16 - 20]. The exposed brickwork appeared to be adjacent to the base of a removed chimney, which I noted in my report, saying “parapet crushed by falling chimney?”.
