CTV BUILDING

CTV BUILDING SITE EXAMINATION
AND MATERIALS TESTS
FOR DEPARTMENT OF BUILDING AND HOUSING
16TH JANUARY 2012

REPORT PREPARED BY:
DR CLARK HYLAND
PhD, BE(Civil), BCom, CWE-NZIW, CPEng
Hyland Fatigue + Earthquake Engineering
PO Box 97282, Manukau, AUCKLAND 2241
Phone: (09) 262 0203
Mobile: 021 348 352
Email: clark@fatigueandfracture.com
www.fatigueandfracture.com

Report Issue Date: 16 January 2012

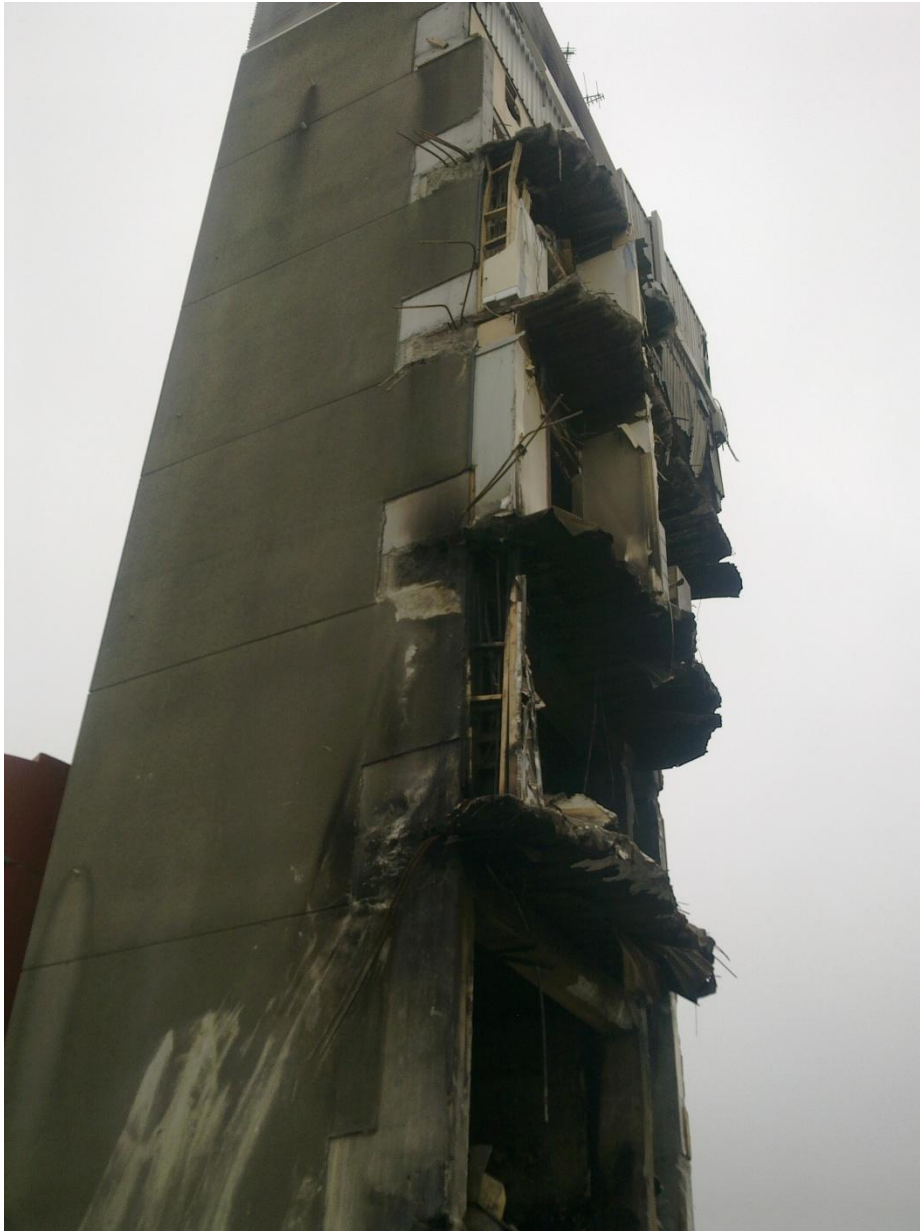
Bottom bars of pre-cast shell beam had been developed into the core wall on this level and beam-column joint type diagonal cracking was seen on the end of the wall consistent with cyclic demands having occurred during the Aftershock.

Figure 2 - West face of North Core (Wall Line C) showing the locations where the Line 4 beams had connected into the wall at Levels 3 to 6 without the bottom bars being developed into the wall as specified.

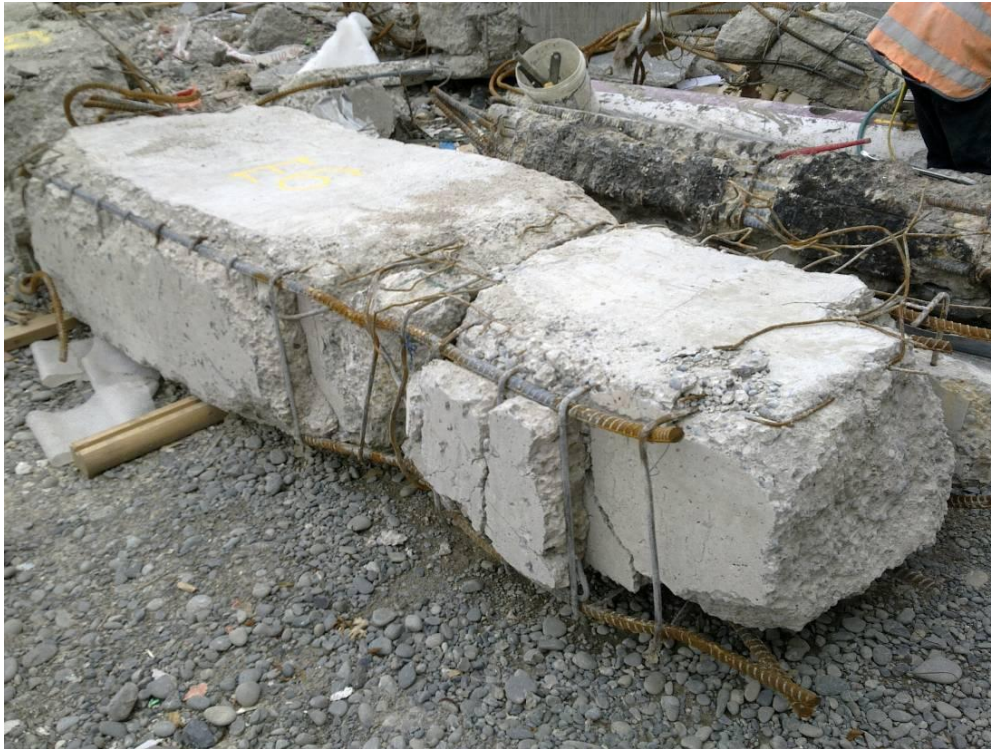
i. Item E6

Figure 6 - Edge shell beam Item E6 showing unreinforced concrete infill and smooth interface between shell beam and in-fill. The DENG Specification Precast Concrete cl 3.12 required roughened interface surfaces (Figure 77).

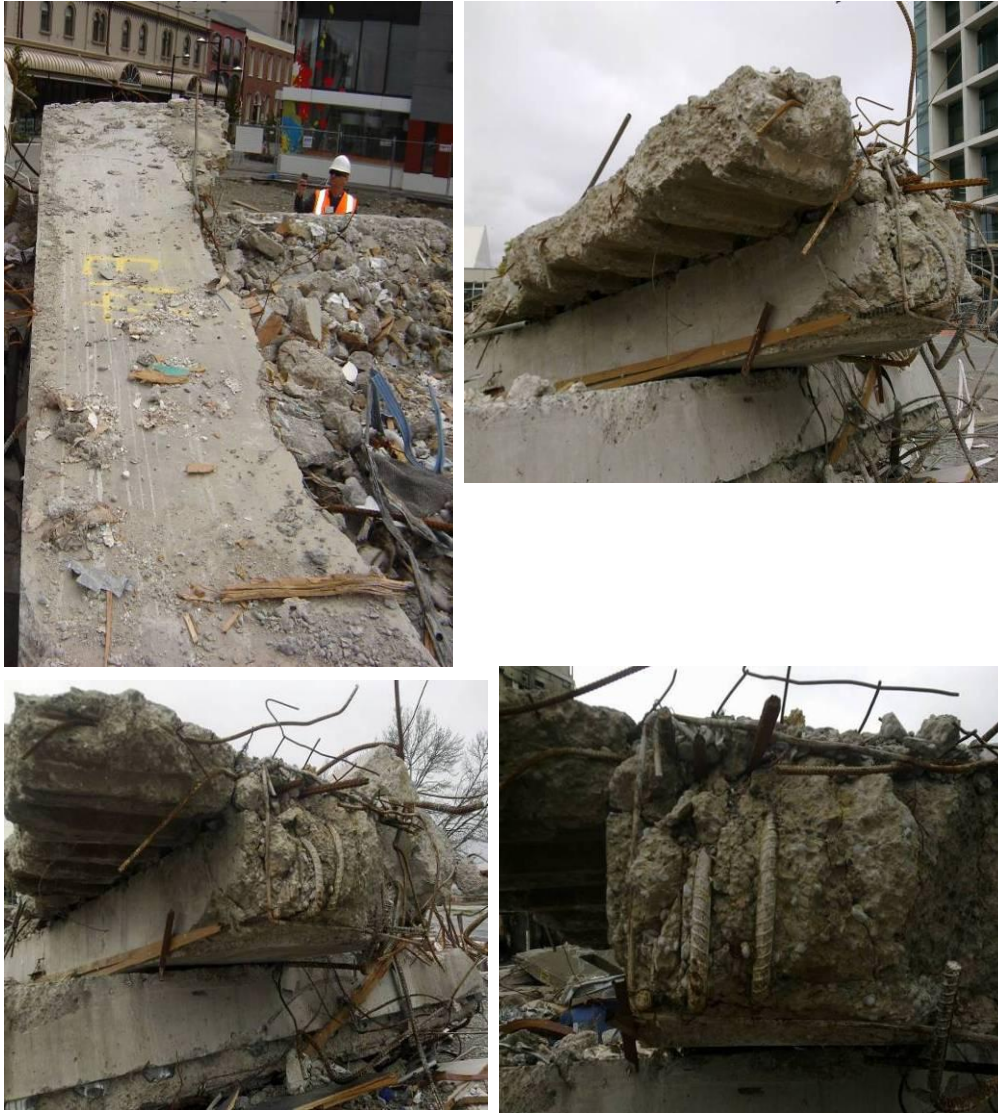
ii. Grid 4 / B-C; Item E14

Figure 7 - Pre-cast shell beam (Item E14) from northern face Grid 4, west side of lift core (DENG B23 Dwg S18 (Figure 67)). (clockwise from top left) (a) Top face with slab fracture along edge of shell beam, extending out further at far end adjacent to lift core attachment; (b) to (d) Fractured slab outstand remnant at east end from which slab concrete cores were extracted. The bottom H24 bars from shell beam have been turned back into the concrete infill rather than embedded in shear wall as specified (DENG Detail 5 Dwg S19). Refer also bar imprint on wall at the connection seen in Figure 29 at Level 4 and Figure 30 at Level 3.

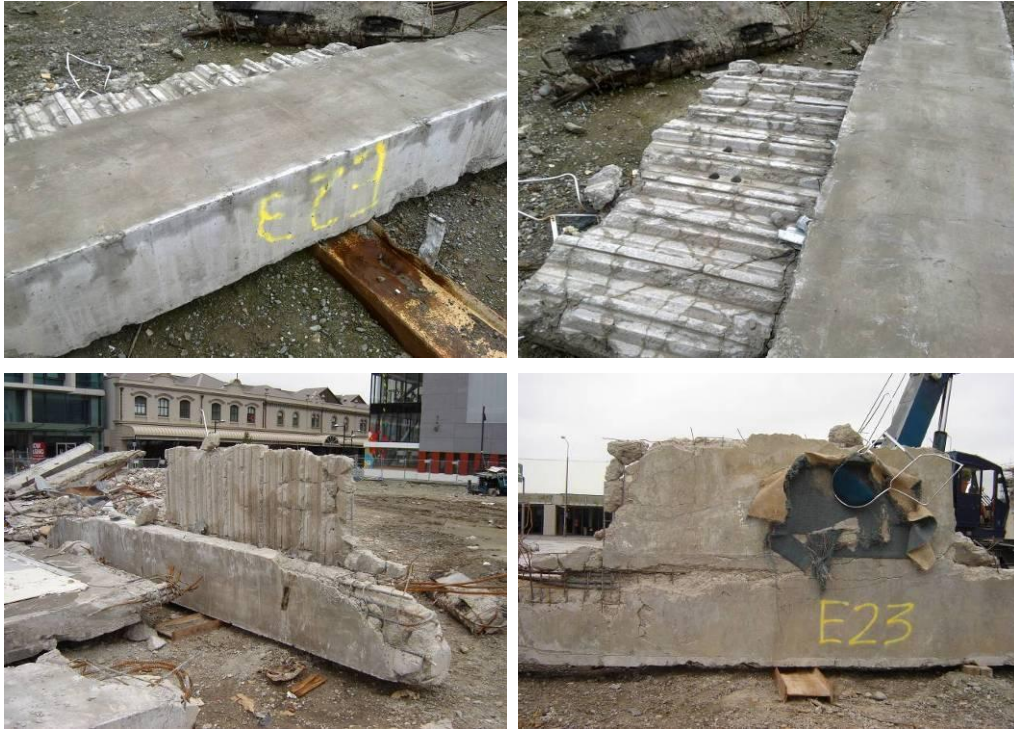
iii. Item E23

Figure 8 - Edge Shell Beam (Item E23) from Line 1 or 5. (Clockwise from top left) (a) Underside and outer face; (b) Underside showing 1200 mm slab outstand with metal decking pulled away and diagonal cracking indicating shear in diaphragm; Holes are where concrete cores were taken for testing; (c) Carpet remnant on top of slab; (d) Damaged shell beam.

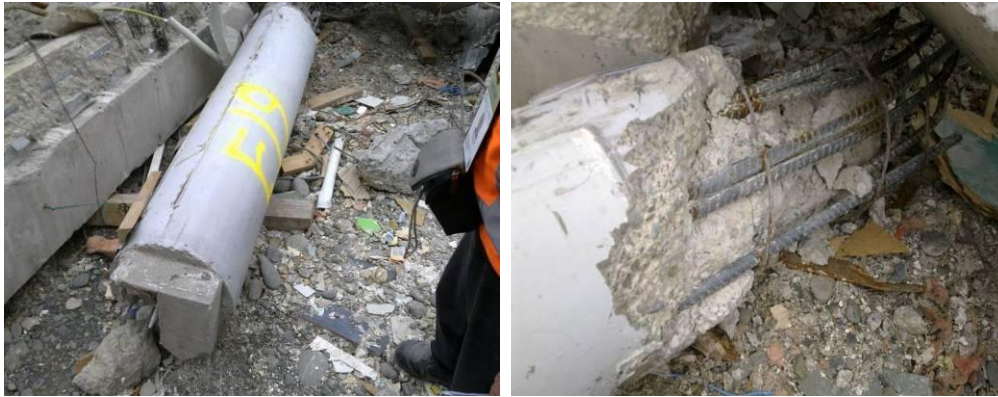
i. Item E19

Figure 9 - 400 mm diameter column Item E19. (Left to right) a) Level 6 to Roof, likely location Grid F (Figure 65) based on roof steelwork hold down attachment detail; b) Flexural fracture at base in lap zone of vertical reinforcing steel. R6 spirals at 250 centres can be seen (Figure 69).

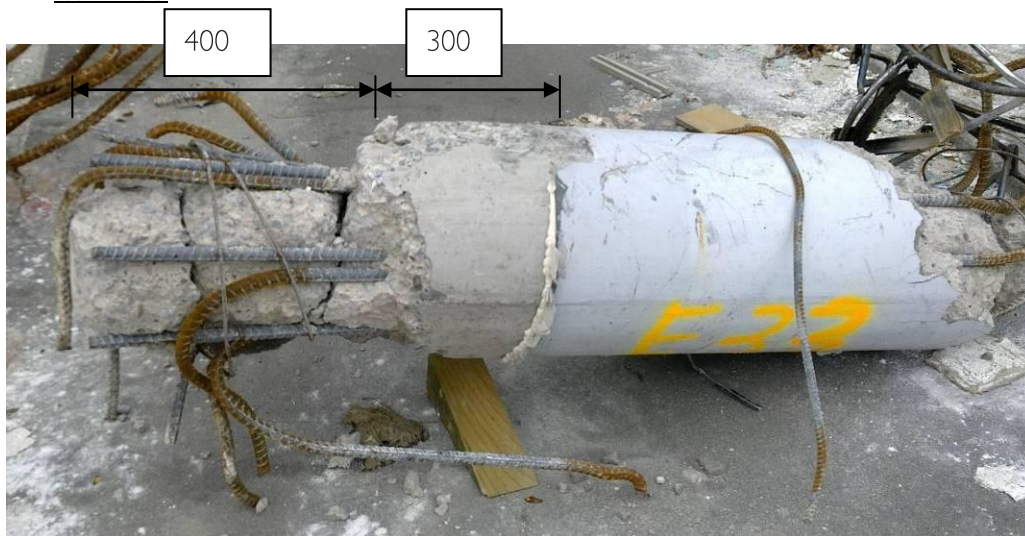
The exterior 400 mm diameter column (Item E33) had flexural failure at the floor level lap joint of the vertical reinforcing steel and compression-flexural fracture at the upper end of the column (Figure 10)

Figure 10 - 400 Diameter Exterior Column Item E33. (DENG C5 or C11, Dwg S15 (Figure 69)). Left end is bottom of column at floor level with concrete spalling over lapped vertical reinforcing. Horizontal cracking could be seen in the core confined by R6 spiral which had fractured. The unpainted portion measured at 700 mm long indicates it had been located between spandrel panels (Figure 5, Figure 72 and Figure 73). The fracture at the right end of the picture commenced approximately 1350 mm from the base of the column.

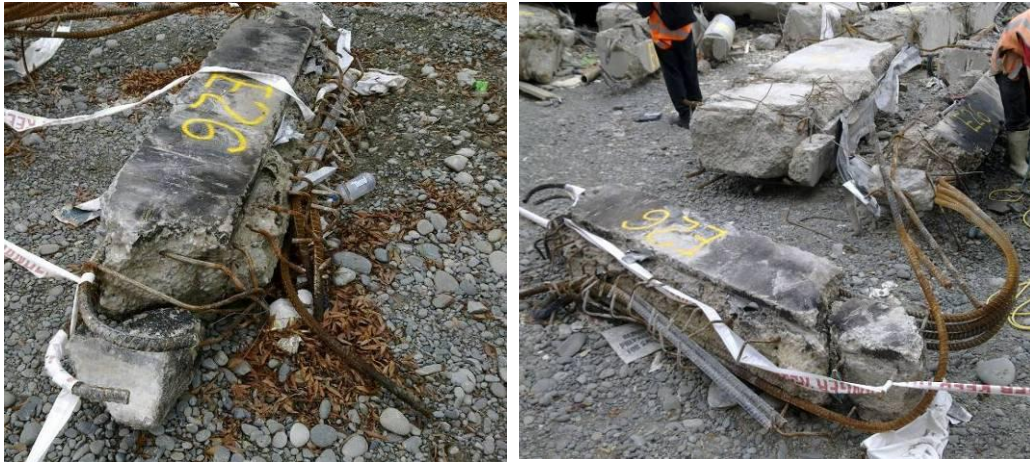
Figure 11 - Interior Pre-cast Log Beam from Line 2 and 3 (DENG Section 3 Dwg S15 (Figure 66)) (left to right) (a) Diagonal shear damage at end and smooth formed surface at beam-column joint; (b) Mid-portion of beam concrete has broken away and stirrups are pulled apart.

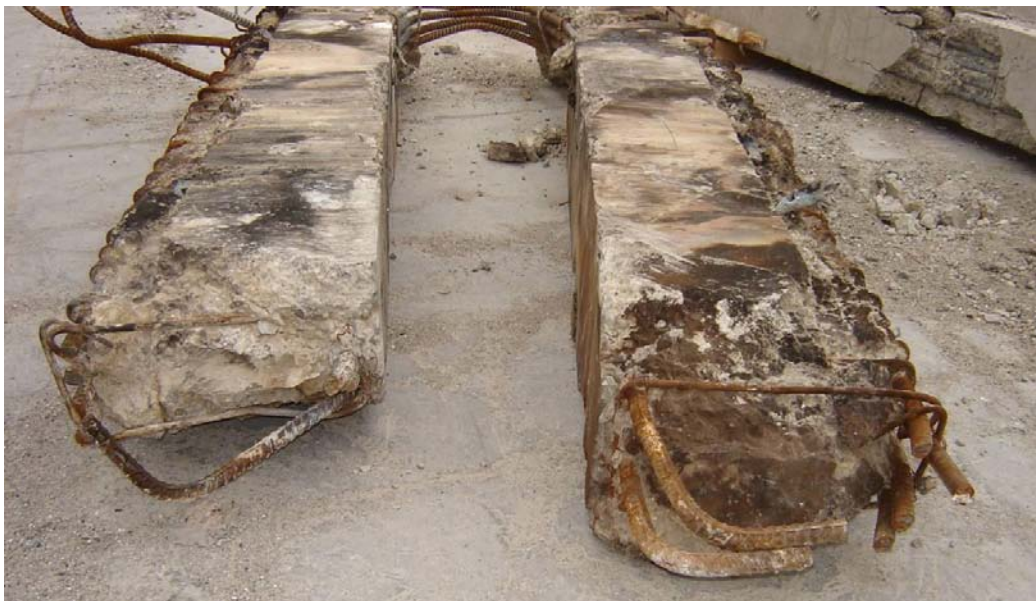
Figure 12 - Interior Pre-cast Log Beams from Line 2 and 3 (DENG Section 3 Dwg S15 (Figure 66)) showing smooth concrete formed for beam-column joint and bottom hooked bars that have pulled out of beam-column joints without any obvious straightening; metal decking has pulled away from slab seating; no slab remains attached to the beams

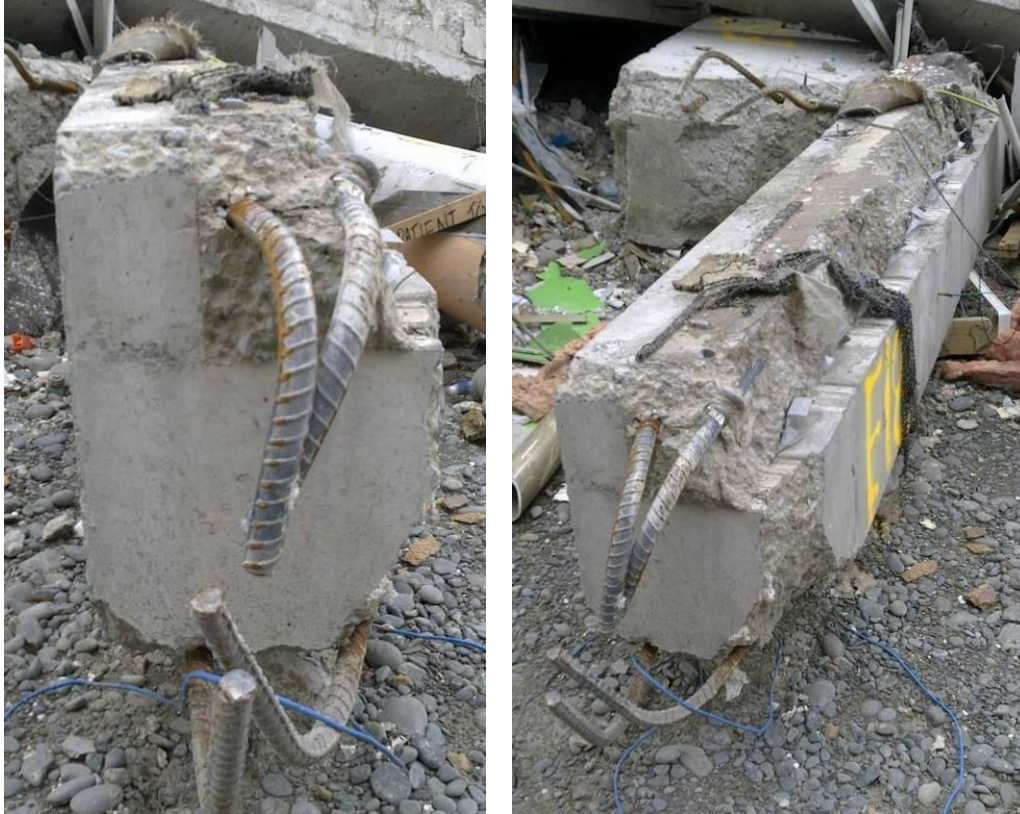
Figure 13 - Item E18 Pre-cast edge beam north-west corner (DENG B22 Dwg S18 (Figure 67) (from left to right) (a) Smooth form finish at attachment to column 4A (DENG Detail I Dwg S19 (Figure 70)); (b) No starter bar reinforcing steel extended from this pre-cast beam into slab. This was consistent with what was shown on the Drawings (DENG Section 4 Dwg S15 (Figure 66).

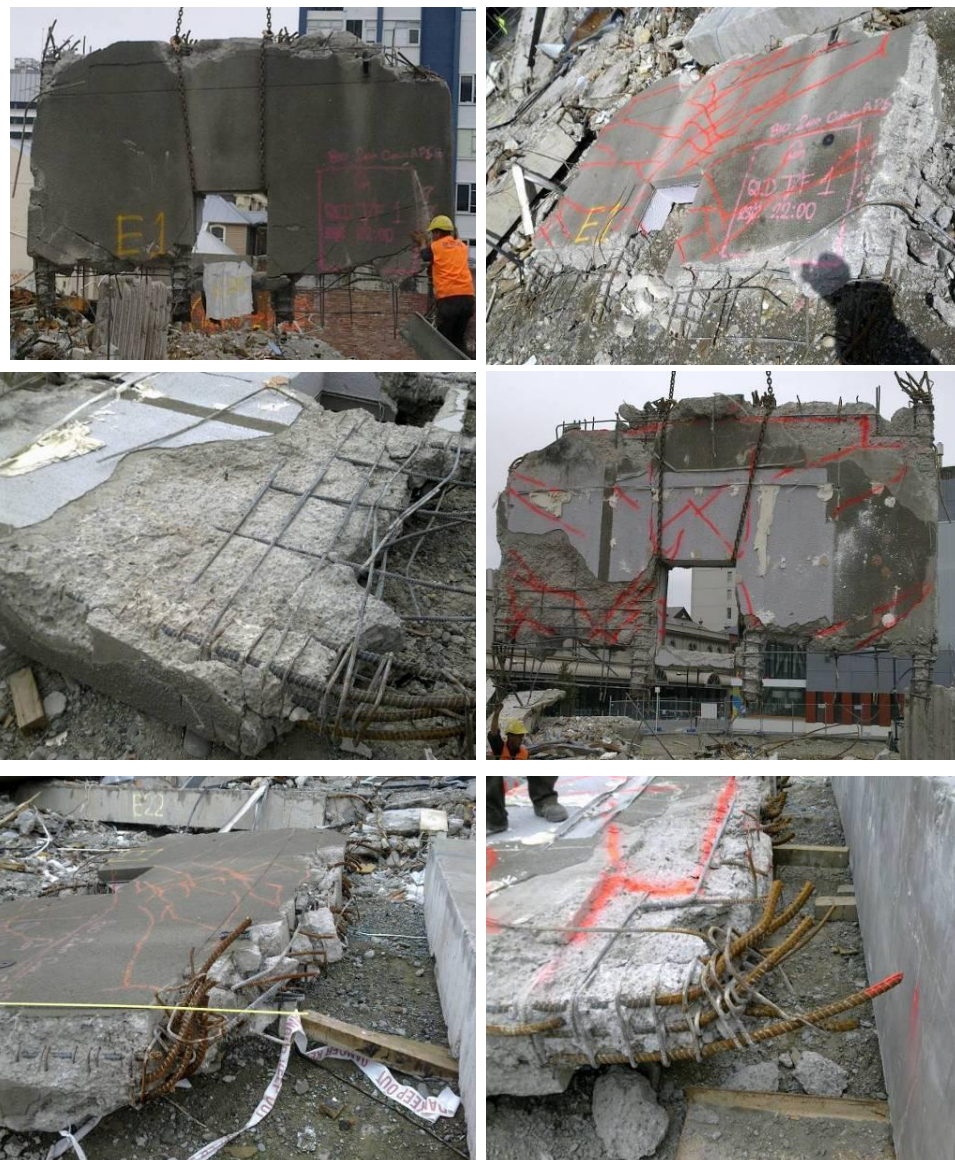
This panel showed flexural cracking patterns typical of cantilever shear walls (Figure 14).

Figure 14 - Line Shear Wall (Item E1) (clockwise from top left) (a) Outer face of wall with lower portion of concrete removed during deconstruction exposing the reinforcing steel; (b) Outer face with cracks highlighted by red paint; (c) Inside face with cracks highlighted by red paint; (d) Top west corner; (e) Top east corner; (f) Inside face of east pier

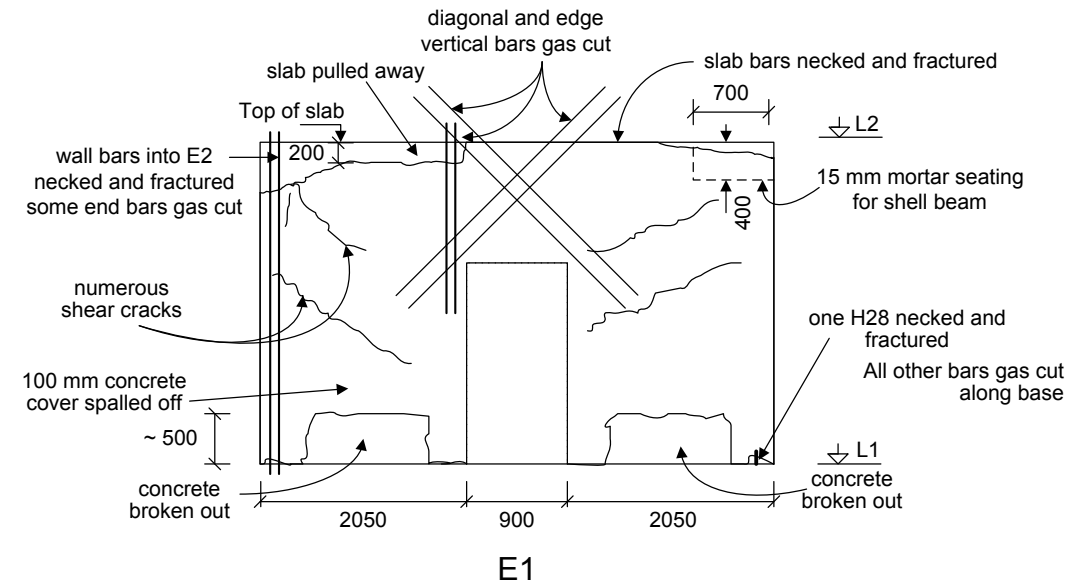
Figure 15 – South Wall Item E1 schematic of damage observed.

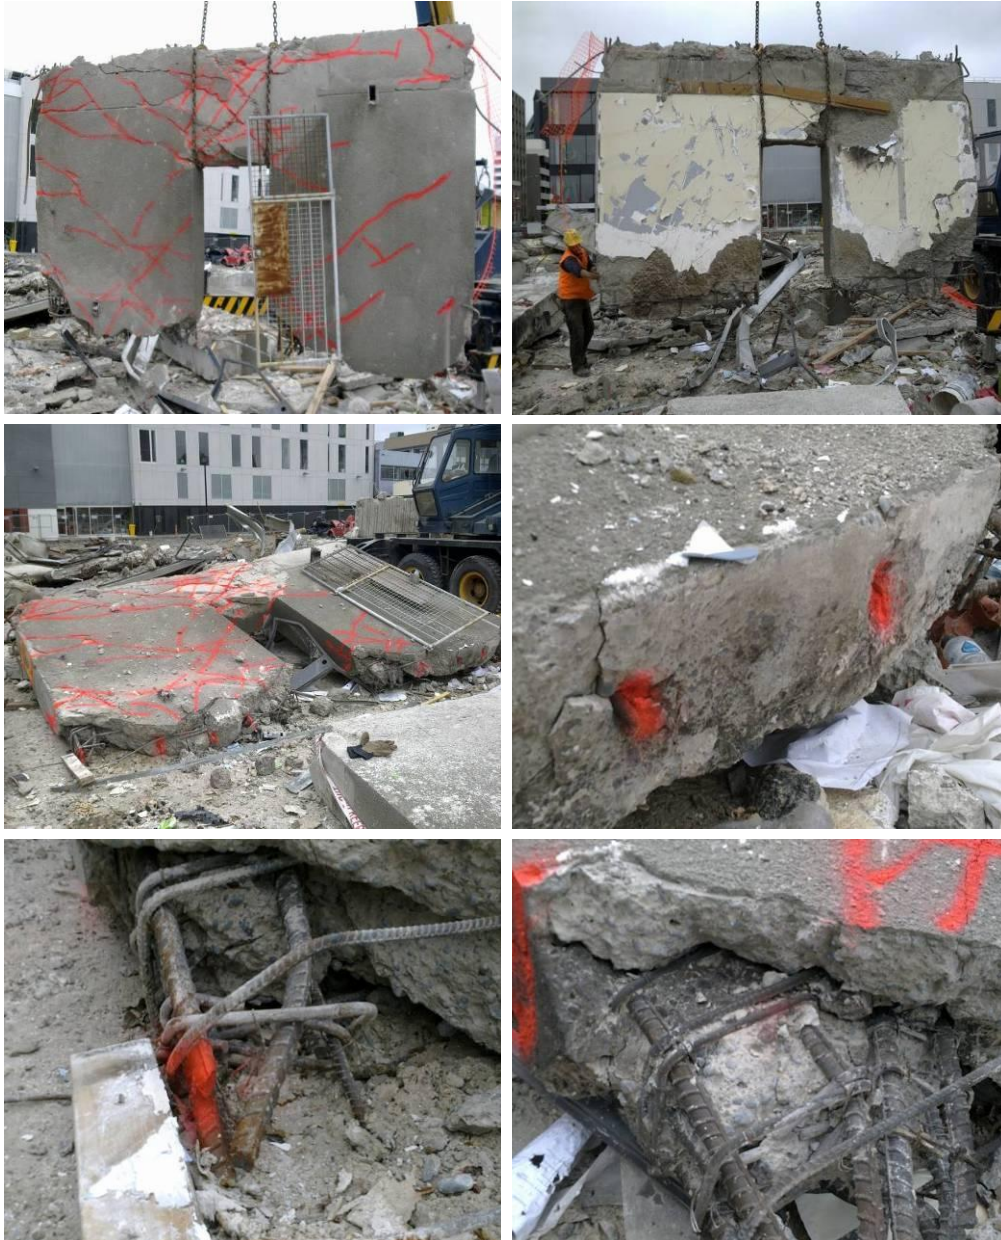
This panel had diagonal cracking in the piers consistent with cantilever wall behaviour and two way diagonal cracking in the door head coupling beam (Figure 16).

Figure 16 - Line 1 South Wall Level 2 to Level 3 (Item E2) (clockwise from top left) (a) Outside face with fire escape door attached. Cracks marked by red paint; (b) Inside face of wall; (c) East pier construction joint with necked and fractured bars indicated by red paint; (d) Escape door edge of east pier showing thick cover concrete to reinforcing; (e) Outer edge of west pier showing necked and fractured bar indicated by red paint others were cut; (f) Outer face of wall with cracks and fractured bars marked.

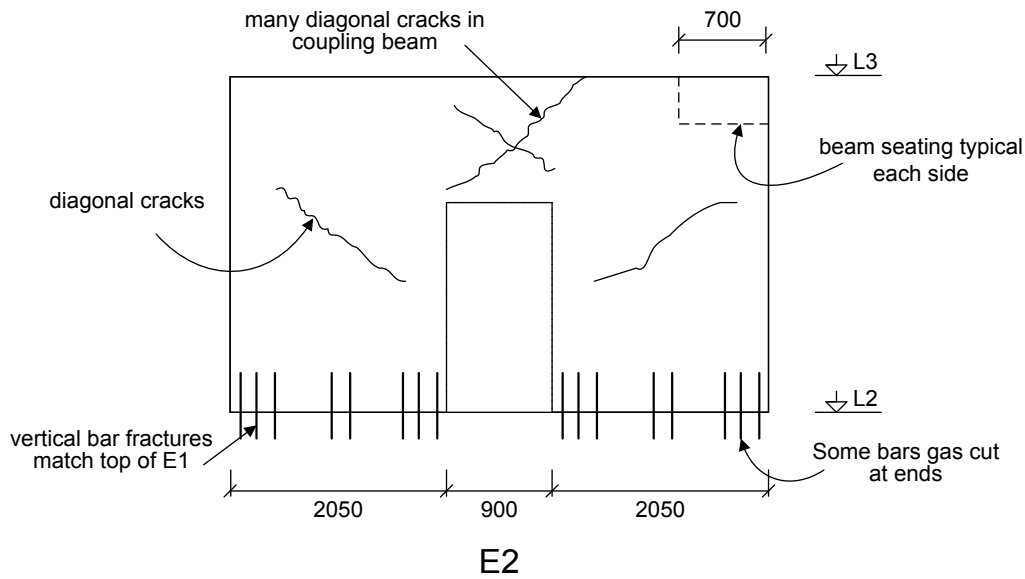
Figure 17 - South Wall Item E2 schematic of damage observed.

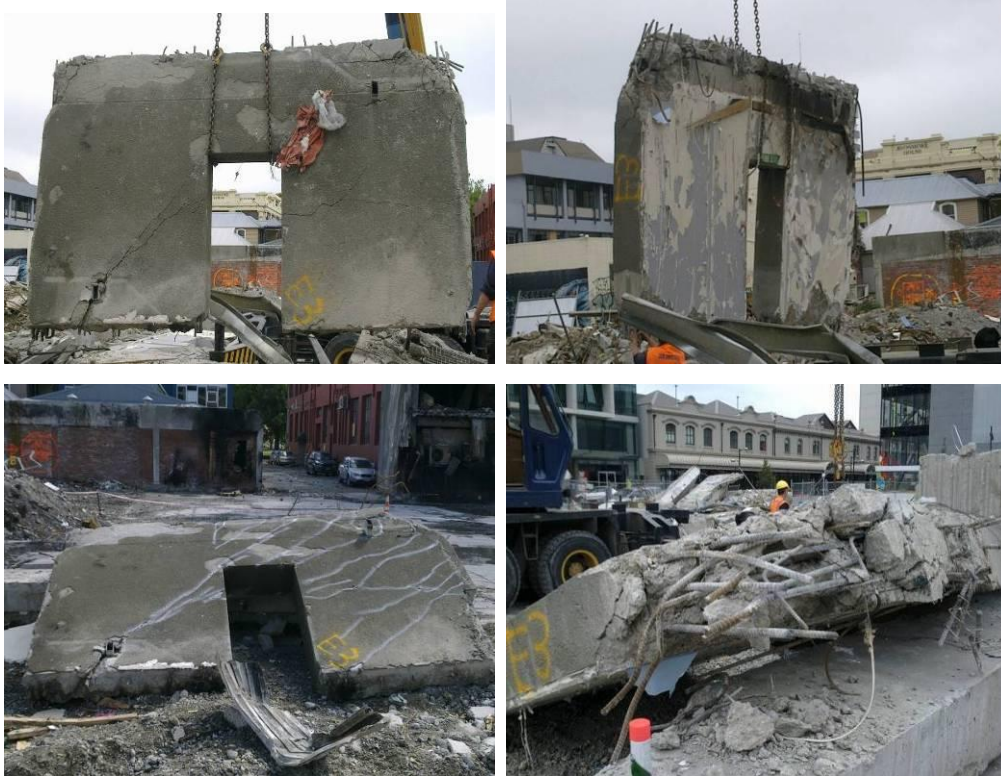
This panel had dominant uni-directional diagonal cracking running from the bottom west corner to the top east end (Figure 18).

Figure 18 - Line 1 South Wall Level 3 to Level 4 (Item E3) (clockwise from top left) (a) Outer face; (b) Inner face; (c) Damaged top east corner; (d) One way diagonal cracks running from bottom west to top east side marked by paint on outer face.

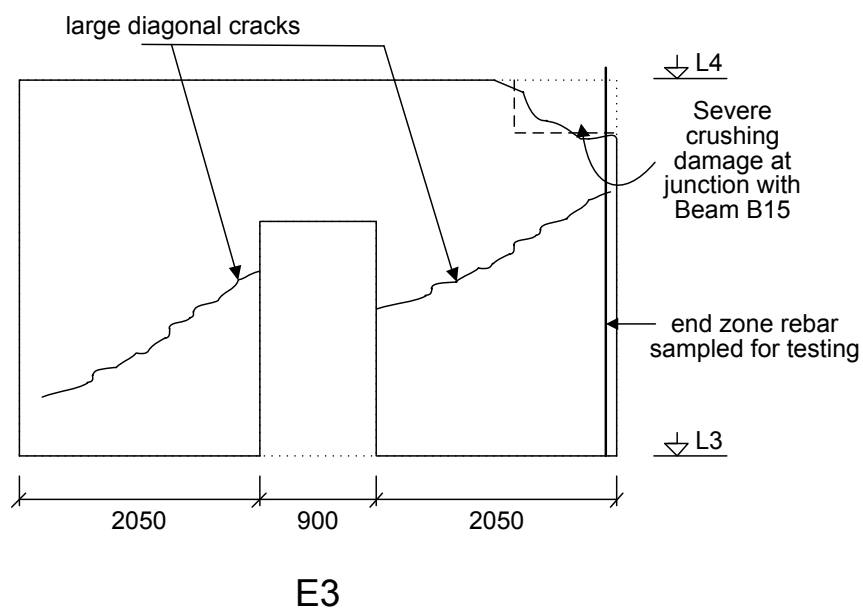
Figure 19 - South Wall Item E3 schematic of damage observed.

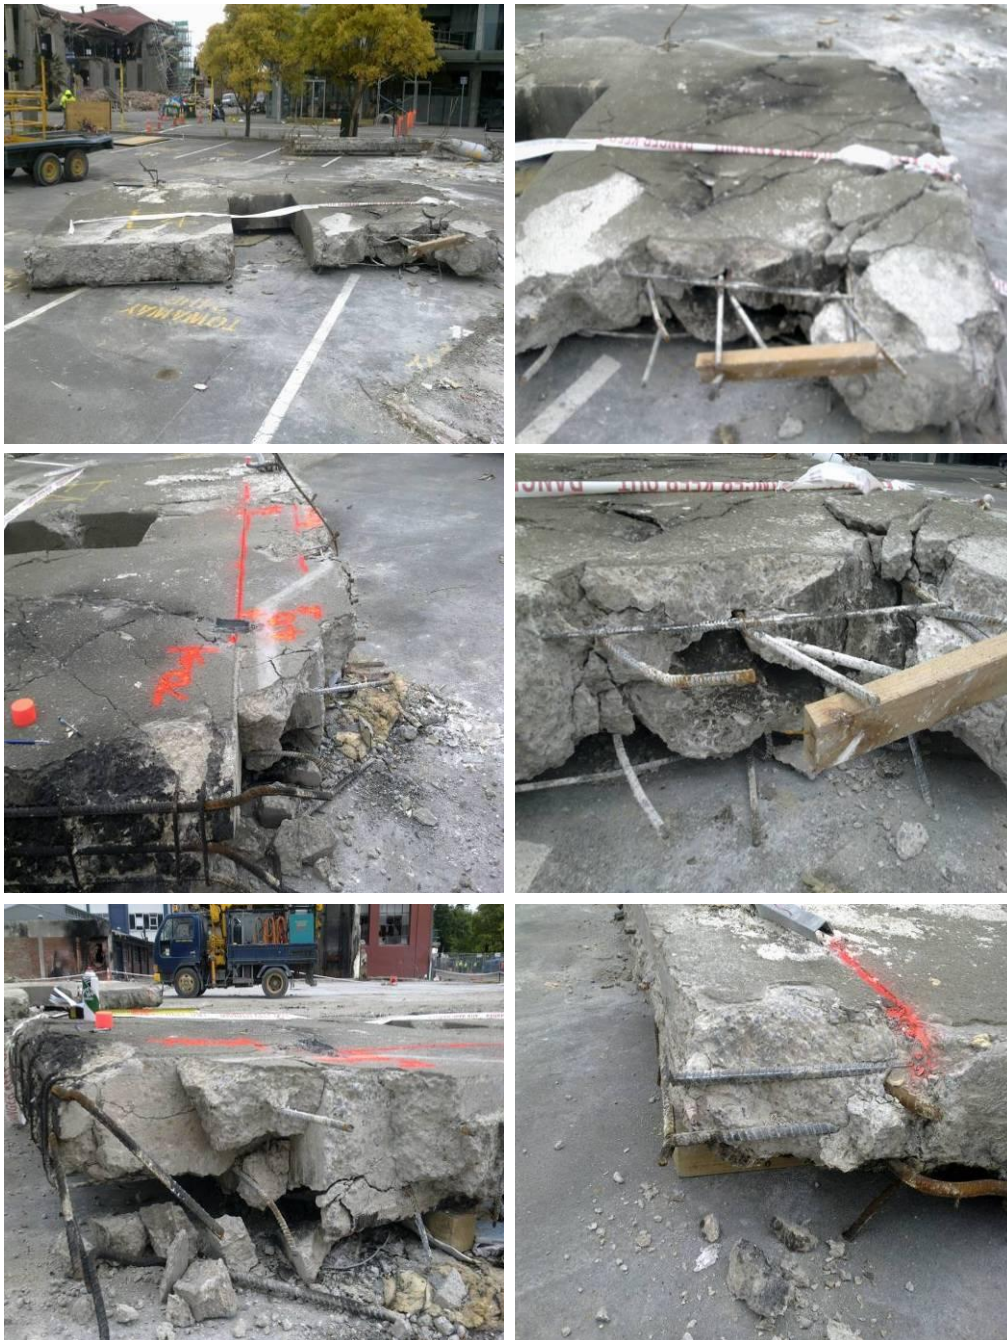
Figure 20 - Line I South Wall Level 4 to Level 5 (Item E4) (clockwise from top left) (a) Outer face with east pier on right with severe shear damage, and timber formwork remnant; (b) and (c) Charring on fractured concrete surfaces prior to deconstruction; (d) Top west corner showing saw-cut on top edge from deconstruction; (e) Top east corner showing smooth construction joint at interface with pre-cast beam B15 (DENG Dwg S18 (Figure 67)) and fire charring to spalled eastern edge; (f) View from east to west of top east corner construction joint notch.

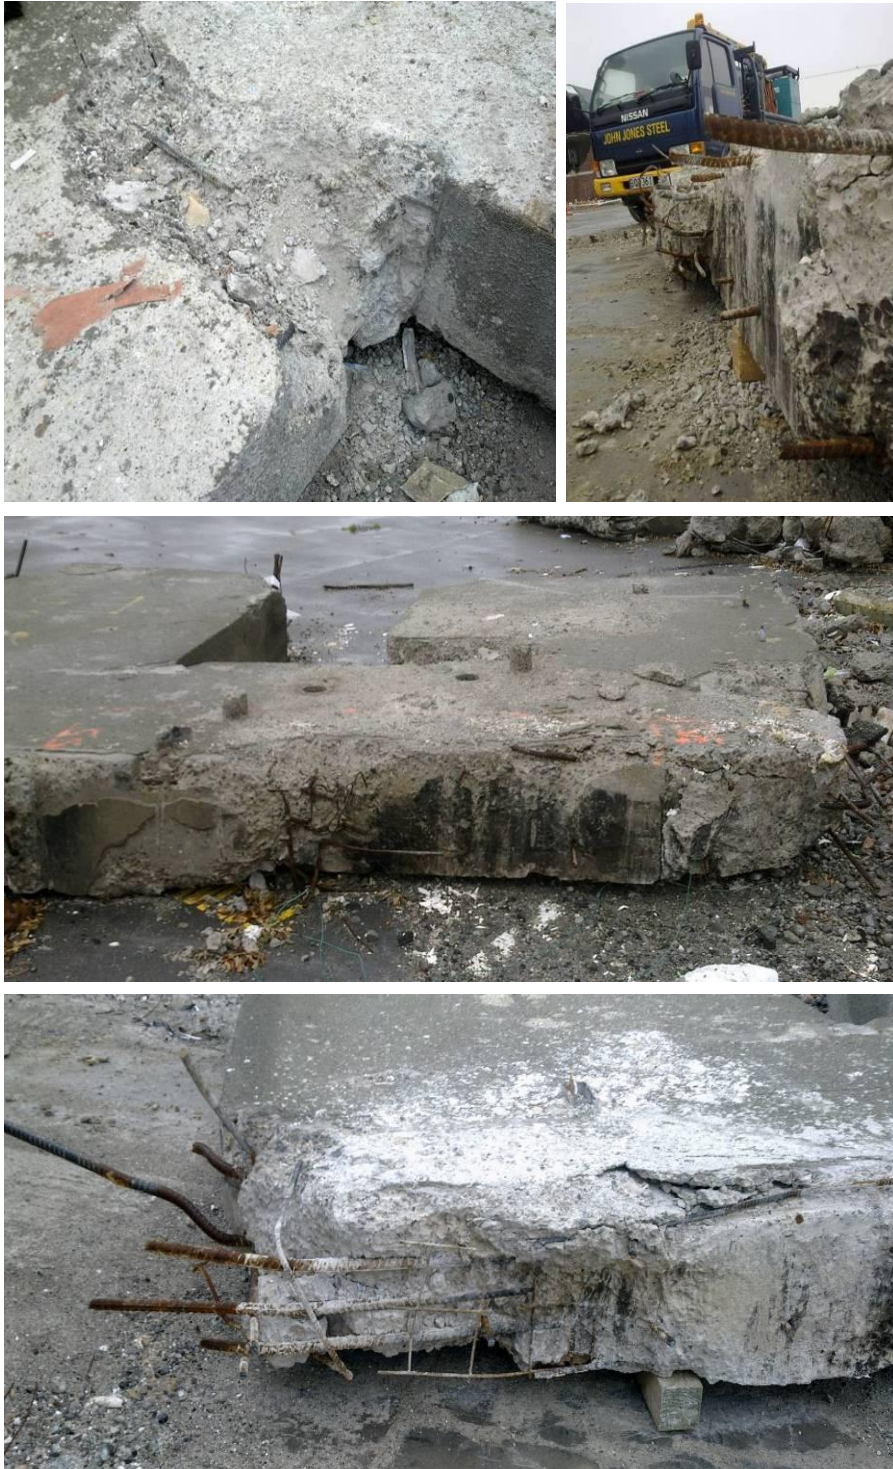
Figure 22 - Line I South Wall Level 5 to Level 6 (Item E5) (clockwise from top left) (a) Crumbly concrete at door edge of west pier able to be dislodged by boot; (b) Smooth and charred construction joint on top west surface looking east; (c) Charred construction joint above west pier. Door sill on left; (d); Top east corner with fractured top 3-H24 bars. Floor 664 mesh exposed.

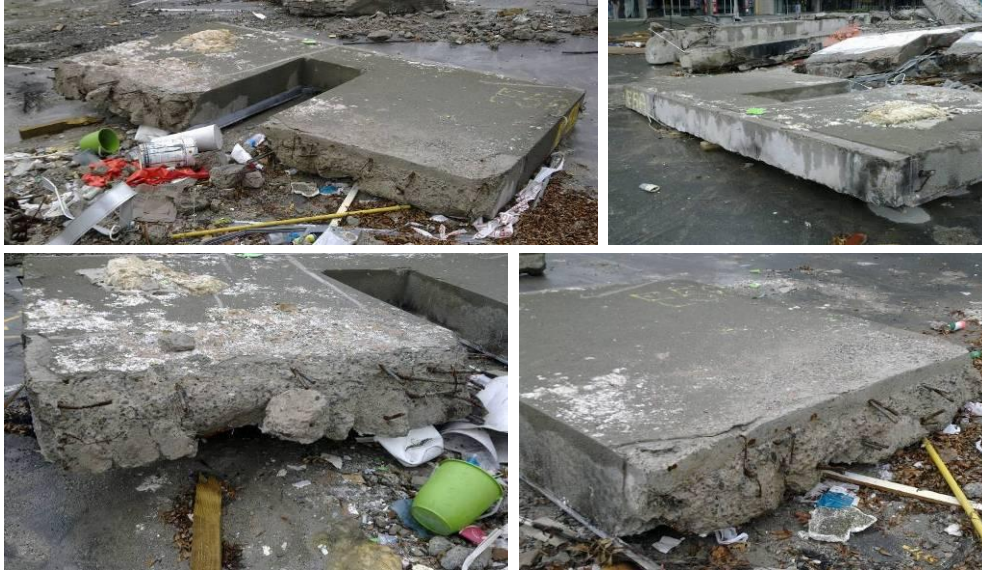
No obvious cracking had occurred in the wall piers or door head coupling beam (Figure 24).

Figure 24 - Line I South Wall Level 6 to Roof (Item E5A) (clockwise from top left) (a) Outer face; (b) Top surface at roof; (c) East pier with saw-cut from de-construction; (d) West pier at construction joint

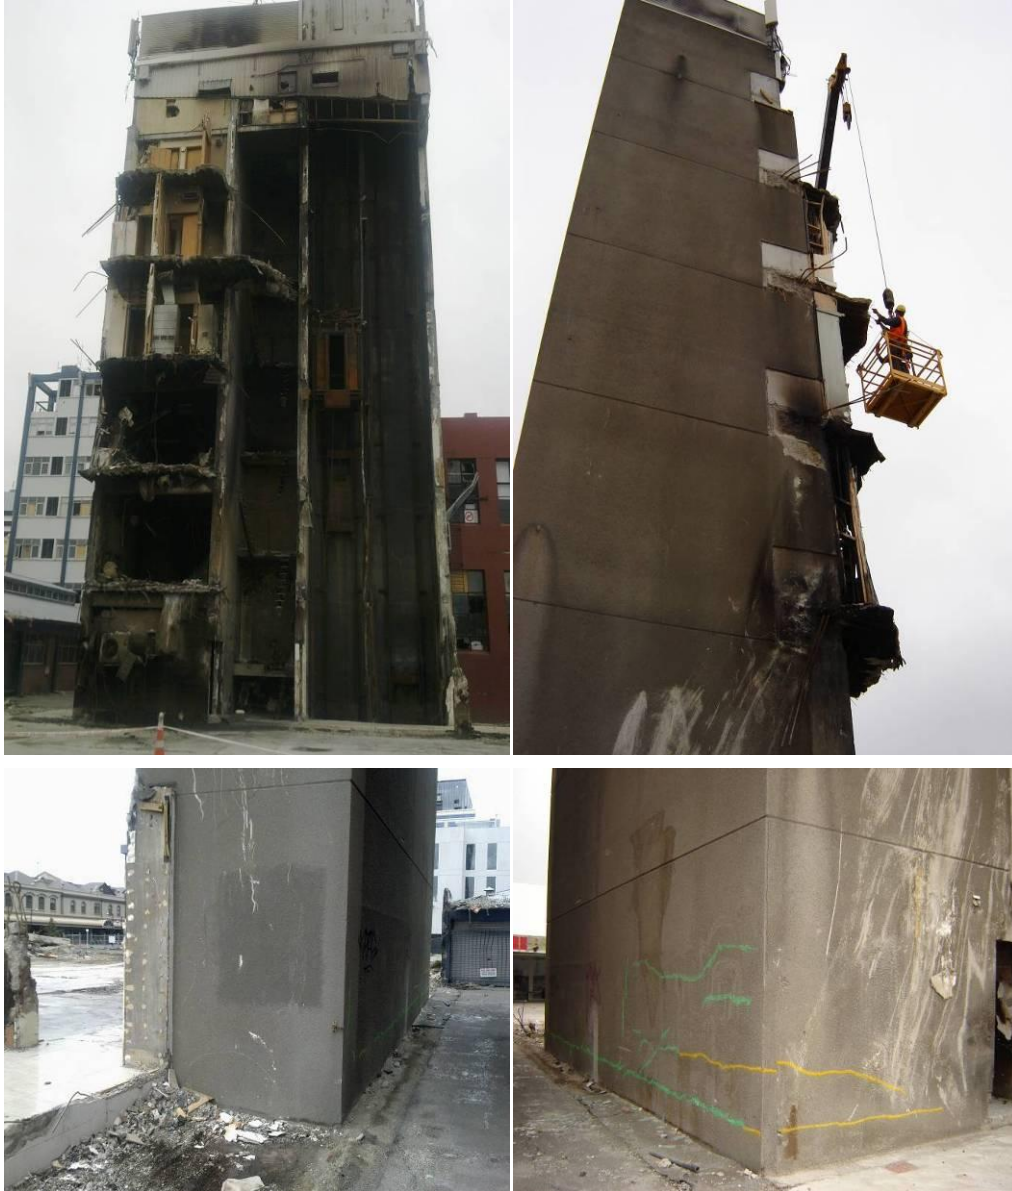
Horizontal flexural cracking on west and north face at Grid C/5 (Figure 25).

Figure 25 - Line 4 to 5 North Core (DENG Dwg S15 (Figure 65)) (clockwise from top left) (a) South face after site cleared with lift shaft for two cars on right, stair well in middle and amenity rooms on the left; (b) West face; (c) West and north face at Grid C/5 corner Level 1 to 2 with horizontal flexural cracks and construction joint identified by paint; (d) East face with column C18 remnant at far left

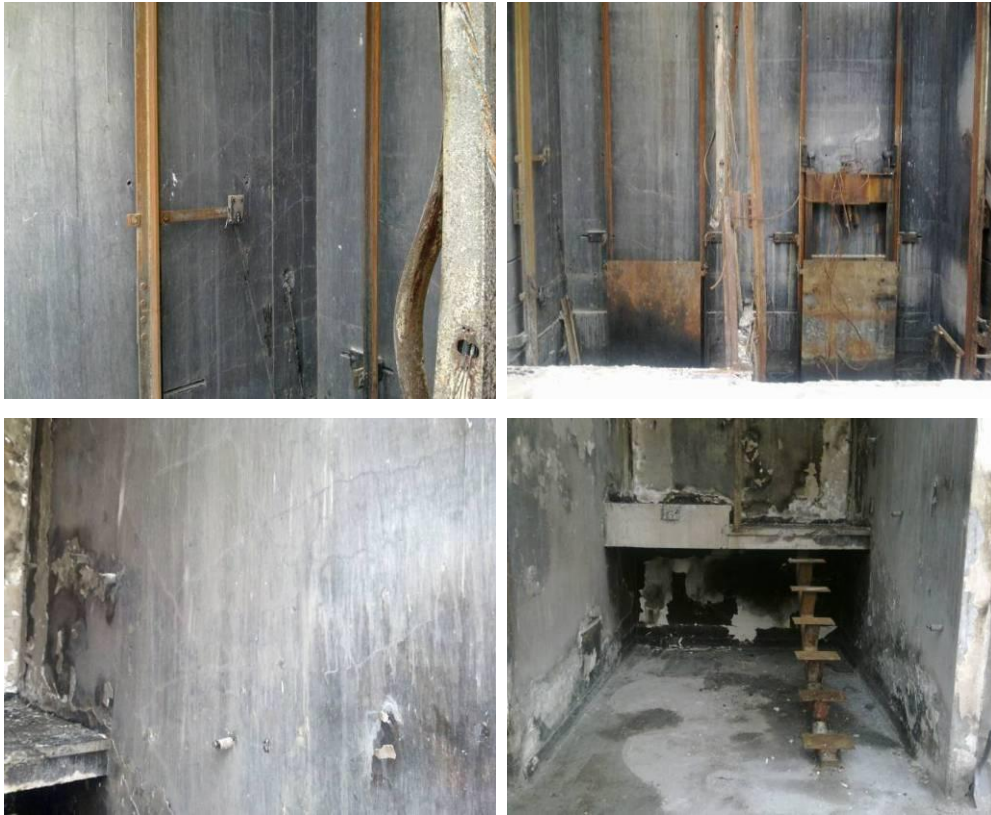
Fine two-way diagonal cracking on the inside faces of Level 1 to 2 walls (Figure 26).

Figure 26 - Lift and Stair well wall cracking Level 1 to Level 2 (clockwise from top left) (a) Lift wall face of Line D wall with fine diagonal shear cracking in both directions; (b) Lift wall face of Line 5 wall with fine diagonal cracking in both directions; (c) Stairwell area with steel stair stringer where concrete cores were extracted; (d) Stair well face of Line D wall with fine diagonal cracking in both directions.

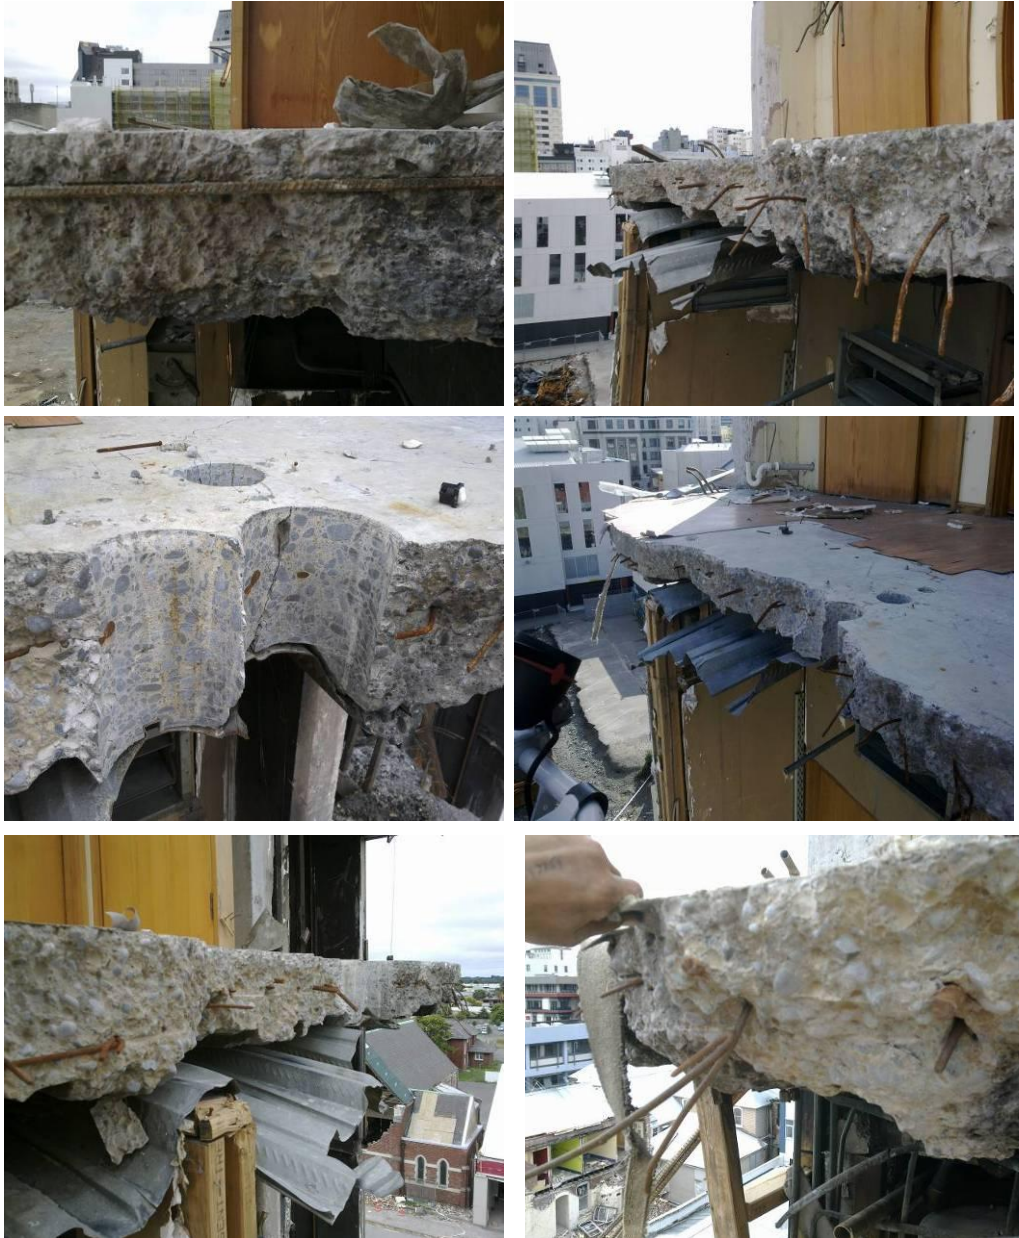
The slab had a vertical fracture face that coincided with the ends of the H12 saddle bars from the support beam on Line 4 (Figure 27).

Figure 27 - Line 4 Core Wall Slab Remnant at Level 6 amenity area (clockwise from top left) (a) Slab edge on stairwell wall looking west with H12 saddle bar exposed and ends of mesh below it; (b) Vertical concrete fracture surface with reinforcing mesh fractured; (c) Slab looking west with cores cut in floor for amenities; (d) Fractured mesh angled downwards; (e) Fractured slab edge looking east. Torn metal decking aligned approximately with concrete fracture edge; mesh at varying height within slab; (f) Cores for amenities at fracture edge.

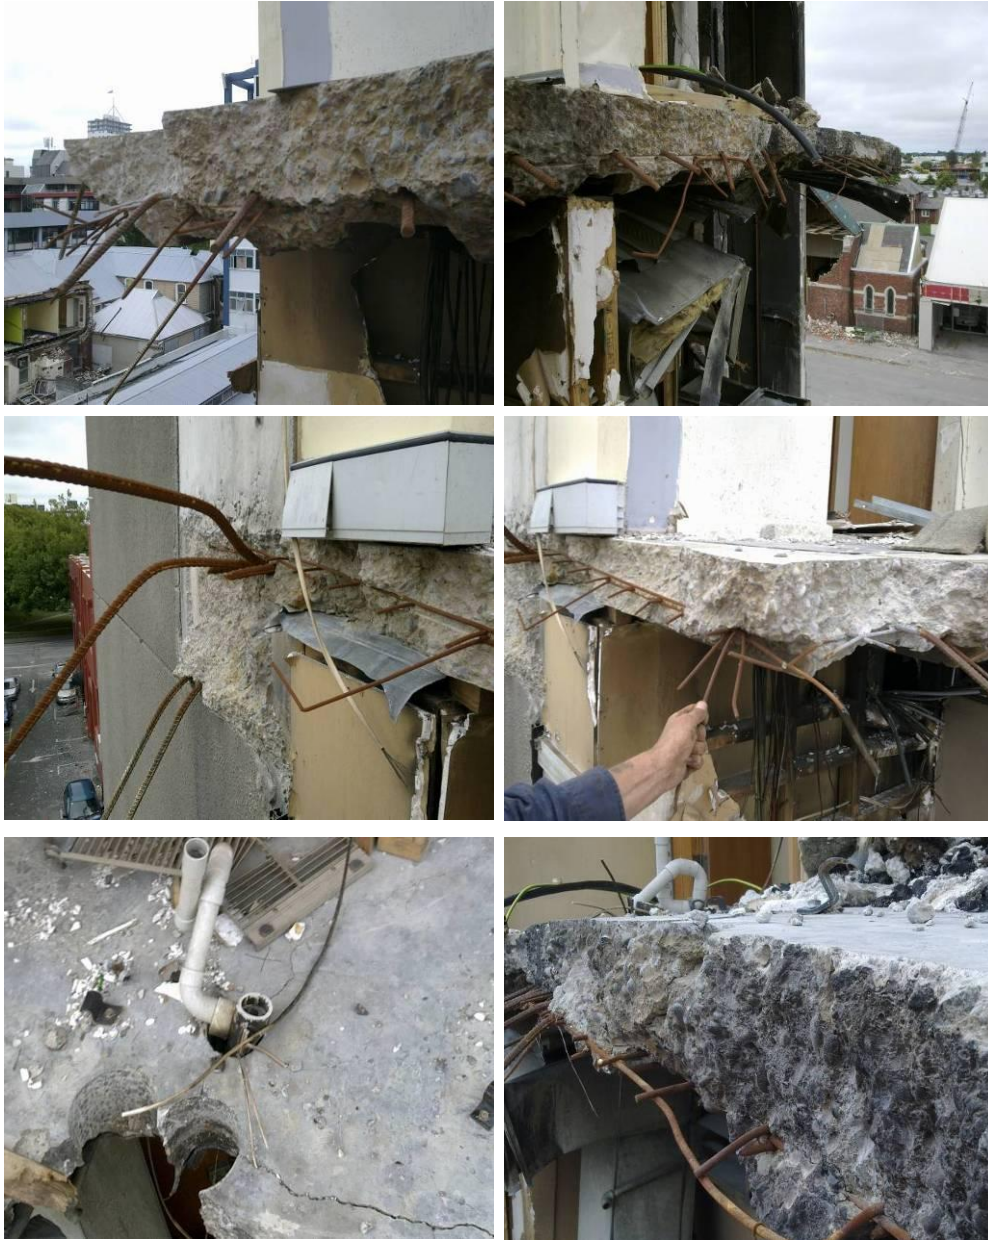
Figure 28 - Line 4 North Core Wall Slab Remnants Level 5 (clockwise from top left) (a) West end with H12 bar ends and mesh at bottom of slab above ribs. It was required on the drawings to be located near the top surface (DENG Dwg S16 (Figure 75)); (b) Looking east. Reinforcing angled down; (c) Slab edge on Grid C west end. Mesh angled down in bottom of slab on top of ribs; (d) Fire charred vertical fractured slab edges adjacent to stairwell. Mesh located low down in slab at top of slab ribs. Edge of mesh sheet with closely spaced parallel wires exposed. Fractured wires can be seen from the lapped mesh below; (e) Cracking in slab running from cored holes; (f) Connection of shell beam to wall with two fractured H24 top bars and two de-bonded top bars. No bottom bars from shell beam embedded in wall (DENG B23 Dwg S18 (Figure 67), Detail 5 S19 (Figure 71)), corresponding to the bent back bottom steel in shell beam Item E23 (Figure 8).

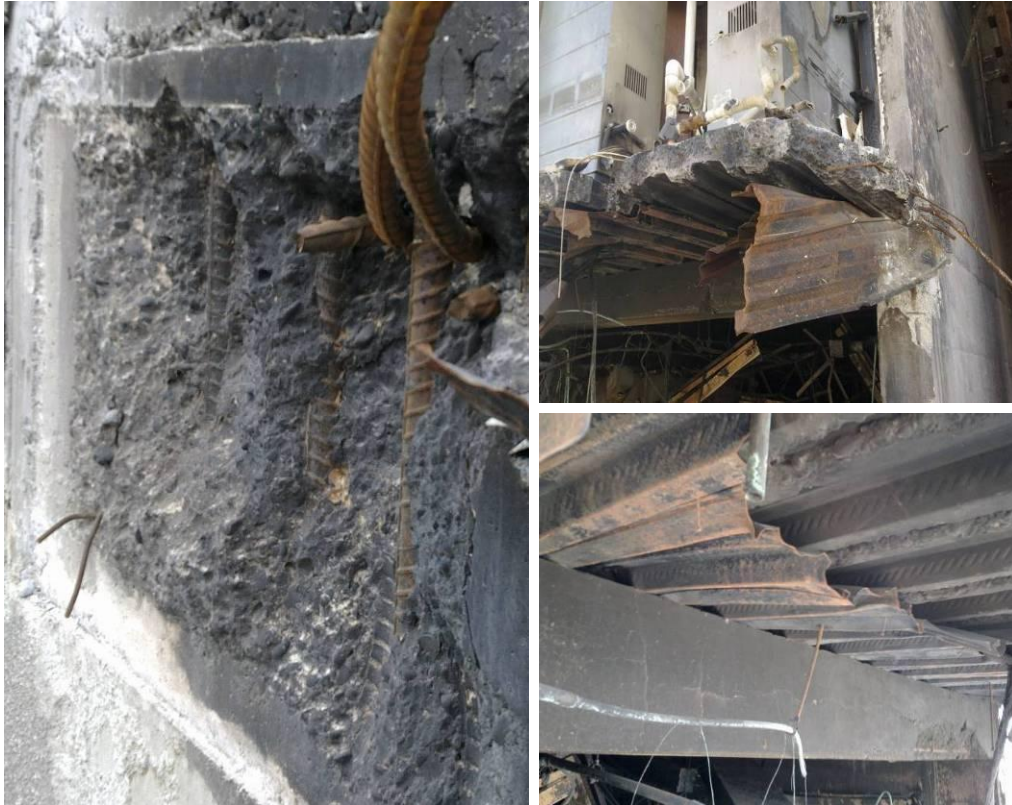
Figure 29 - Line 4 North Core Walls Level 4 slab remnants (top to bottom) (a) Connection of shell beam to wall with two fractured H24 top bars and two de-bonded top bars. No bottom bars from shell beam embedded in wall but imprints from bars evident (DENG B23 Dwg S18 (Figure 67), Detail 5 S19 (Figure 71)), corresponding to the bent back bottom steel in shell beam Item E23 (Figure 8); (b) Fractured vertical face of slab at stairwell wall, with fractured slab support beam (DENG B25 Dwg S18 (Figure 67)) top bar and charred fracture surface; (c) Torn profiled metal deck sheeting de-bonded from slab but still fixed in at pre-cast beam support.
