CTV BUILDING

CTV BUILDING SITE EXAMINATION
AND MATERIALS TESTS
FOR DEPARTMENT OF BUILDING AND HOUSING
16TH JANUARY 2012

REPORT PREPARED BY:
DR CLARK HYLAND
PhD, BE(Civil), BCom, CWE-NZIW, CPEng
Hyland Fatigue + Earthquake Engineering
PO Box 97282, Manukau, AUCKLAND 2241
Phone: (09) 262 0203
Mobile: 021 348 352
Email: clark@fatigueandfracture.com
www.fatigueandfracture.com

Report Issue Date: 16 January 2012

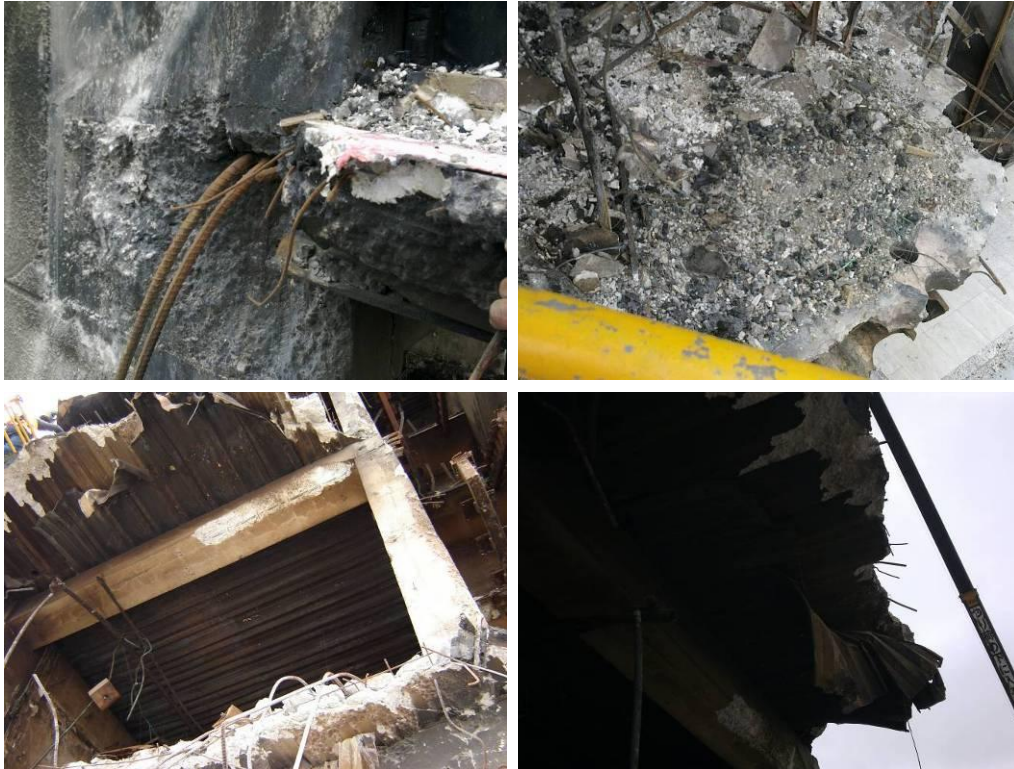
Figure 30 - Line 4 North Core Walls Level 3 slab remnants (clockwise from top left) (a) Connection of shell beam to wall with two fractured H24 top bars and two de-bonded top bars. No bottom bars from shell beam embedded in wall but imprints from bars evident (DENG B23 Dwg S18 (Figure 67), Detail 5 S19 (Figure 71)), corresponding to the bent back bottom steel in shell beam Item E23 (Figure 8); (b) Ash on slab;. Cored holes at fractured edge; (c) Torn profiled metal deck sheeting de-bonded from slab but still fixed in at pre-cast beam support (DENG B24 Dwg S18 (Figure 67)); (d) Profiled metal deck and slab from below supported on beam B24.

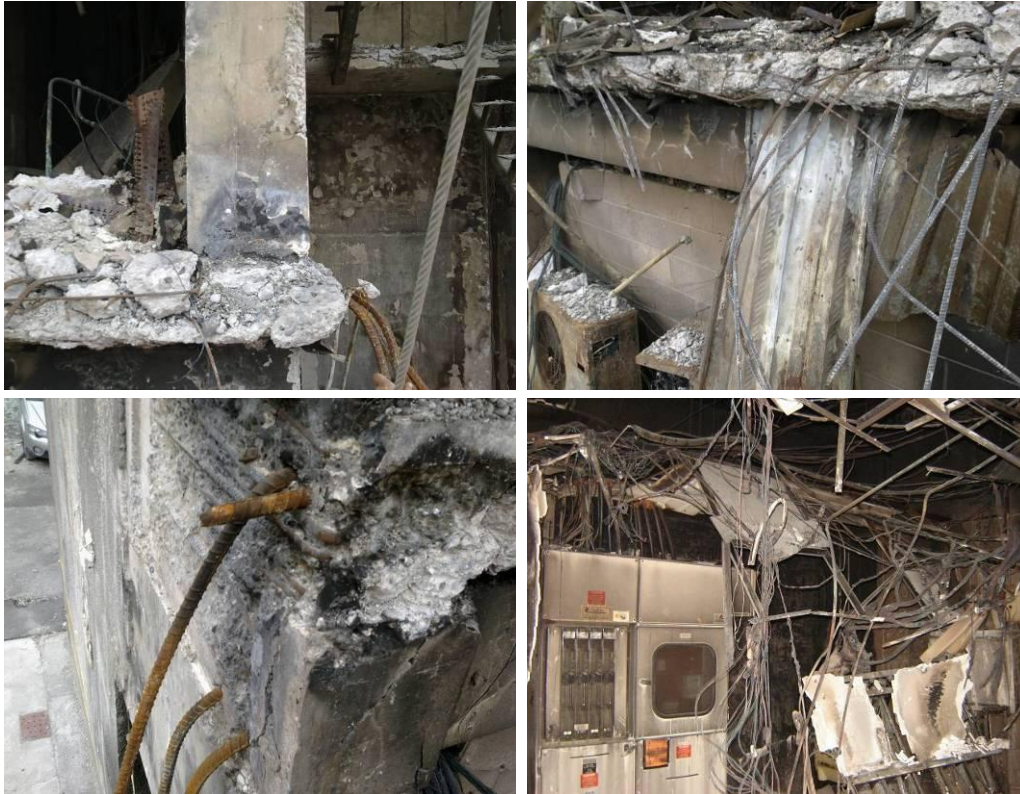
Figure 31 - Line 4 North Core Walls Level 2 slab remnants (clockwise from top left) (a) Slab edge broken back during de-construction adjacent to stairwell wall; (b) Broken back slab with H12 saddle bars exposed. Masonry wall with separation along top course; (c) Switch room under Level 2 slab; (d) Connection of shell beam to wall with two fractured H24 top bars and one de-bonded top bars. Bottom bars from shell beam have been embedded in wall as specified (DENG B23 Dwg S18 (Figure 67), Detail 5 S19 (Figure 71)). Some diagonal beam-wall joint zone shear cracking can be seen in the wall end..

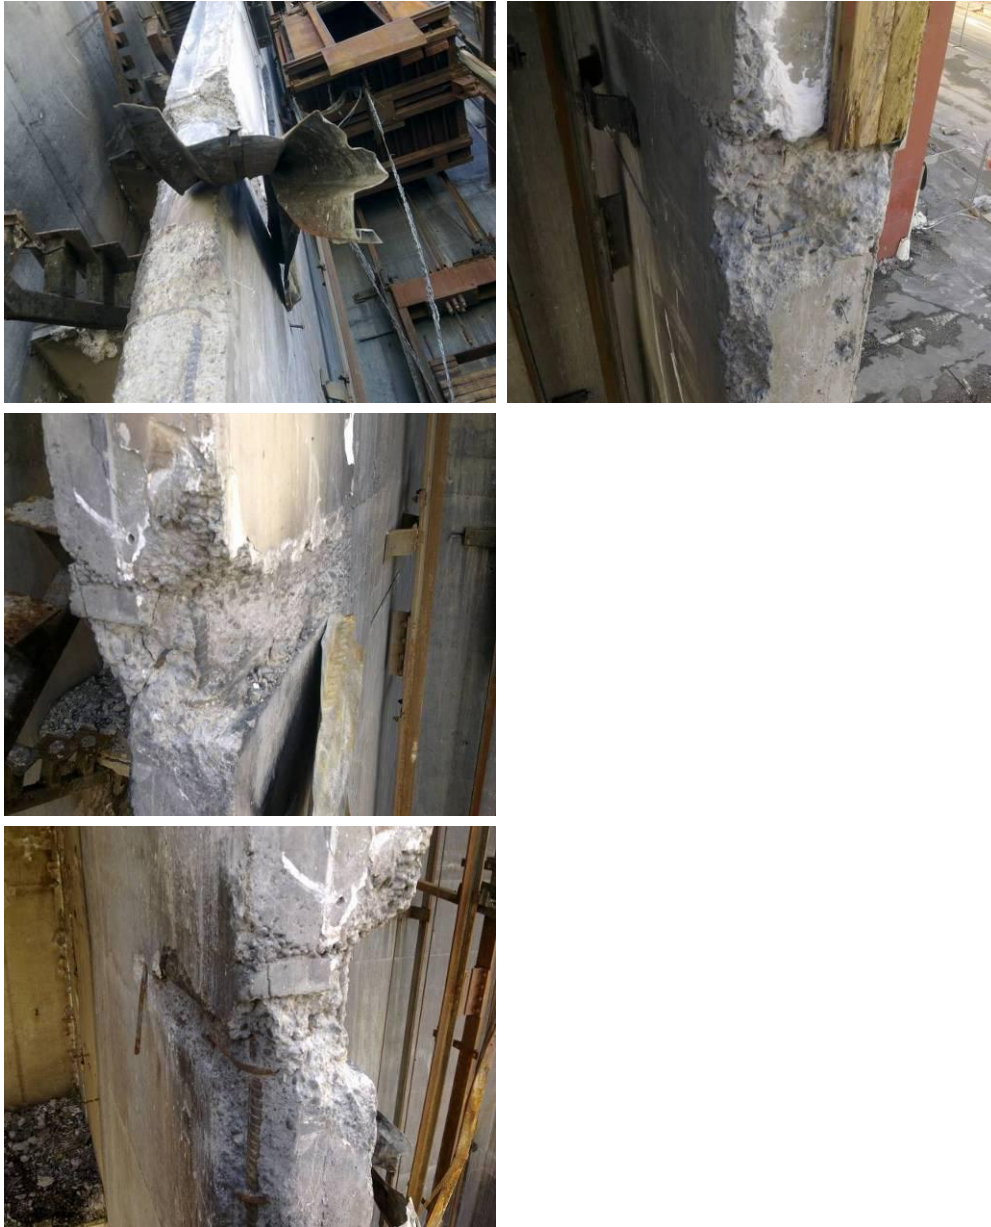
No reinforcing steel was found to have connected the east wing wall D/E to the slab (Figure 35).

Figure 35 - Level 3 Lift Well Wing Walls Grid D and D/E (anti-clockwise from top left) (a) Profiled metal deck decking side lapped into western Grid D wall, just hanging on; (b) H12 bar necked and fractured at centre of wing wall (indicated by chalk arrow); (c) Concrete cover appeared to have broken away as the slab pulled southwards; (d) Localised spalling of concrete. No reinforcing found connecting end of east wall with slab.

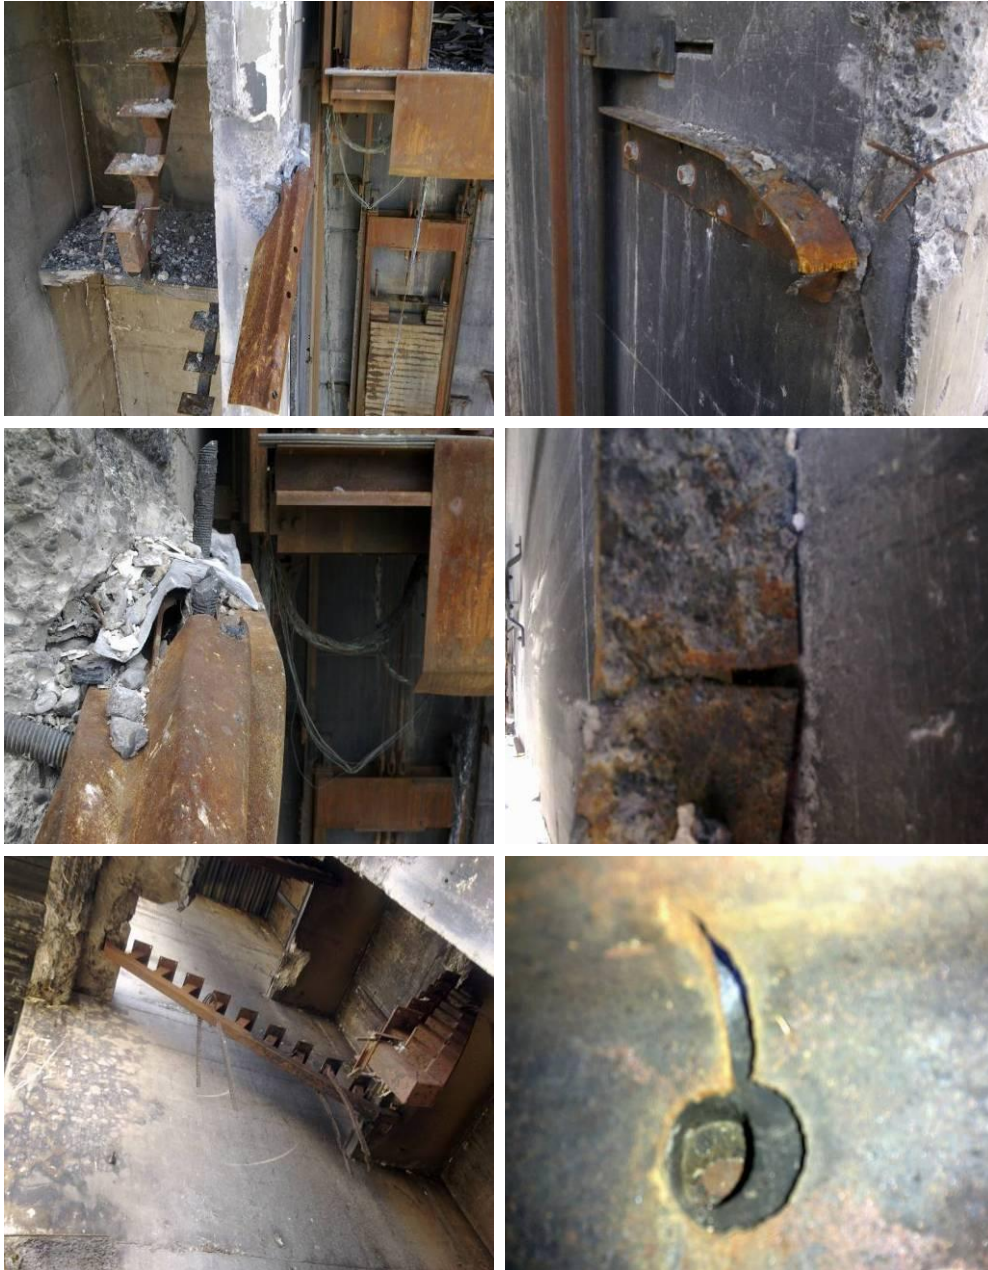
The Drag Bars on both the west and east wing walls had partially fractured in bending and tension. The epoxy grouted 20 mm threaded anchors that were fixed vertically into the slab and into the Drag Bar on the west wall appeared to have pulled out in tension as the slab pried it off as it rotated downwards during the collapse (Figure 36 and Figure 37).

Figure 36 - Level 4 Lift Well Wing Walls Grid D and D/E (anti-clockwise from top left) (a) 150x150x10 L with 51 x 3.2 SHS; 3-M24 threaded rods fixed into wall and 6 –M20 threaded rods 350 mm long fixed into the slab at the profiled metal deck rib with epoxy grout around rod; (b) Three M20 threaded rods remained upright in the Grid D Drag Bar. The 51x3.2 SHS had fractured in bending and tension at the bolt hole adjacent to last bolt into wall; (c) Stair stringer running up to Level 5 fixed rigidly into landings with visible vertical bow (DENG Stair S8 Dwg S31 (Figure 76); (d) Initiation of fracture in the steel angle at the elongated hole without bolt into east wall; (e) Fracture in angle running from corner of angle out towards toe viewed from above; (f) Remnant of 150x75x10 L Drag Bar with 4-M24 threaded rods fixed into grid D/E wall. Angle has fractured in bending and tension two bolts in. End of Drag Bar had been gas cut during de-construction.

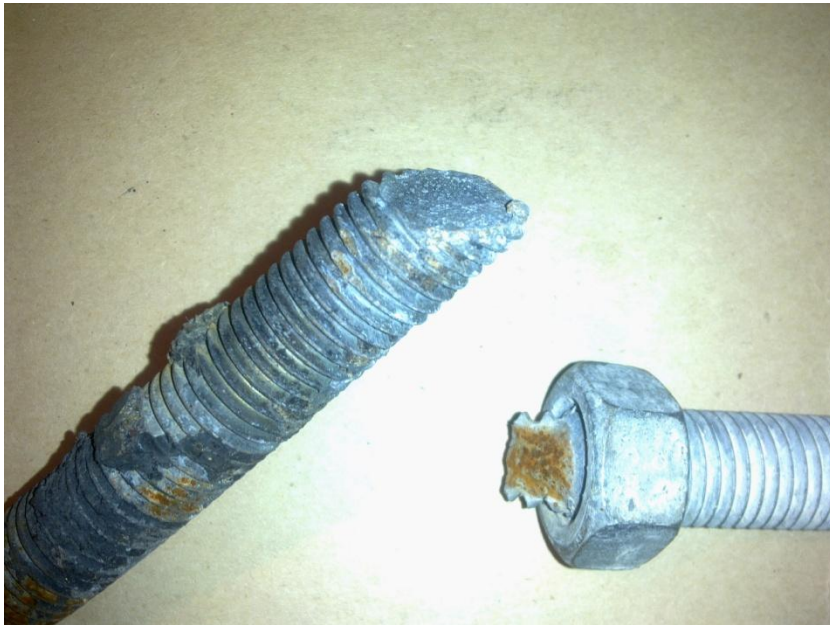
Figure 37 - M20 Drag Bar Bolts (Portions shown are from two different bolts) (left to right) (a) Grey portion with smooth diagonal end had epoxy residue from slab indicating it was cut this way prior to installation; (b) Necked and dimpled fracture surface at underside of bolt typical of direct tensile fracture in threaded rods.

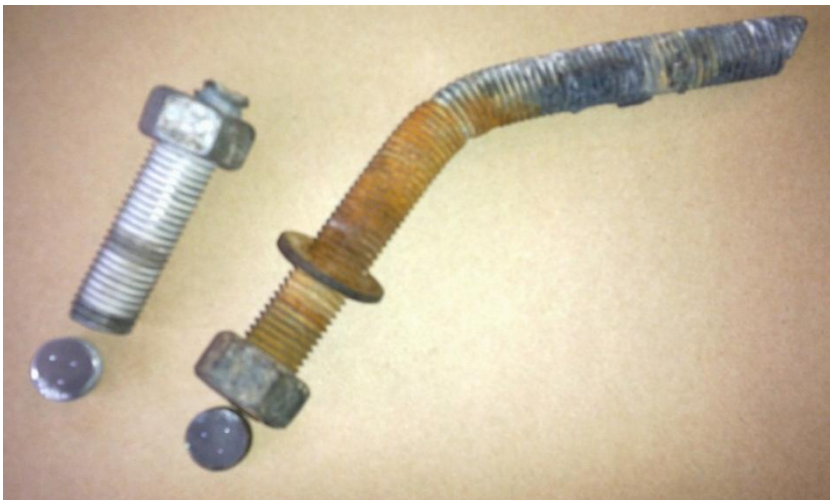
The 20 mm diameter Drag Bar threaded anchor rods were hardness tested by MTL (Figure 62) and found to have Rockwell Hardness HRB greater than the minimum required by AS 4291.1:2000 (SAA 2000) for Property Class 5.8 threaded rods.

Figure 38- M20 Property Class 5.8 threaded studs from Drag Bars after hardness testing by MTL (Figure 62)

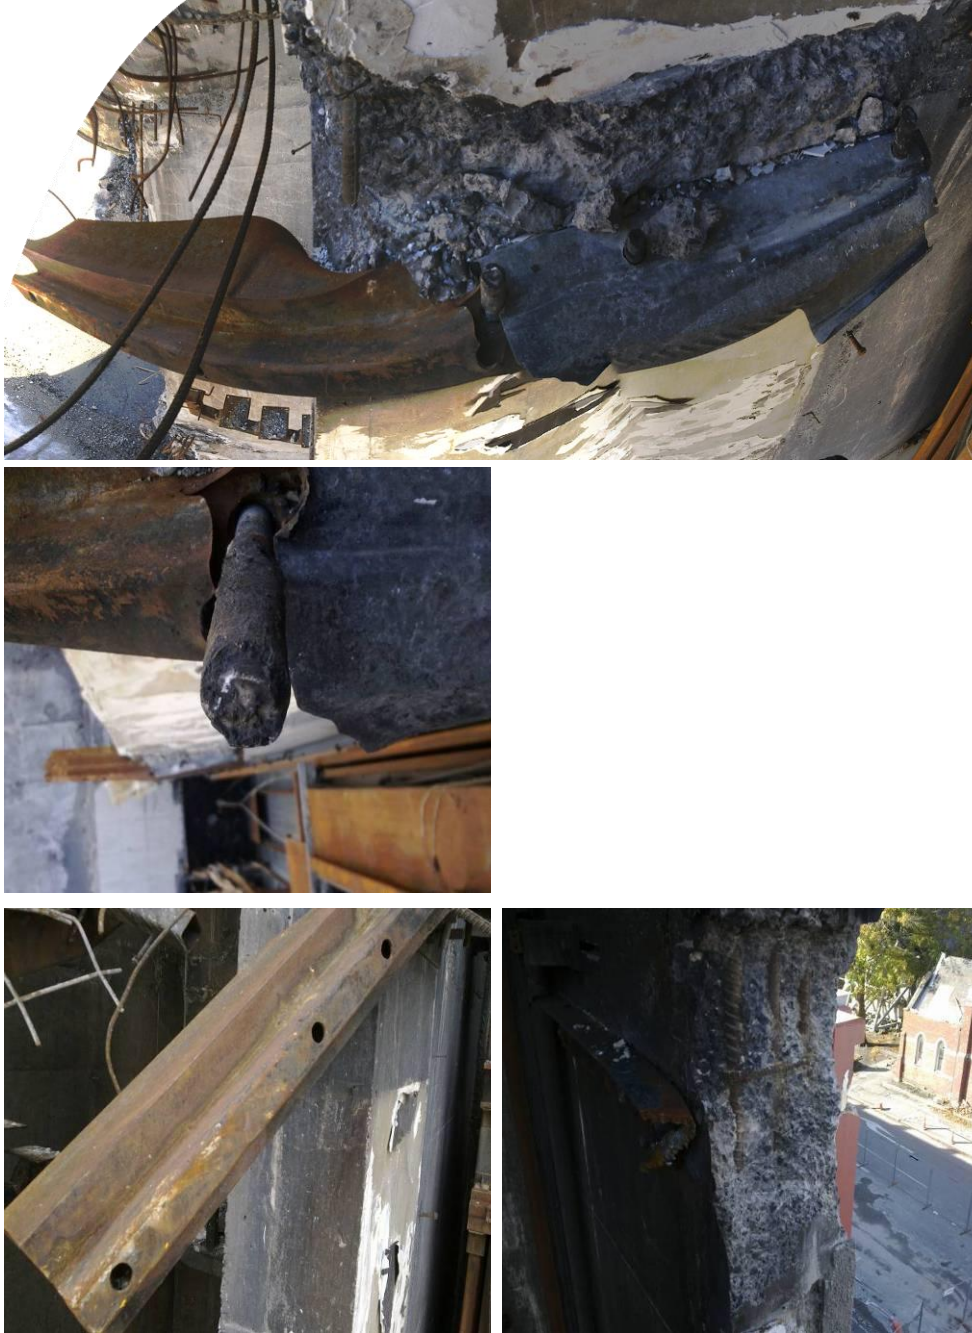
Figure 39 - Level 5 Lift Well Wing Walls Grid D and D/E (anti-clockwise from top) (a) 150x150x10 L with 51 x 3.2 SHS; 4-M24 bolts into wall and 6 –M20 threaded rods 350 mm long fixed through the slab at the profiled metal deck rib with epoxy grout around rod; Three M20 threaded rods remained vertical the Grid D Drag Bar. The 51x3.2 SHS had fractured in bending and tension at the bolt hole adjacent to last bolt into wall and twisted with the slab; (b) Epoxy grout around threaded rod in slab; (c) Holes for 3-M20 threaded rods in slab in twisted Drag Bar; d) 150x75x10 L Drag Bar with 5-M24 threaded rods fixed into wall D/E. End of Drag Bar had been gas cut during de-construction.

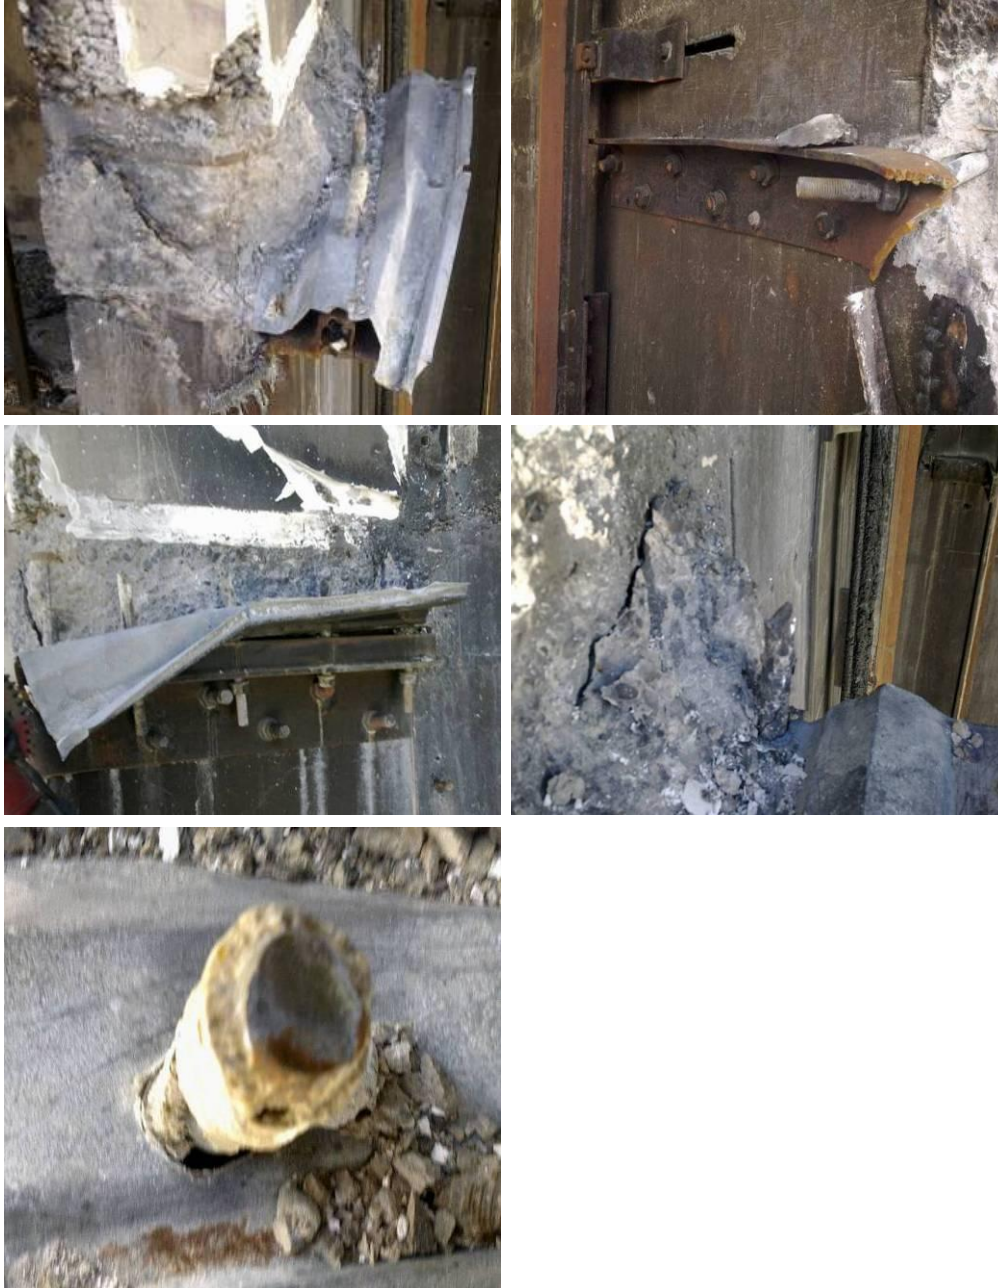
Figure 40 - Level 6 Lift Well Wing Walls Grid D and D/E (anti-clockwise from top left) (a) 150x150x10 L with 51 x 3.2 SHS into west wall on Grid D, similar to Level 5 and 4 Drag Bars; 6-M24 bolts into wall; The remaining 4 -M20 bolts 350 mm long had been fixed into the slab at the profiled metal deck rib with epoxy grout around bolt; These remained vertical and were measured with 110 mm stick-out above the item. The 51 x3.2 SHS has fractured in bending and tension at the bolt hole adjacent to last bolt into wall and the bar had twisted with the slab; (b) Side view of Drag Bar remnant showing deck uplift at end bolt; (c) Top surface of M20 threaded rod with typical smooth diagonal face and grout around rod through slab. (d) End rod with diagonal top surface and slab concrete remains; (e) 150x75x10 L Drag Bar with 7- M24 threaded rods fixed into east wall D/E. End of bar had been gas cut during de-construction.

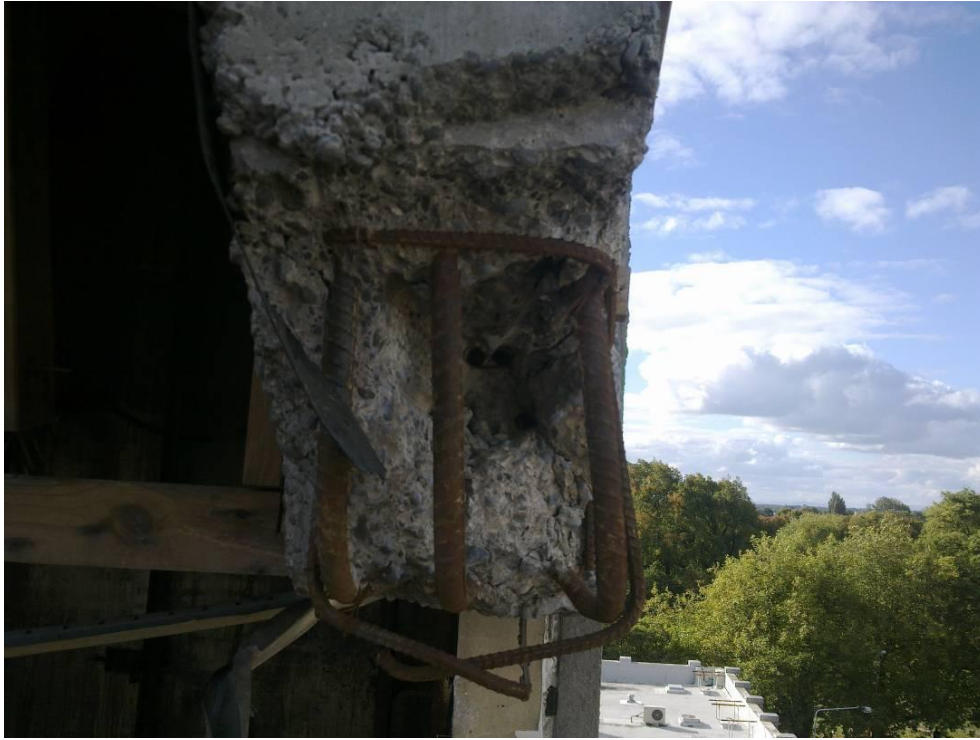
13. The connection of the C18 column (located at Line 4-D/E) into the lift core wall at Level 7 was less than specified and the bars had debonded.
14. A number of circular columns examined showed mid-height hinging failures as well as hinging at the base or head. This was also seen in a column remnant clearly identified as being a perimeter column that had been located between precast spandrel panels. Other circular columns were found full height with hinging damage at the head and base.

Figure 41 - Lift Well Wing Wall D/E: Column D/E 4 Connection (DENG Dwg S14 (Figure 69); 3 x 20 to 24 mm diameter holes could be seen where reinforcing bars from the column had pulled out. The drawing shows that 4-H20 bars were required to be bent into the wall.

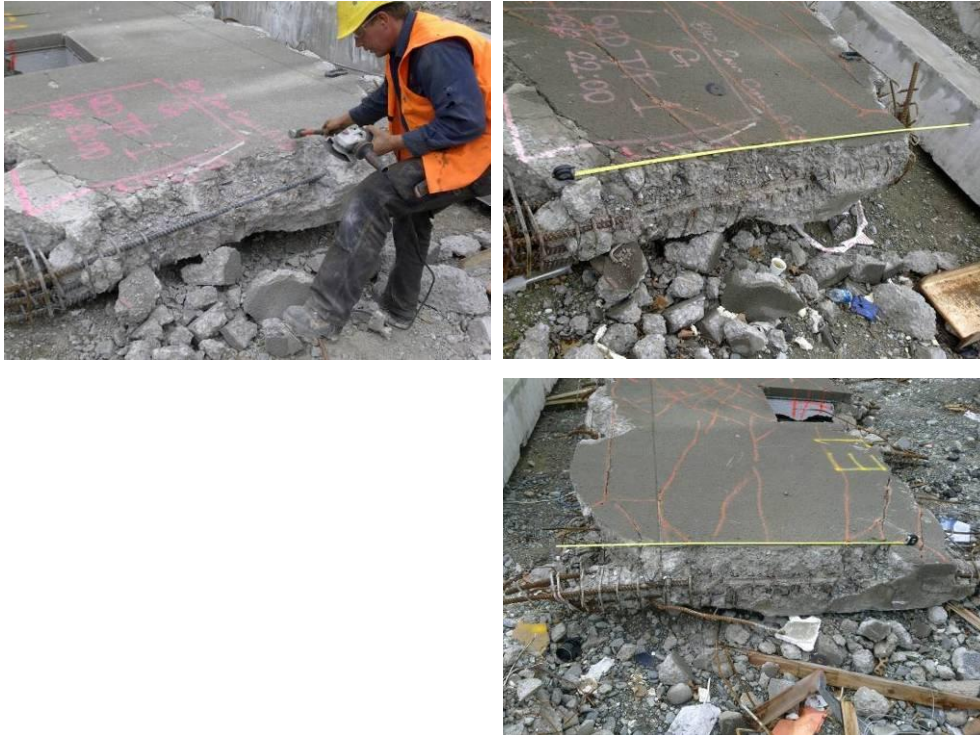
The H28 steel extracted from the lower portion of the Line 1 South Wall EI was found to have elongated 3.3 % more than the other 16 to 28 mm bars extracted. It also had an elevated yield stress. This indicated that the bar had work-hardened during the Aftershock and prior to the collapse of the building (Table 1).

Figure 43 - H28 from east and west end of Line 1 South Wall Item E1 (clockwise from top left) (a) H28 about to be cut from east end (E1E); (b) Top of 1000 mm long E1E sample 1300 mm from top of L2 slab; (c) Top of 1000 mm long E1W sample from west end 750 mm from top of L2 slab. Coupling beam depth was 1700 mm.

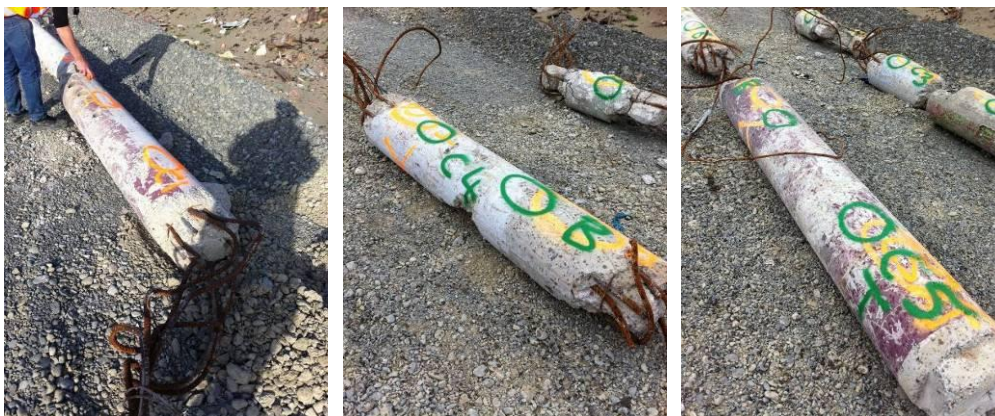
Figure 49 -400 mm diameter columns full height (left to right) (a) Test Item tC1 Level 6 to roof column with base hinging failure, still connected by reinforcing to tC8 below; (b) tC4 hinging top and bottom; (c) tC5 Level 6 to roof column with hinging at base.

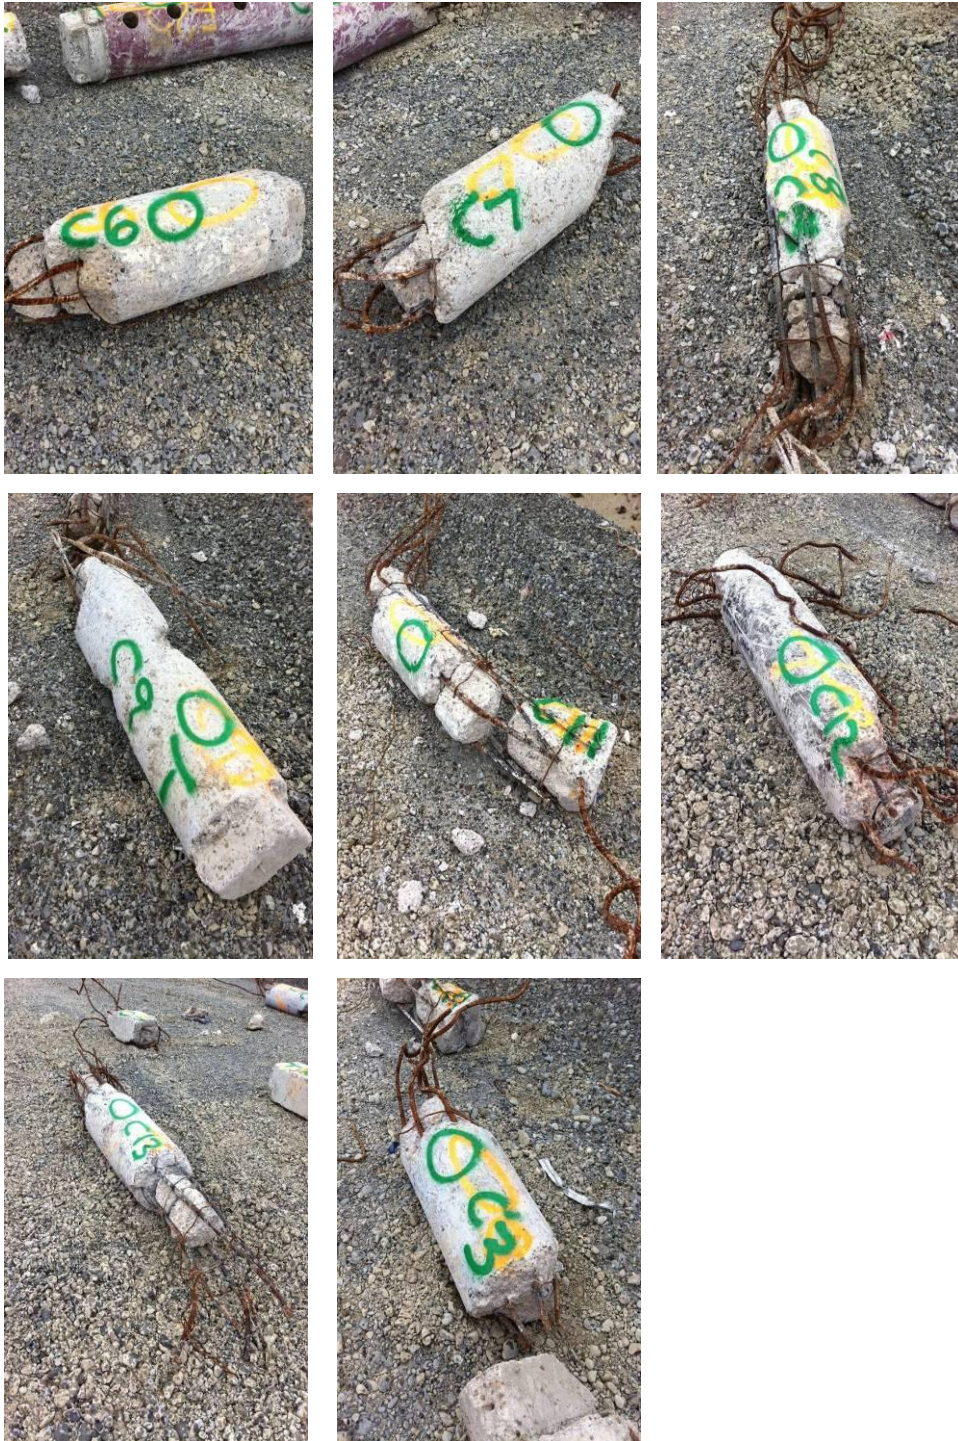
Figure 53 -400 mm Diameter Columns at Burwood showing similar base and/or mid-height failures (Left to right, top row down) (a) Test item tC6 Level 6 column head with mid-height failure; (b) tC7 with base and mid-height failures; (c) tC8 with base flexural (near end) and mid-height spearhead failures; (d) tC9 Level 6 column head with mid-height failure; (e) tC11 base (near end) and mid-height failure; (f) tC12 base and mid-height failure; (g) tC13 base and mid-height flexural failure (near end); (h) tC3 similar to tC13 but lower bars have been cut during de-construction at start of spalling.

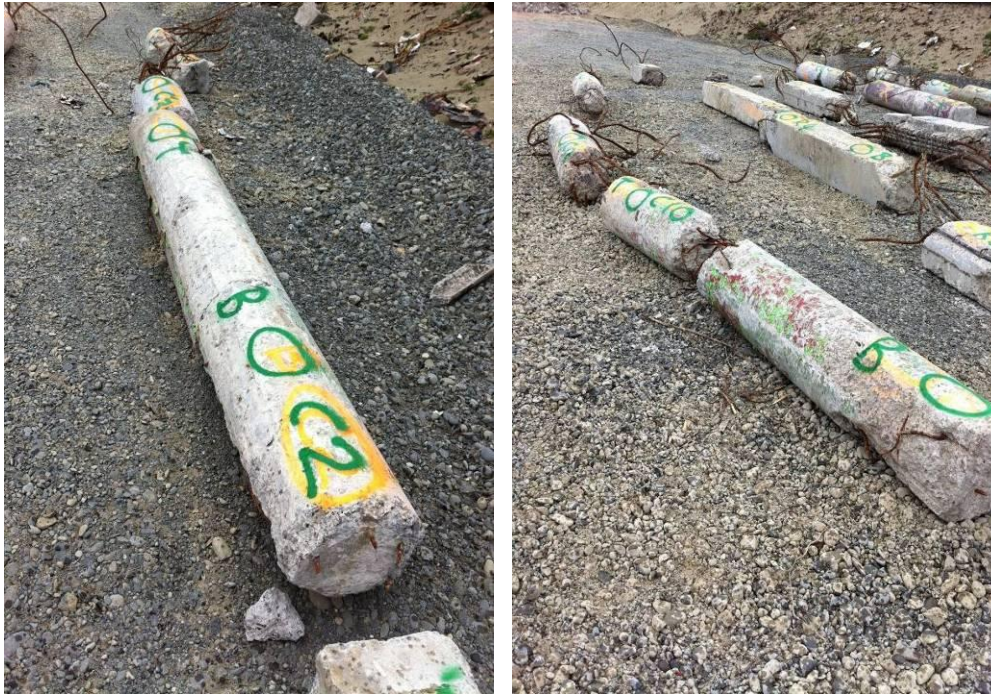
Figure 54 - Level I Entry 400 mm Diameter Columns (left to right) (a) Test item tC2, 6-D12 vertical bars fractured at base (DENG Dwg S14 C23); (b) Item tC10 with down pipe cast in (DENG Dwg S14 C21 or C22)

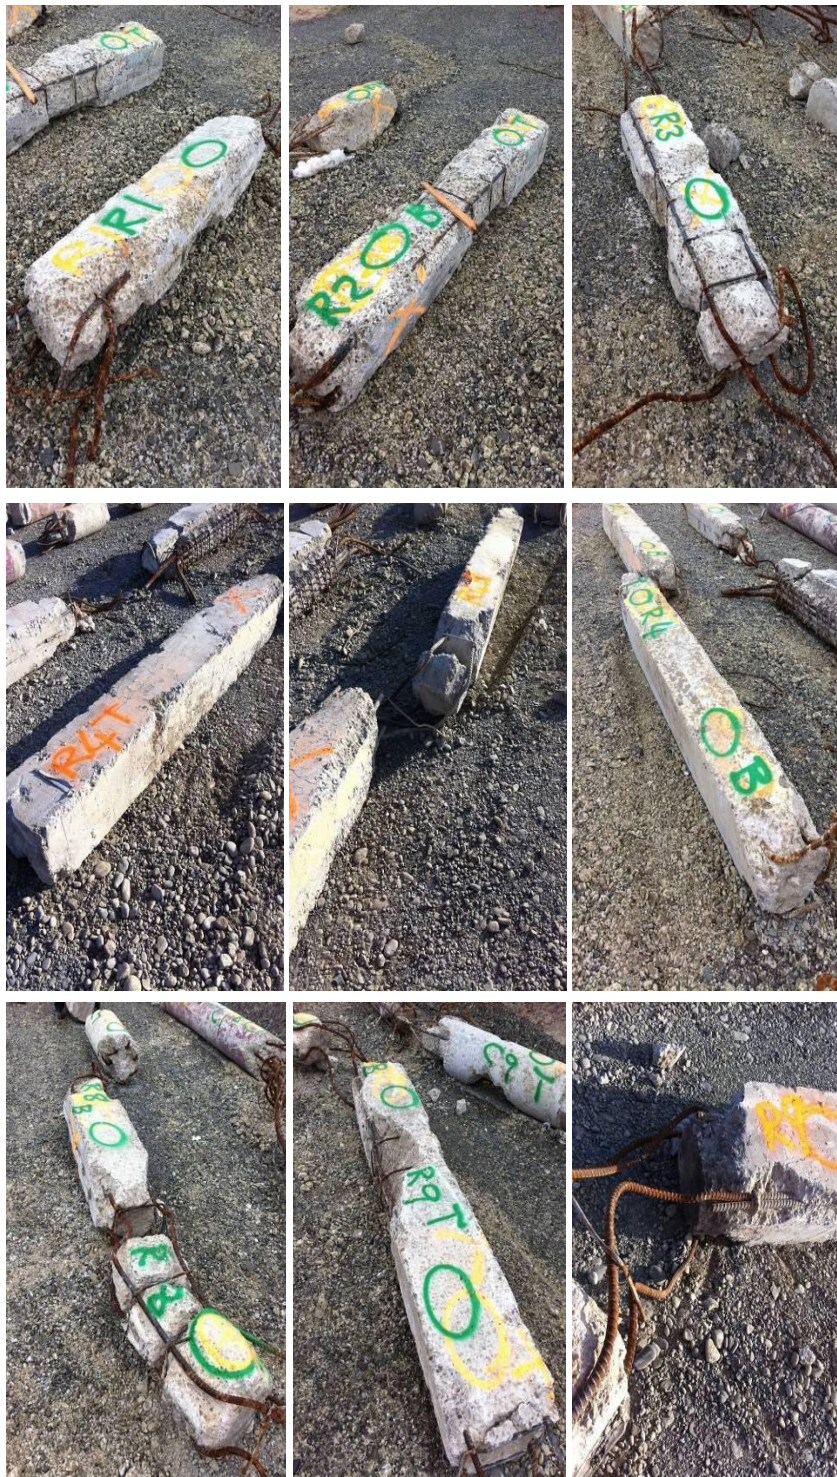
15. Rectangular columns which had all been located on Line A in the structure, typically exhibited beam-column joint failure as well as other damage.

Figure 55 -400 x 300 mm Rectangular Columns (Left to right, top down) (a) tR1 beam-column joint failure at base, mid-height failure; (b) Level 6 to Roof base or beam-column joint failure; (c) tR3 failure base and top; (d) tR4 Level 6 to Roof with beam-column joint failure, still connected by rebar to (e) tR4' below which also (f) indicates beam-column joint failure at tR4' base (near camera); (g) tR8 with damage from mid-height still connected to tR9 above (h) with beam-column joint failure with (i) underside of tR9 smooth.

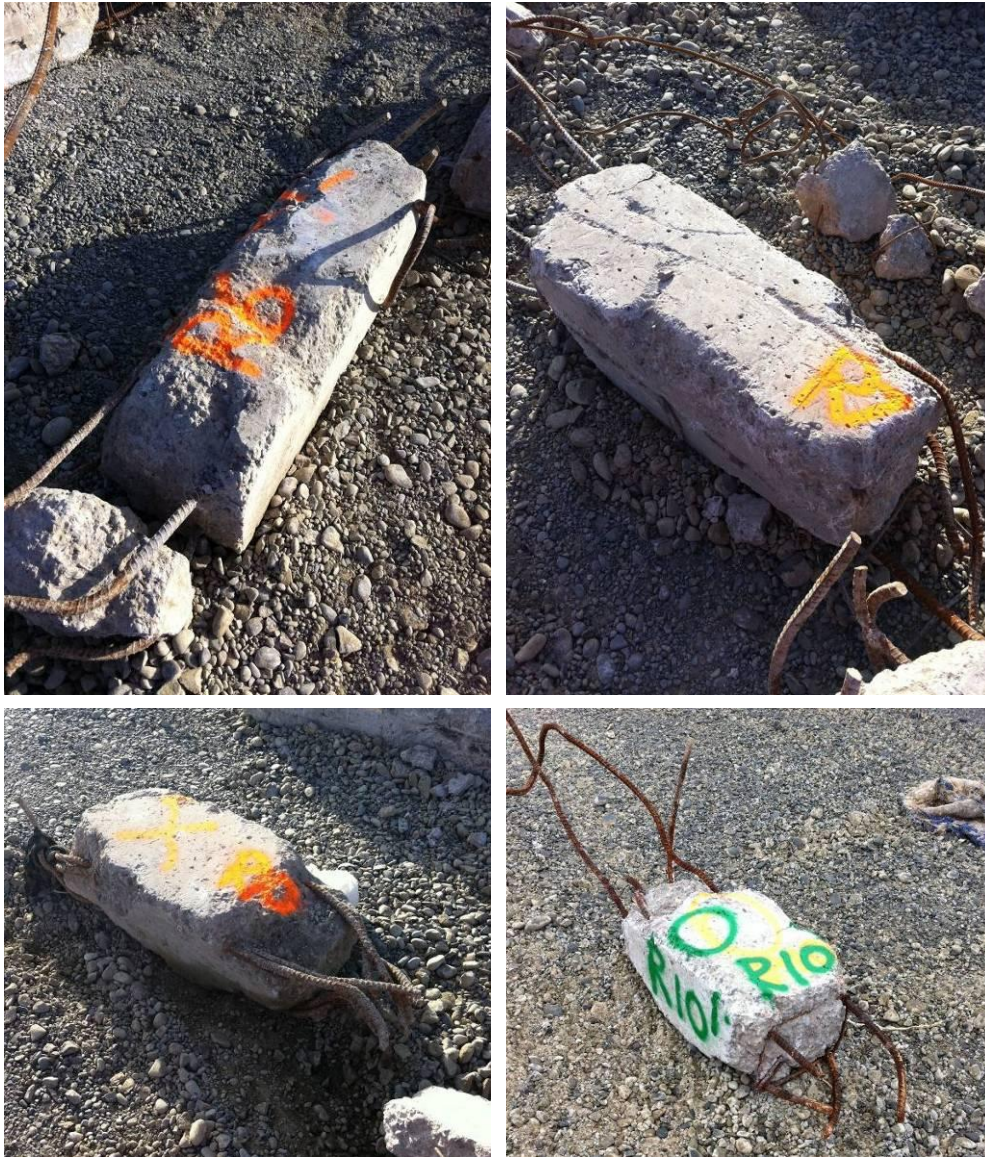
Figure 56 -400 x 300 mm Rectangular Columns (from left to right and top down) (a) tR6 base at far end connected by reinforcing to (b) tR7 below, with beam-column joint failure; (c) tR10 remnant; (d) tR10' remnant

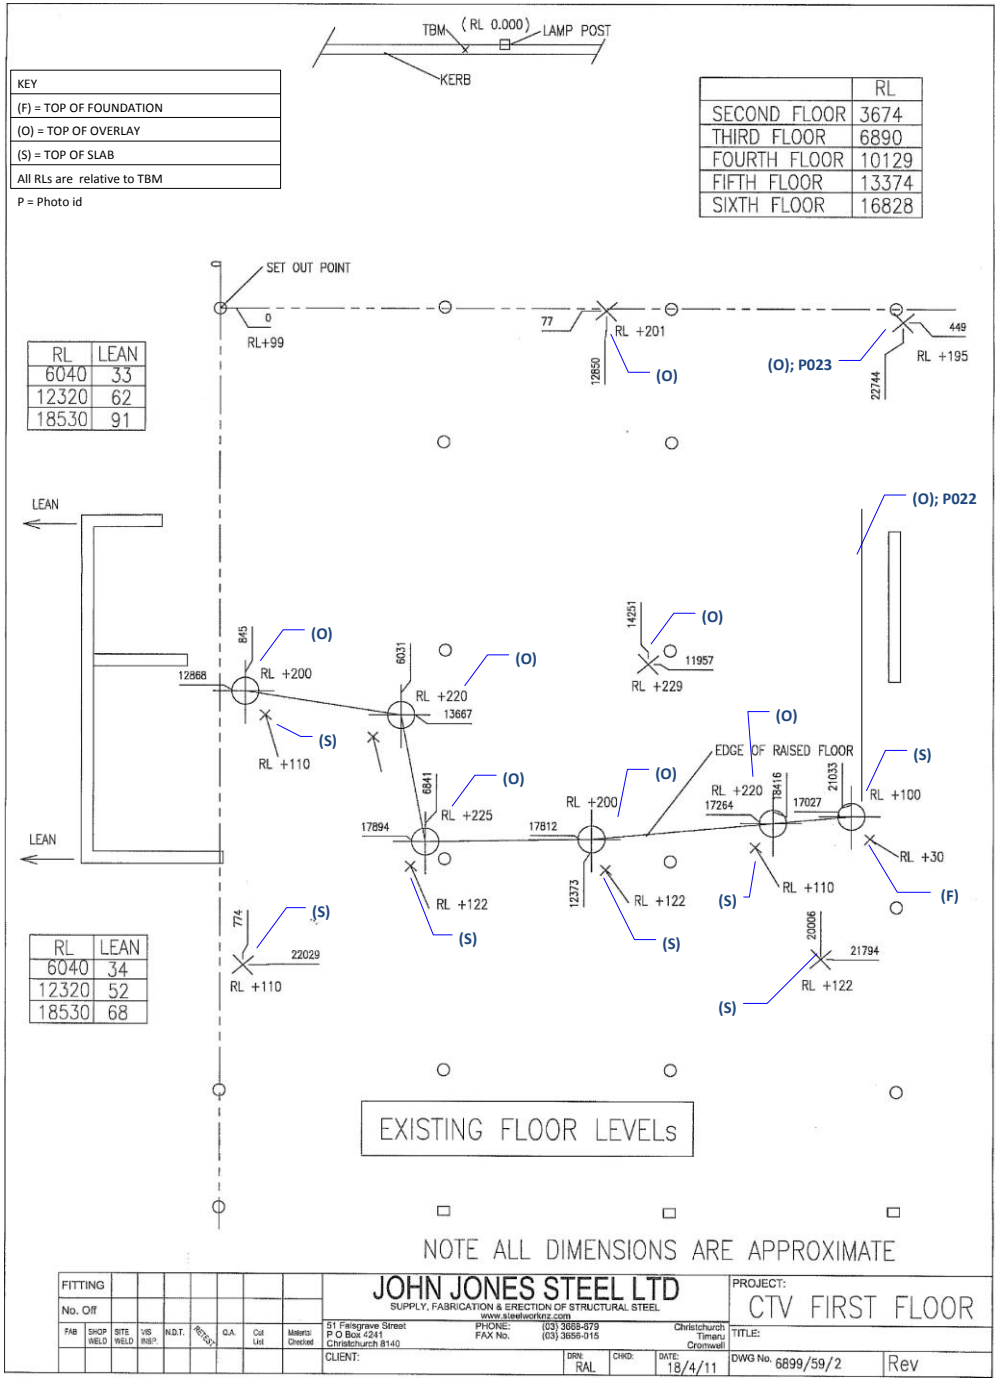
The North Core Line 5 wall was surveyed for verticality by sighting on the eastern and western corners of the north face of the wall. It was found that there was a northwards out-of-vertical measurement of 91 mm over 18.53 m between Level 1 and Level 7 at the northeast corner, and 68 mm over 18.53 m at the northwest corner (Figure 57).

Figure 57 - JJS Dwg 2: Location of overlay edge and lift core lean annotated with levels on adjacent concrete identified as 100mm overlay (O), 125mm slab (S) or foundation beam (F)
