## **CANTERBURY EARTHQUAKE ROYAL COMMISSION**

### **Statement of Marton David Sinclair in relation to Building at 601 – 601A Colombo Street, Christchurch**

## 601/601A Colombo Street

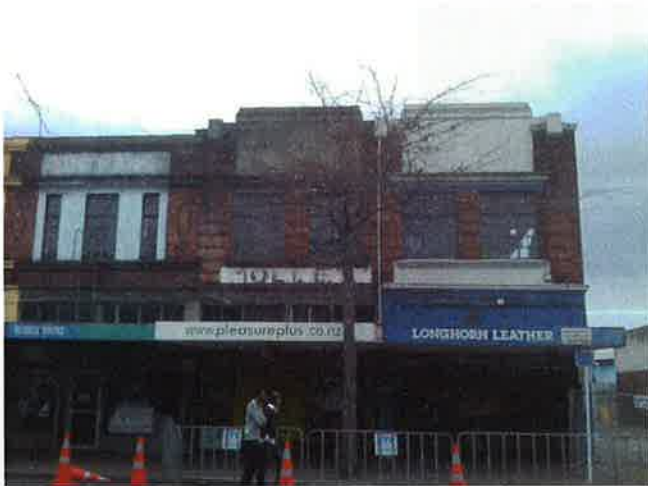
Figure 1 - 601/601A Colombo Street, Mollett Street to right, 16th September 2010

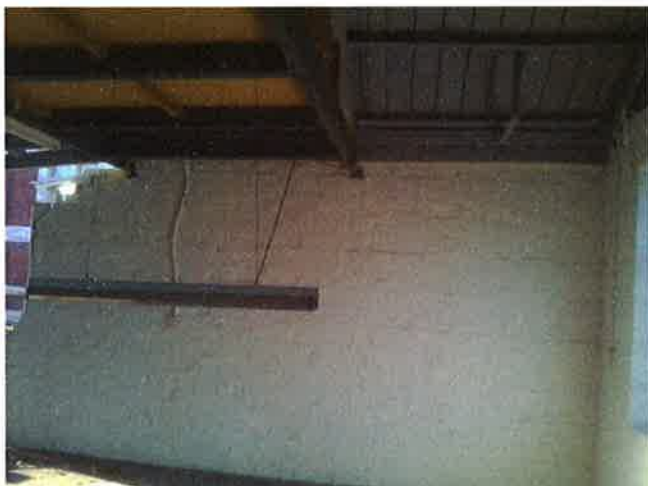
4. A double brick wall on the north side of the building had collapsed onto Mollett Street during the 4<sup>th</sup> September 2010 earthquake leaving the roof partially supported.

Figure 2 - 601A Colombo Street north east interior corner and north wall, 15th September 2010

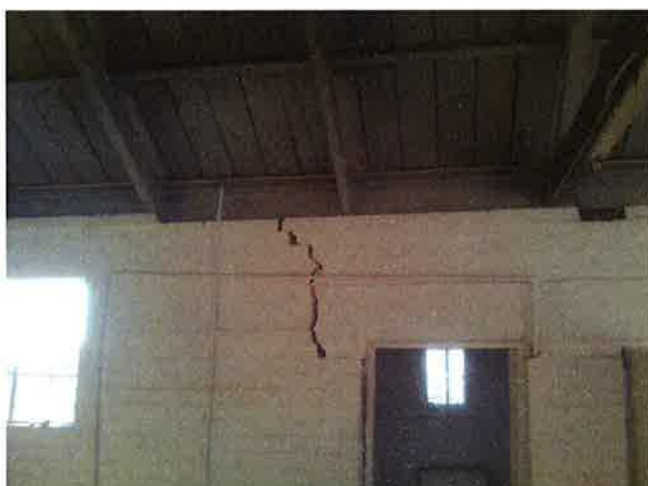
Figure 3 - Crack west wall, 15th September 2010

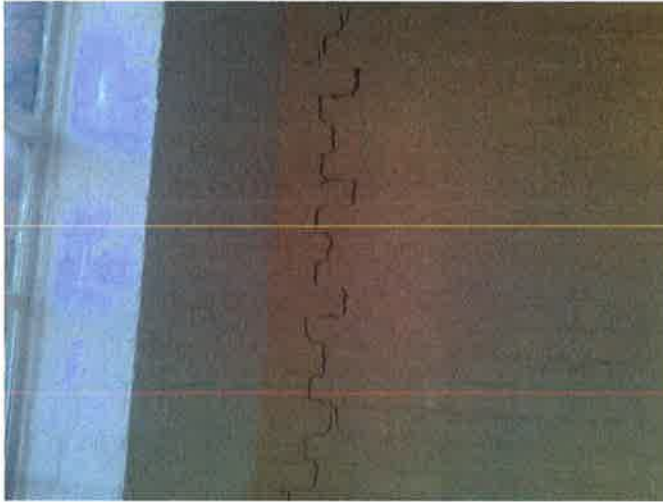
7. Our photographs, taken on the 15<sup>th</sup> September 2010, record that there was a stepped vertical crack in the transverse dividing wall at the south east corner of unit 601A. This crack was related to the predominantly north/south shaking of the September earthquake which had affected the north and south walls rather than the eastern façade fronting onto Colombo Street.

**Figure 4 - Cracking in transverse wall southeast corner, 15<sup>th</sup> September 2010**
