**INDEPENDENT ASSESSMENT ON EARTHQUAKE PERFORMANCE
OF**

151 WORCESTER STREET

**Royal Commission of Inquiry into building failure caused by the Canterbury
Earthquakes**

**Report prepared by Peter C Smith and Jonathan Devine
Spencer Holmes Limited**

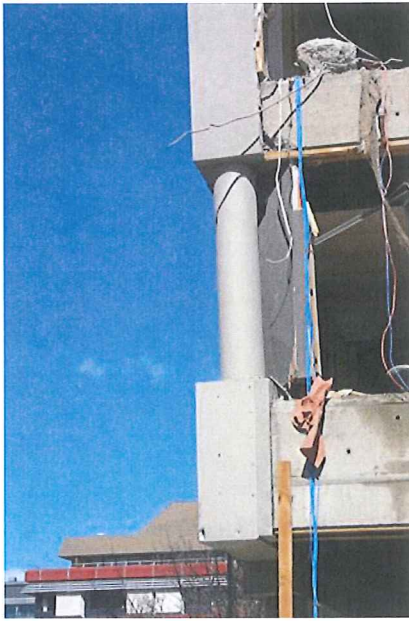
Damage to columns at east end of north wall

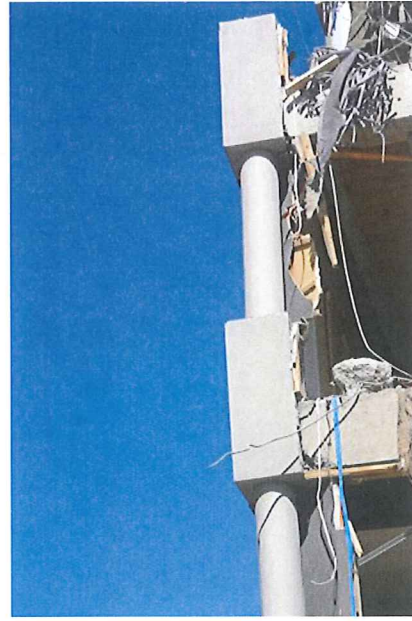
Damage to columns at east end of north wall

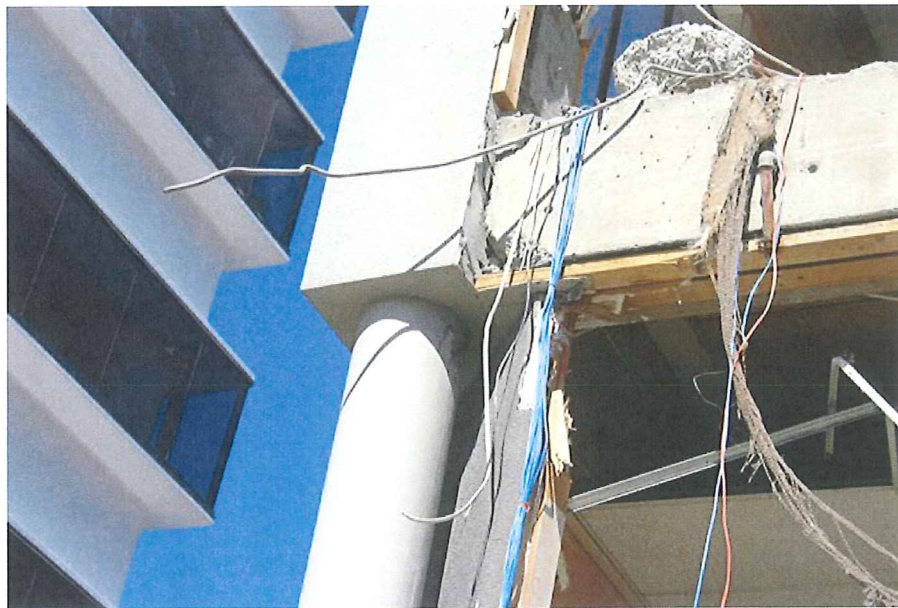
Damage at columns at east end of north wall

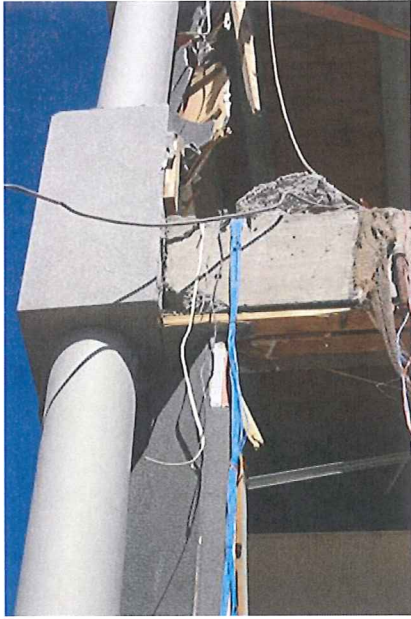
Damage east end north wall frame

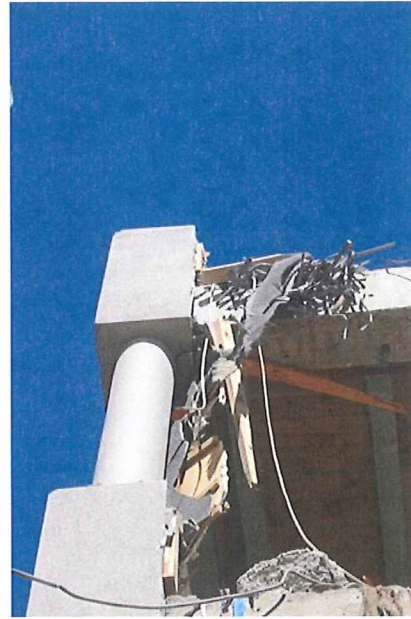
Damage east end north wall frame – upper level

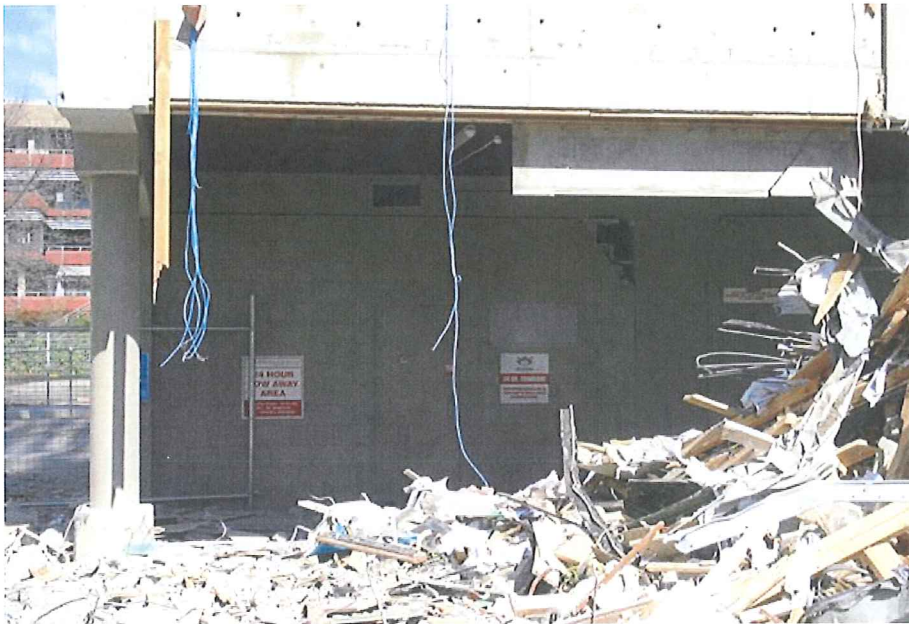
Damage to east end north wall – ground floor

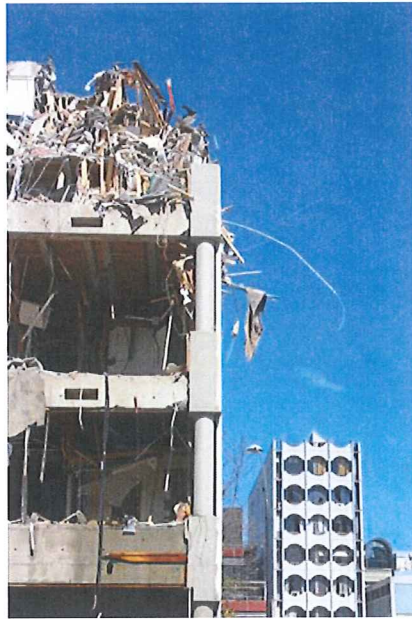
Damage west end north wall frame - upper levels

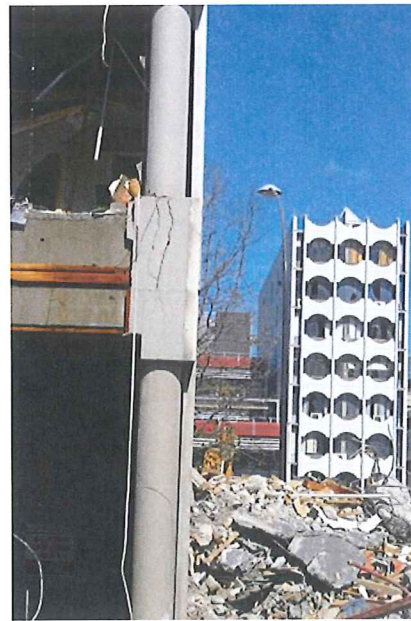
Damage east end north wall frame – lower levels

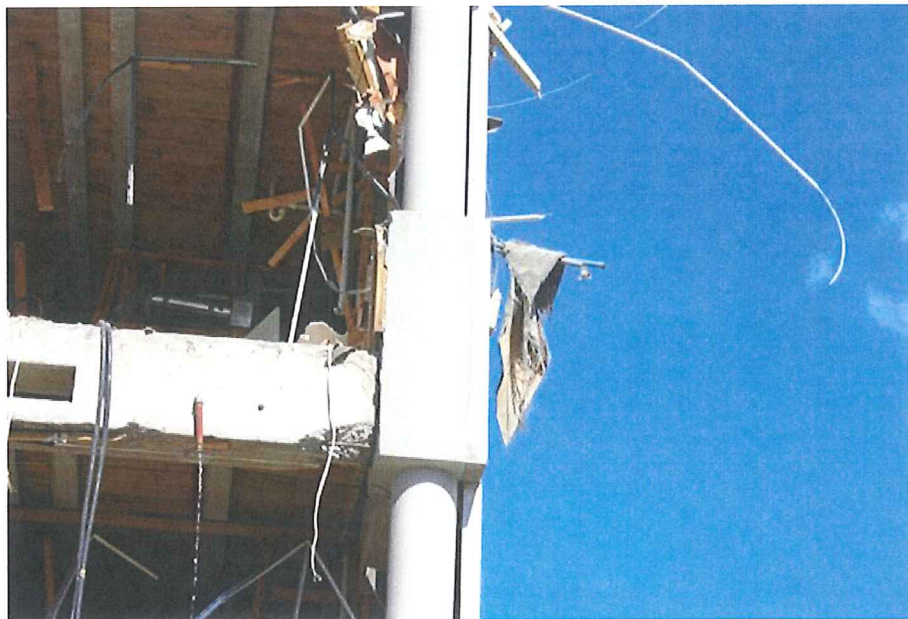
Damage to west end of north wall frame – lower levels

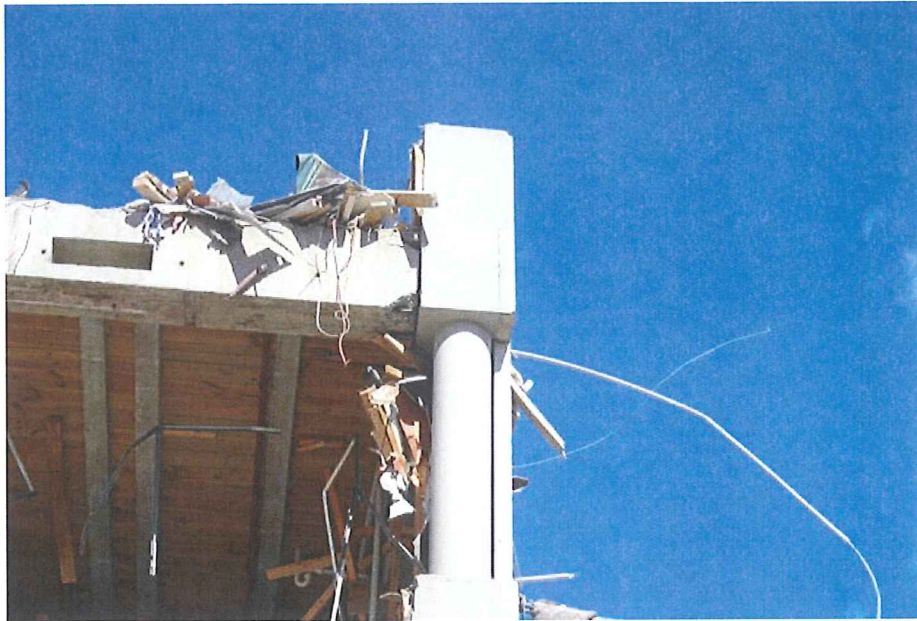
Damage to west end of north wall frame - upper levels

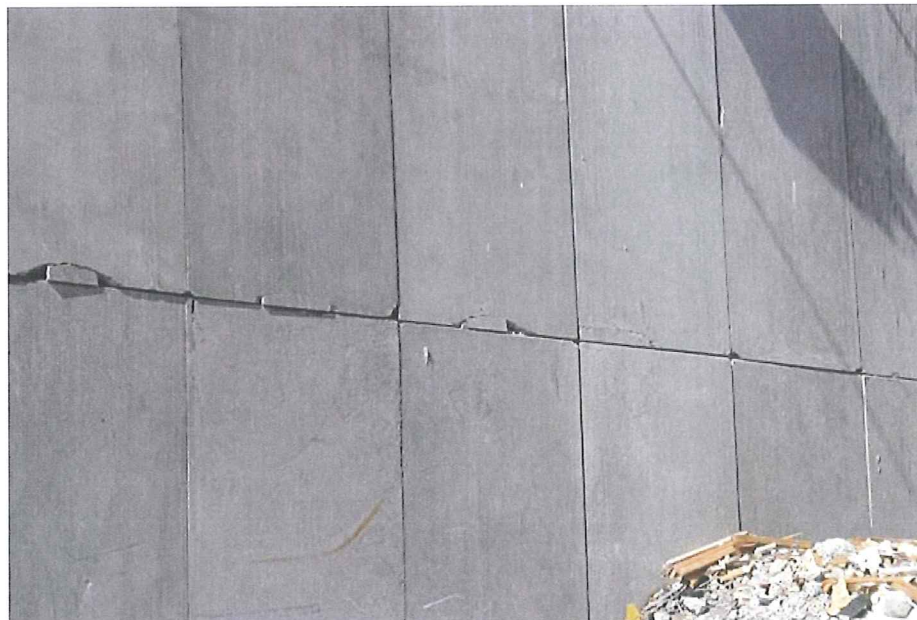
- Damage to the pre-cast concrete wall cladding panels on the west wall. The panels were detailed with mid panel connections top and bottom and at mid-height between floors with a 15mm clearance all round.

It appears that mortar and weathering sealants reduced the clearance such that the rotation induced by inter-storey lateral deflections of the building resulted in compression crushing and spalling at panel corners and excess tension at the lower connection, causing severe cracking and spalling at the base of the panels. The top connections (with a stronger detail) were relatively unaffected.

Damage to panels west wall – lower levels

Effective separation of non structural elements such as precast panels and stiff block work walls is important to achieving reliable structural performance. It is suggested that seismic separation should be provided for an adequate margin beyond the calculated ultimate limit state deformations.

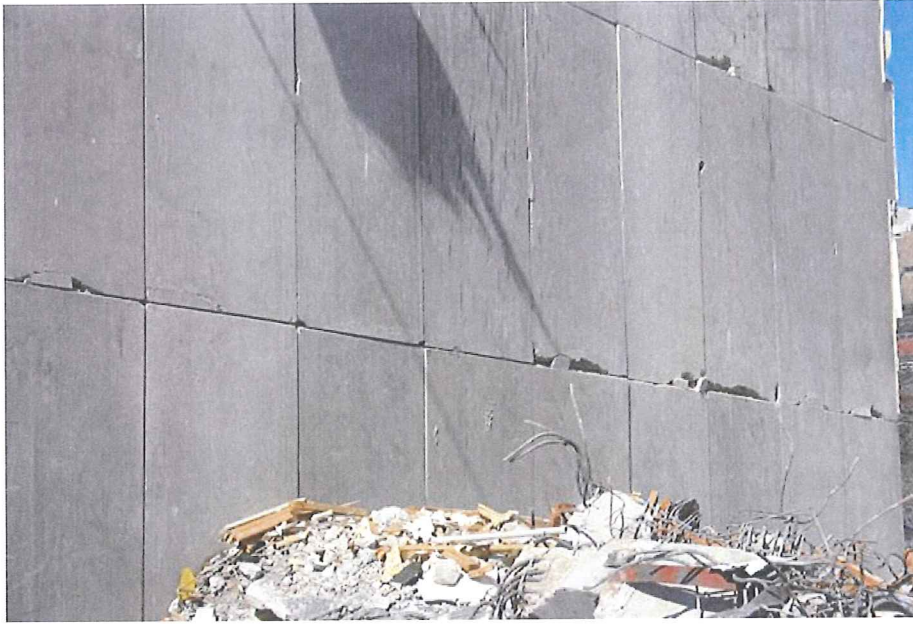
Damage to panels lower level of west wall

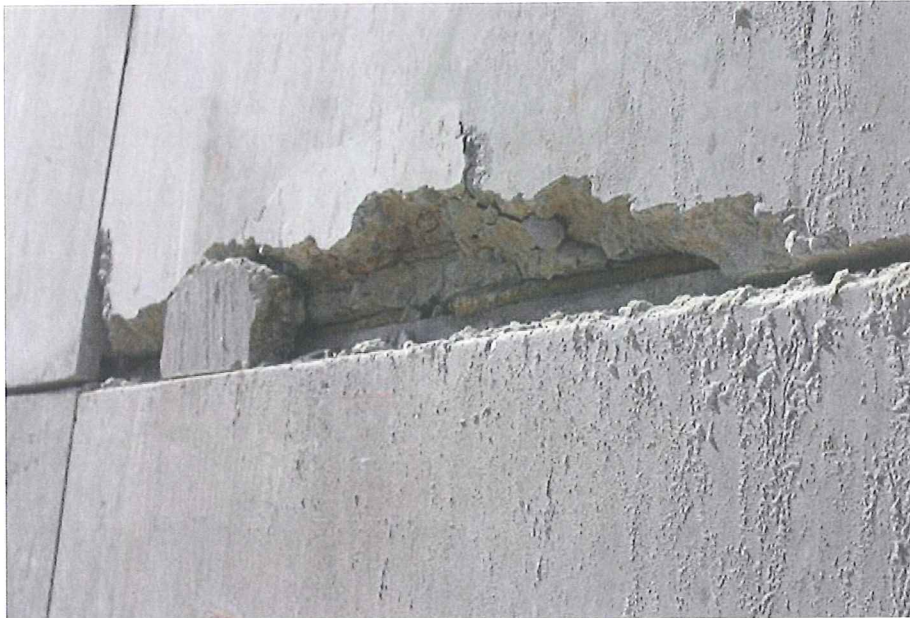
Damage to lower level of precast panels

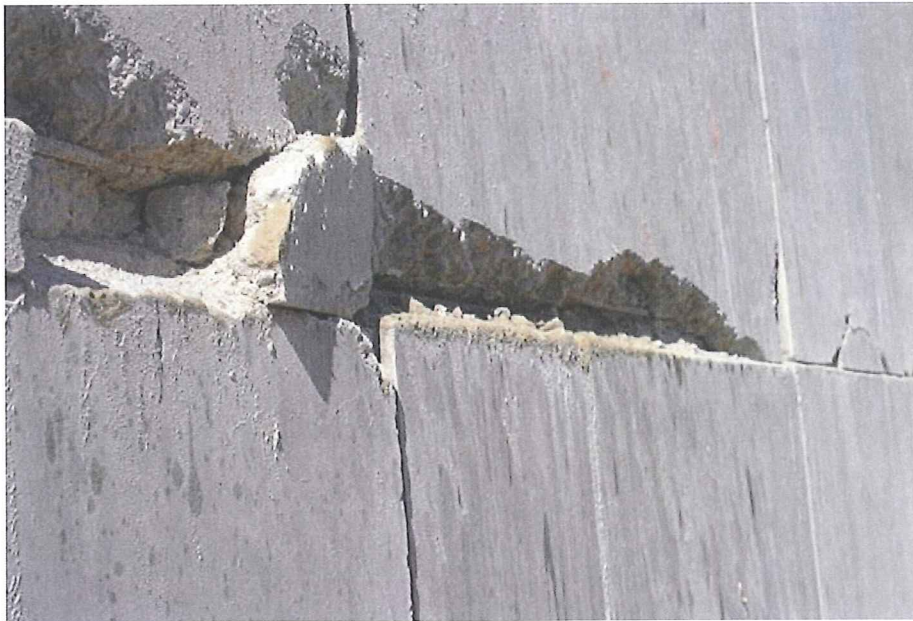
The extent of damage at the horizontal junction of the precast panels demonstrate that these elements were not effectively structurally isolated from the west wall frame. The panels are detailed as having a 15mm seismic separation, but this does not appear to have been provided during construction, possibly due to the use of shims and mortar. During the earthquake these joints locked up as the frame would be expected to have an inter-storey deflection of 80mm at 2.5% drift, significantly more than the movement joints could have sustained. The effect of the lack of separation is assessed as causing the centre of rigidity to shift towards the west wall and to induce a significantly greater torsional response in the building than that which would have been taken into consideration in the design of the building.

Damage to precast panels – west wall

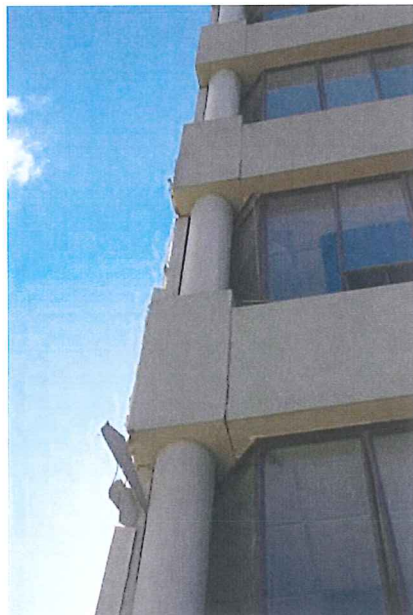
Damage to south wall frame

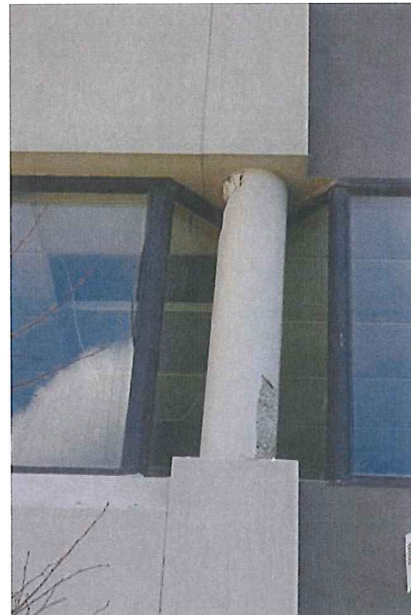
Damage to south wall frame

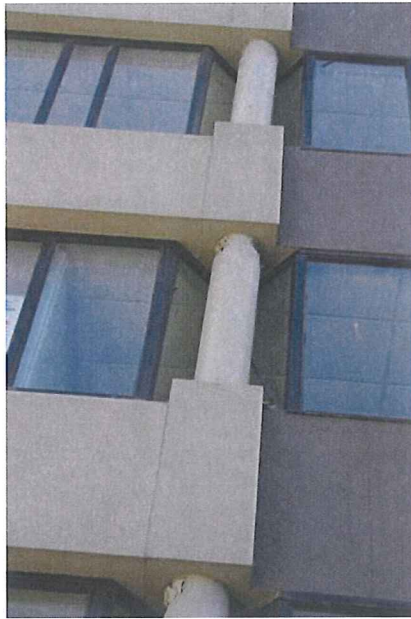
Damage to south wall frame

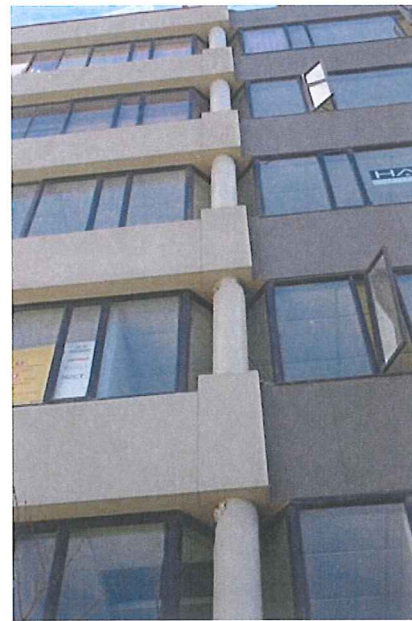
Damage to south wall frame

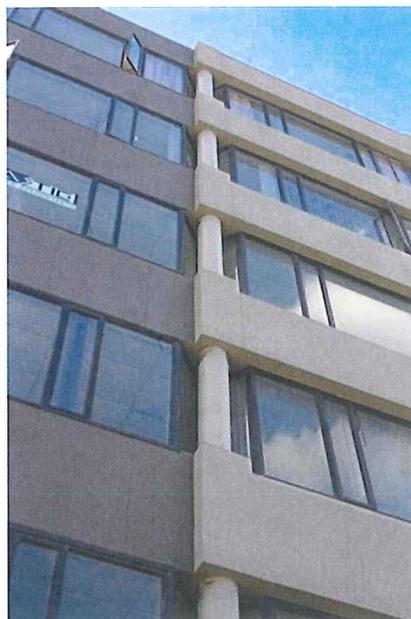
Damage to south wall frame

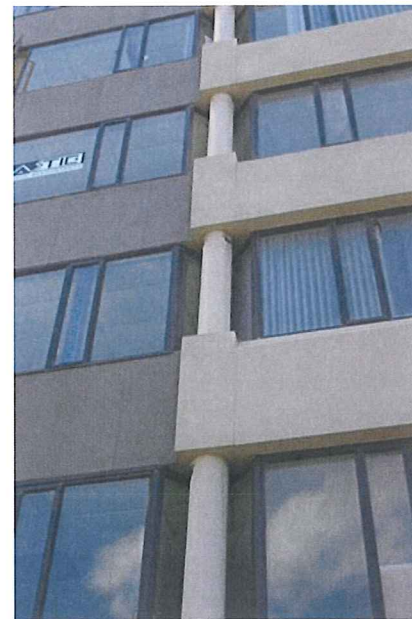
Damage to south wall frame

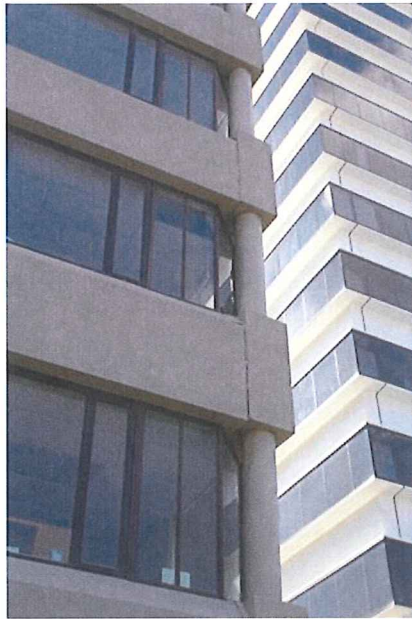
Damage to east end south wall frame

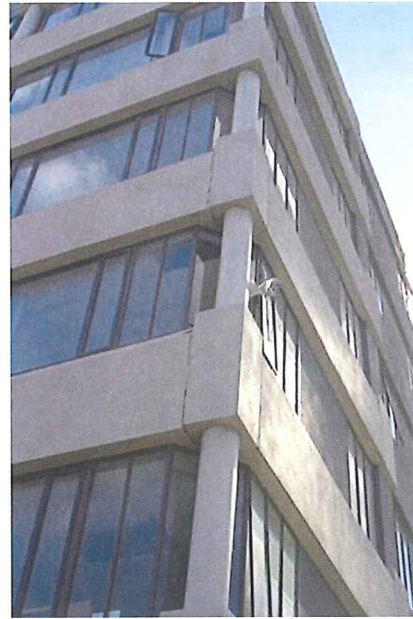
Damage to east end south wall frame

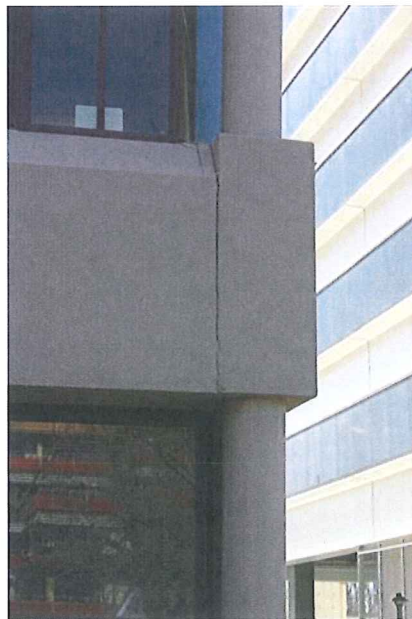
Damage to east end south wall frame

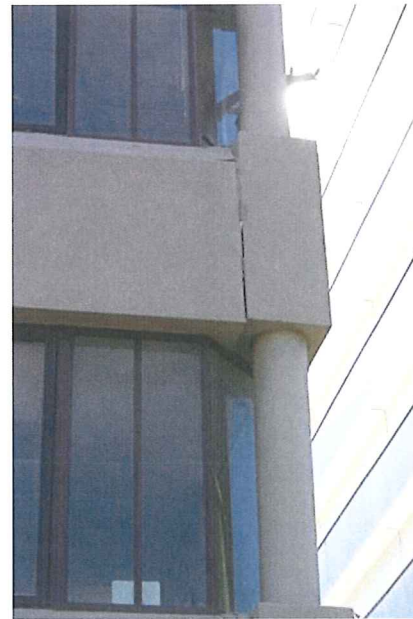
Damage to east end south wall frame

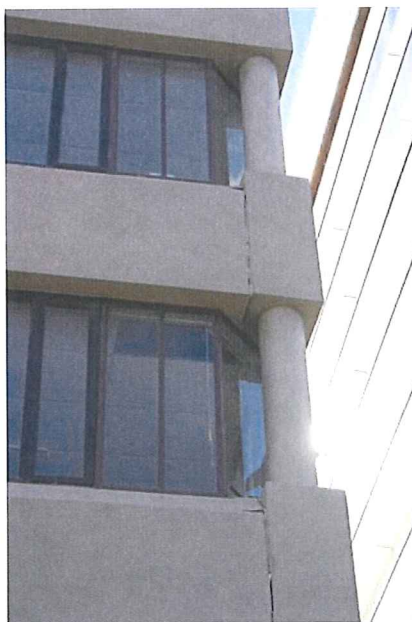
Damage to east end south wall frame
