**INDEPENDENT ASSESSMENT ON EARTHQUAKE PERFORMANCE
OF**

WESTPAC TOWER – 166 CASHEL STREET

**Royal Commission of Inquiry into building failure caused by the Canterbury
Earthquakes**

**Report prepared by Peter C Smith and Vaughan England
Spencer Holmes Limited**

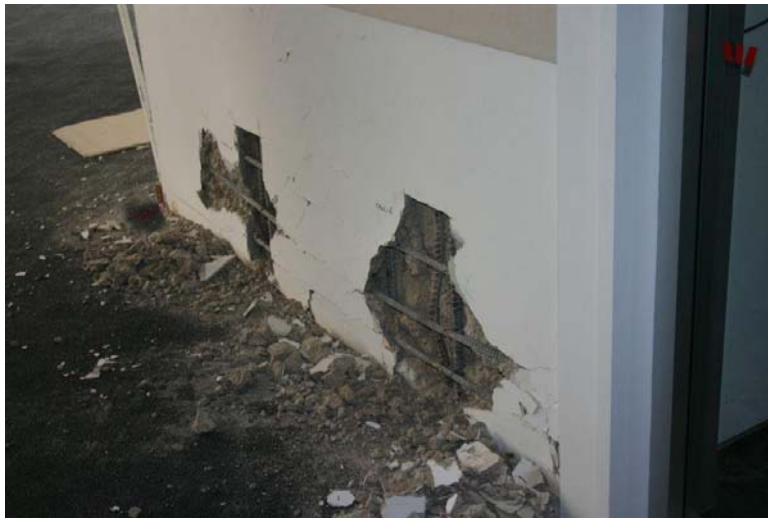
Inspection of the shear core walls establishes that the more significant inelastic deformation and spalling of the walls occurred above level 2. The walls were designed on the assumption that inelastic deformations would occur below level 1 where the end zones of the walls were detailed with greater confinement.

Spalling of shear wall level 1

- It is suggested that ductile detailing of shear walls should not end abruptly, but extend above expected zones of inelastic deformation and reduce gradually to prevent a brittle failure of upper levels.
- For thin walls subject to inelastic deformations, further consideration needs to be given to the resilience of the concrete core of the wall, and in particular the ability to confine an adequate end region to resist compression loads following spalling under repeated inelastic deformations.
- Consideration needs to be given to the confinement and lateral restraint of horizontal reinforcement following spalling of cover concrete under repeated inelastic deformations. It is suggested that both the horizontal reinforcement and vertical reinforcement should be enclosed with ties, thereby restraining both the vertical and

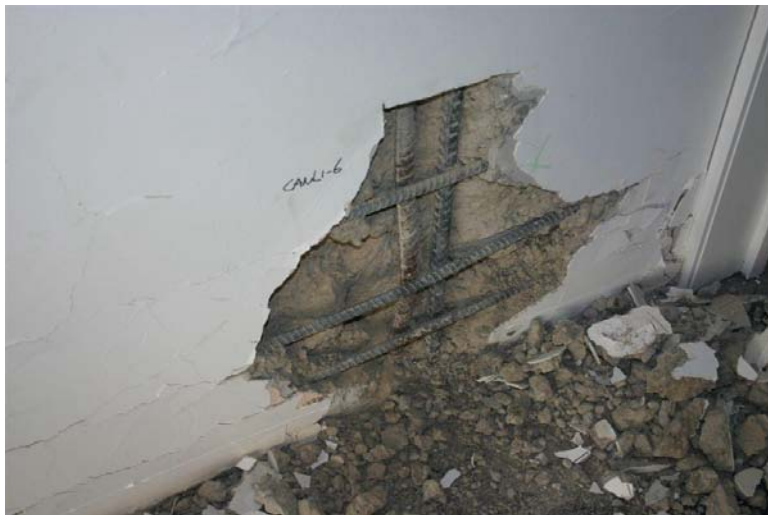
Buckling of the main tensile reinforcement occurred in the areas of greatest inelastic deformation. (Refer Photos in Appendix 3). The importance of maintaining stirrup spacing at distances that prevent buckling of longitudinal reinforcement is obvious. The spacing of stirrups in the area of main reinforcement buckling was measured as 120mm. The longitudinal reinforcement size that buckled was 16mm deformed bar (D16), giving a relative spacing of 7.5 diameters. The spacing of lateral restraint reinforcement detailed on the plans was 100mm, or 6.25 diameters, which is close to the current code requirements of 6 diameters. Refer photo in Appendix 3. The difference of 20mm emphasises the importance of engineering inspection of those aspects of construction that are critical to achieving the inelastic performance necessary to achieve the design level of ductility. As the performance of the building under seismic loading is determined by the widest spacing of stirrups in the areas of inelastic demand, consideration should be given to all areas of expected inelastic deformation being inspected and approved to level CM4 construction monitoring.

Buckling of vertical reinforcement level 1

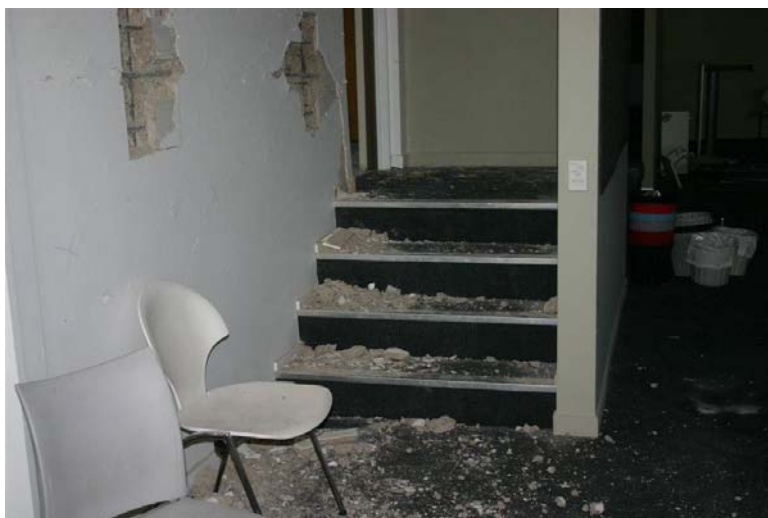
Spalling of shear wall level 2

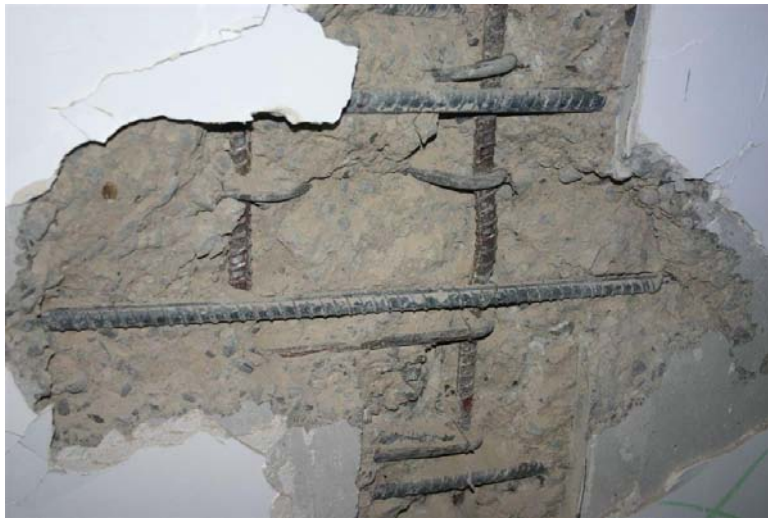
Buckling of vertical reinforcement level 2

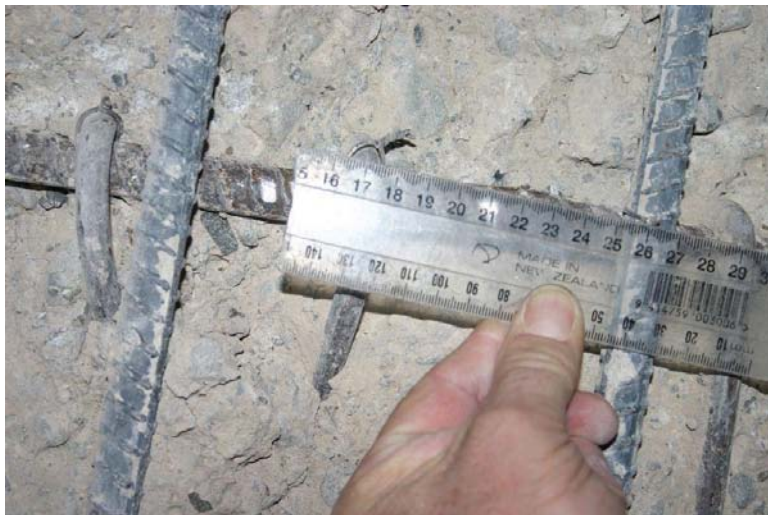
Variation in spacing of restraint at location where reinforcement has buckled

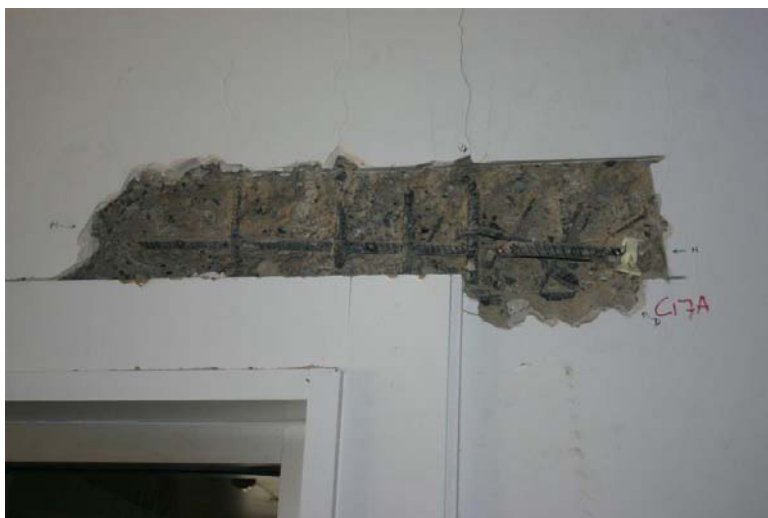
Buckling of reinforcement at corner of shear wall coupling beam

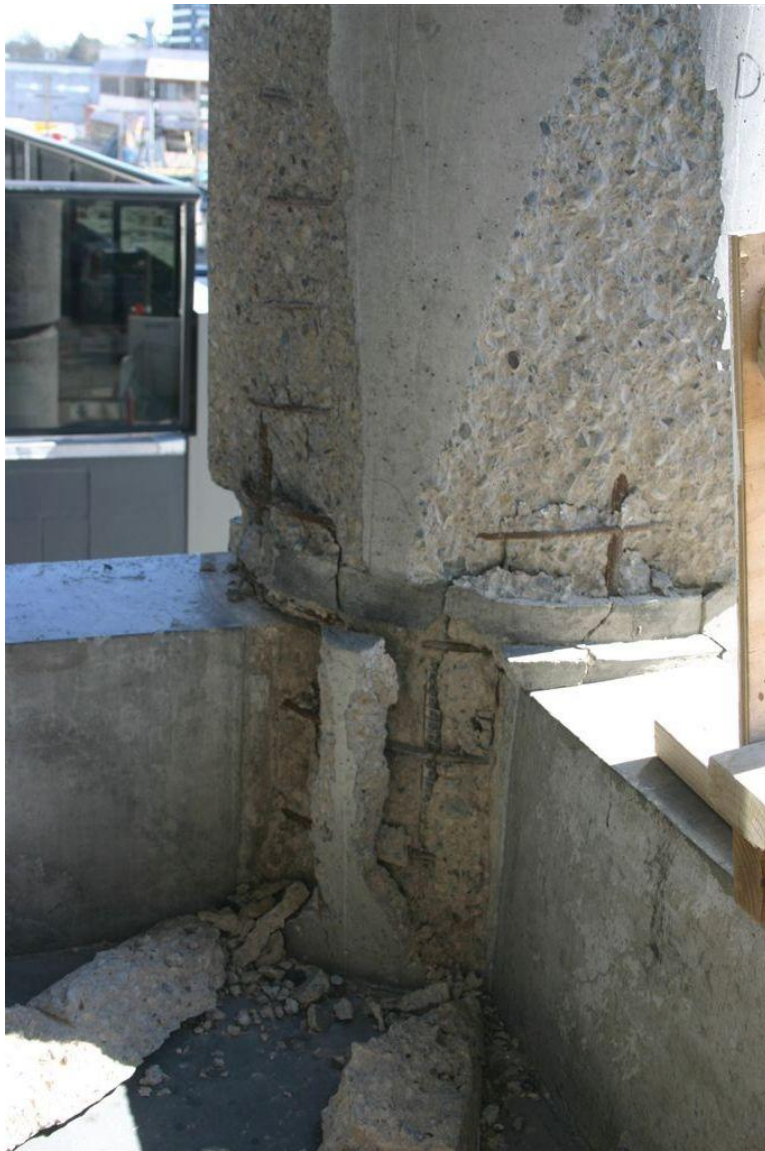
A noticeable feature of the damage to the 900mm diameter columns to the perimeter of the Tower is the depth of cover and the steep angle of the interface of the spalled concrete, an interface that extended over half the height of some columns (Refer to photos in Appendix 3).

The use of cover concrete in excess of the minimum requirements not only creates a danger from falling concrete, but also results in a greater loss of strength when spalling occurs than where minimum code cover was provided.

Spalling of circular external column

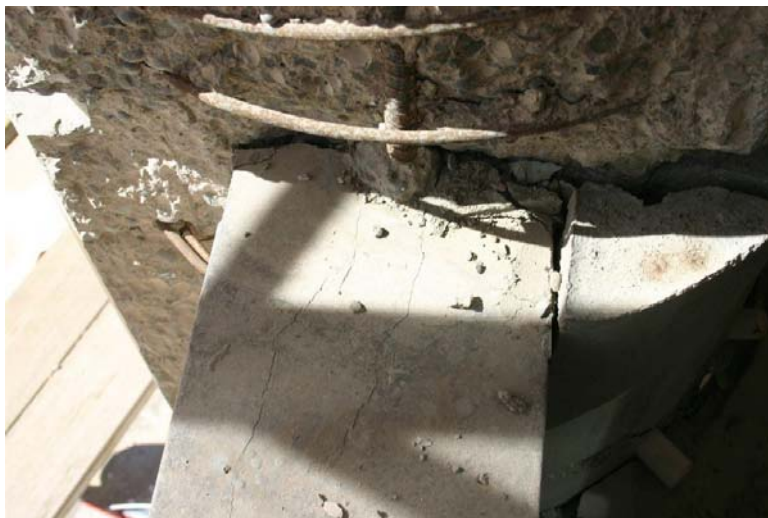
The presence of construction joints within the columns at the pre-cast truss column junction created by seating the ends of the pre-cast trusses on the 900mm circular columns during construction of the building contributed to the extent of damage at the pre-cast truss- 900mm dia column connections. Continuing the spiral column reinforcement through the depth of the truss by use of spirals proved reasonably effective in protecting the column at the joint, but the weakness induced through the projection of the pre-cast truss into the column reduced the resilience of the joint. Testing of the concrete to the circular in-situ columns established concrete strength in the order of 20-25MPa. The concrete strength to the precast truss is yet to be tested but it is expected that the concrete strength of the trusses was approximately double that of the columns. The significant difference in strength combined with the projection of the truss into the column is assessed to have significantly contributed to the damage that occurred to the pre-cast truss-columns at the joint.

Spalling of circular external column at junction with pre-cast truss

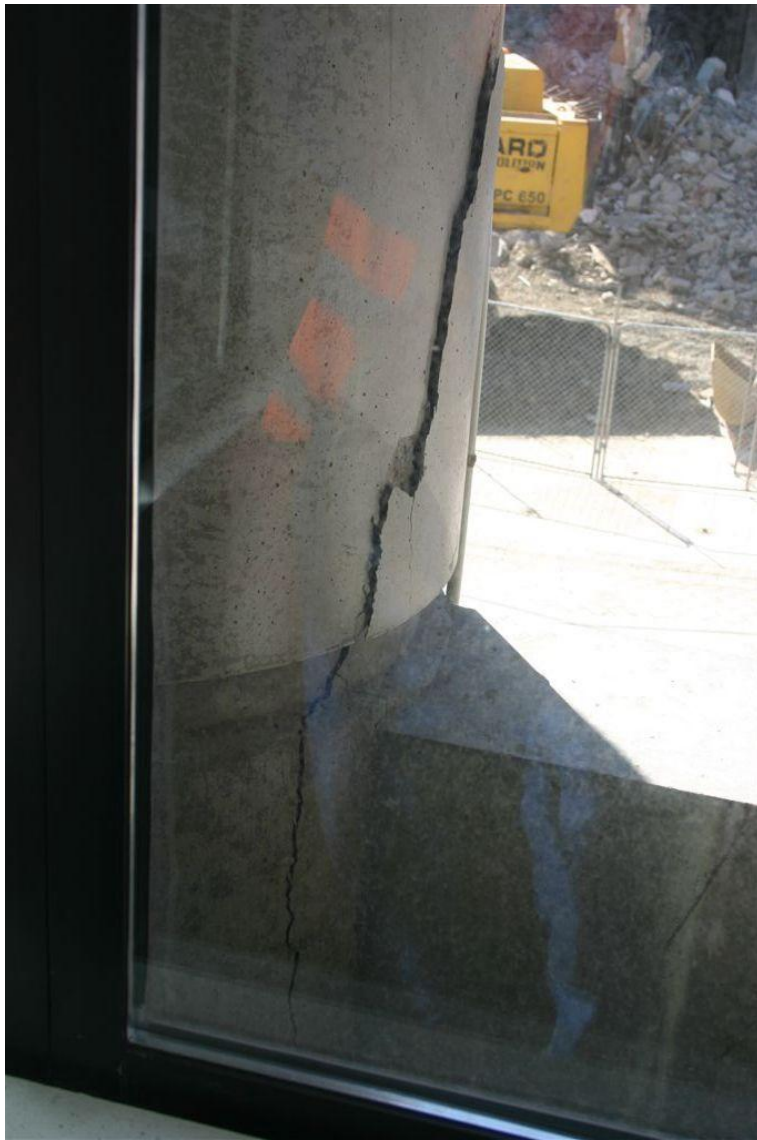
Spalling of circular external column

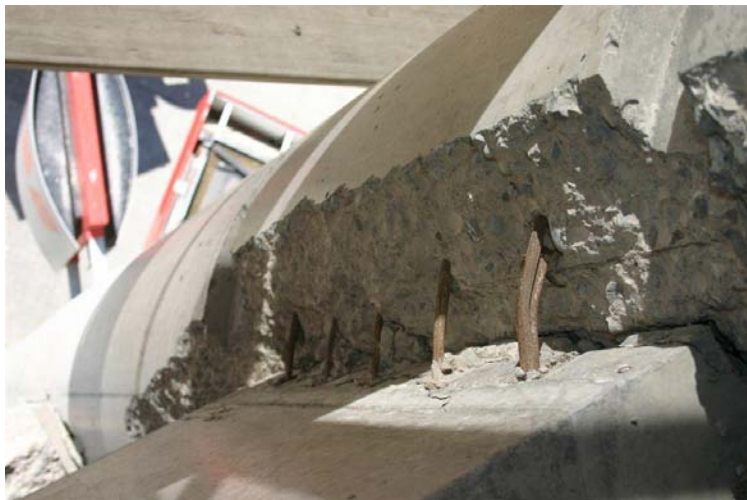
Spalling of circular external column at junction with pre-cast truss

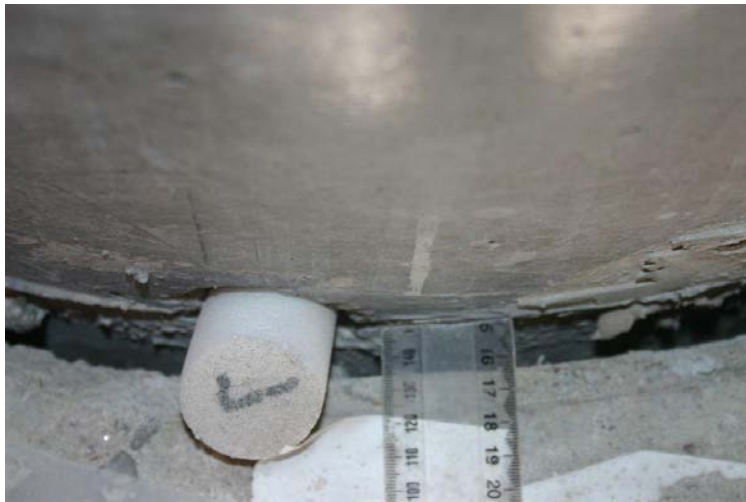
Outward movement of the 900mm diameter columns due to inelastic deformations at the pre-cast truss-column interface has also caused outward movements between the truss and the floor over a distance of several metres either side of the columns. This movement has likely caused a failure of the 50mm deep inserts embedded in the 100mm thick up-stand of the pre-cast trusses, or failure of the starters threaded into the inserts under the forces induced through inelastic deformations at the truss-column connection. Furthermore, the use of shallow inserts or inserts embedded in thin singly reinforced concrete elements in such situations is not recommended.

Tearing between pre-cast truss and floor

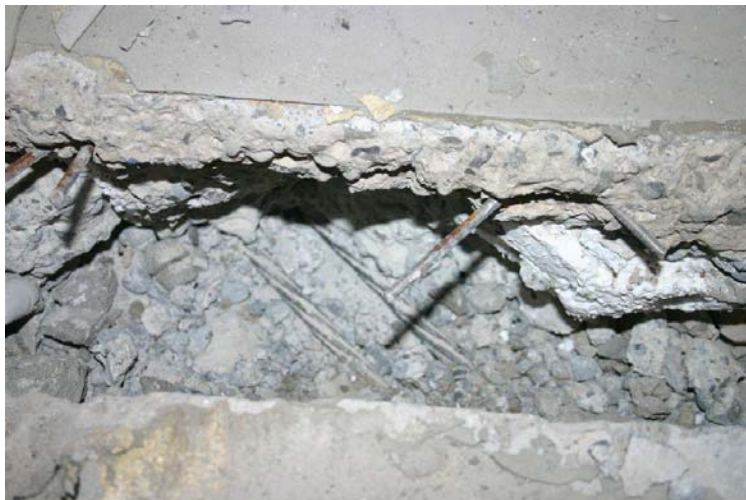
The concrete either side of the level 1 seismic joint is damaged indicating that combined inter-storey deflections at this location exceeded the as-constructed joint width. The joint is detailed as having 25mm of movement between the tower and the podium at level 1 and 2.

Damage to seismic joint

- Seismic joints need to be sized to provide for an adequate margin above the combined elastic and inelastic deformations of adjacent buildings under the ultimate limit state.
- It is suggested that even where sufficient seismic gaps have been provided for an ultimate limit state event, robust detailing be specifically required in areas where impact of adjacent structures may cause critical damage. This will provide resilience of the structure under the occurrence of higher than expected displacements, and under the maximum credible earthquake load case.

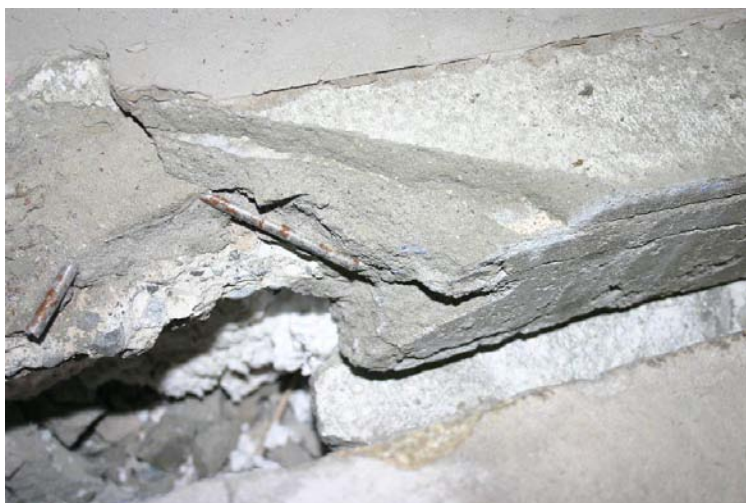
Damage to seismic joint

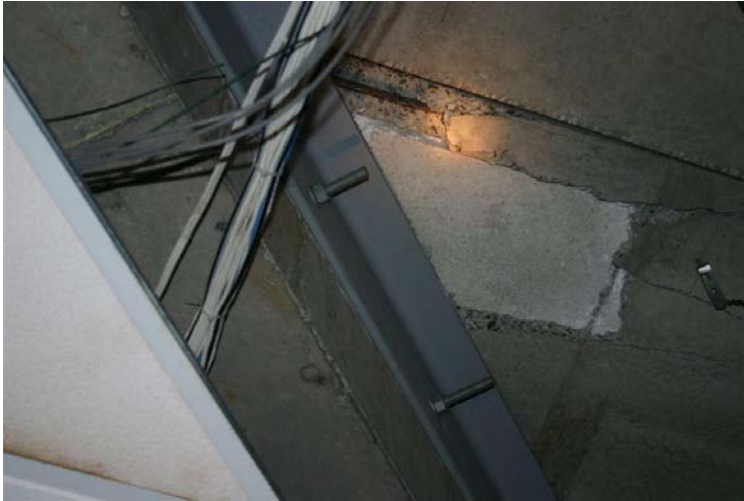
Retrofitted steel angles for seating of Dycore floor units

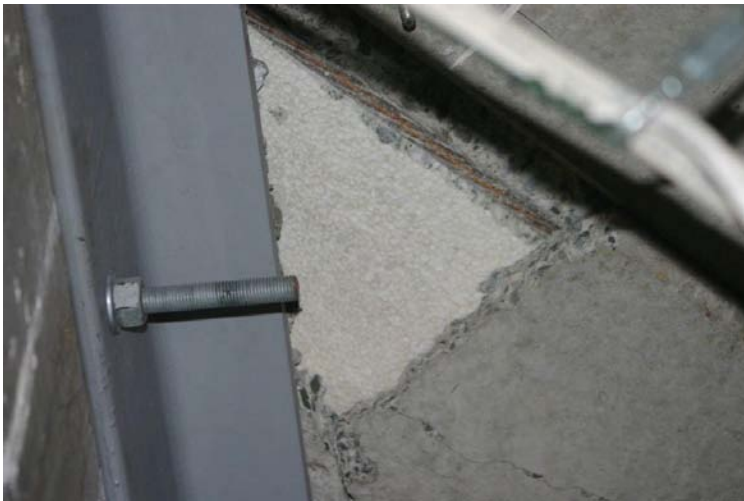
Spalling of Dycore concrete has exposed the pre-stressing strand

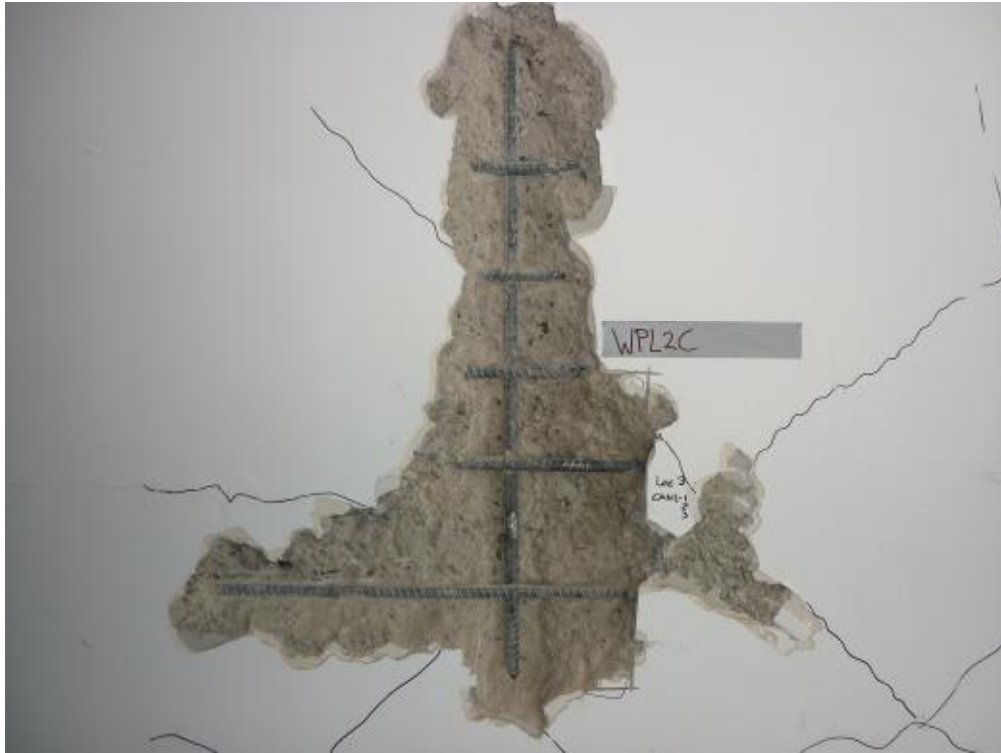
Figure 8 *Exposed reinforcing steel in zone of damage in wall element*

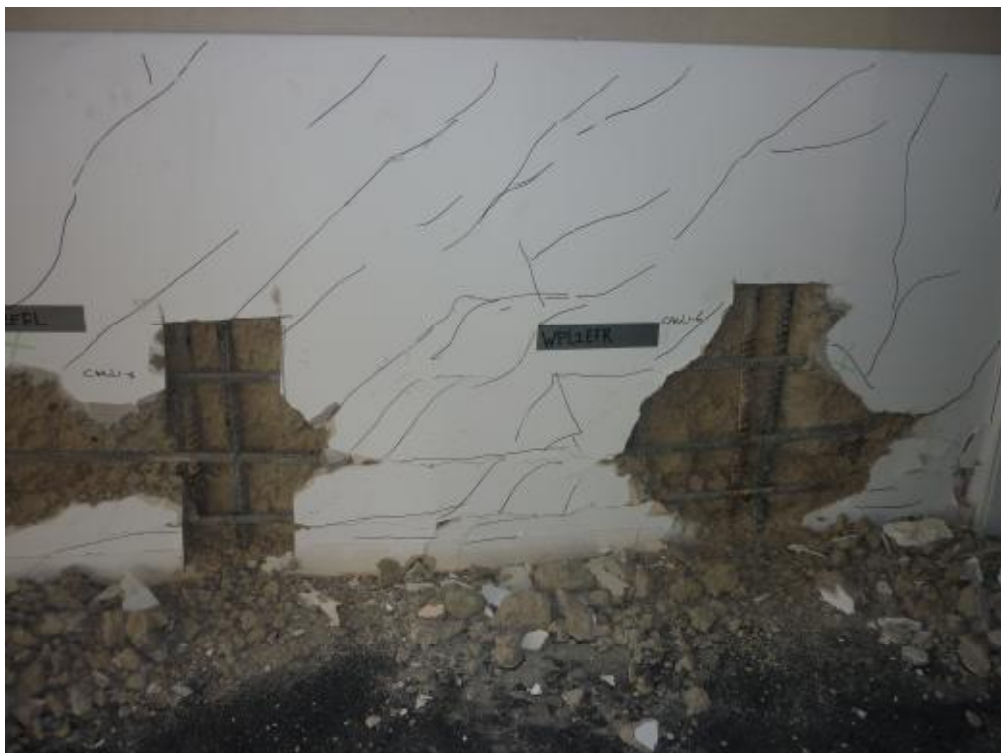
Figure 9 *Exposed reinforcing steel in zone of damage in wall element*
