Central Police Station
48 Hereford Street, Christchurch

INDEPENDENT EARTHQUAKE PERFORMANCE ASSESSMENT

Ref: 11051-01
Draft for Review R0
February 2012

For: Canterbury Earthquakes Royal Commission
Te Komihana Rūwhenua o Waitaha
PO Box 14053, Christchurch Airport,
Christchurch 8544

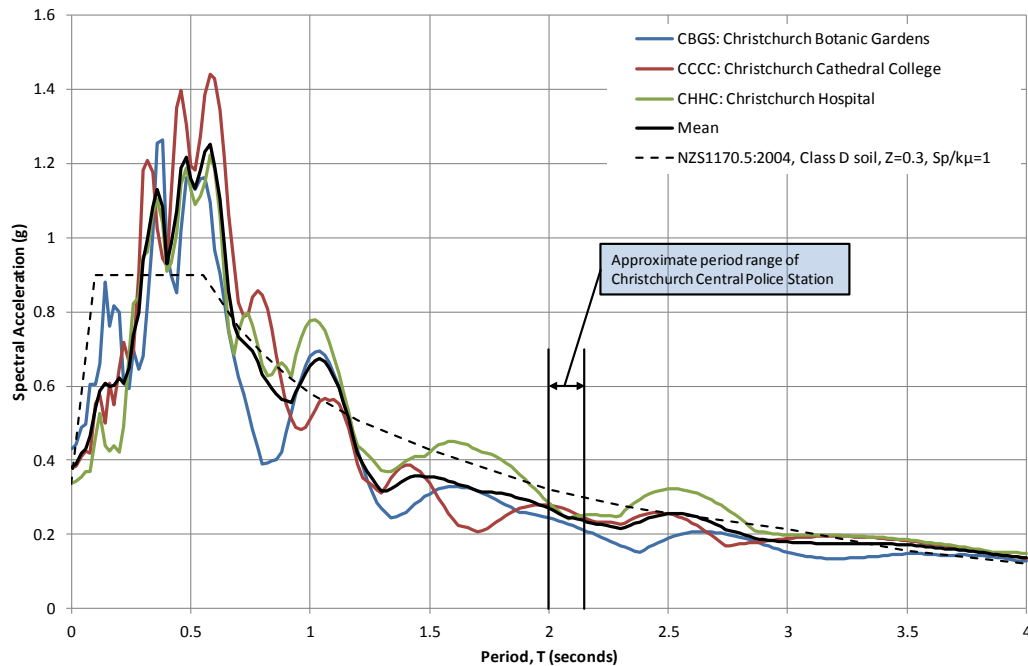
Figure 11 and Figure 12 show the north-south and east-west components of the February 2011 Christchurch earthquake recorded at three stations in the vicinity of the Christchurch CBD. Both figures also show the current design spectrum for a typical CBD site (i.e. NZS 1170.5 [13], class D soil, $Z = 0.3$). These plots indicate that the demands imposed on the Christchurch Central Police Station by the February earthquake would have been similar to those that would be used to design an equivalent new structure. The actual forces imposed on the structure could in fact have been somewhat less than those suggested by the NZS 1170.5 spectrum due to the observation made by Carr that the force reduction factors for ductile structures during the 22nd February earthquake exceeded the ductility factor in most cases [14].

Figure 11: 22nd February 2011 N00E earthquake components for Christchurch CBD compared to NZS 1170.5 design spectrum

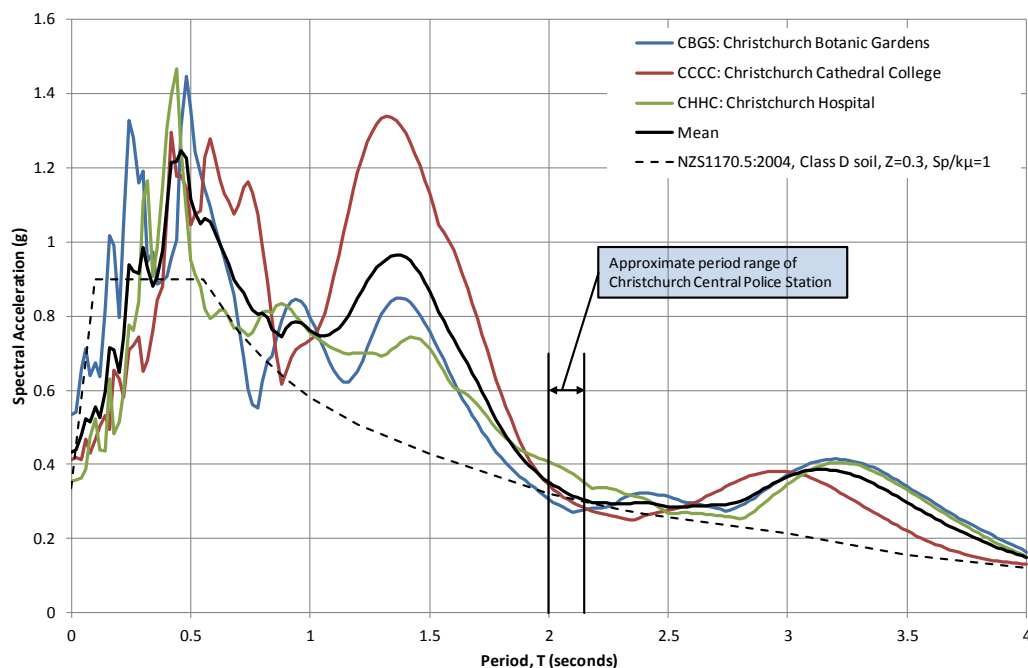
Figure 12: 22nd February 2011 N90E earthquake components for Christchurch CBD compared to NZS 1170.5 design spectrum

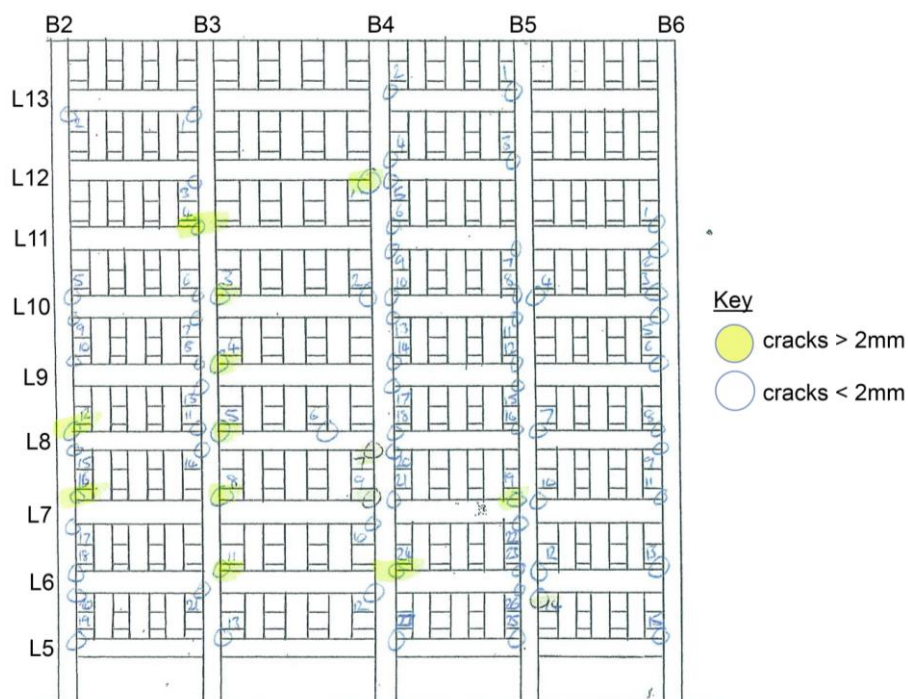
Returning to the aforementioned reports of damage inflicted on the Christchurch Central Police Station, it appears that the level of damage that occurred is of the same order as would be expected based on the ductility demands estimated in section 7.1. As noted an appendix describing an exterior survey of the building reported cracks at beam-column interfaces of greater than 2 mm width in multiple locations. Figure 13 shows an elevation of the north face of the structure adapted from this appendix, while Figure 14 and Figure 15 show associated photos of beam cracking. It is difficult to draw precise conclusions regarding the deformation demands indicated by these cracks due to the imprecise nature of the information. However, moment-curvature analysis confirms that the occurrence of a 2 mm wide crack would coincide with a curvature of approximately 12 rad/km (see Figure 16). The yield curvature of the beam would be approximately 4.5 rad/km, and hence the curvature ductility in the beam would be of the order of $\mu_\phi = 3$. This is likely to correspond to a structural displacement ductility of approximate $\mu = 1.5$ [15].

Figure 13: North elevation showing locations of cracking (adapted from Appendix D [11])

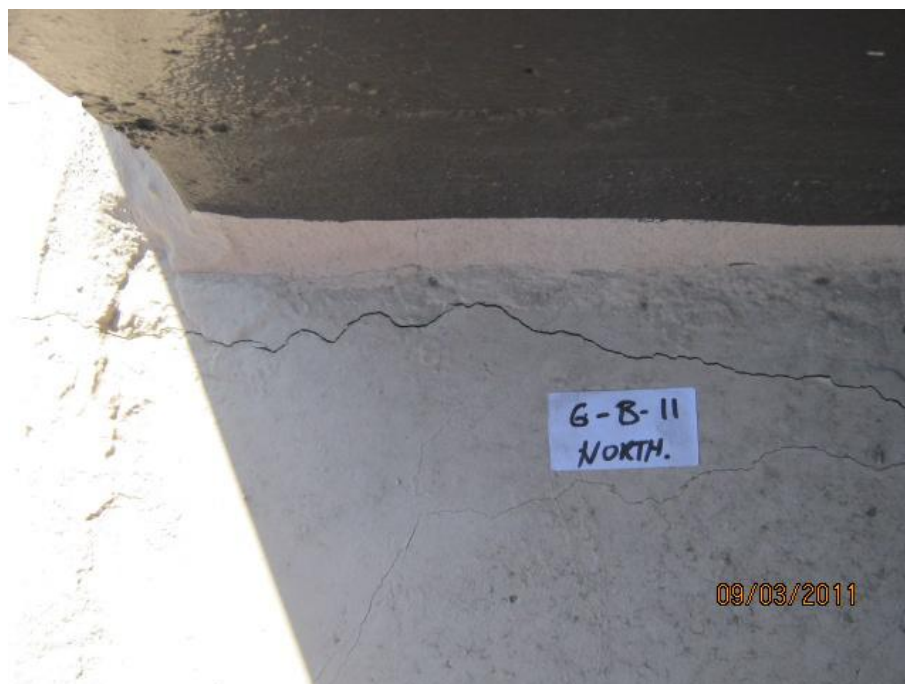
Figure 14: Example of beam cracking (Grid B3 Level 6, from [11])

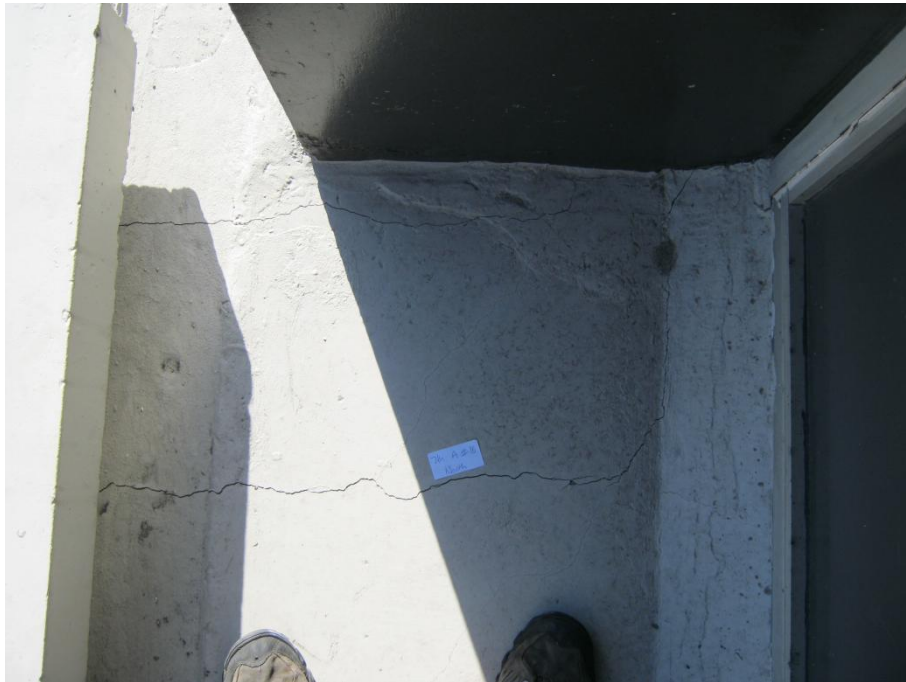
Figure 15: Example of beam cracking (Grid B2 Level 7, from [11])

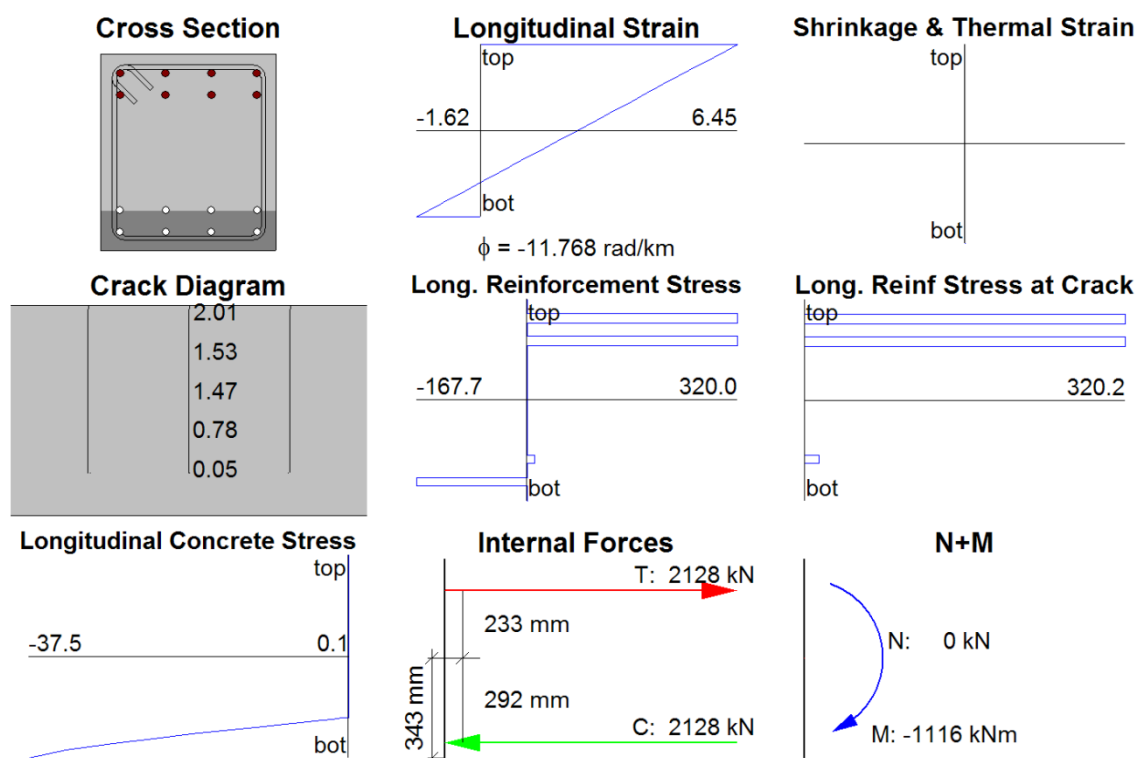
Figure 16: Moment-curvature results for a typical beam obtained using Response 2000 [16]
