Analysis of the CTV Floor Diaphragm Adequacy

**By Associate Professor G Charles Clifton
Department of Civil and Environmental Engineering**

November 2011

Report to Hyland Consultants Ltd for the Department of Building and Housing investigation into the collapse of the CTV Building during the 22 February 2011 earthquake after-shock.

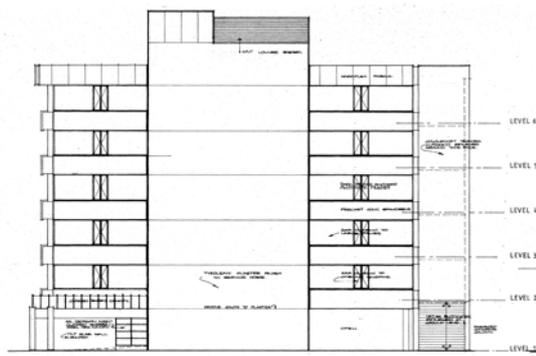
Figure 3 North side elevation

Figure 3 shows the north side elevation with the levels indicated. These levels are shown again in Figure 6 with reference to the north side lift/services core.

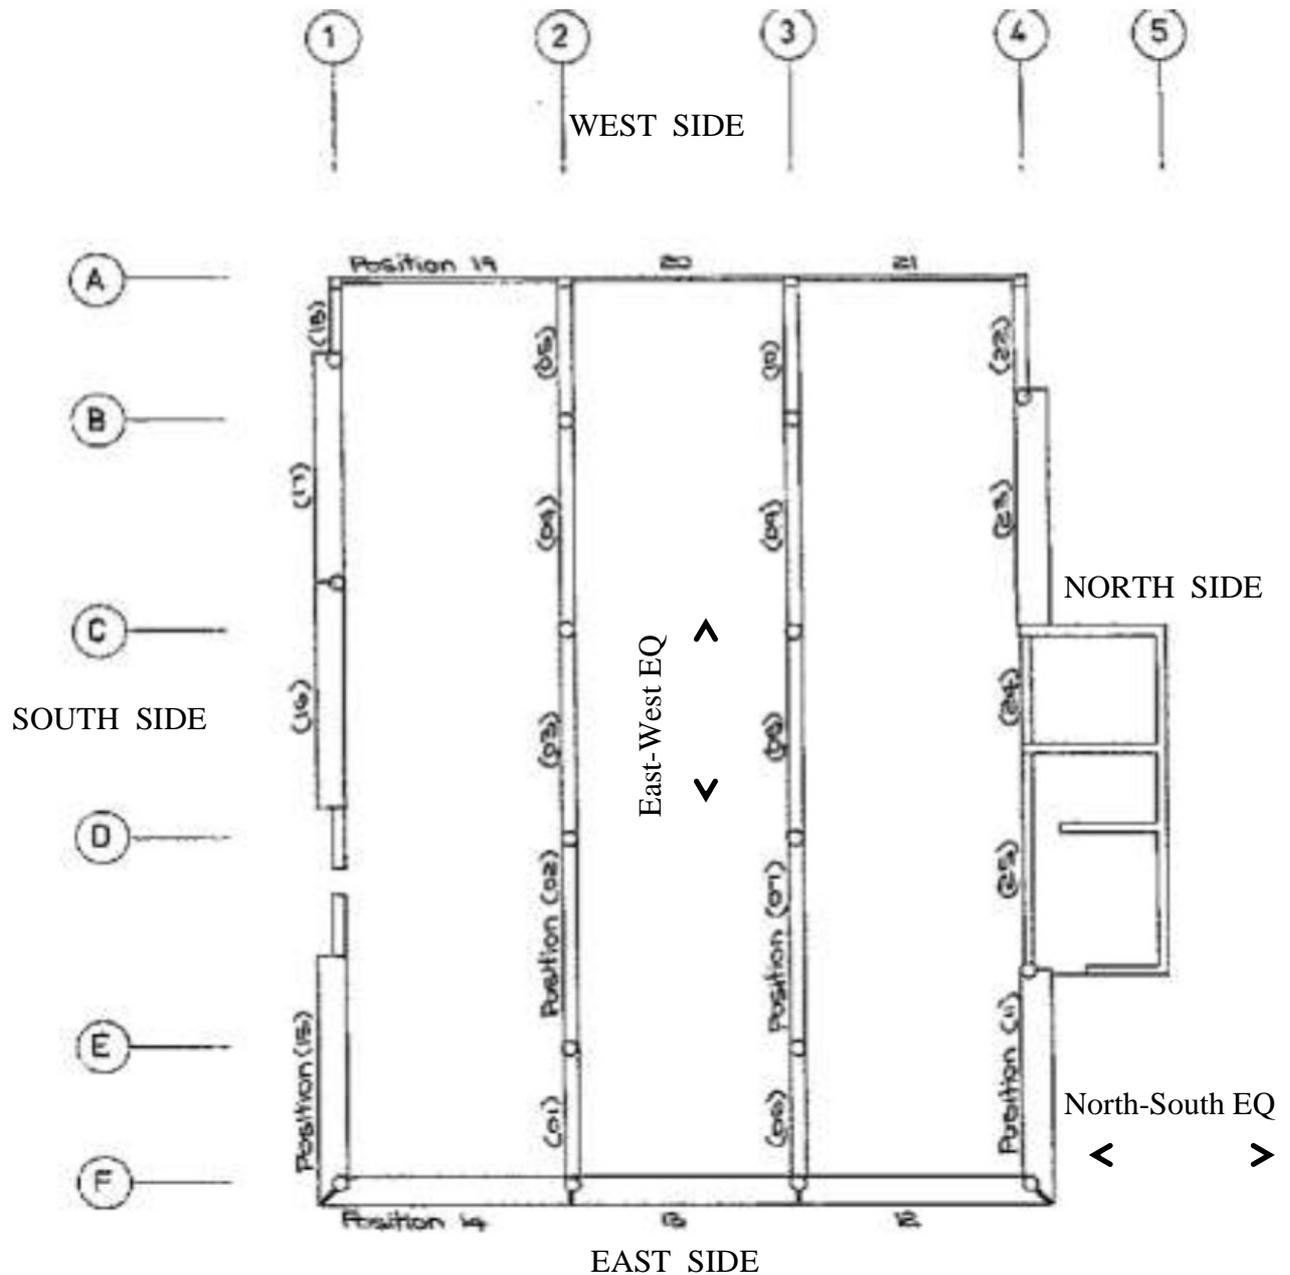
Figure 4 Plan view showing orientation of building and earthquake directions

Figure 4 shows the floor plan with the compass directions and the directions of earthquake action included. The calculations for diaphragm demand and capacity have been undertaken for ground shaking in the north-south direction and for ground shaking in the east-west direction, separately. Concurrent action would make the demand/capacity ratio worse than what is calculated in this report.

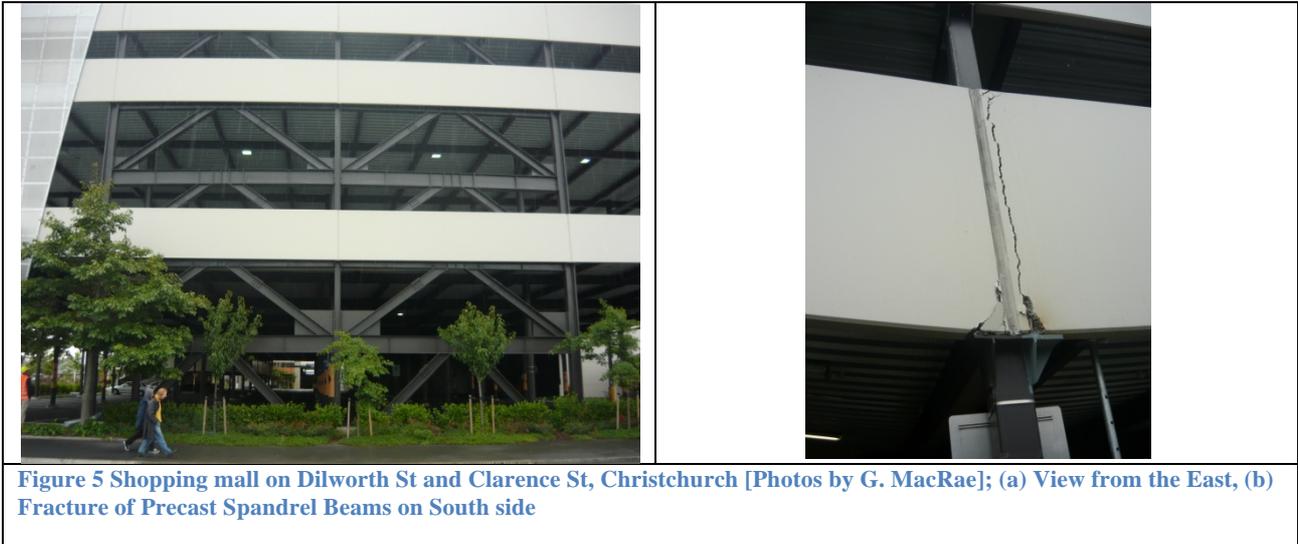
3. Figure 5a shows a 5 storey EBF building in Riccarton. This building underwent minor tensile movement across a seismic separation, causing tension across the sealed joint between two precast panel units. Figure 5b shows that the sealant was sufficiently strong in tension not to fail but to cause failure in one concrete unit adjacent to the sealed joint. Sealants have improved in quality since the CTV building was built in 1988 and the outer layer of sealant would have been exposed to the weather since that time, however it is possible that the resistance of the sealant would have prevented effective opening of the tension joint

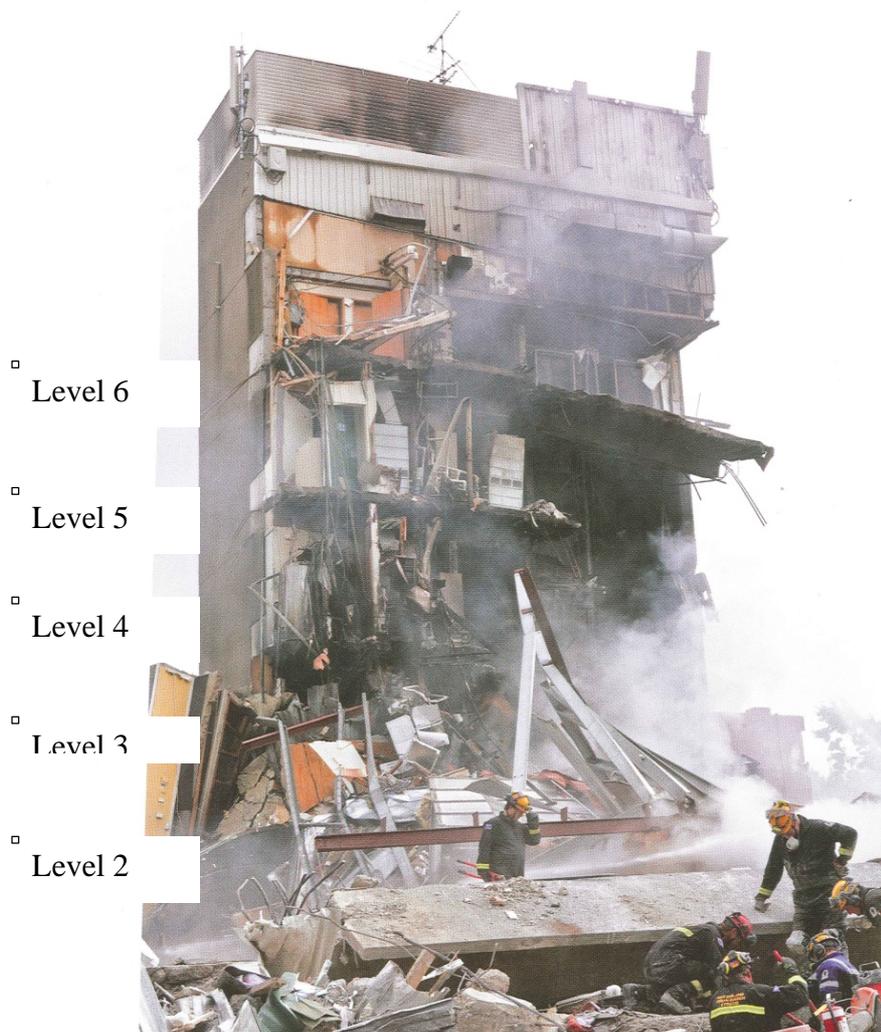
Figure 6 View of north side lift/services core following collapse identifying the levels (photo from (Burns, 2011))

1. The failure planes in the floor diaphragms as advised by Clark Hyland, identified in his report (Hyland, 2011) and in the police photographic records published in (Burns, 2011). As seen in Figure 6, the failure plane on levels 6 and 5 is within the floor slab in front of the North side lift/services core while that on levels 3 and 2 is at the front of the core along the west portion only. (See Appendices A/B and C for more details)

1. The strongest indicator is the failure plane at level 6 and to a less clear extent at levels 5 and 4. The failure plane in the slab at level 6 is clear in Figure 6 and is shown dimensionally in Appendix A pages A1 and A3. This involves a front face of the break some 1.2m into the floor slab from the precast beam along the front of the north side lift/services core. Calculation of the design capacity of this floor slab in Appendix A and B shows that the capacity of this interface is much greater than that between the edge of the slab and the lift/services core walls, shown in Appendix B pages B1 and B2 under floor diaphragm actions, especially moment from east-west ground shaking. Therefore, had the failure been by slab pull-out of the lift/services core from the top under diaphragm action, the failure plane would have been in a different location to that observed.

2. The failure plane observed at level 6 can be explained by a vertical downwards failure of the main body of the floor initially, which broke off the floor slab at level 6 at the position shown in Figure 6. Similarly with level 5 and probably with level 4, however it is getting harder to see in that photo.
