Victoria Square Apartments
100 Armagh Street, Christchurch

INDEPENDENT EARTHQUAKE PERFORMANCE ASSESSMENT

Ref: 11051-02

January 2012

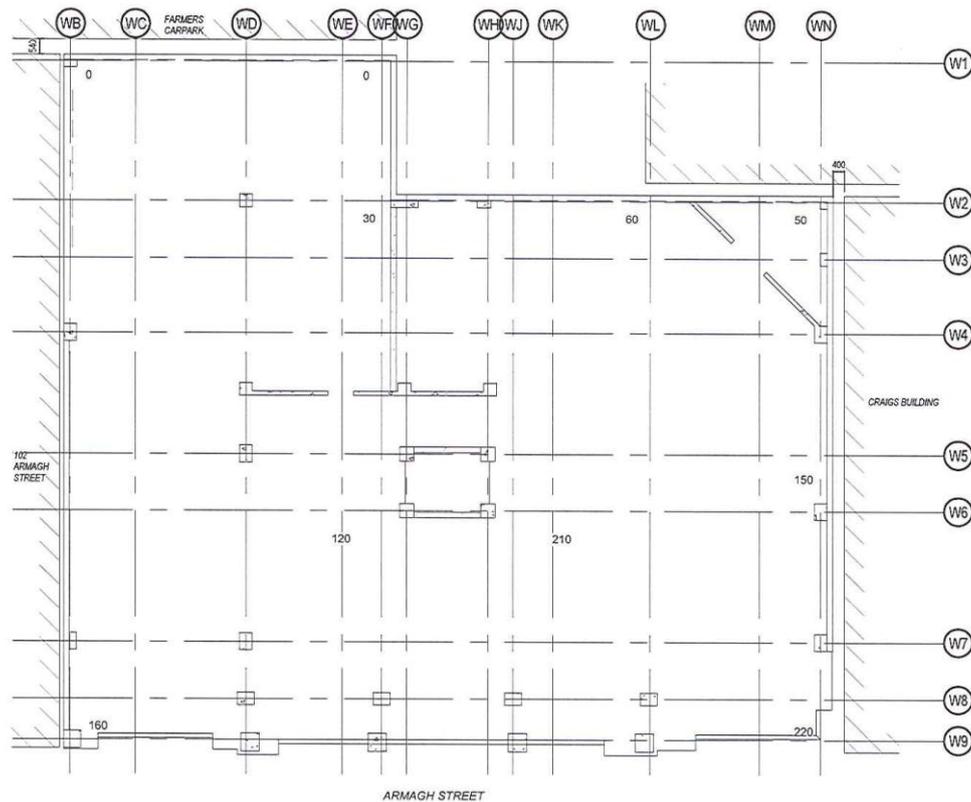
Although the structural damage resulting from the February earthquake was minor, the earthquake caused a significant, permanent overall displacement of the Victoria Square Apartments building. The magnitude of this displacement was reported by Aurecon as being approximately 450 mm at the “top” of the building, or approximately 0.8% drift. This displacement is clearly visible in photos of the structure taken from appropriate angles. Aurecon survey results (reproduced in Figure 6) indicate that the total displacement/drift can be attributed to settlement of the foundations. The structure was found to have settled by 220 mm at the north-west corner and 160 mm at the north-east corner, both levels taken as relative to the south-east corner.

Figure 6: Aurecon surveyed foundation levels

As noted in the previous section, the major effect of the February earthquake on the Victoria Square Apartments building was to cause a permanent (rigid body) rotation of approximately 0.8% drift towards the north-west. The assertion made in other reports that the rotation was due to differential foundation settlement appears correct, and the reasons for the required pattern of foundation settlement appear to be readily explainable. Two different factors contributed to the differential settlement:

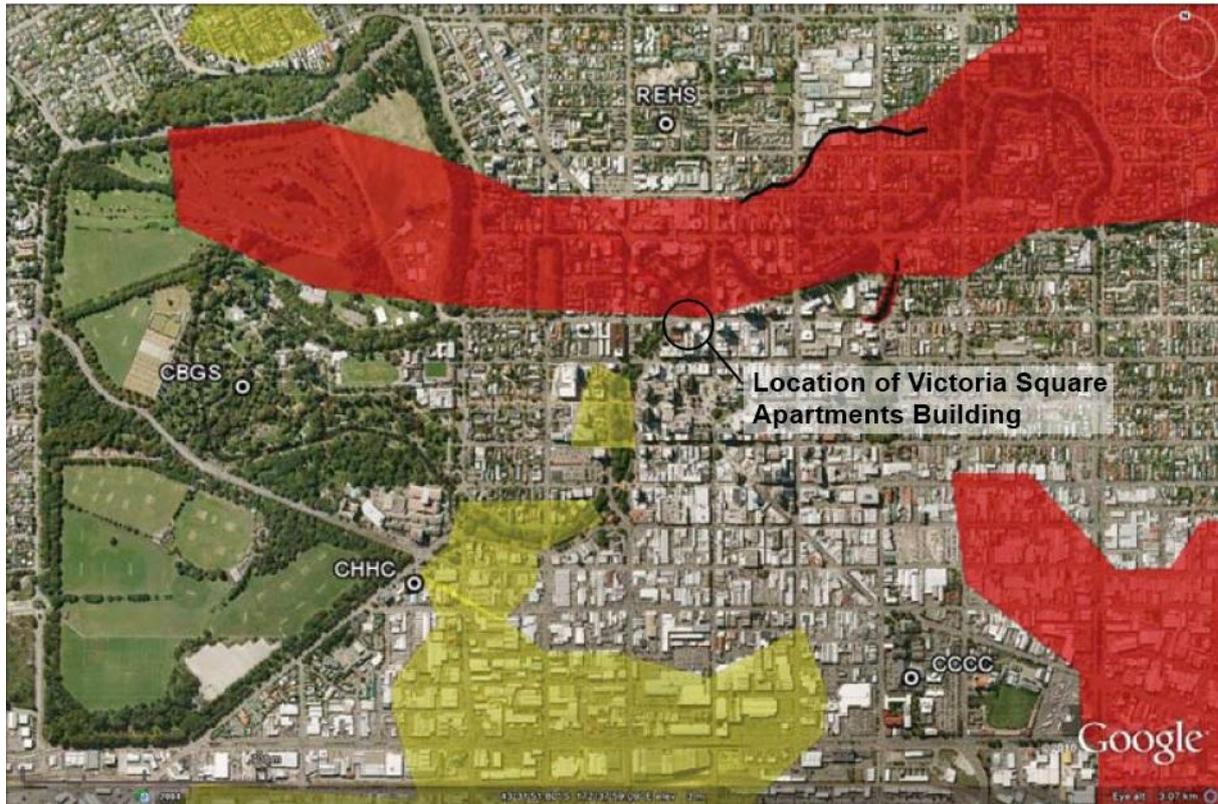
Figure 7 shows the preliminary map of liquefaction in areas surrounding the Christchurch CBD that was presented in the Royal Commission Interim Report [7]. The location of the Victoria Square Apartments Building has been marked on this map. It can be seen that the boundary of the zone of severe liquefaction lies approximately at the north side of Armagh Street. Later revisions of this map [8] in fact show the zone of severe liquefaction extending to the south side of Armagh street, i.e. directly adjacent to the front face of the Victoria Street Apartments. Victoria Square, a prominent park directly north of the apartments, has also been identified by Tonkin & Taylor as an area where lateral spreading occurred [9]. Based on available geotechnical information [6, 9] it is most likely that liquefaction at the north side of the Victoria Square Apartments building would have occurred at depths between 8 m and 14 m below the surface, with some possibility of liquefaction from 16 m to 20 m below the surface.

Figure 7: Preliminary map indicating moderate (yellow) and severe (red) liquefaction in areas surrounding the Christchurch CBD (reproduced from [7])

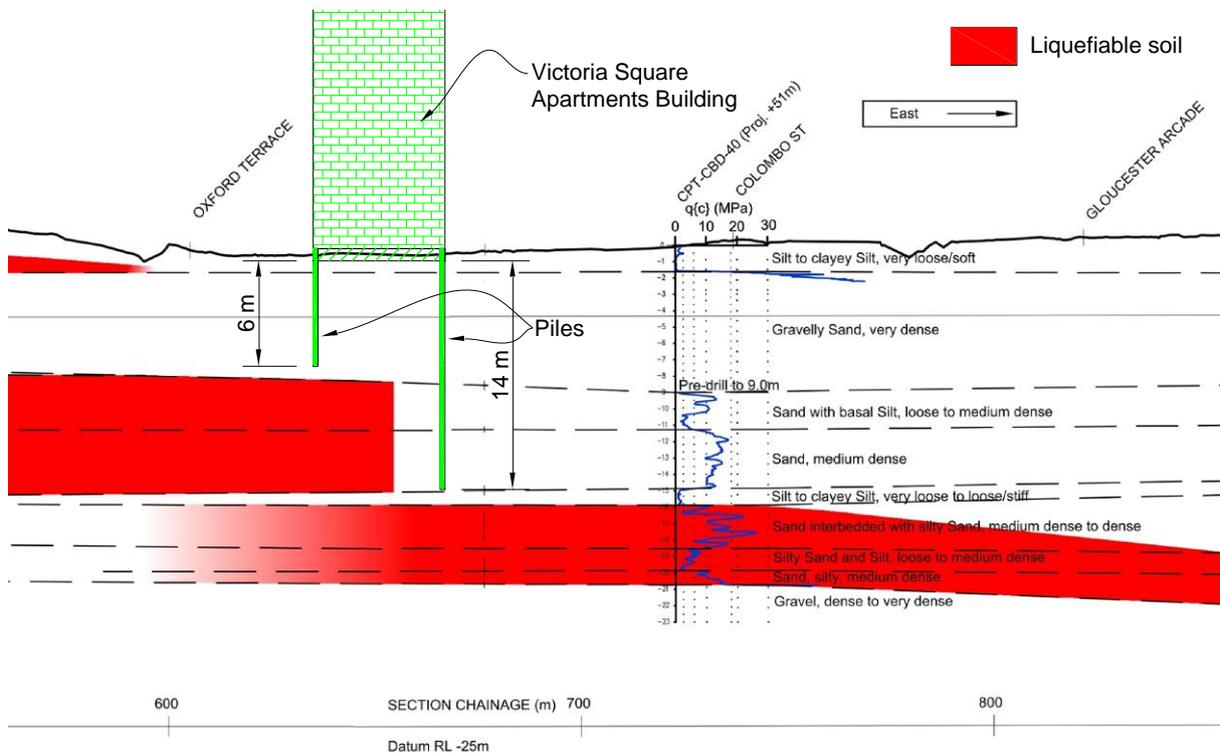
A ready explanation for the residual displacement of the Victoria Square Apartments building is provided by the occurrence of severe liquefaction and lateral spreading at one side of the structure in conjunction with the mixed foundation layout. The failure of the ground at the north side of the building would have resulted in the significant rotation towards the north. The structure also has a less significant rotation to the west. The principal cause of this rotation is likely to have been structure-soil-structure interaction as suggested elsewhere [10]. Specifically, the existence of a second large structure immediately to the west of the Victoria Square Apartments building would have resulted in both structures influencing the stress state in the soil in the vicinity of the boundary line. A secondary contribution may have been the provision of piles of only 6 m length at the north-west corner of the structure. Such short piles are unlikely to have penetrated below the liquefiable material under this region of the structure (see Figure 8).

Figure 8: Schematic showing approximate position of Victoria Square Apartments Building in relation to zones of liquefiable soil (adapted from [9])

Considering the foundation behaviour of the Victoria Square Apartments building, with hindsight it is clearly unfortunate that the selected foundation arrangement placed those elements least able to accommodate soil liquefaction (isolated pad foundations) adjacent to the area in which liquefaction occurred. The behaviour of the Victoria Square Apartments building indicates that the ground conditions in the vicinity of a structure should be considered as carefully as the ground conditions directly beneath the structure. It is further suggested that designers should be wary of “hybrid” foundations, irrespective of whether these consist of combined shallow and deep foundations or piles of differing length. It is probable that the performance of the Victoria Square Apartments building would have been significantly improved if an adequate number of deep piles had been installed on the north side of the structure.

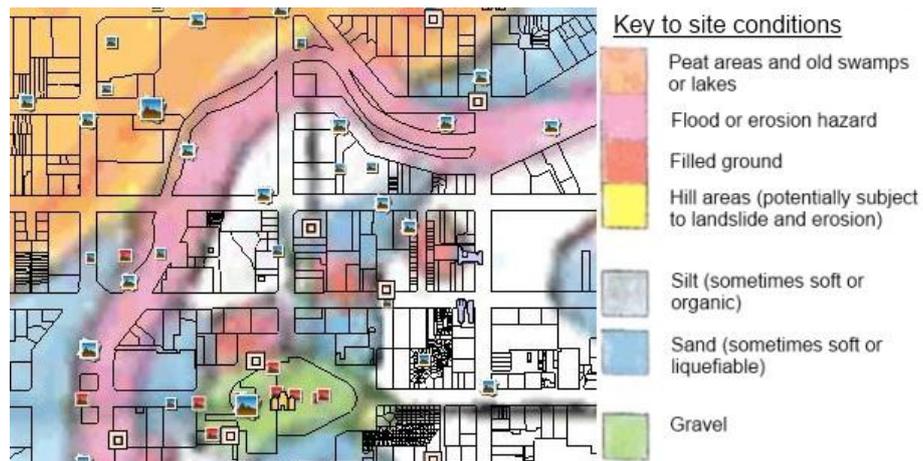
It is not known to what extent the liquefaction potential of the area was understood by the original designers or why the selected foundation scheme was chosen. The original geotechnical investigation (provided to Compusoft Engineering by the Royal Commission) shows that the ground conditions under the site were known, and not apparently susceptible to liquefaction. However, it is not known whether the likelihood of liquefaction under the adjacent Victoria Square was known or considered. The 1990 Christchurch shallow foundation hazard map (see Figure 9) does not identify the area around the Victoria Square Apartments building as being susceptible to liquefaction, although commonly referred to ground profiles [13] show that Victoria Square is underlain by sandy deposits that can be liquefiable. Given the known susceptibility of Christchurch soils to liquefaction and the proximity of the Avon River to the site, it is reasonable to state that the possibility of adjacent land liquefying should have been considered, which may have lead to a more regular foundation scheme being selected.

Figure 9: Excerpt from Christchurch shallow foundation hazard map 1990

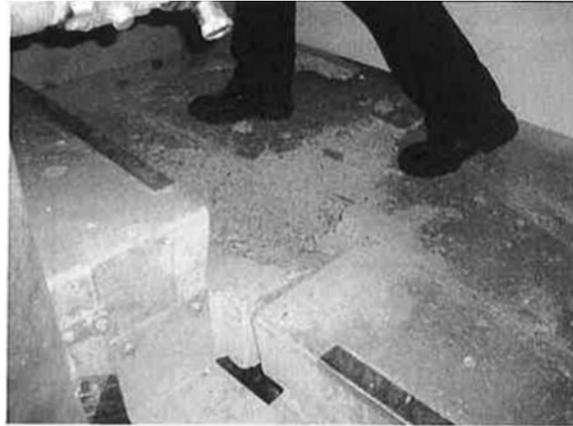
Little information is provided in the assessment reports regarding the nature or extent of stair landing damage. The only elaboration regarding the nature of the damage is in the form of a photo reproduced here as Figure 10.

Figure 10: Photo of stair landing damage (reproduced from [5])

The limited information available about the damage makes it difficult to draw conclusions about the cause of the damage. However, review of the structural drawings indicates that the typical stair detailing provides no isolation of the stairs from the structure (see Figure 11). This lack of isolation would allow the stair units to act as struts able to transfer forces between floors in a manner they are unlikely to have been designed for.

As noted previously, only minor structural damage was inflicted on the Victoria Square Apartments building by the 2010 and 2011 Canterbury earthquakes. However, it appears probable that stair landing damage occurred due to the inadequate isolation of the stairs from the structure.

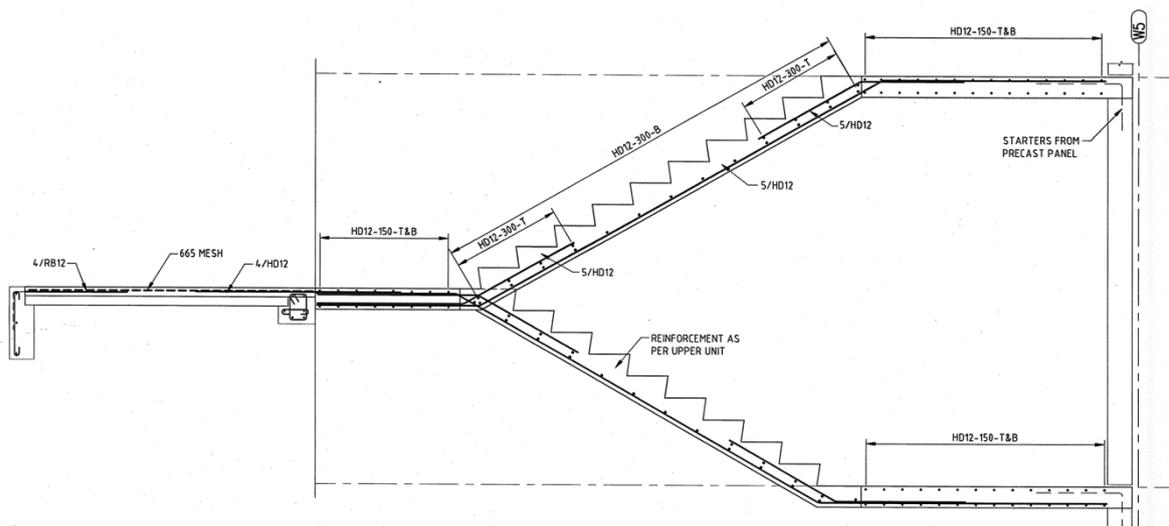
Figure 11: Typical stair detailing in Victoria Square Apartments building
