Christchurch Civic Building  
53 Hereford Street, Christchurch

### INDEPENDENT EARTHQUAKE PERFORMANCE ASSESSMENT

Ref: 11051-03  
Draft for Review R0  
March 2012

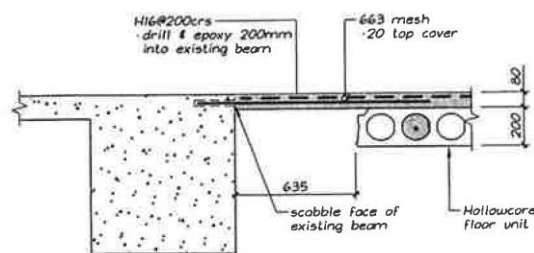
**Figure 5: Section at interface of original and extension structure**

It was noted in section 6.2 that damage occurred at the interface between the existing and extension structures. Damage to the concrete infill slab was attributed by others [17] to the infill slab being thinner than intended. While this may have contributed to the damage, it seems probable that damage would have occurred to the infill slab even if it had been constructed in accordance with the drawings. While heavily reinforced, the purpose of the infill slab is to span between elements deforming in an incompatible manner, and would thus have experienced significant out of plane deformations during the 2010 and 2011 earthquakes.

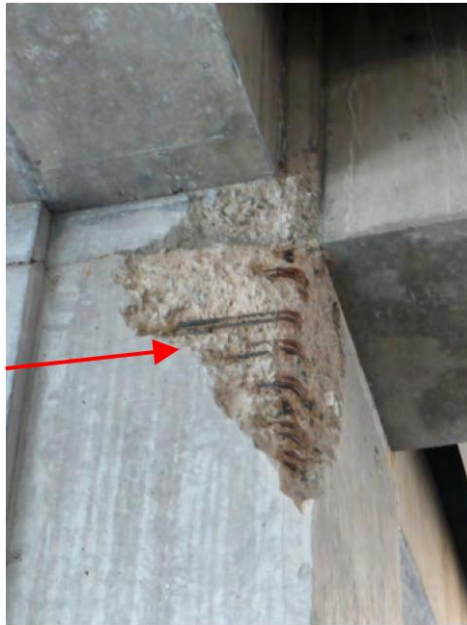
Damage to the moment resisting frames of the original structure was reported to be minor [10], with most cracks having widths of 0.5 mm or less and a maximum crack width of approximately 2.0 mm [15]. Additional damage taking the form of spalling of cover concrete

from the column corners below beam-column joints occurred in a number of locations. An example of this damage is shown in Figure 7.

**Figure 7: Concrete spalling at column corner under beam-column joint (from [10])**

It has been reported that hardness testing of reinforcement in the structure has been undertaken by Holmes Solutions to assess the level of residual strain in the bars [10]. While Compusoft Engineering Limited have not seen the results of this testing, the results of the testing apparently indicated that the residual strains were generally less than 10% of the ultimate strain and that yielding of the reinforcement has not significantly affected the residual capacity of the structure [15].

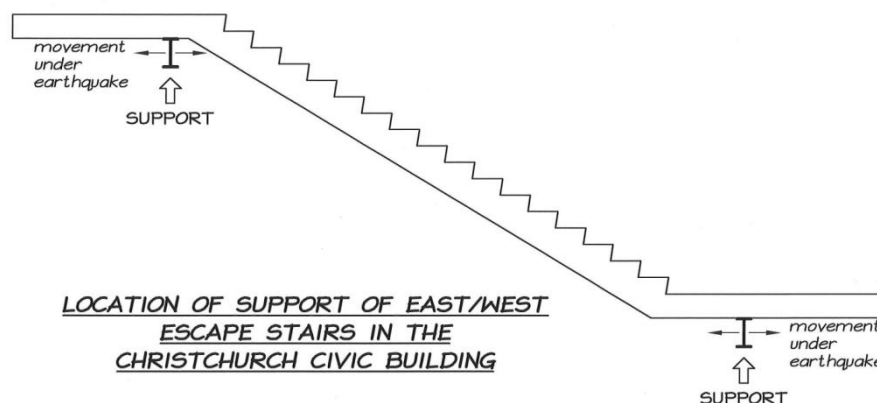
It is apparent that the designers paid attention to support and isolation of the stairs of the Christchurch Civic Building during the recent upgrade of the structure (see for example Figure 8). As a result, the damage incurred by the stairs was generally minor. Through the main part of the structure damage was typically limited to cracking and minor spalling at the landings where topping concrete cracked and spalled where precast units met. A set of stairs spanning from level 1 to level 2 was more significantly damaged during the February earthquake. It was reported that this damage was due to the performance of the sliding joint at the stair base being impeded by the installation of tiles [10].

**Figure 8: Schematic of stair support used at Christchurch Civic Building (from [10])**
