**ROYAL COMMISSION OF INQUIRY INTO
BUILDING FAILURE CAUSED BY CANTERBURY
EARTHQUAKES**

THE CTV BUILDING COLLAPSE

**STATEMENT OF EVIDENCE OF MARGARET JANE AYDON
IN RELATION TO THE CTV BUILDING**

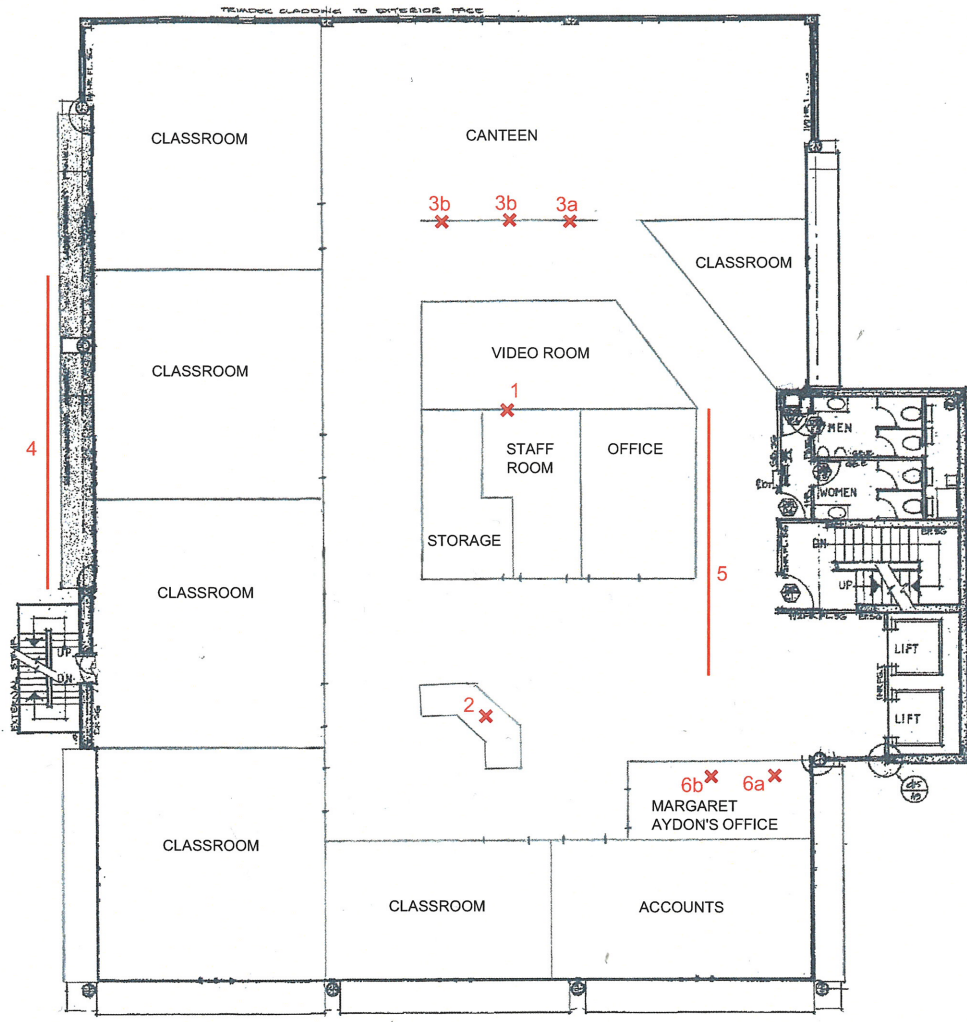
"A"

4. Attached is a floor plan of the Building I have prepared (marked "A"). The positions of the rooms and internal walls have not been drawn to scale and their placement is approximate only. The cracks and other issues of concern that I refer to in my evidence are marked on this plan.

5. There was a crack in the video room, which ran down the wall attached to the pillar. I have marked this as "1" on the plan. I was particularly concerned with this crack because it was very noticeable. The room was painted with a dark paint and you could clearly see the plasterboard underneath. The crack was approximately 1cm in width. It ran vertically down the pillar and was approximately half the length of the

6. Sandra Hii, our receptionist, could not put a pen down on her reception desk without it slowly rolling. We used to comment that we wondered what they had done when they had inspected the Building because it was clear to us that the floor was not level. The pen would roll in a south-east direction. The problem seemed isolated to the reception desk, although we didn't have anything around there with which to compare. I have marked this area as "2" on the plan. This again was brought to the attention of Brian and brought up in staff meetings.

7. There was also damage to a glass partition in the canteen area. I have marked this as "3" on the plan. The glass had been taped with blue masking tape. I think this was to stop it from cracking further. The tape was shaped like a cross and I understood that this was to hold the panes of glass together. The other panes, that didn't have cracking, were also taped. I think they were taped as a precaution.

9. Ron Godkin, who was a tutor at Kings Education, had noticed some bulging or possible cracking of the glass along the south wall. I couldn't pick it up with the naked eye but I could see it when he pointed it out to me. The Building Manager arranged for someone to check it and the glass was subsequently replaced. I didn't query who the Building Manager was at the time. I have marked where I think the areas of damage to the glass were as "4" on the plan.

12. The crack in the video conference room had increased. It was the full length of the pillar running ceiling to floor. At the top of the pillar, close to the ceiling, it was approximately 5cm in width. You could now put your hand right through the wall. It was also clear to me that whatever was causing the reception desk to slope had increased. I covered Reception a lot for the two weeks after Christmas so I had first hand experience of how bad it really got and it definitely seemed to get worse following Boxing Day. We had to use blutac and rubber-bands to stop pencils rolling off the desk.

14. On two occasions we had water running down the wall outside of the toilets causing flooding on the floor. I have marked this as "5" on the plan. The first occasion was probably around the middle of October, but I can't be sure of the exact date. This was repaired, but the flooding occurred again and this time the flooding was worse. I think this second occasion was some time after Boxing Day. Again John Drew got it

- 1. Crack in the plasterboard
- 2. Reception desk
- 3a. Cracked pane of glass
- 3b. Taped panes glass
- 4. Damaged windows
- 5. Flooding
- 6a. Location of Margaret Aydon
- 6b. Location of Rosendo Ramos
