Seismic Performance Summary
Draft Report

Christchurch Town Hall for the Performing Arts

86 Kilmore Street
Christchurch, New Zealand

April 2012

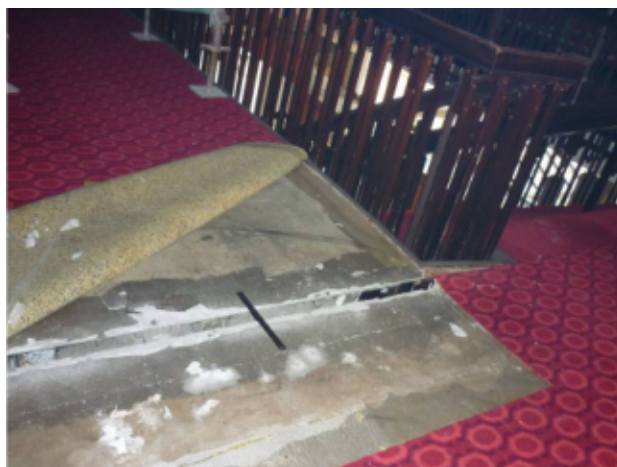
Total and differential settlement due to liquefaction and lateral spreading was significant after the Lyttelton event. A survey undertaken in April 2011 indicates foundation settlement in the range of 70mm to 460mm but more typically between 200mm and 350mm and is attributed mostly to liquefaction-induced settlement plus some limited strain as a result of building loads [5]. These measurements match well with those estimated by Tonkin & Taylor as described under Liquefaction of the Foundation & Land Damage section of this report. The auditorium, lobby and restaurant have tilted toward the southeast, south and northwest, respectively, as a result of differential settlement [2]. Put another way, the auditorium and lobby tilted towards the river while the restaurant tilted away. Such tilting, in addition to lateral spreading, has resulted in lateral separation between areas of the building and at seismic gaps for pedestrian bridges [1]. Figure 8 shows an example of separation damage where a building joint widened due to settlement. The restaurant suffered additional movement towards the Avon River after the June earthquakes and it is inferred that this resulted from reoccurrence of liquefaction and lateral spreading [5].

Figure 8: Building Joint Damage [1]

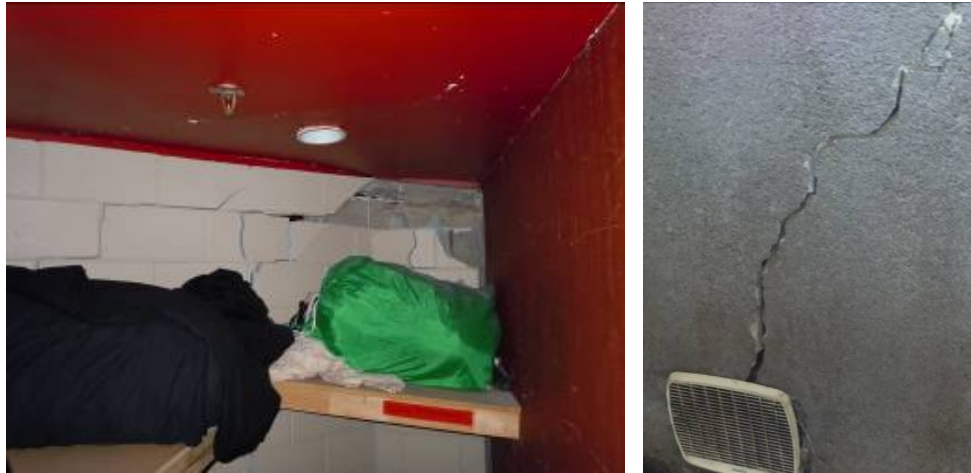
The majority of damage to these elements appears to have occurred during the Lyttelton earthquake as a result of differential settlement caused by liquefaction and lateral spreading [1]. Detailing of the concrete shear walls seems to have anticipated some inelastic response, which is thought to have occurred in limited form, and damage reflects response beyond yield especially in the north wall of the 1976 addition's Cambridge Room. Other than limited shaking damage, the concrete shear walls and block walls primarily cracked and spalled in order to accommodate foundation movement. Typical block wall damage, most apparent in the auditorium, and concrete shear wall damage are shown in Figure 9.

Figure 9: Typical Block Wall Damage (left) and Concrete Shear Wall Cracking (right) [1]

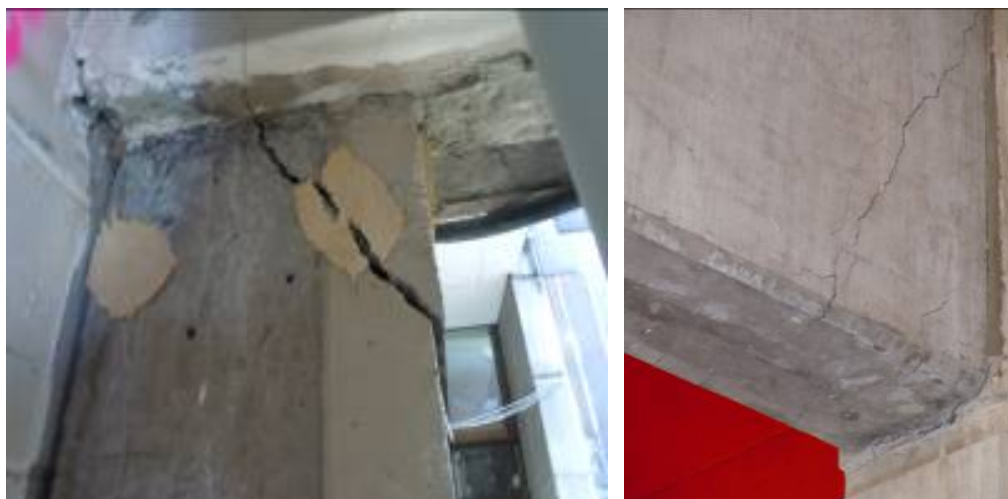
Moderate damage of beams and columns during the Lyttelton earthquake appears to have resulted from foundation settlement although some cracking may have been caused by shaking. Flexural cracking of beams in the auditorium's promenade were measured between 0.2mm and 2.0mm while shear cracks up to 5.0mm were observed in the Lobby columns [1]. Figure 10 depicts the damage just described.

Figure 10: Column Cracking (left) and Beam Cracking (right) [1]

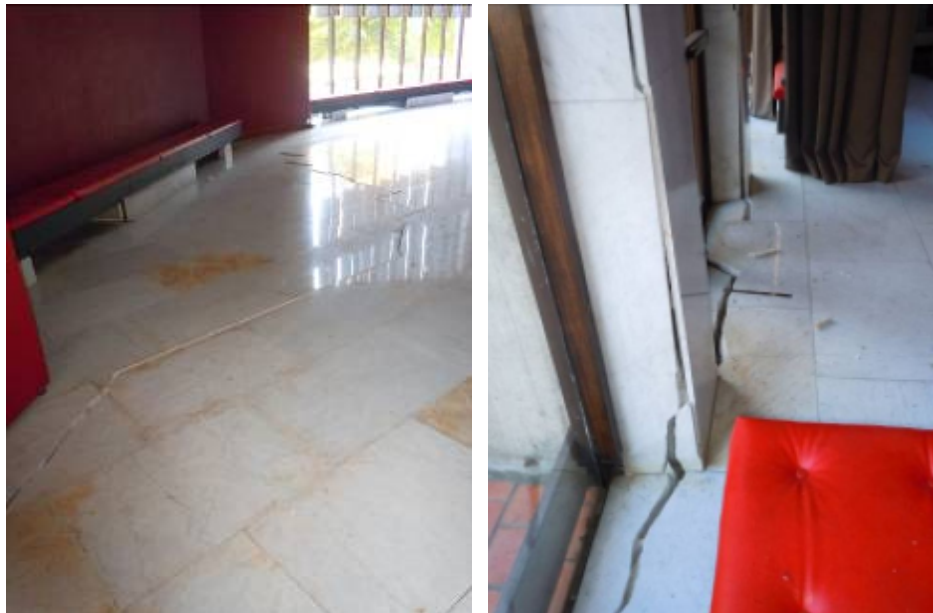
All of these reinforced concrete structural elements suffered damage during the Lyttelton event due to differential vertical and horizontal movements brought upon by liquefaction and lateral spreading [1]. Much of the basement became flooded with water and a mixture of sand and silt [2]. As the underlying soils liquefied, the more highly loaded strip and pad footings settled to a greater extent than their adjacent slabs-on-grade thus causing forces to build up within the service tunnels and basement walls. Fracturing of the concrete members then occurred to alleviate these incompatibilities [3]. Additionally, the sand and silt ejecta pushed the slabs-on-grade of the auditorium and theater upward which, in combination with settling of the footings, exacerbated cracking and damage in them. Lateral movement of adjacent structures also contributed to damage of slabs-on-grade. Representative damage to slabs-on-grade is shown in Figure 11.

Figure 11: Slab-on-grade Damage [1]

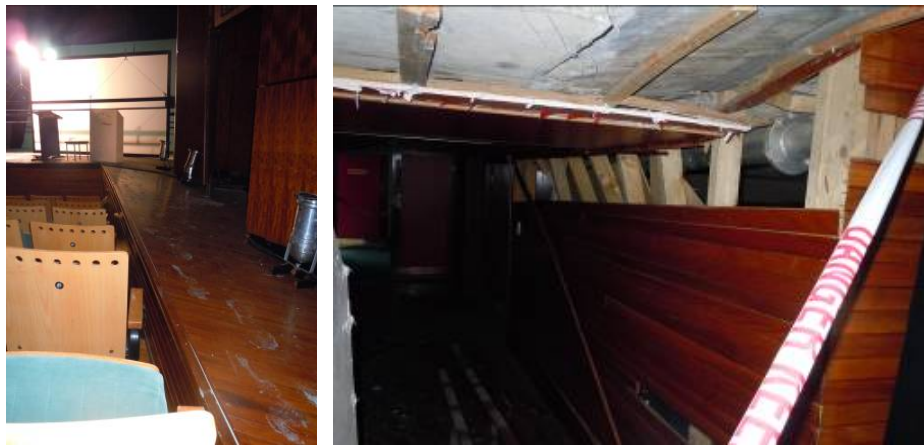
The auditorium and theater employ timber framing above the concrete slabs-on-grade. This timber flooring became sloped and uneven after the Lyttelton event because the slab-on-grade on which it was supported suffered significant differential settlement [1]. For the same reason, timber-framed walls in the auditorium were damaged in the form of fractured framing and distorted wall linings. Photos of representative damage can be found in Figure 12. Accompanying the building tilting and separation previously discussed, connections of glue-laminated timber beams in the lobby and restaurant tore out while the members themselves distorted as seen in Figure 13.

Figure 12: Timber Floor Damage (left) and Timber Wall Damage (right) [1]

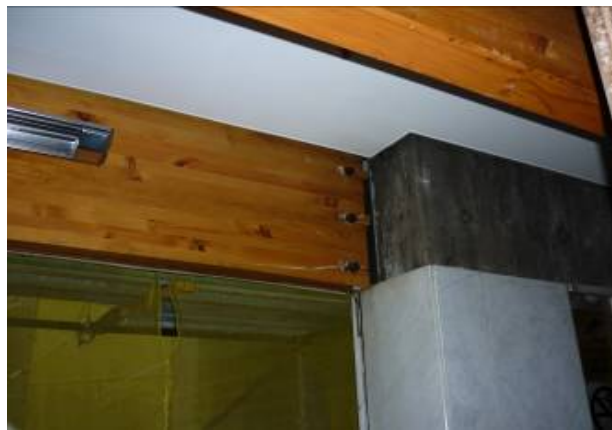
Figure 13: Glue-Laminated Beam Connection Tear-Out [1]

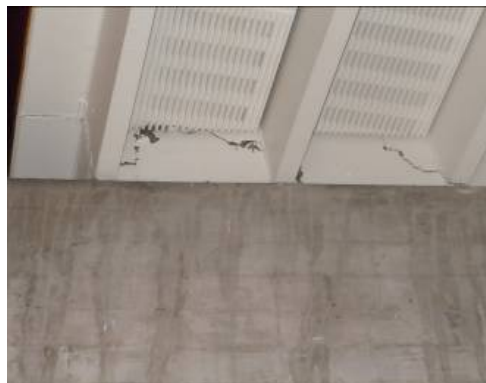
Precast double-tee units were found cracked and spalled after the Lyttelton earthquake, especially at their ends, as seen in Figure 14, and in their webs near points of seating [1]. It is unclear whether this results from differential settlement, shaking, poor detailing or some other unintended action although it is thought to be a result of lateral separation of the structure.

Figure 14: Double-Tee Cracking [1]

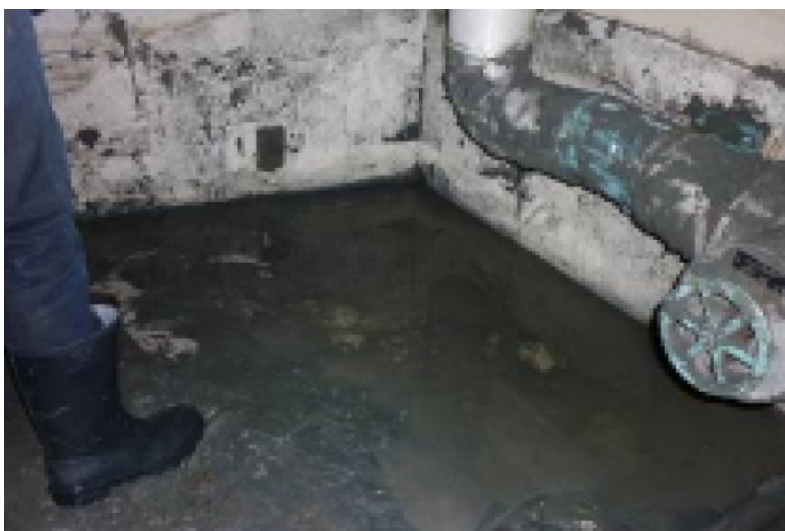
Widespread liquefaction was observed after the Lyttelton earthquake both within and around the building footprint and resulted in differential settlement of the building, heaving of slabs-on-grade, and flooding of the basement [2]. Sand boils on the ground surface around the Christchurch Town Hall and on the roads and properties immediately surrounding it were one form of evidence. Additionally, approximately 70 cubic meters of ejected sand and silt was removed from the Christchurch Town Hall's basement in addition to daily pumping of water. Immediately following the June earthquakes, additional sand and silt flowed into the Christchurch Town Hall's basement accompanied by more sand boils in the general vicinity. Figure 15 shows a mixture of sand and silt discovered in the basement.

Figure 15: Evidence of Liquefaction in Basement [1]

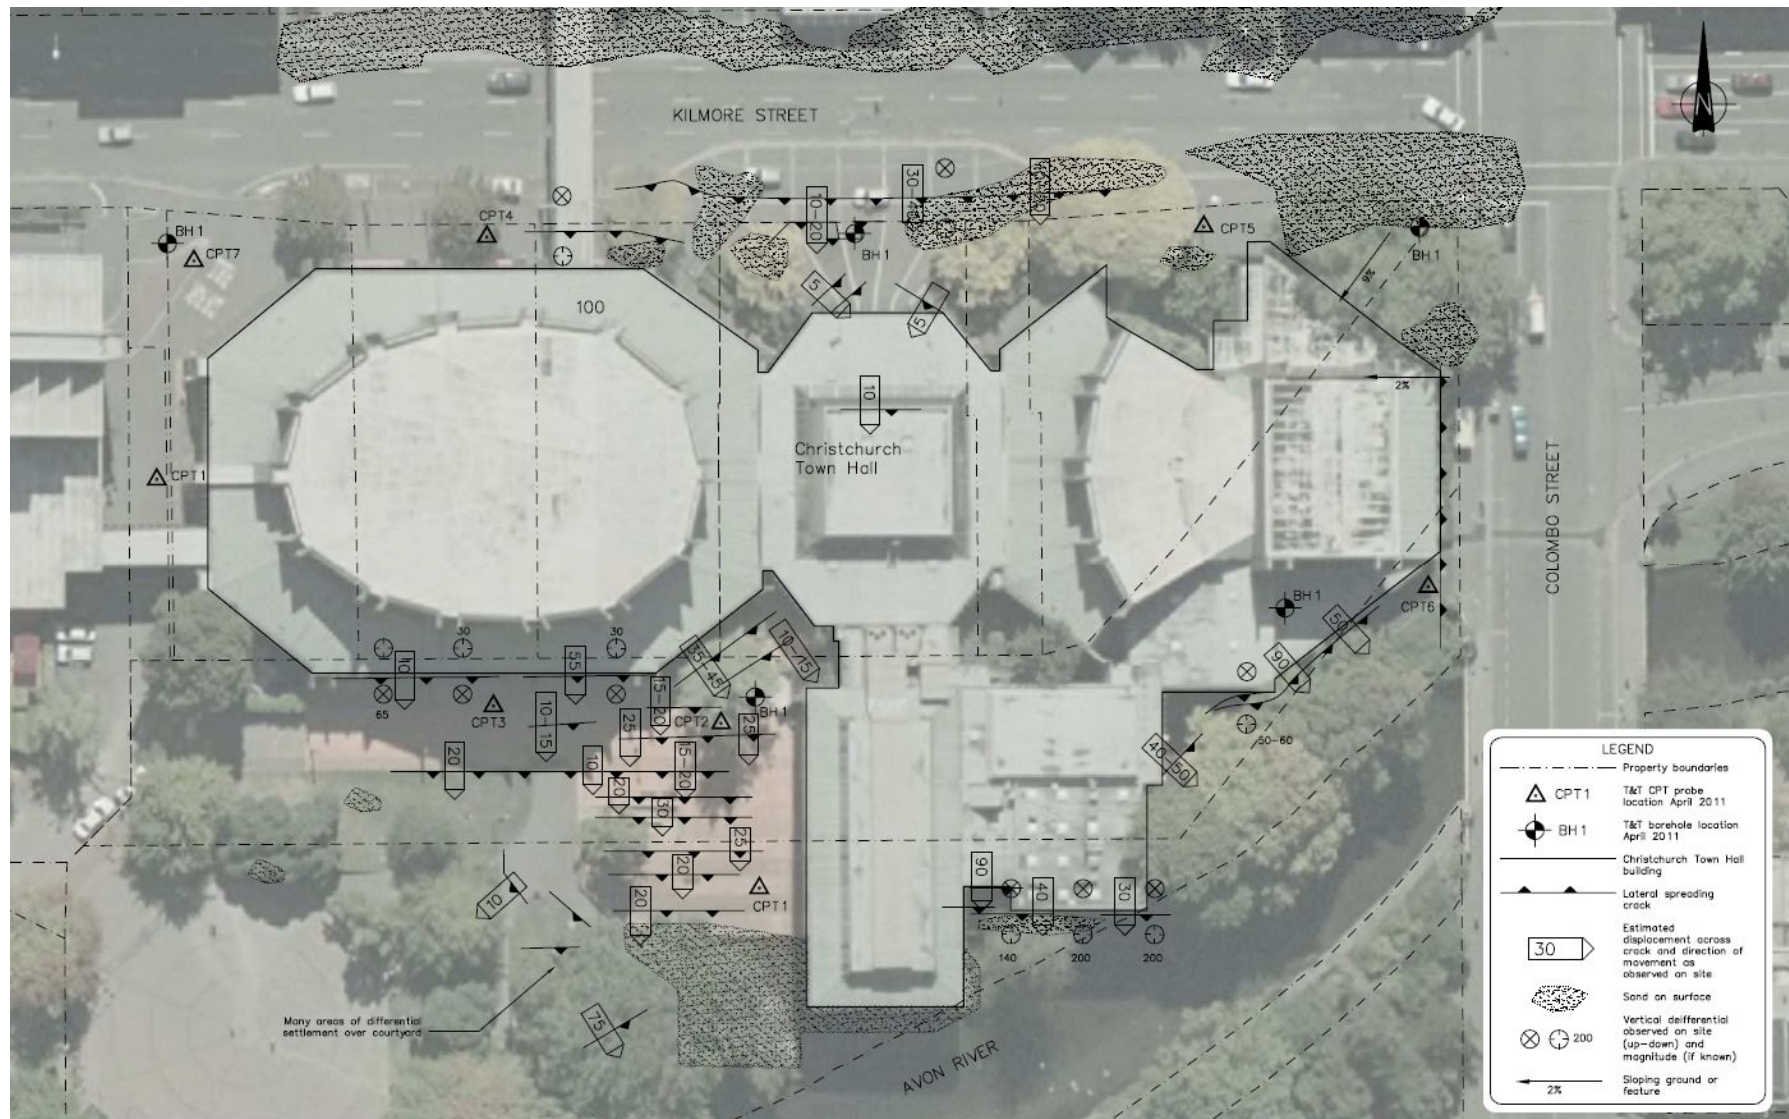
Liquefaction often results in a phenomenon known as lateral spreading when the terrain is sloping such as exists for the Christchurch Town Hall due its proximity with the Avon River. Evidence of liquefaction-induced lateral spreading was observed following the Lyttelton event all around the Christchurch Town Hall but most prominently on the north bank of the Avon River as seen in Figure 17 [2]. It manifested as ground cracking, slumping, and cracks in pavements and is thought to be associated with an old river terrace. Lateral spreading was most pronounced nearest the Avon River and decreased as you moved away [5]. Tonkin & Taylor's analyses tended to overestimate the lateral displacements under the Lyttelton event but were of the correct order of magnitude. Summation of crack widths yielded the following lateral spread displacements:

- 350mm lateral displacement within 20m of the Avon River bank
- 100mm lateral displacement at the south side of the auditorium
- 50mm lateral displacement at the north side of the auditorium
- Null lateral displacement at the north side of Kilmore Street

Figure 17: Lateral Spreading Map [5]

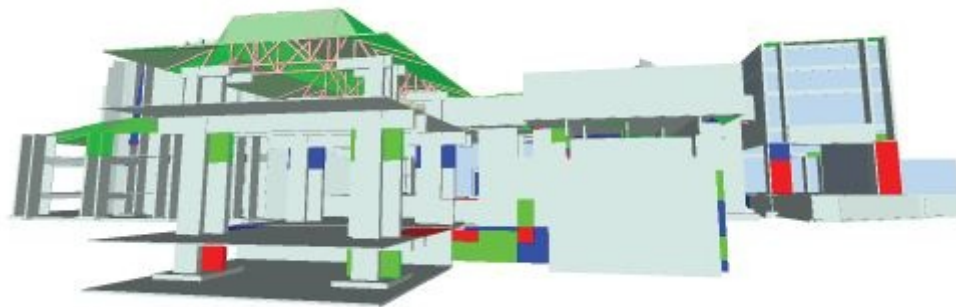
Differences in superstructure strengthening between 67% and 100% NBS appears relatively minor with small additions of strength and stiffness for 100% compared to 67%. Recommendations have been based off nonlinear response history analysis in accordance with NZS 1170 [6]. Several critical deficiencies were identified during the quantitative analysis as shown in Figure 18 and listed below [4].

1. Some concrete shear walls in the auditorium have excessive shear deformations
2. The slender piers and block walls of the theater's fly tower become severely damaged
3. The lobby and restaurant's slender piers experience excessive flexural deformations
4. The kitchen's concrete walls suffer severe shear deformations

Figure 18: Critical Superstructure Deficiencies [4]

In addition to the new foundation discussed next, it has been proposed to use hydraulic jacks to re-level the structure so as to return it to a serviceable condition.
