**ROYAL COMMISSION OF INQUIRY INTO  
BUILDING FAILURE CAUSED BY  
CANTERBURY EARTHQUAKES**

**THE CTV BUILDING COLLAPSE**

**STATEMENT OF EVIDENCE OF MICHAEL TREVOR WILLIAMS  
IN RELATION TO THE CTV BUILDING**

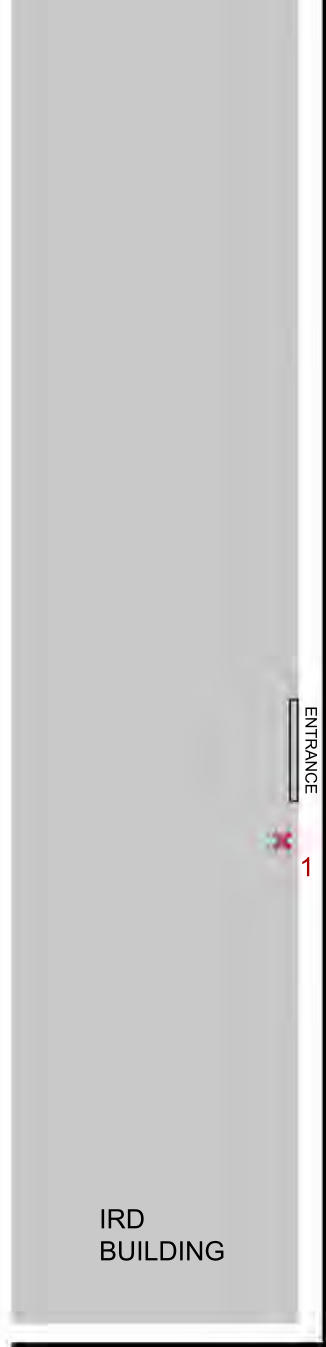
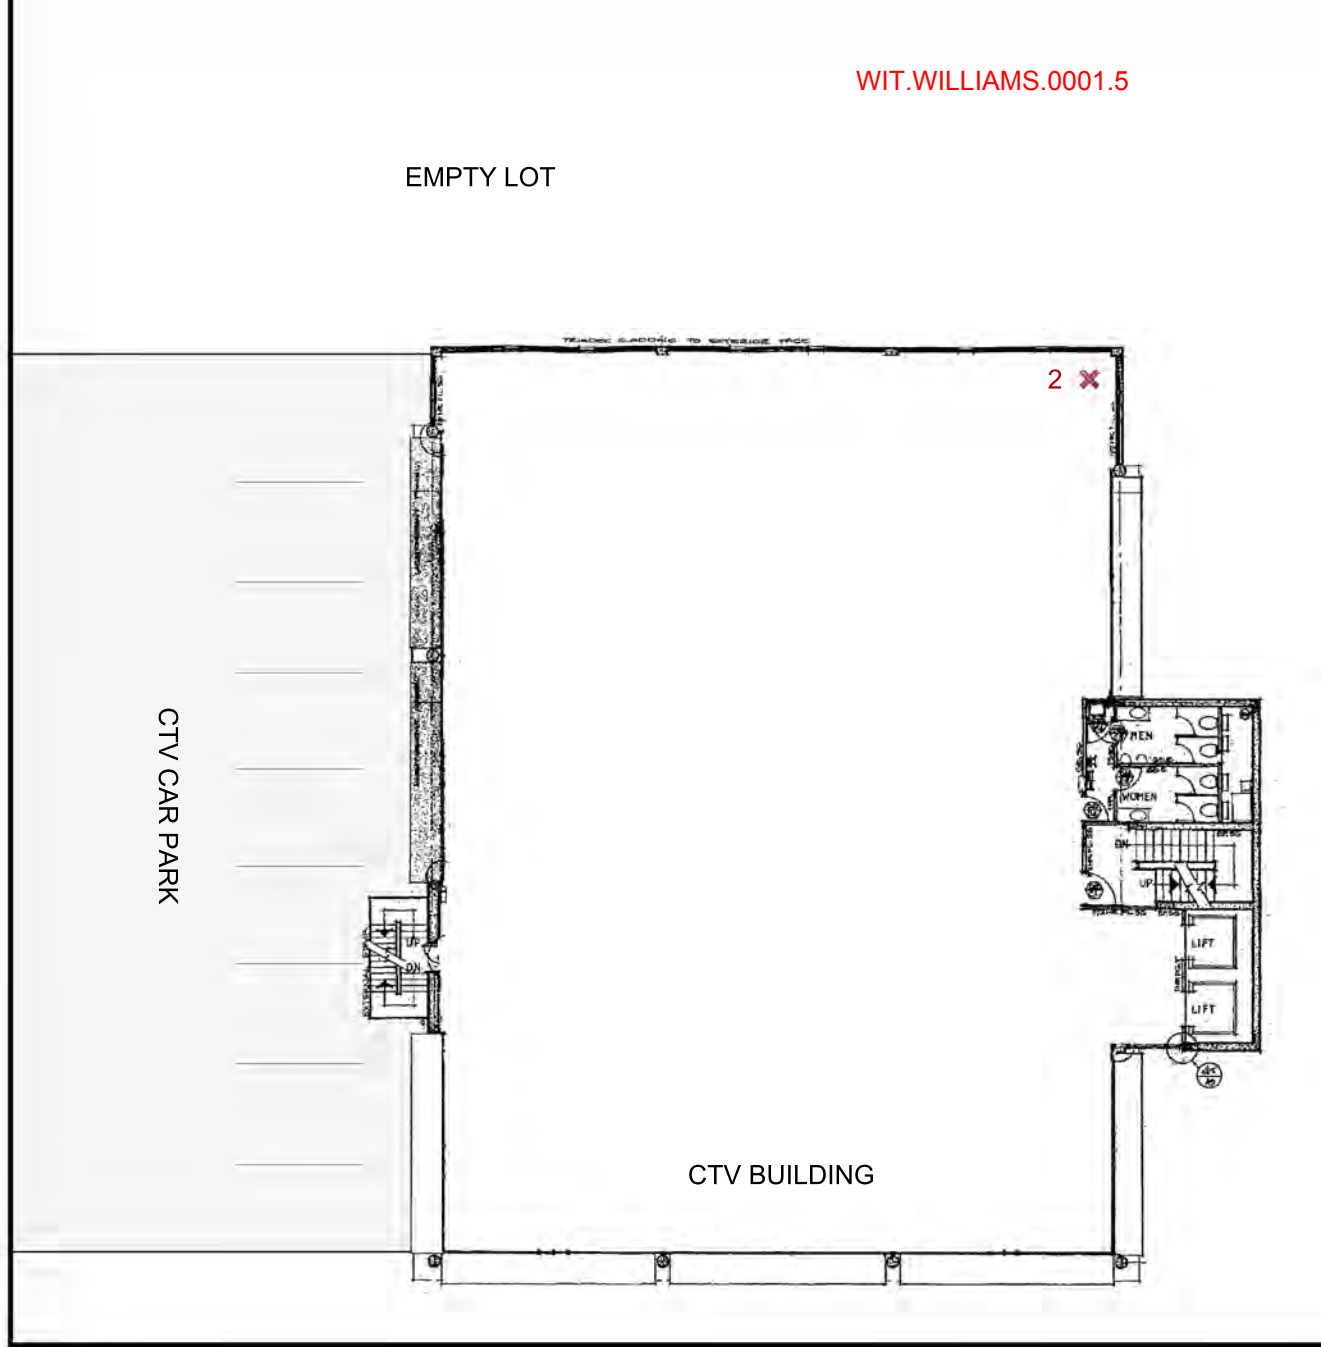
"A"

- 1. Location of Michael Williams
- 2. Fire

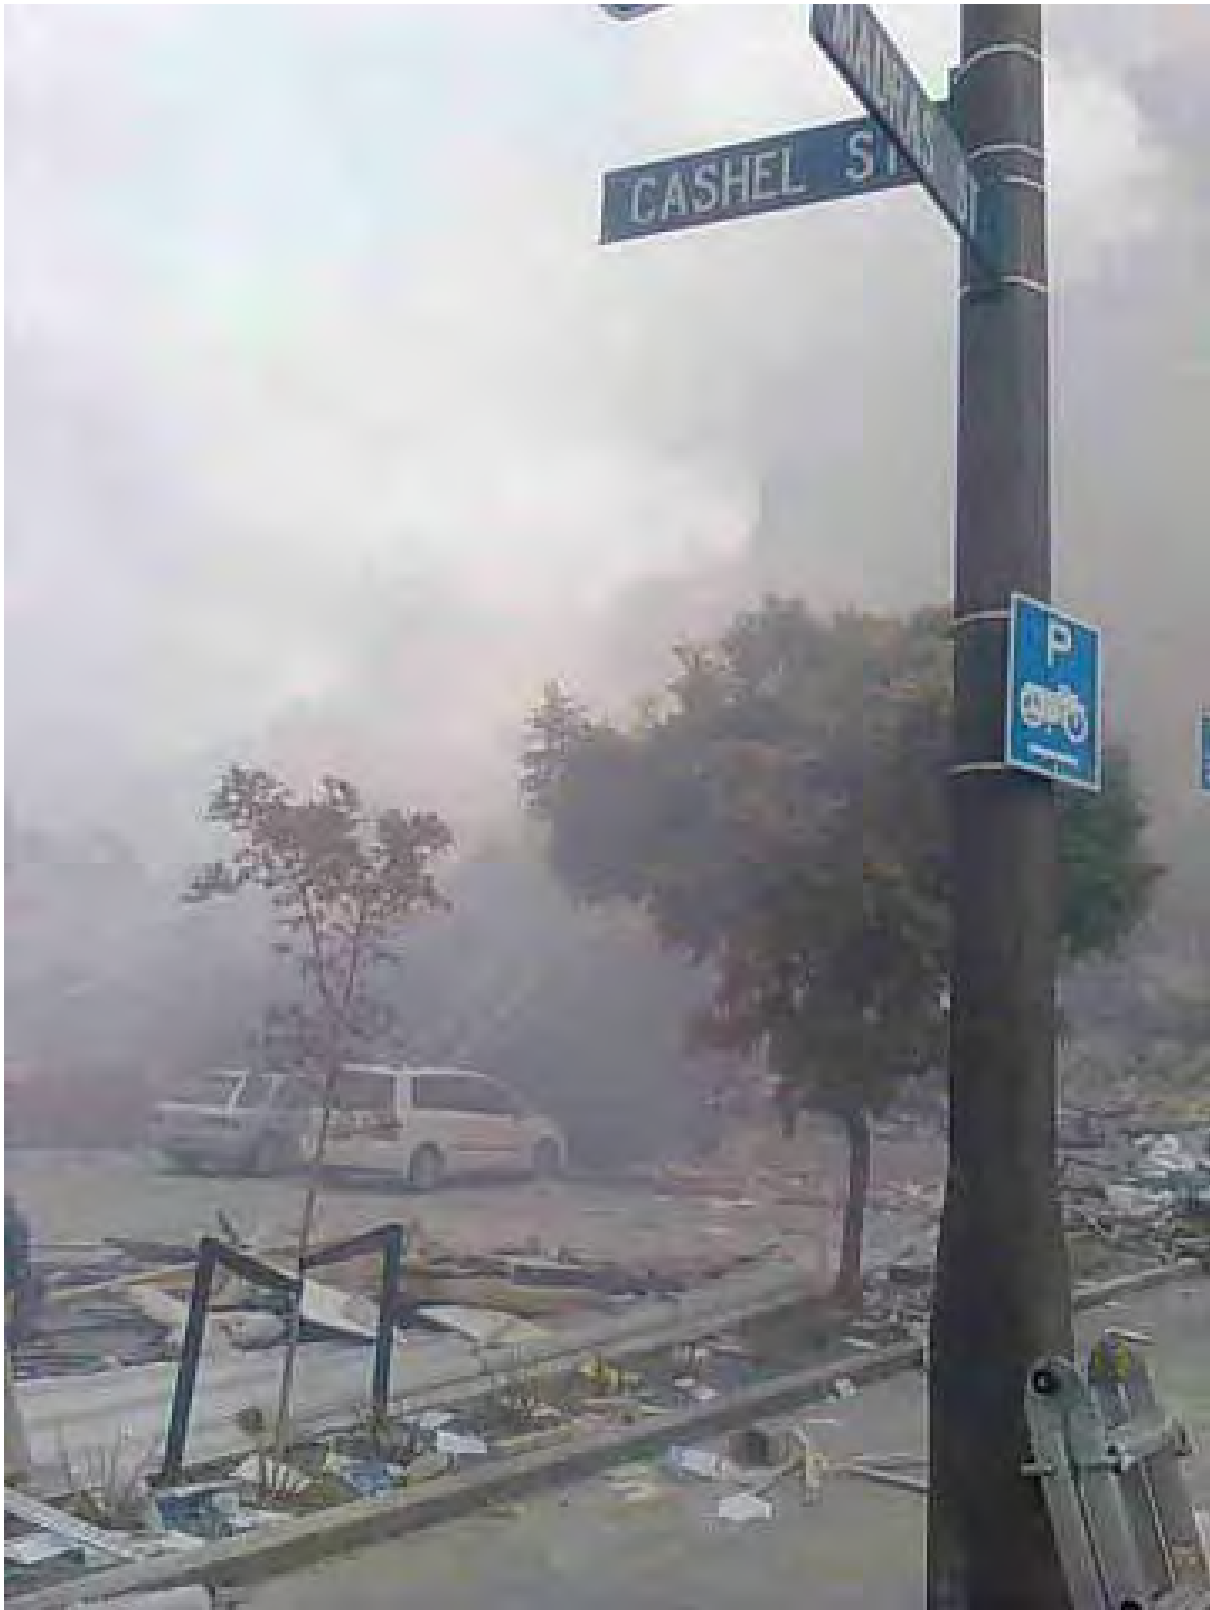
15. The next thing I knew I was out of the IRD building and at the CTV site. I am not sure of the details and think I may have lost some moments of time. I had an expectation that the building would be all over the show so I was very surprised to see that it had fallen in a complete square. I didn't think that it was normal for a building to fall like that. It looked like it had come straight down. I could see cars parked up against the front of the building that were relatively undamaged.

2. The building has landed directly in front of the cars parked in the CTV car park.  
Taken within 90 minutes of the collapse.

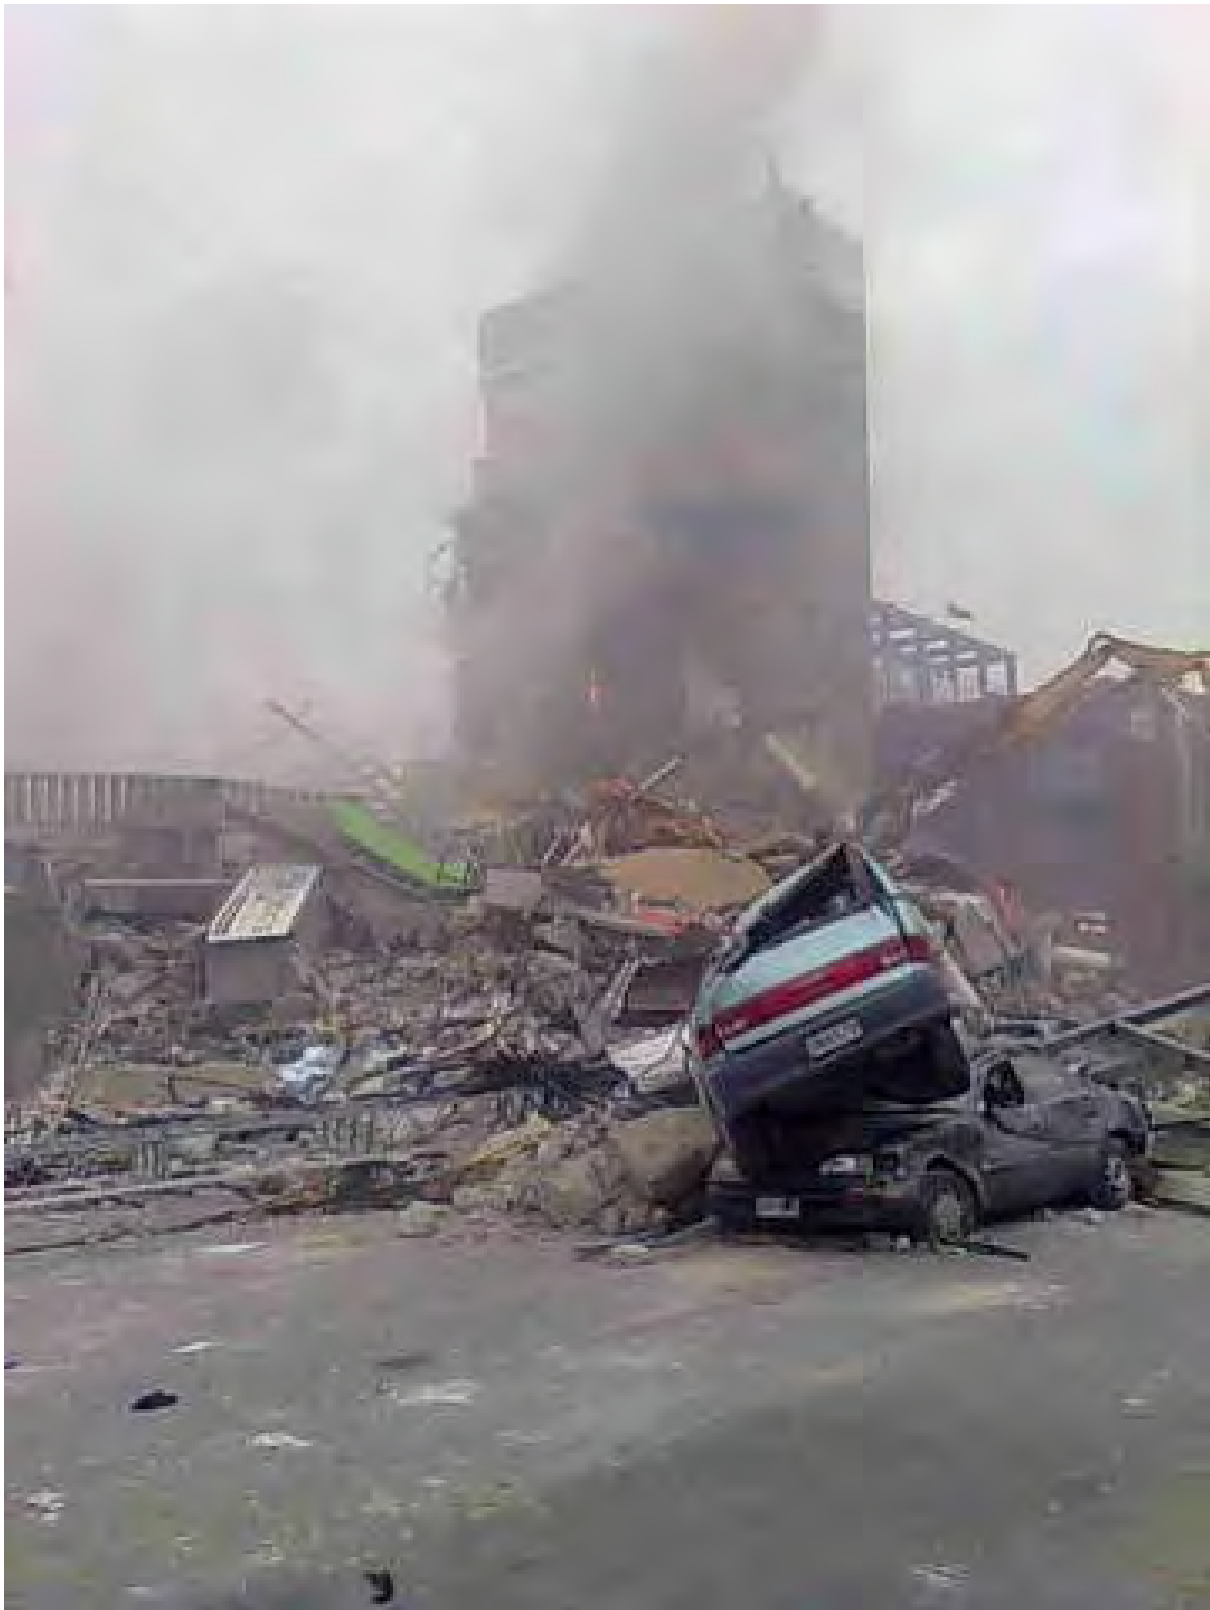
13. It was exactly like seeing the collapse of the World Trade Centre buildings. The top floated down and was engulfed by dust.
14. A minute or so later, once the dust had settled, I could see the building was gone. The lift well was the only thing I could see that remained standing.

4. The liftwell.

Taken within 60 minutes of the collapse.
