William T. Holmes
Structural Engineer
2600 La Cuesta Ave.
Oakland, California, 94611
USA

April 30, 2012

Subject: Peer Review
CTV Building Collapse Investigation dated 25 January, 2012
by Hyland Consultants, Ltd, and StructureSmith Ltd.

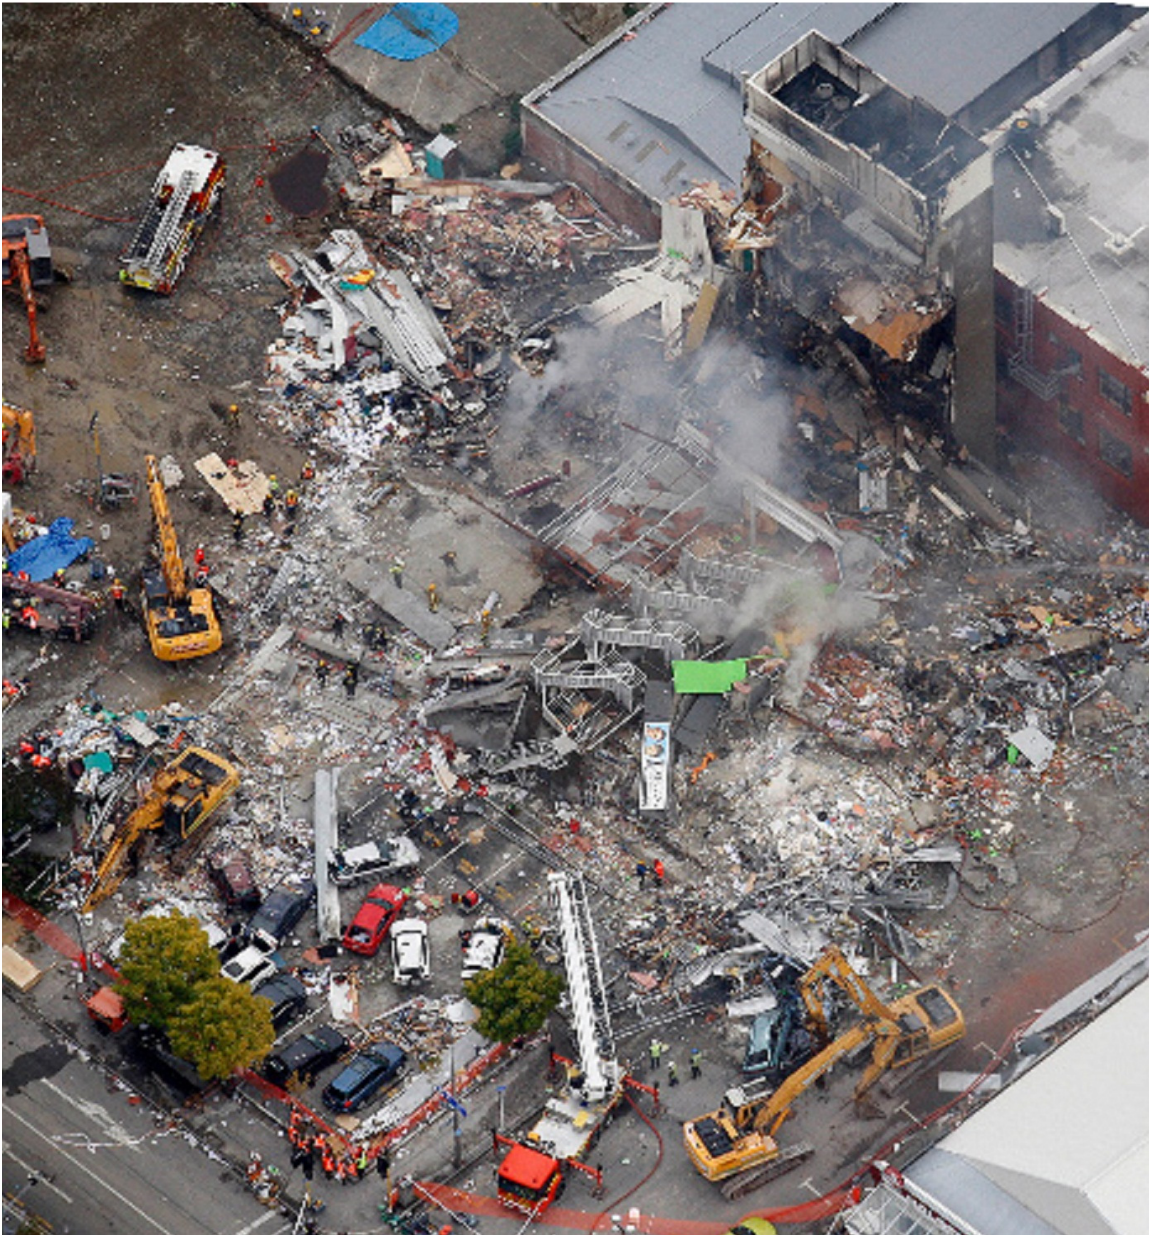
The more or less vertical collapse is also consistent with eye witness accounts and with the folding over of the front coupled shear wall into the center of the building—with only a slight tilt towards the east (as shown in Figure 1), and several of the lower floor slabs leaning against the tower (Figure 165, page 267 of report), indicating that line 3 probably collapsed before these slabs lost vertical support from the tower along line 4.

Figure 1. Aerial Photo from Southeast (probably taken at the same time as Figure 6 in the investigative report) Source: Google images
