**ROYAL COMMISSION OF INQUIRY INTO  
BUILDING FAILURE CAUSED BY CANTERBURY  
EARTHQUAKES  
KOMIHANA A TE KARAUNA HEI TIROTIRO I  
NGA WHARE I HORO I NGA RUWHENUA O  
WAITAHA**

**STATEMENT OF EVIDENCE OF PENELOPE ANN SPENCER  
IN RELATION TO THE CTV BUILDING**

**DATE OF HEARING: COMMENCING 25 JUNE 2012**

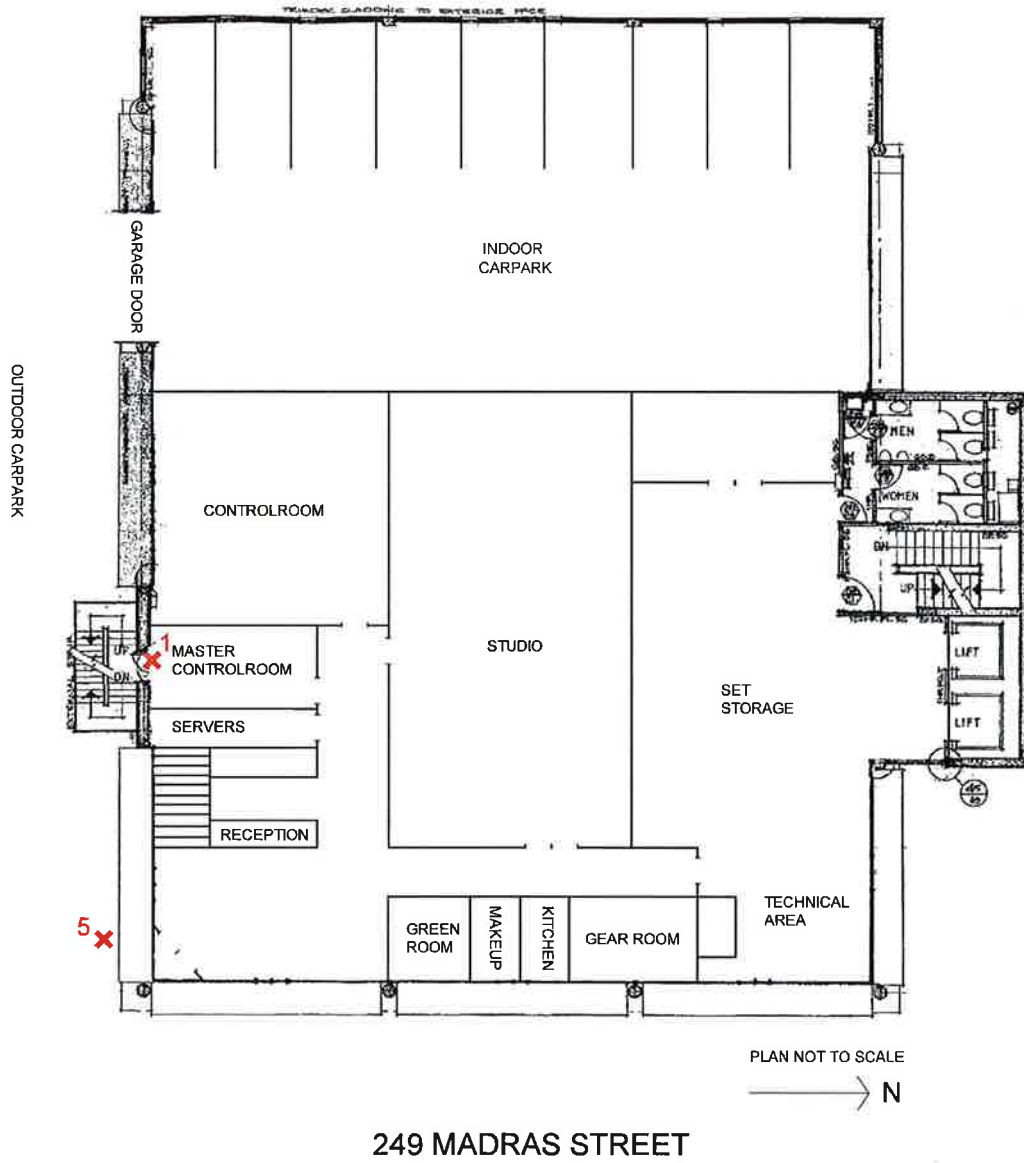
# CTV BUILDING LEVEL 1 (GROUND FLOOR)

6. After the September 2010 earthquake the Building also had several noticeable cracks. On Level 1 there were cracks in the plasterboard on the south wall of the master control room. One crack went diagonally up the wall and was about 50 centimetres long. After Boxing Day this crack went almost the whole length of the wall, about 2 to 2.5 metres in length. This crack also had other cracks leading off it after the Boxing Day earthquake. I have marked the location of this crack with the number "1" on the Plan.

12. On 22 February 2011 I was walking back to the Building on my lunch break with my boyfriend, Tom Hawker (Tom). We had just been to the dairy on the south side of Cashel Street opposite Les Mills. We were walking back across the road, almost in line with the Building car park entrance to the south of the Building and in line with the west wall when the earthquake struck. I could see the whole south side and the southern end of the west side of the Building. Where I was standing on Cashel Street is marked with the number "4" on the Plan.

14. Level 5 then collapsed down and hit the next floor down. It stopped for about half a second and then it dropped again onto the next floor down. The Building then pancaked all the way down to the ground. The top floor (Level 6) dropped as a unit, staying intact until it hit the rubble at the bottom.
15. After the collapse, water pipes from the top levels had sheared off at the North Core and were leaking out a significant amount of water onto the rubble below. A fire started at the northern end of the Building almost immediately after the collapse.
16. The Building had come down so straight that Tom's car, which was parked in the second car parking space closest to Madras Street and along the South Wall of the Building, really only had the bumper knocked off it and the windscreen smashed. I have marked the location of Tom's car with the number "5" on the Plan.

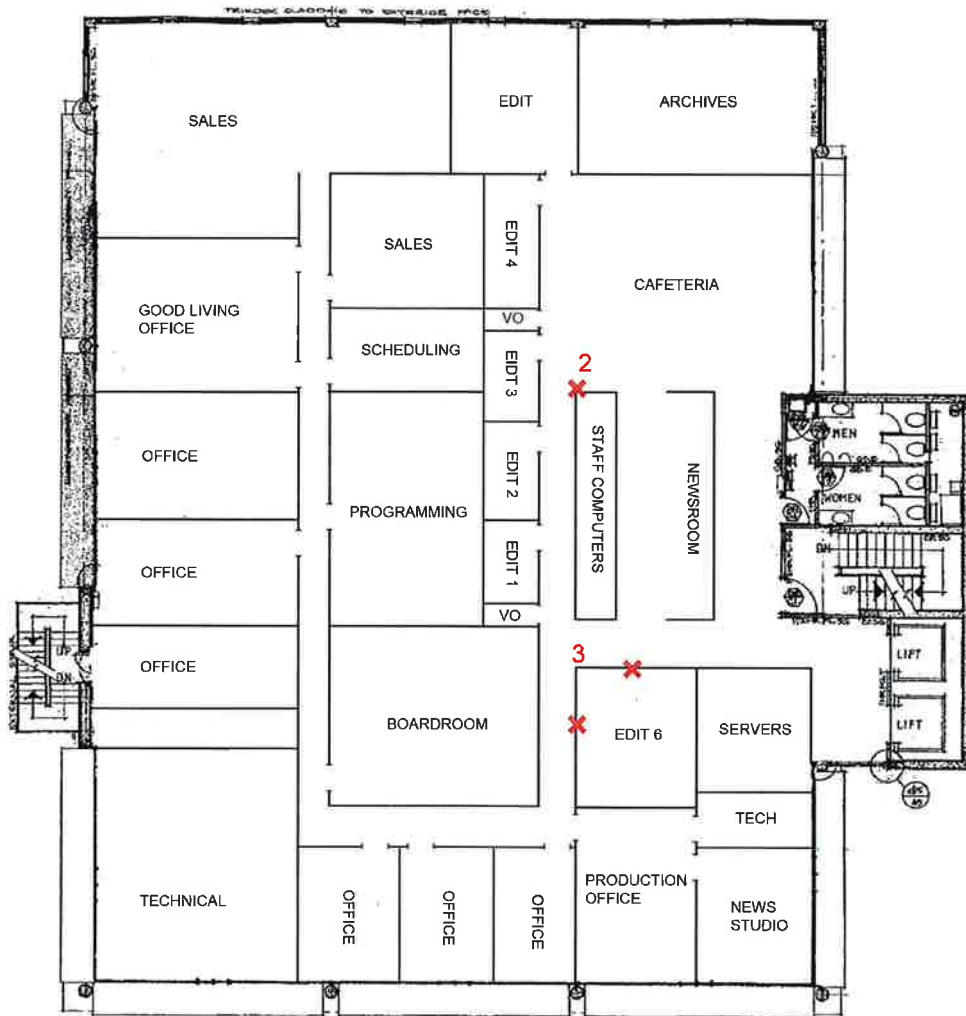
# CTV BUILDING LEVEL 2

7. There was a significant crack around the internal pillar between the cafeteria and the staff computers on Level 2. Here the carpet along the edge of the internal wall had separated from the pillar by about 1 centimetre. This had previously been attached before the September 2010 earthquake. I have marked the location of this pillar with the number "2" on the Plan.

8. There were cracks on internal walls on Level 2. Cracks on walls along the corridor by the editing room went straight up the wall and were 10 to 20 centimetres long. I am sure these cracks also grew bigger after the Boxing Day 2010 earthquake. I have marked the location of these cracks with the number "3" on the Plan. I am sure there were also cracks around windows and door frames but I do not recall where they were. I think windows may have been broken along the east wall of Level 2 too.
9. I never saw any cracking on the outside of the Building.
10. I do not think anyone at CTV felt safe in the Building. Sometimes we would joke around and jump into the cafeteria on Level 2 which would make the floor shake. The floor also shook every time someone walked down the corridor on Level 2. This did not happen prior to the September 2011 earthquake.
