RAPID EVALUATION OF BUILDING SAFETY: LEARNINGS FROM THE DECEMBER 2007 GISBORNE EARTHQUAKE

D R Brunson¹

Keynote Presentation delivered at the 2008 Australian Earthquake Engineering Society conference at Ballarat, Victoria.

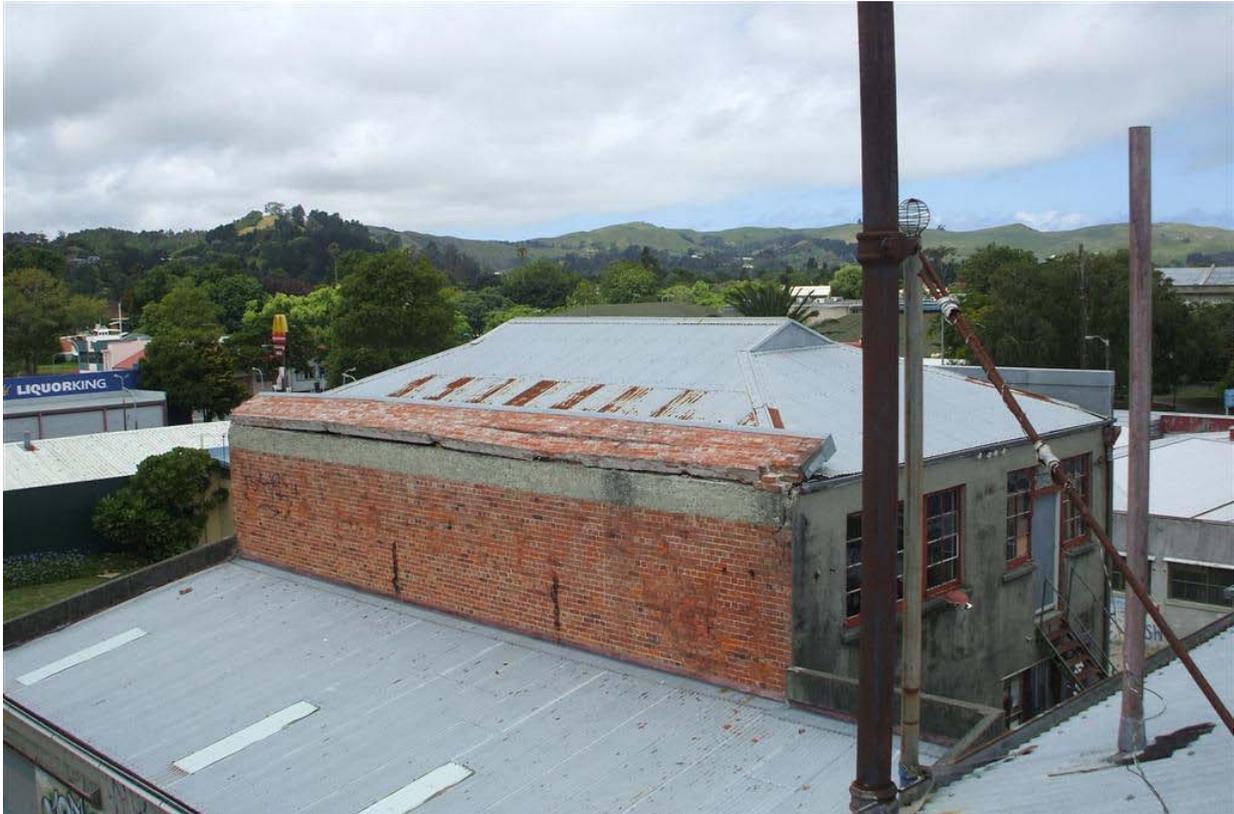
The earthquake was highly directional, being almost exactly parallel to the main street of Gisborne. This meant that unrestrained parapets and walls perpendicular to the main street experienced the greatest out-of-plane accelerations (Figure 3). A common form of damage was therefore from masonry falling from a two storey building onto (and in many cases through) the sheet metal roofing of an adjacent single storey building (Figure 4). Most of the damage in the CBD was directly attributable to damaged or failing parapets.

Figure 3: Indication of common mode of parapet failure parallel to the main street (noting unaffected roof below)

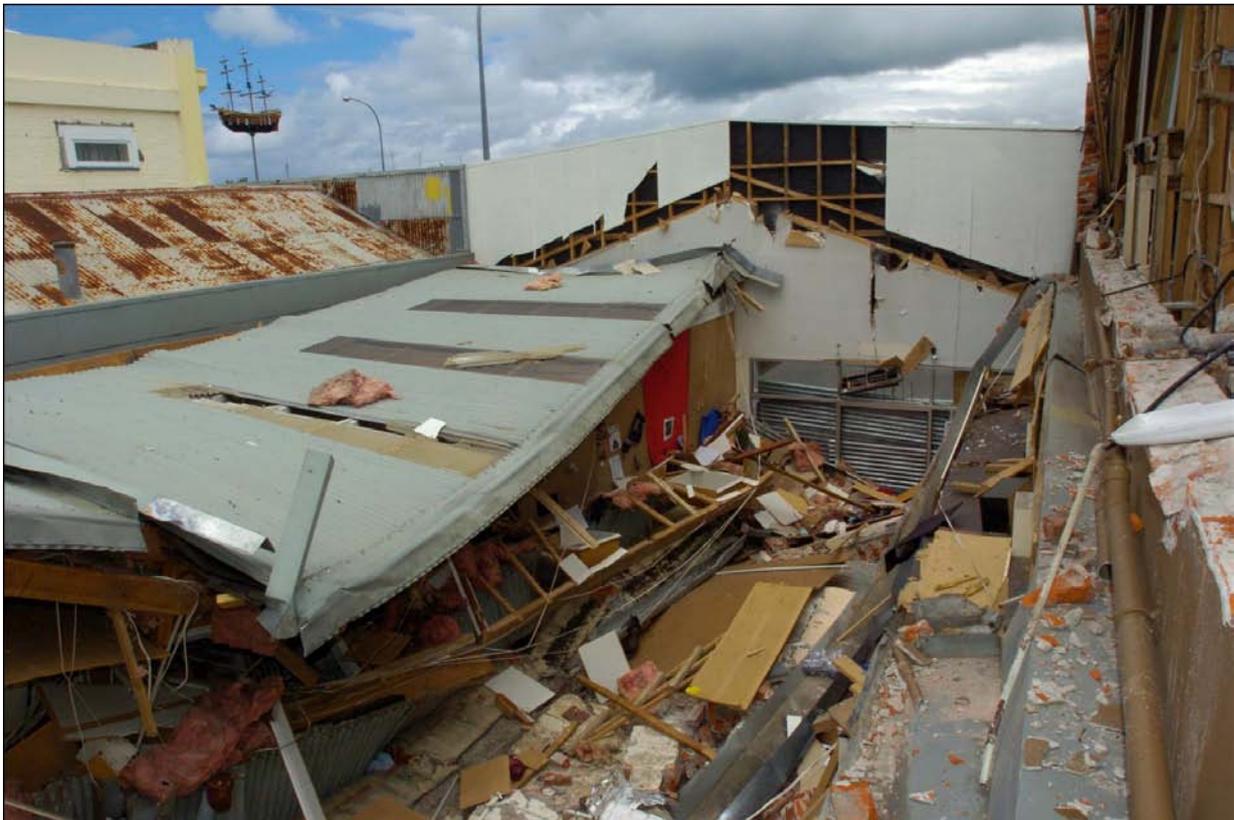
Figure 4: Damage to single-storey building from failure of upper level wall and parapet from neighbouring building at right (Photo from Gisborne Herald)
