**ROYAL COMMISSION OF INQUIRY INTO
BUILDING FAILURE CAUSED BY
CANTERBURY EARTHQUAKES**

THE CTV BUILDING COLLAPSE

**STATEMENT OF EVIDENCE OF BRUCE MICHAEL CAMPBELL
IN RELATION TO THE CTV BUILDING**

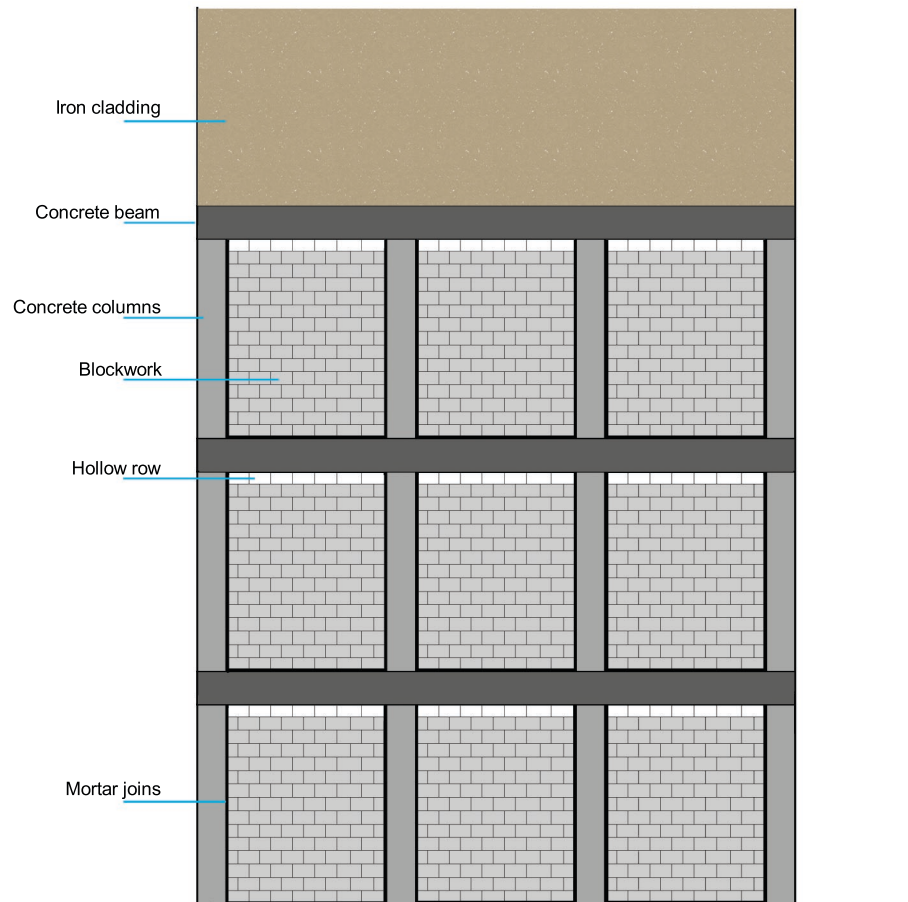
Figure 1
Western wall

8. The masonry infill blocks had been laid in a brick bond formation (Figure 2). The blockwork was then joined to the columns using mortar. The top row of masonry blocks had been slid in last and they appeared to sit tight under the beam. There were no gaps between the blockwork and the columns, or between the blockwork and the beam, on the western side of the wall (Figures 1 and 3).

9. I noticed that one of the horizontal rows of masonry infill blocks was not filled with concrete (Figures 1 and 3). I am not sure if this was structural but it did surprise me. I assumed it couldn't be filled because it was at the top of the row so was slotted in last and the horizontal beam would have impeded filling it.

10. The wall wasn't flat on the western side. Mortar had spilled out through the joins in the masonry infill blocks and we had to scrape this off to obtain a flat surface. I assumed that this was because the CTV Building was built right up against the adjacent building and you couldn't access the western side at the time it was constructed to clear this away.
