**ROYAL COMMISSION OF INQUIRY INTO
BUILDING FAILURE CAUSED BY CANTERBURY
EARTHQUAKES
KOMIHANA A TE KARAUNA HEI TIROTIRO I
NGA WHARE I HORO I NGA RUWHENUA O
WAITAHA**

**STATEMENT OF EVIDENCE OF DAVID JOHN BAINBRIDGE
IN RELATION TO THE CTV BUILDING**

**STATEMENT OF DAVID JOHN BAINBRIDGE
IN RELATION TO THE CTV BUILDING**

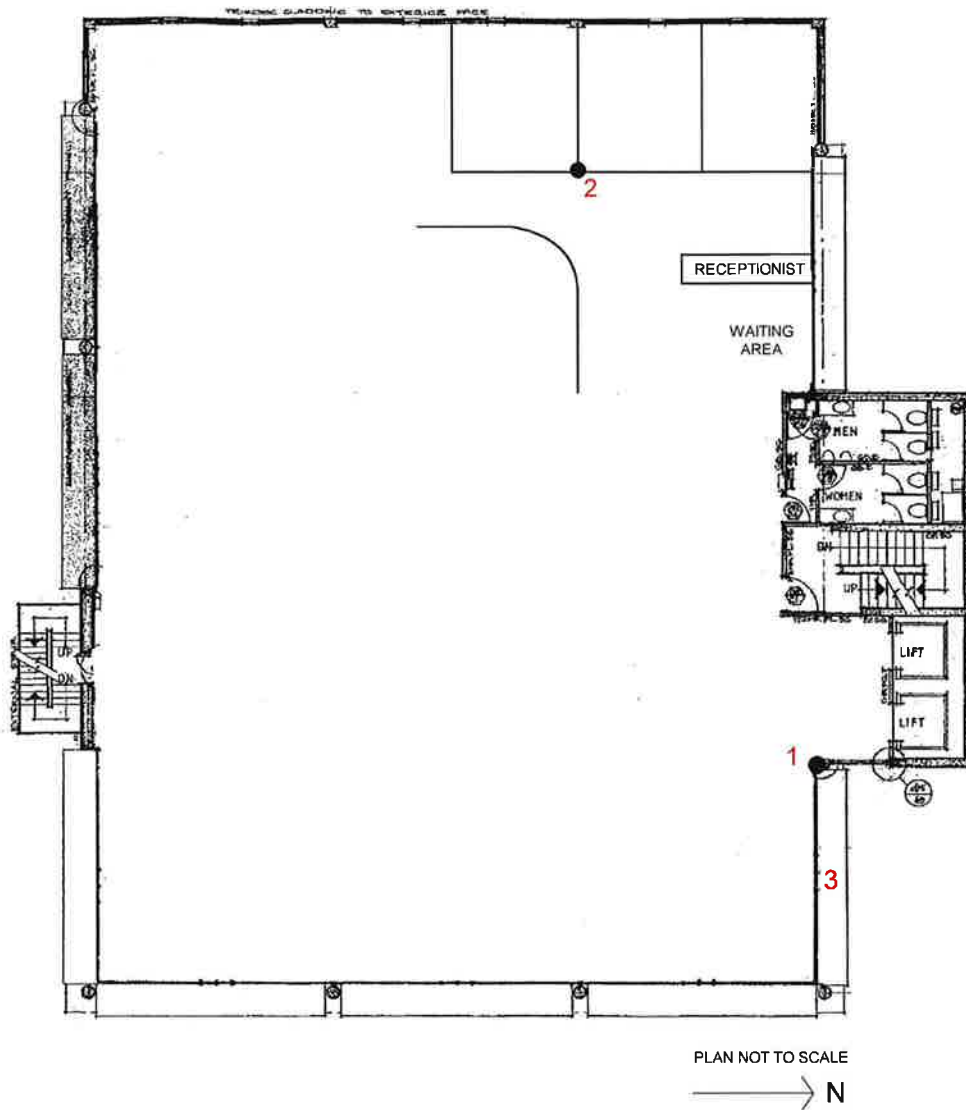
249 MADRAS STREET - LEVEL 6

7. When walking out of the lift onto Level 6 I noticed the internal column in the foyer had cracks in it. This column was along the north wall in the corner where the east side of the North Core met the wall. I have marked this column with the number "1" on the Plan.

11. I observed one other column while I was in the Building. This was on the corner of the consultation room on the west side of the Building. I have marked the location of this column with the number "2" on the Plan. This column had cracks in it also. However, I was with our counsellor, Ann Malcolm (Ann), when I walked past this column, so I never got the opportunity to examine it closely.

14. As I was waiting for the lift to leave, I looked out the window in the foyer on the east side of Level 6. I saw one of the spandrels on the exterior of the Building. This Panel was between Levels 5 and 6. I have marked its location on the Plan with the number "3". The spandrel was exposed aggregate, which was a feature of the Building design. I could see the interior and exterior sides of the end of the spandrel that was closest to the North Core.
15. I observed that this spandrel was uneven and not in line with the Building by about 100 millimetres. It was damaged and chipped at the end. From what I observed I believe it had experienced significant movement prior and had at some stage been compressed against the North Core.

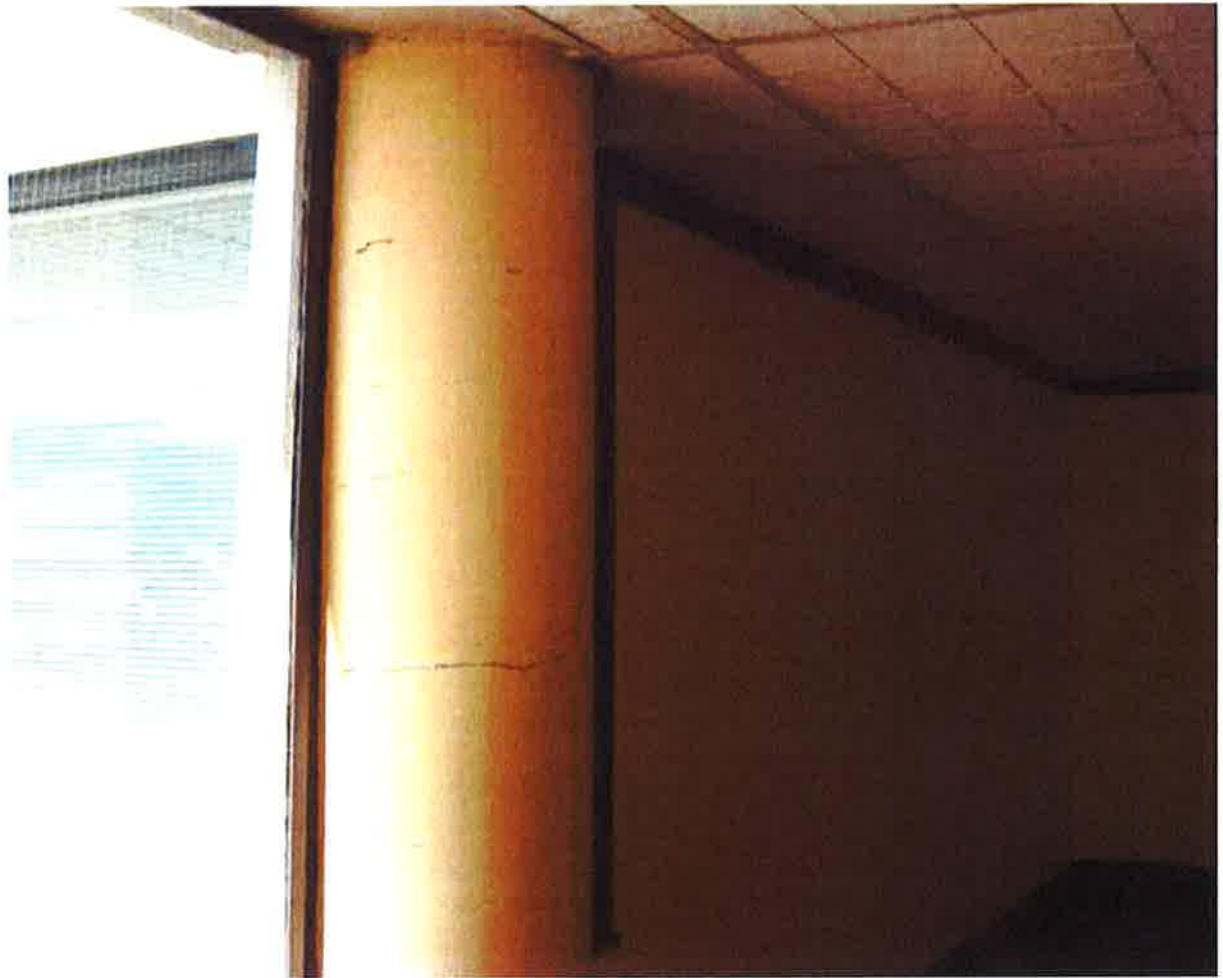
8. Approximately three-quarters of the column circumference was visible, from the floor to the ceiling. The column had at least three large cracks around it of approximately 5 millimetres in thickness and other hairline cracks of about 2 to 3 millimetres in thickness. These ran all the way around the column at about 20 centimetre intervals. There were flakes of concrete, three of which were about the size of a 50 cent coin, at the base of the column. You could also see 'blowout' marks on the column.

9. From what I observed, it looked like the column had performed to its maximum capacity in the previous earthquakes, but would fail in any further events. It definitely did not look like it could withstand another large earthquake. I was more concerned because this column was on the perimeter of the Building.

10. I have been shown a photograph of a column by Counsel Assisting the Royal Commission. This photograph is annexed hereto and marked with the reference **WIT.BAINBRIDGE.0001.6**. I can confirm that this column is the column I am referring to in the foyer marked with the number "1" on the Plan.

12. When I looked at the top of the column in the foyer, I could see around the bulkhead where the column attached to the ceiling. There was water damage on the plasterboard. This was a brownish discolouration on the ceiling panels that went about a metre inwards from the column.
