**ROYAL COMMISSION OF INQUIRY INTO  
BUILDING FAILURE CAUSED BY CANTERBURY  
EARTHQUAKES  
KOMIHANA A TE KARAUNA HEI TIROTIRO I  
NGA WHARE I HORO I NGA RUWHENUA O  
WAITAHA**

**BRIEF OF EVIDENCE OF GRAHAM EDWARD FROST  
IN RELATION TO THE CTV BUILDING**

**DATE OF HEARING: COMMENCING 25 JUNE 2012**

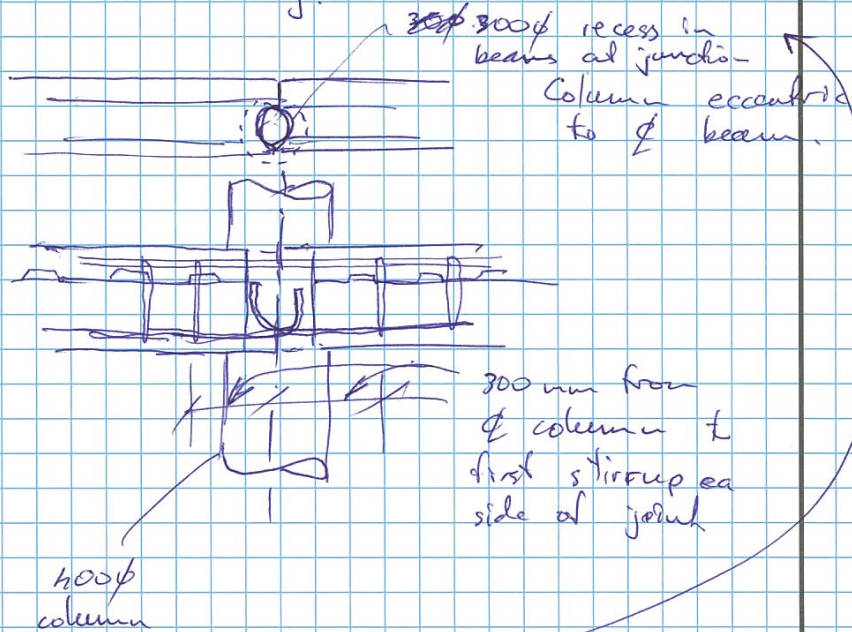
Found first beam-beam-column joint where components still 'linked' near NW cor of bldg.

(to allow precast beams to be bowed over column starter bars).

No column spiral through depth of beams -

No beam stirrups within 300mm of centerline of column.

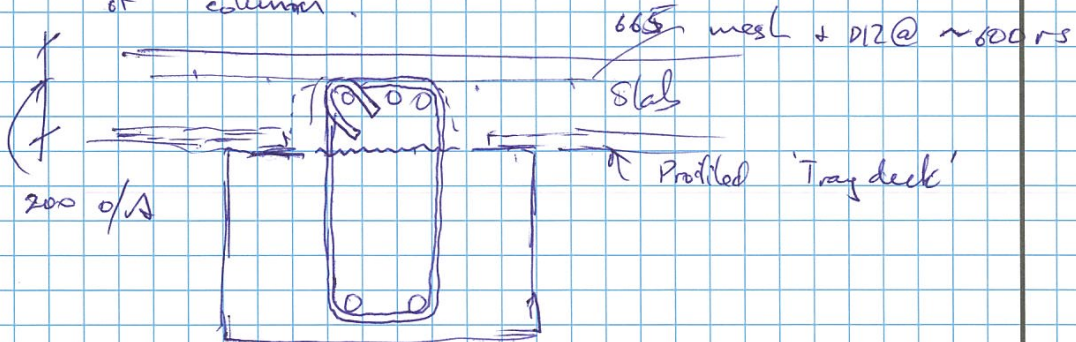
Still no sign of any slabs still bonded to 'Tray Deck'

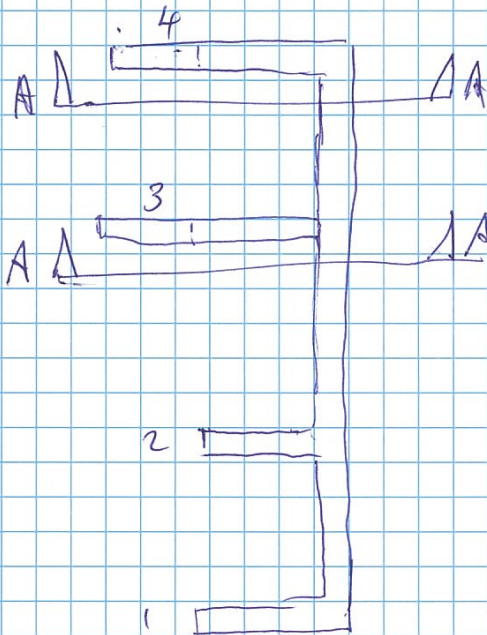
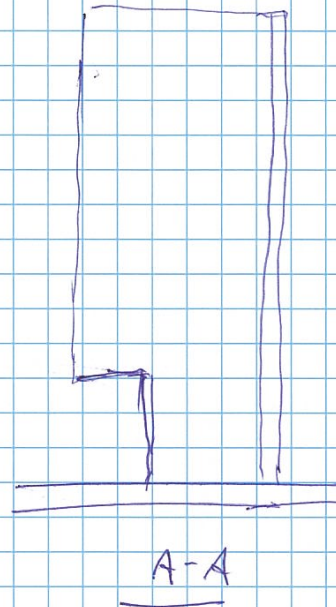
blade walls have doorway in southern edge a ground floor level - releases width of blade to similar to Eastern most two blades.

No sign of damage at base of blade walls 1, 3 + 4 or back wall. other than minor horizontal cracks near base of wall - not enough to spall & plaster finish.

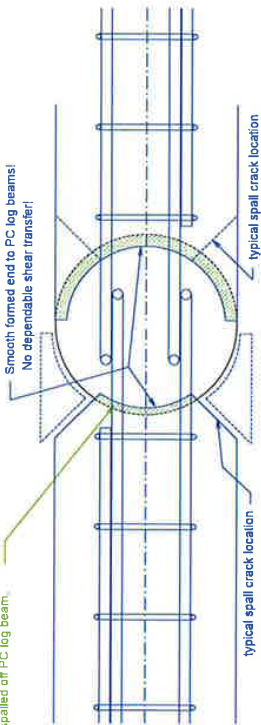
PLAN SECTION 2-2 - INTERIOR BEAM-COLUMN JOINT  
(ALLOWING 10mm CONSTRUCTION TOLERANCE)

Reduced Bearing Area Available for PC Log Beam on Column (10,180mm<sup>2</sup>)  
(if PC beam length or column position out by just 10mm

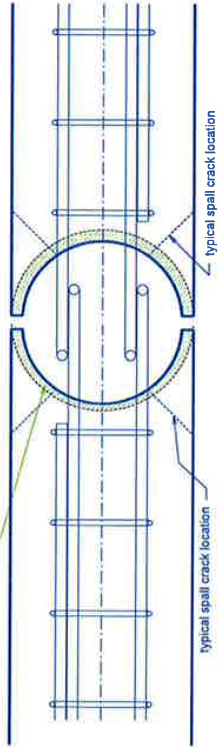
PLAN SECTION 2-1 - INTERIOR BEAM-COLUMN JOINT  
(AS DESIGNED)

MAXIMUM Bearing Area Available for PC Log Beam on Column (14,170mm<sup>2</sup>)

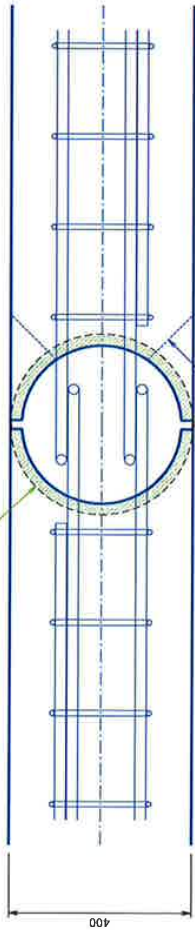
PLAN SECTION 3-3 - INTERIOR BEAM-COLUMN JOINT  
(ALLOWING 10mm CONSTRUCTION TOLERANCE + CORNER SPALLING)

Reduced Bearing Area Available for PC Log Beam on Column (3,510mm<sup>2</sup>)  
(if PC beam length or column position out by just 10mm  
and corners have spalled off PC log beam.

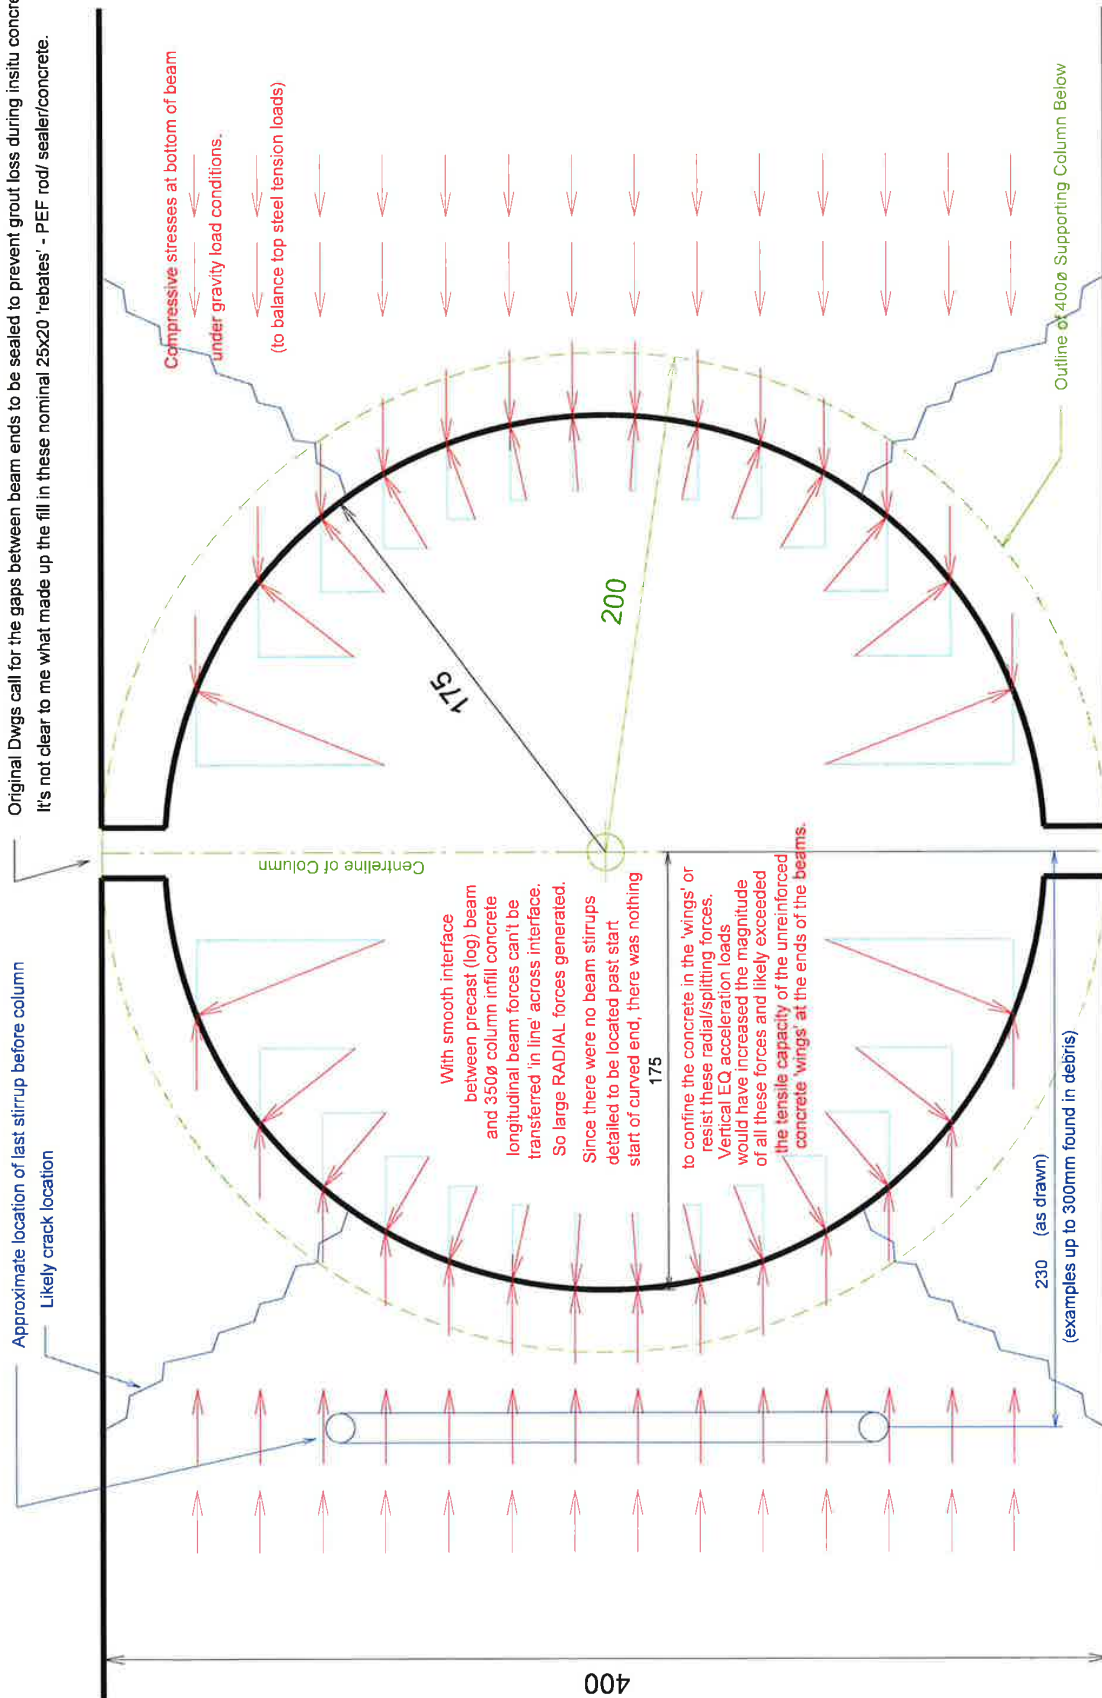
SK GF 20120501

Original Dvgs call for the gaps between beam ends to be sealed to prevent grout loss during insitu concrete (infill) pour. It's not clear to me what made up the fill in these nominal 25x20 'rebates' - PEF rod/ sealer/concrete.
