**ROYAL COMMISSION OF INQUIRY INTO
BUILDING FAILURE CAUSED BY
CANTERBURY EARTHQUAKES**

THE CTV BUILDING COLLAPSE

**STATEMENT OF EVIDENCE OF MATTHEW DOMINIC ROSS
IN RELATION TO THE CTV BUILDING**

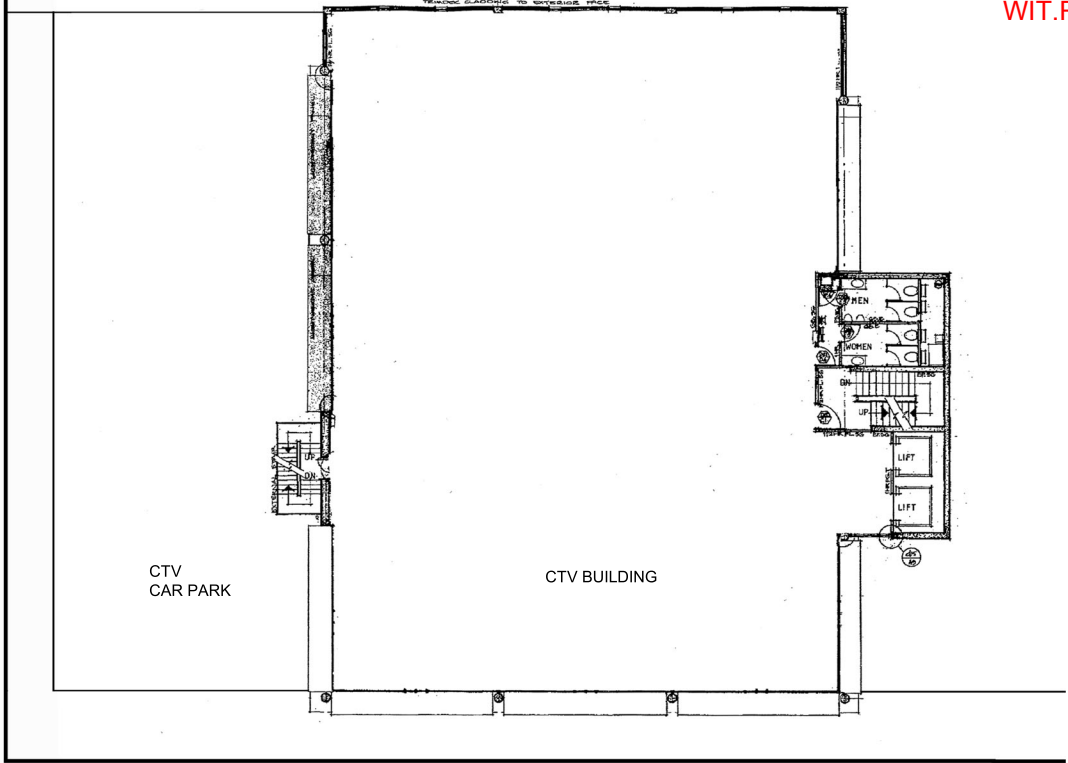
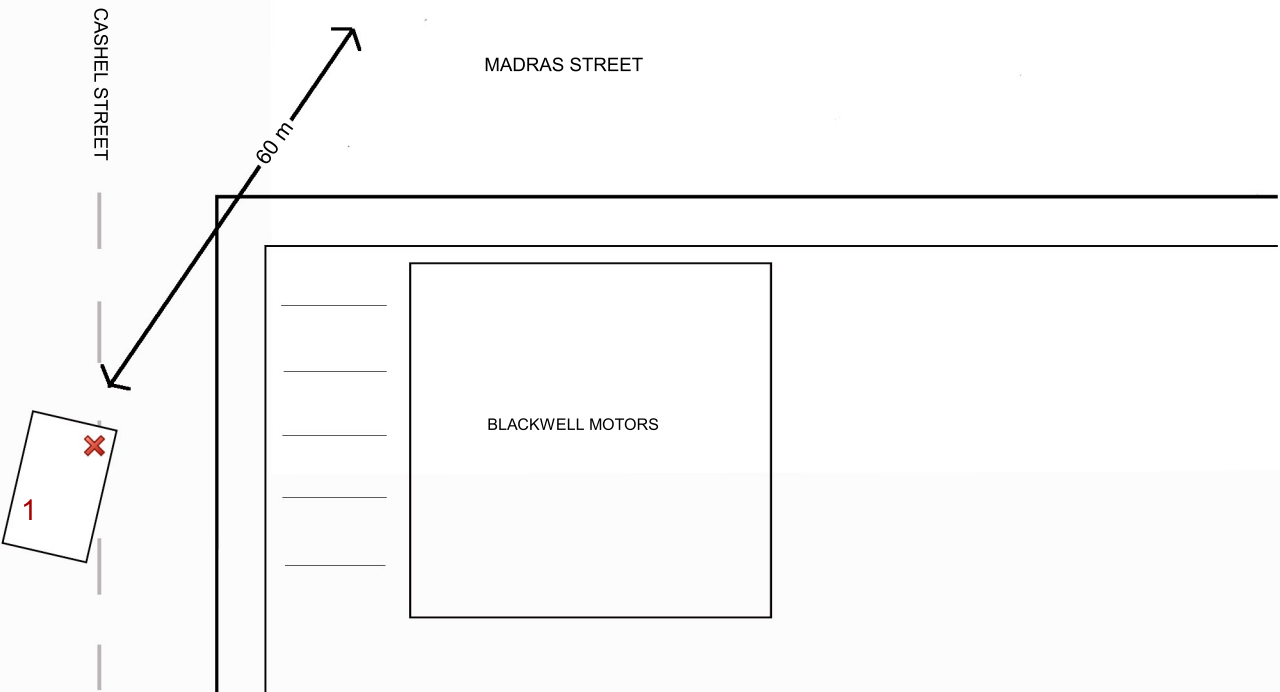
KEY
 1. Location of Matthew Ross

3. I was driving my van west down Cashel Street and was approaching the Madras Street intersection when the earthquake struck.
4. I have prepared a plan of the intersection of Madras and Cashel Streets (the Plan). This is attached and marked "A". Blackwell Motors, the Church and the IRD building have not been drawn to scale and their placement is approximate only. The issues that I refer to in my evidence are marked on this plan.

5. My first concern was that the Church would fall and land on my van. To get out of its way I turned the van so that I was in the middle of Cashel Street on about a 45 degree angle facing north-west. I have marked my approximate position as "1" on the Plan.
