Under **THE COMMISSIONS OF INQUIRY ACT 1908**  
In the matter of the **CANTERBURY EARTHQUAKES ROYAL COMMISSION  
OF INQUIRY INTO THE COLLAPSE OF THE CTV  
BUILDING**

**STATEMENT OF EVIDENCE OF DOUGLAS JON HAAVIK**

**BRIEF OF EVIDENCE OF DOUGLAS JON HAAVIK**

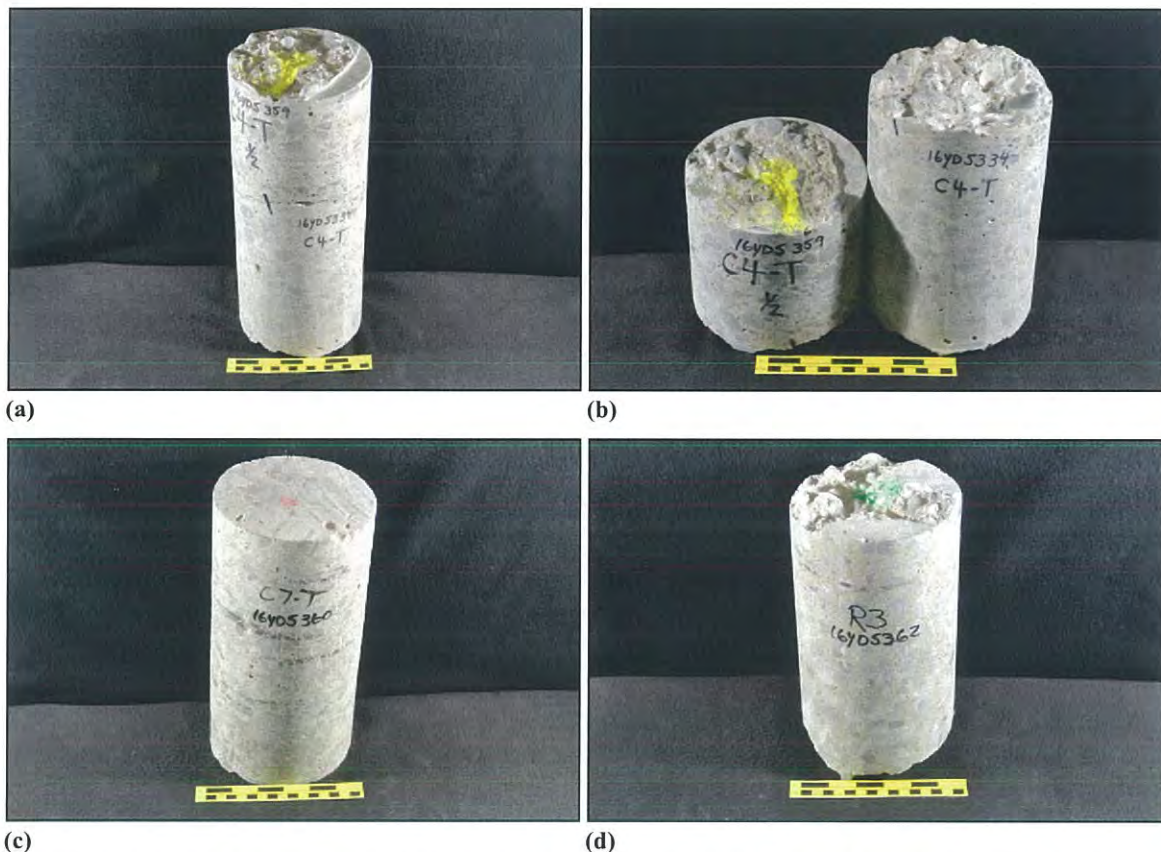
Figure 1. Photographs of some cores in as-received condition. Core C4 T showing two pieces (a) restored to original configuration and (b) as-received in separate shipments. (c) Core C7 T, which was the longest core received as one piece and which had saw-cuts at both ends. (d) Core R3 in as-received condition. Note combination of fracture and saw-cut surfaces on C4 T  $\frac{1}{2}$  and R3.

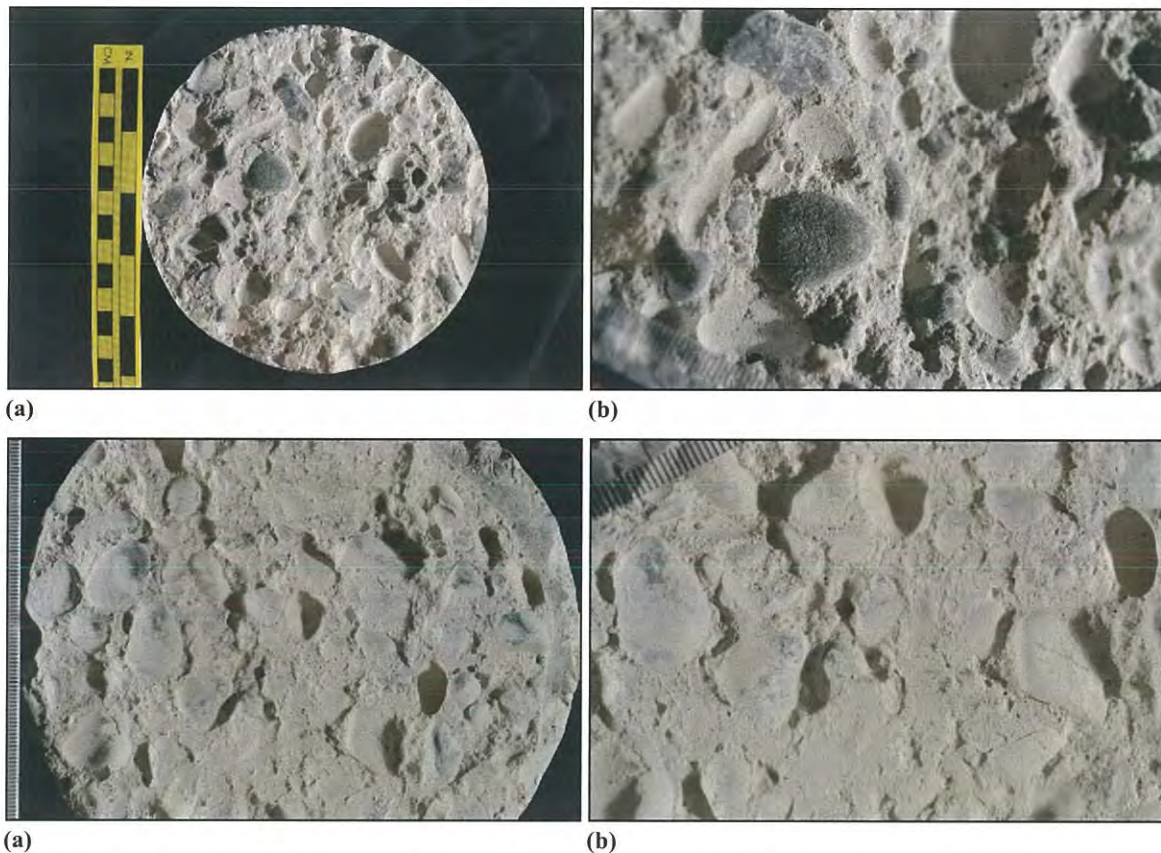
**Figure 2. Photographs of as-received fracture surfaces. Photos (a) and (b) show overview and detail of as-received fracture surface at the bottom of Core C4 B, which was relatively clean. Note the clean aggregate particles exposed by the surface and the aggregate sockets. Photos (c), (d) show Core C1 T ½ showing a fracture surface that was covered with drilling mud or other detritus. The scale in (b), (c) and (d) is in millimeters.**

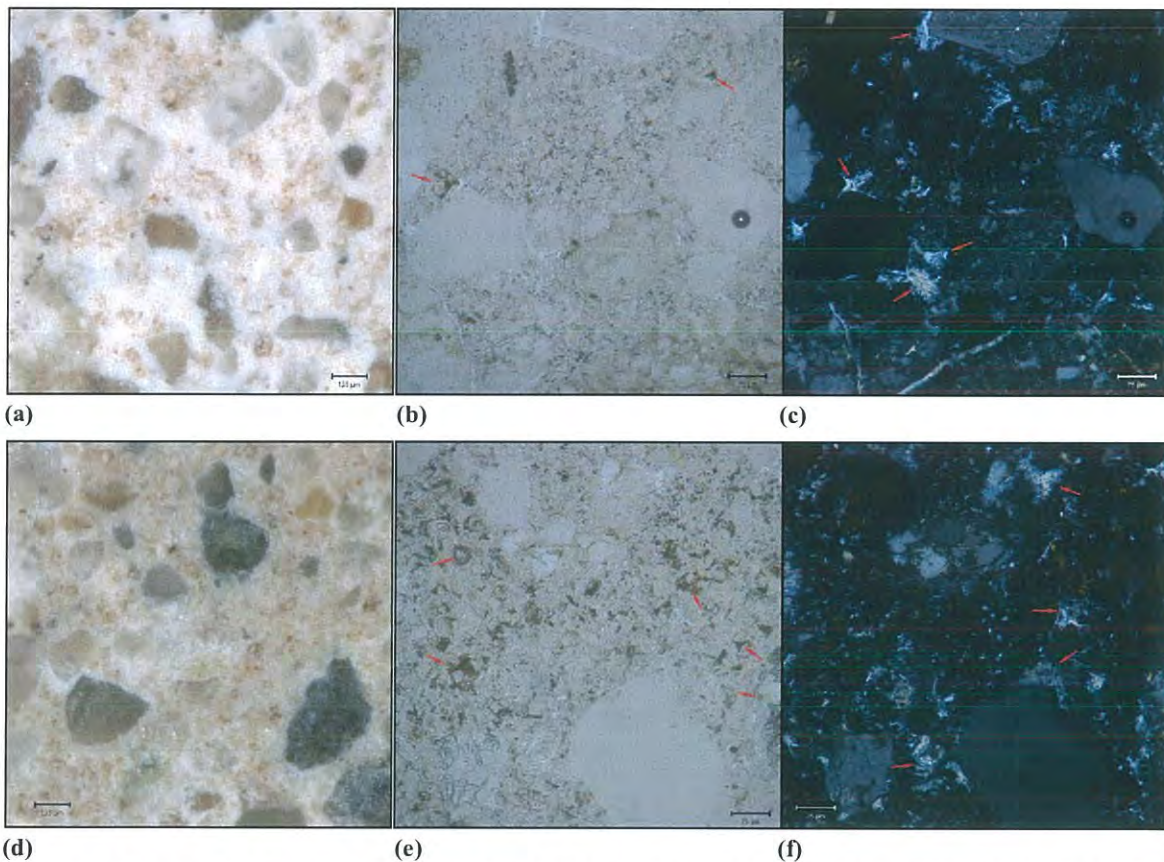
Figure 3. Paste photomicrographs from (a)-(c) Core C1 B, which had the higher  $w/cm$  typical of  $\sim 25$  MPa concrete and (d)-(f) Core C4 B, which had the lower  $w/cm$  typical of  $\sim 35$  MPa concrete. (a), (d) Reflected light photomicrographs of polished surface showing detail of paste color, texture and luster. (b), (e) Plane-polarized and (c), (f) cross-polarized transmitted light photomicrographs of thin sections showing detail of paste. Red arrows in (b) and (e) indicate relict and residual cement grains while the red arrows in (c) and (f) indicate calcium hydroxide.

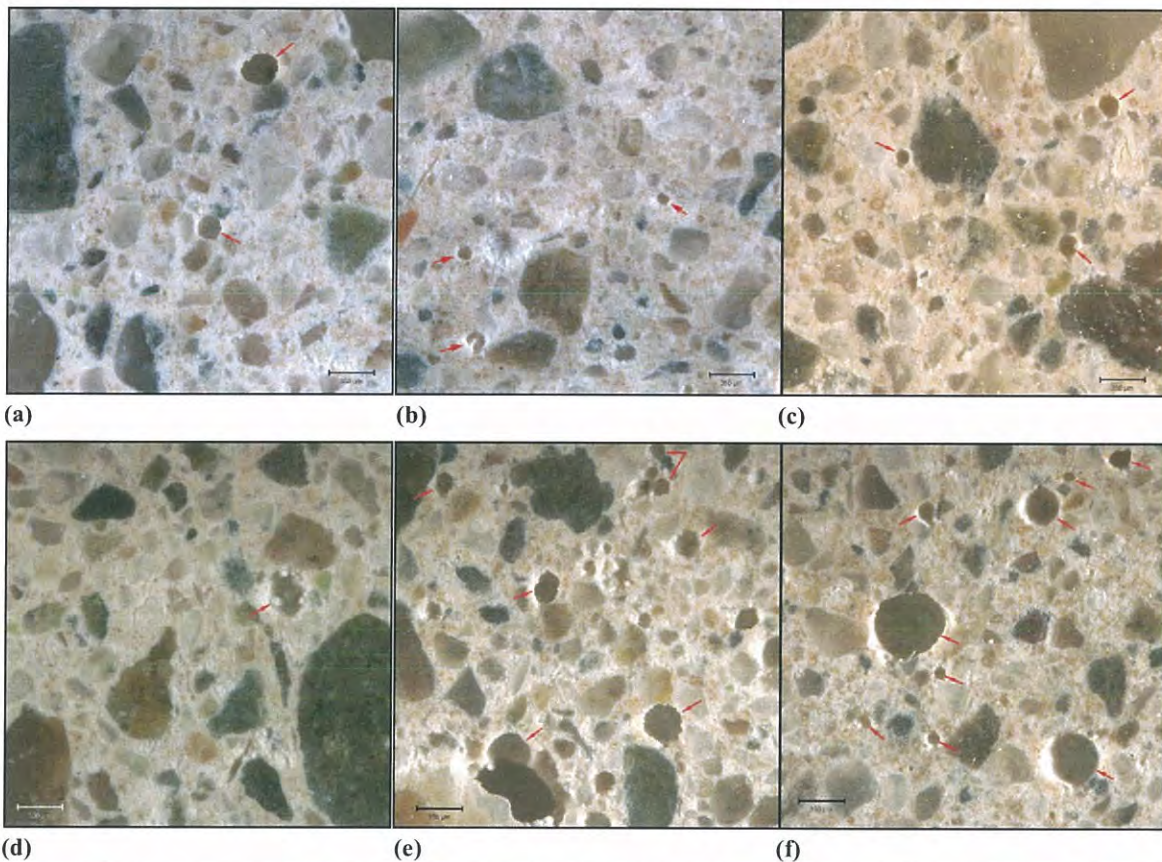
Figure 4. Oblique reflected light photomicrographs of polished surfaces of (a) C1 B ½, (b) C4 B, (c) C7 T, (d) C12 B ½, (e) R3 and (f) R7 showing voids. The red arrows show all or nearly all of the voids on the surface except in (e), where the red arrows highlight examples of voids but dark circles are also voids. This core (R3) had 4.6% total air whereas all the other cores contained less than 2% air.

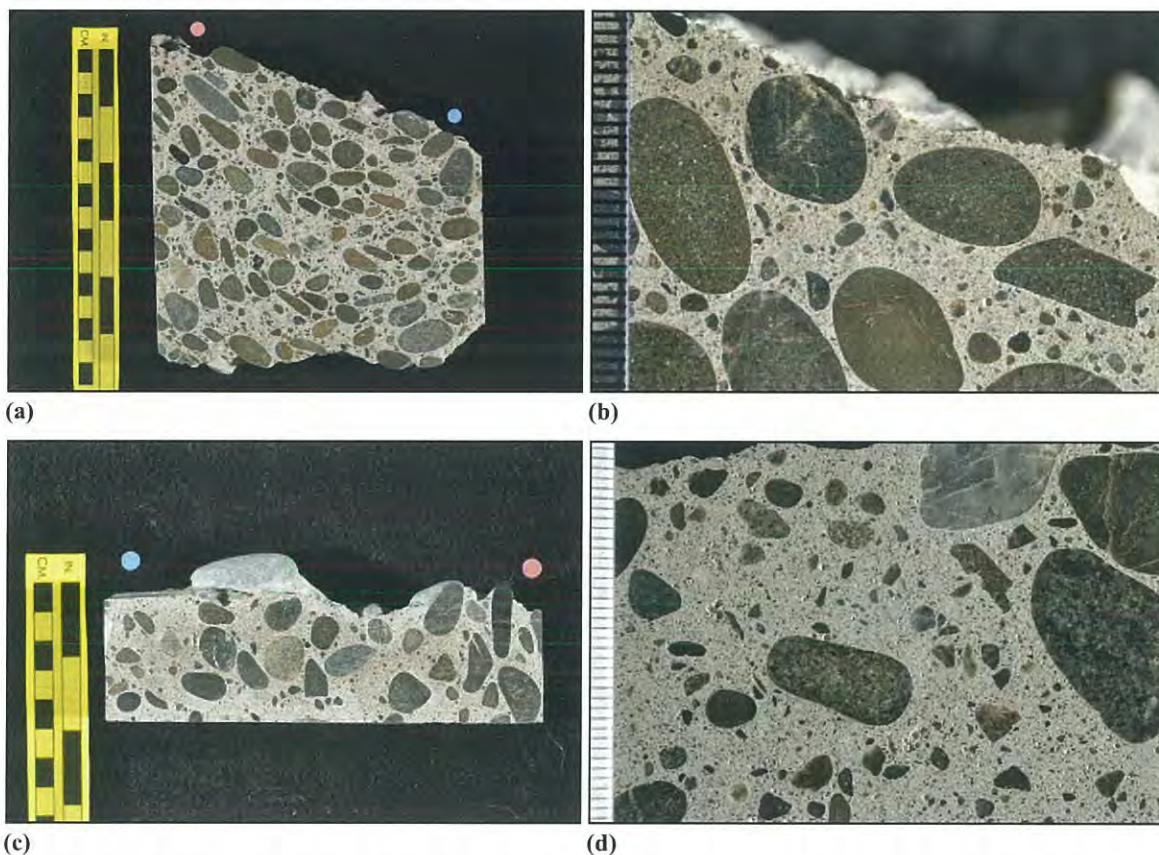
Figure 5. Photographs of the polished surfaces of (a), (b) Core C1 T  $\frac{1}{2}$  and (c), (d) Core R3 showing the well-rounded nature of the river gravel. Note the tighter particle packing, alignment of aggregates and more even gradation in C1 T  $\frac{1}{2}$  and the lack aggregate alignment and poor gradation (high sand content) in R3.

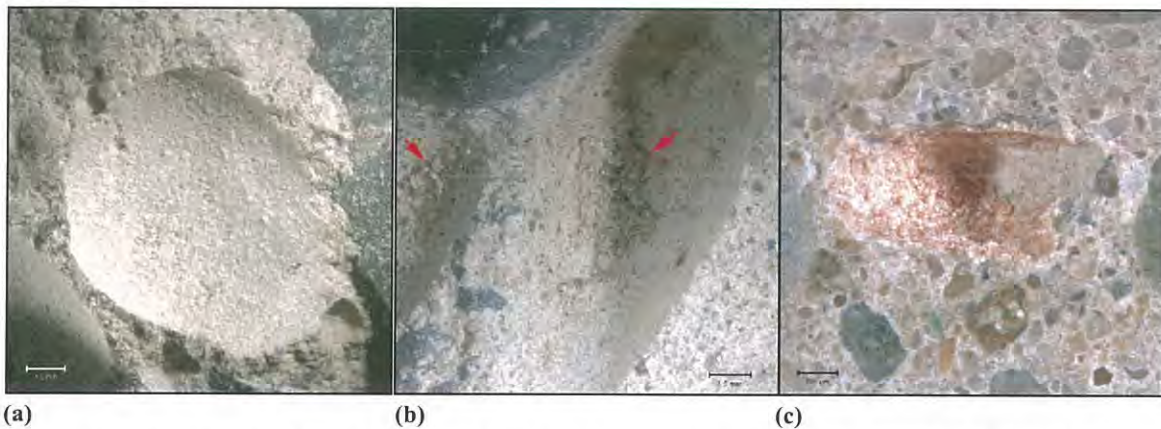
**Figure 6.** Reflected light photomicrographs showing various aggregate sockets. (a) Clean socket on fresh fracture surface in Core C7 T. (b) Aggregate socket on fresh fracture surface on Core C1 B ½ showing sand grains (red arrows) lining a portion of the socket. (c) Aggregate socket on polished surface of Core C4 B showing a lining of red granular sand.

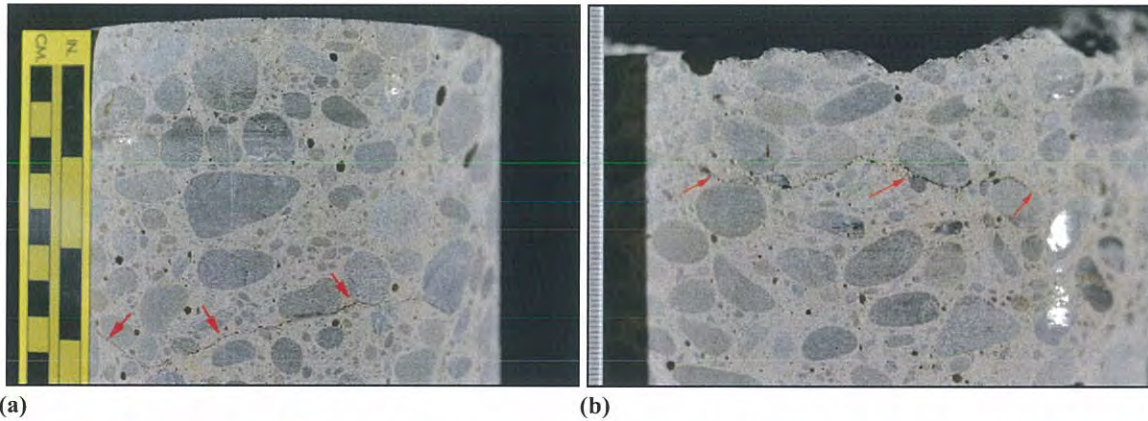
Figure 7. Photographs of hairline cracks (red arrows) observed on the sides of (a) Core C4 B and (b) Core C1 T 1/2. Scale in millimeters in (b).

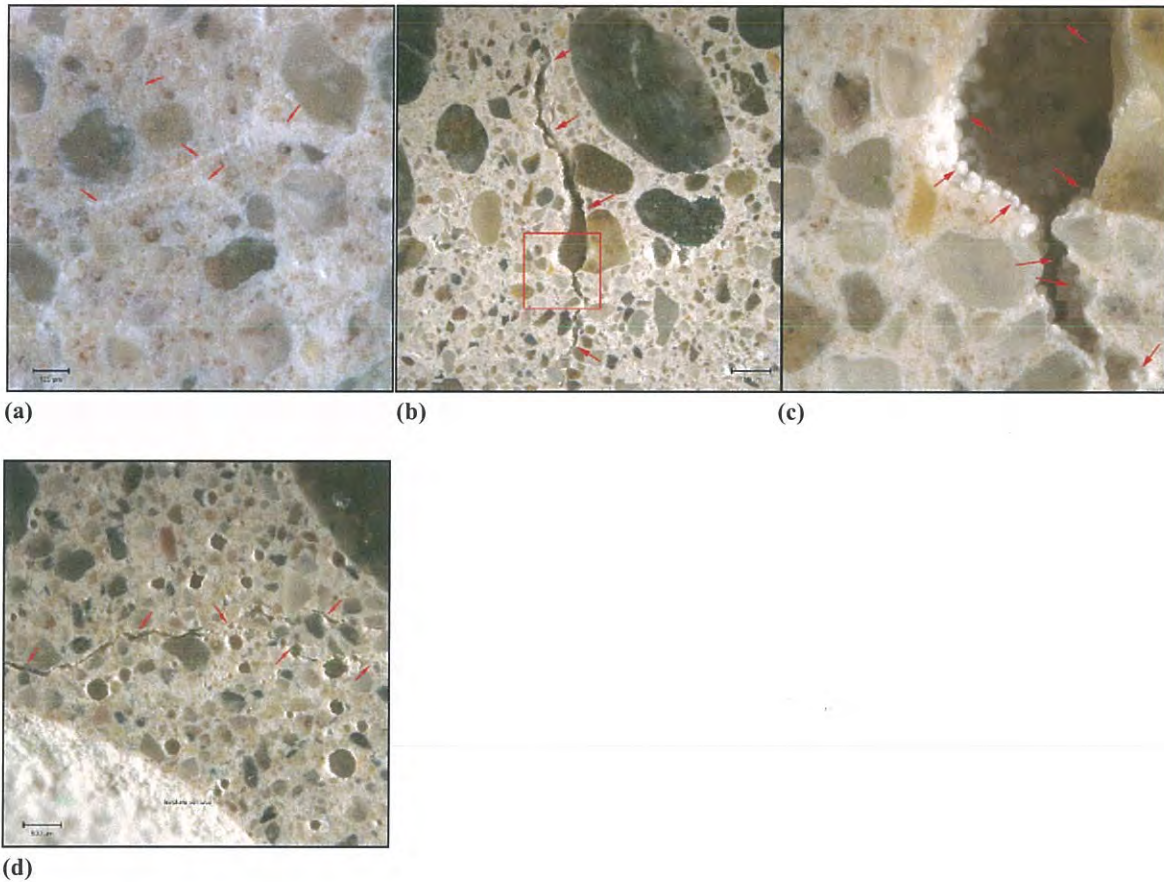
Figure 8. Reflected light photomicrographs of polished surfaces showing microcracks (red arrows). (a) Core C4 T 1/2 (b) Core C12 B 1/2; the red square in (b) indicates the approximate area of (c), where red arrows highlight rosettes of ettringite. (d) Core R3, where the microcrack occurs proximal to the as-received fracture surface.

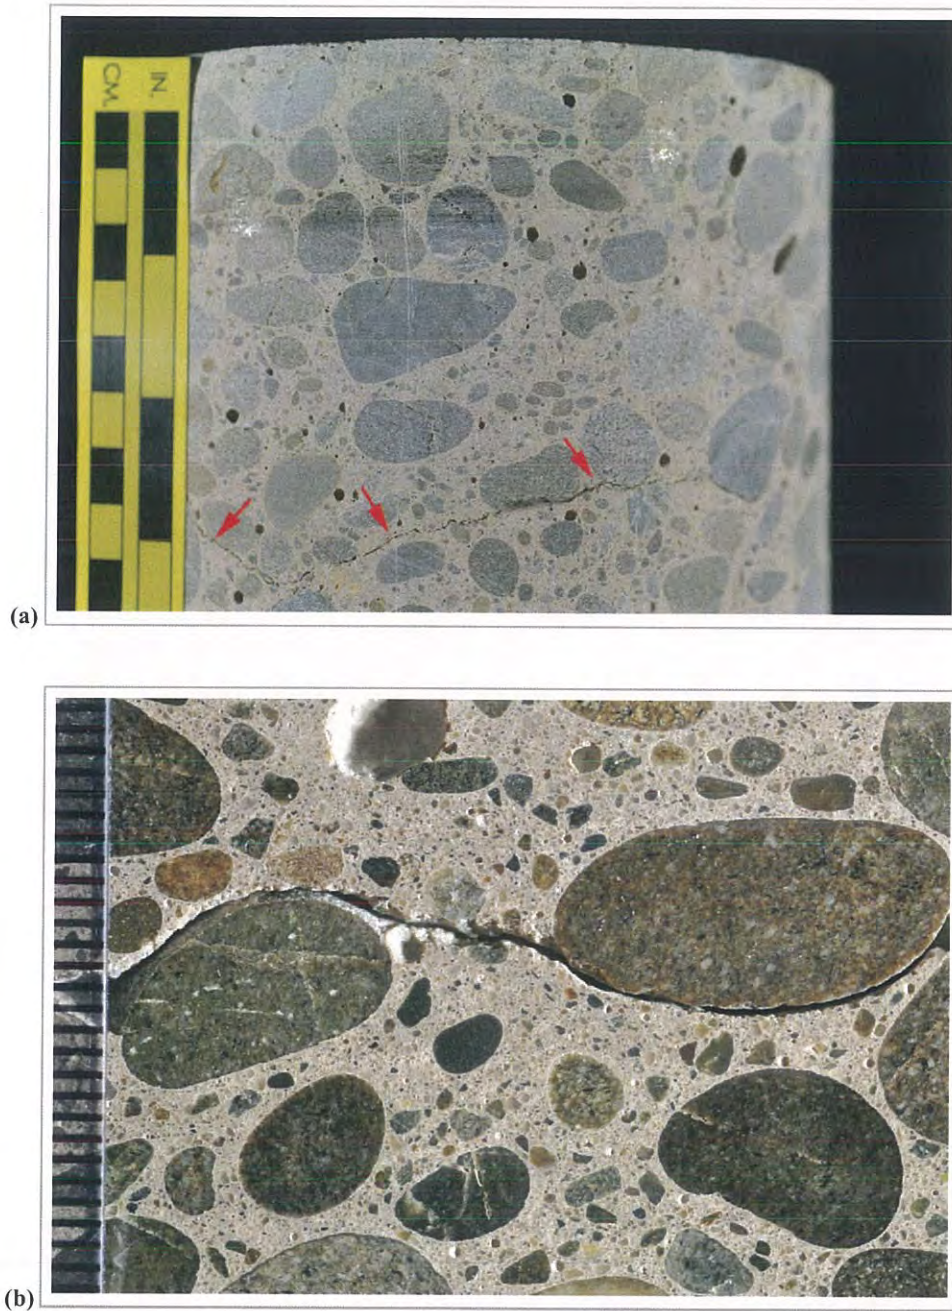
Figure C4. Photographs of (a) side of core showing sub-horizontal crack (red arrows) and (b) polished surface showing the sub-horizontal crack shown in (a). Scale in millimeters in (b).

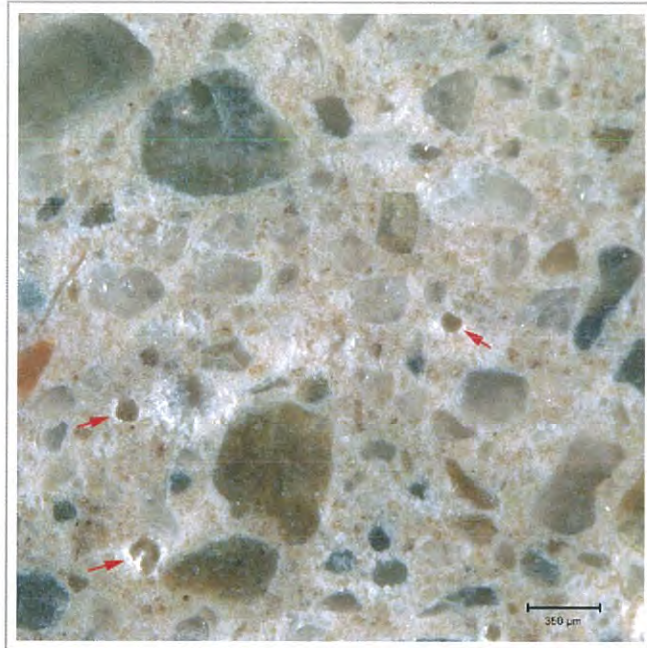
Figure C5. Oblique reflected light photomicrograph of polished surface showing voids (red arrows).

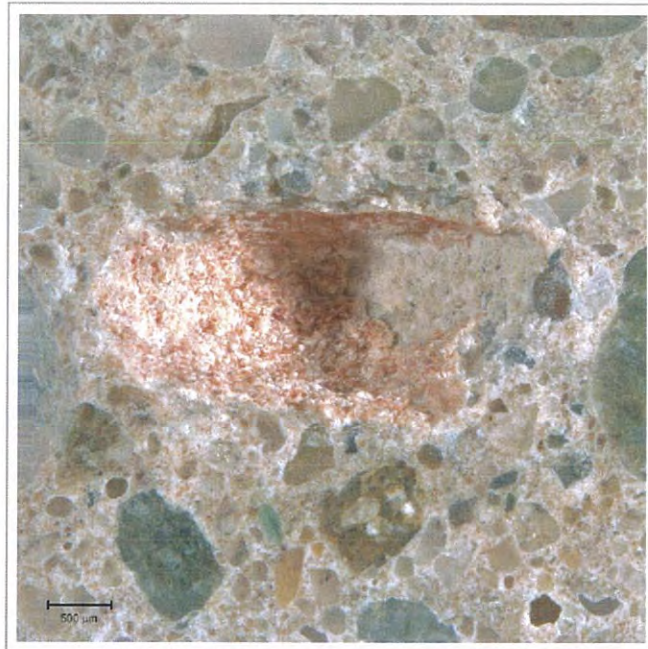
**Figure C7.** Reflected light photomicrograph of polished surface showing rust-colored sand on an aggregate socket.

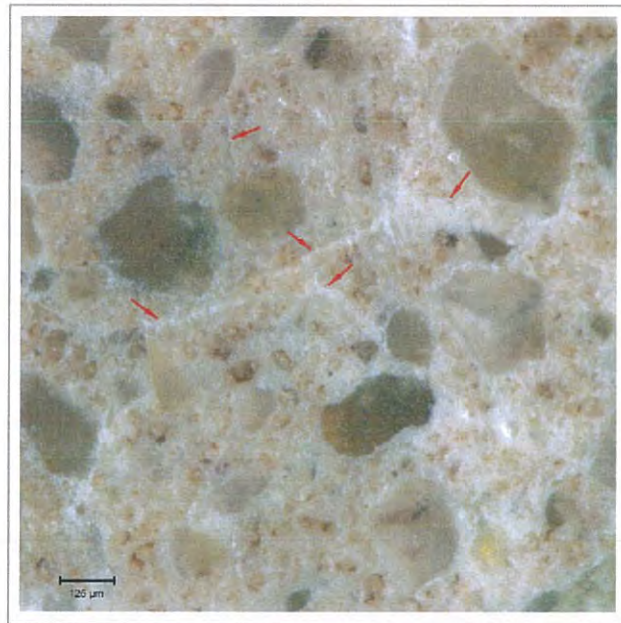
Figure D4. Reflected light photomicrograph of polished surface showing detail of microcrack (red arrows).

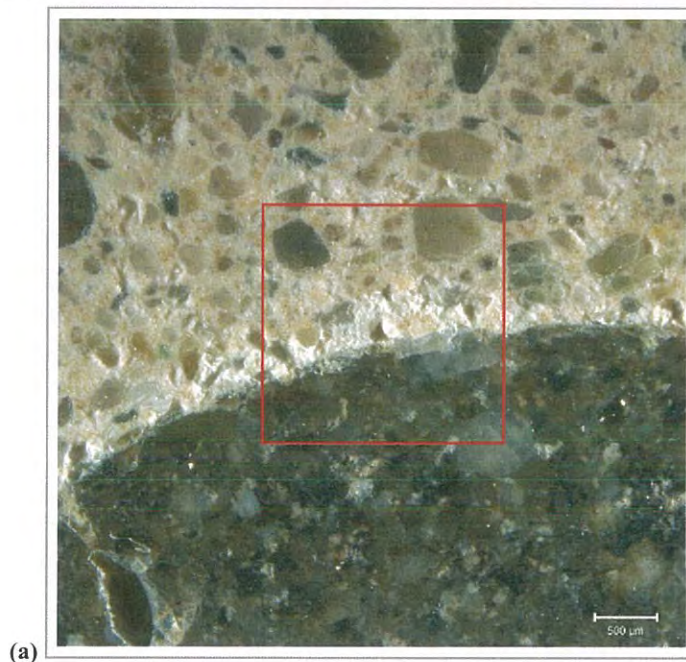
Figure E6. Reflected light photomicrograph of polished surface showing paste-aggregate contact where some loss of paste was observed. The red square indicates the approximate area of (b).

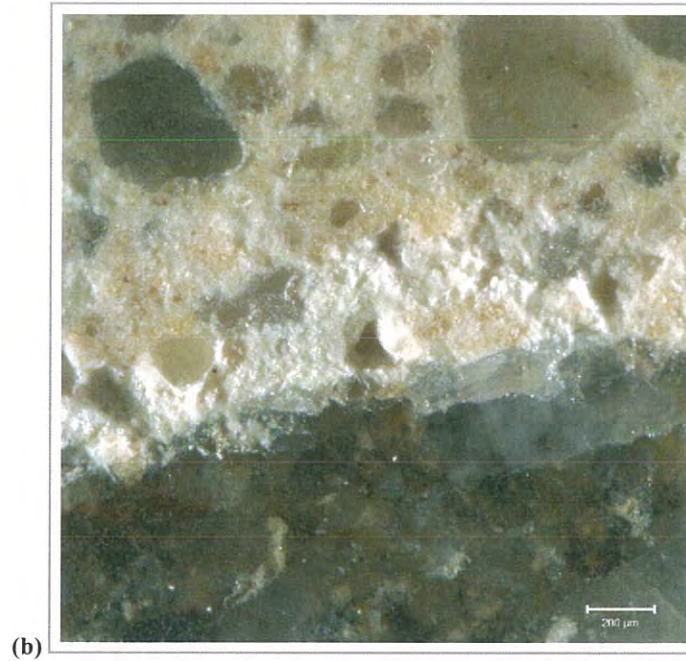
Figure E6. Reflected light photomicrograph of polished surface showing detail of paste-aggregate contact where some loss of paste was observed.

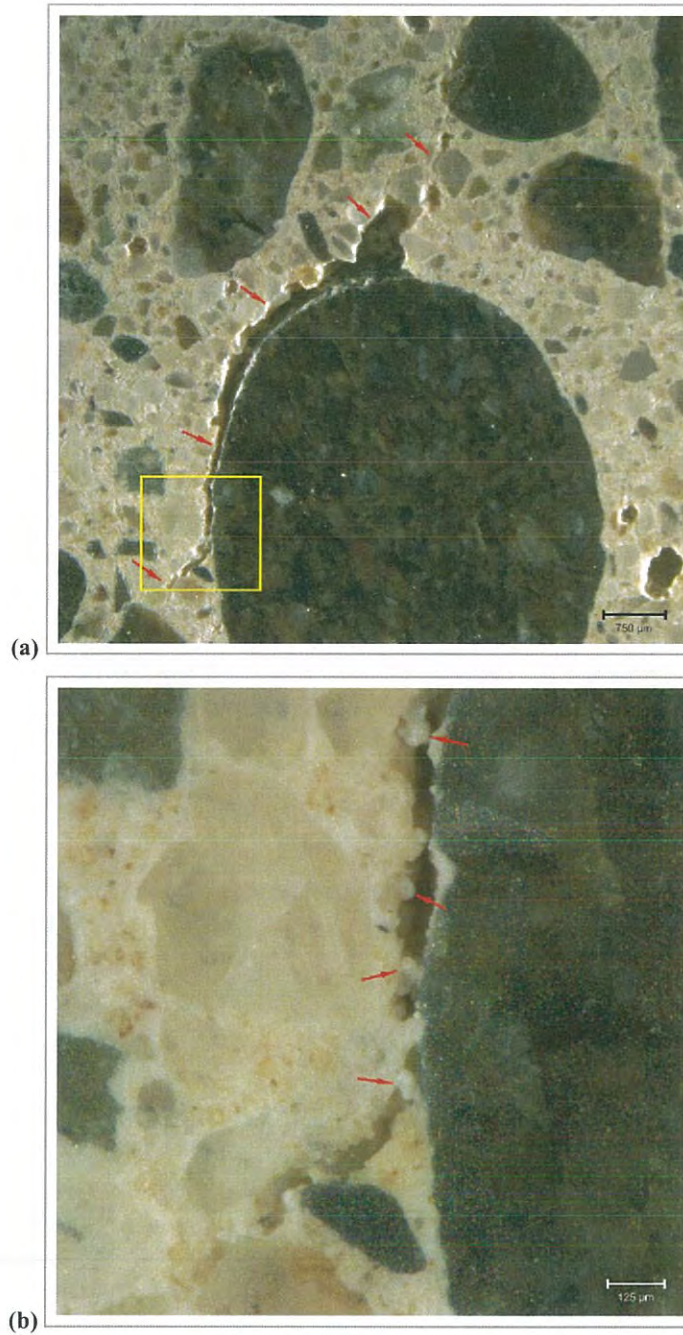
Figure F4. Reflected light photomicrographs of polished surface showing microcrack near the bottom of the polished surface. The red arrows in (a) indicate the microcrack and the yellow box shows the approximate area of (b), where the red arrows highlight rosettes of ettringite.

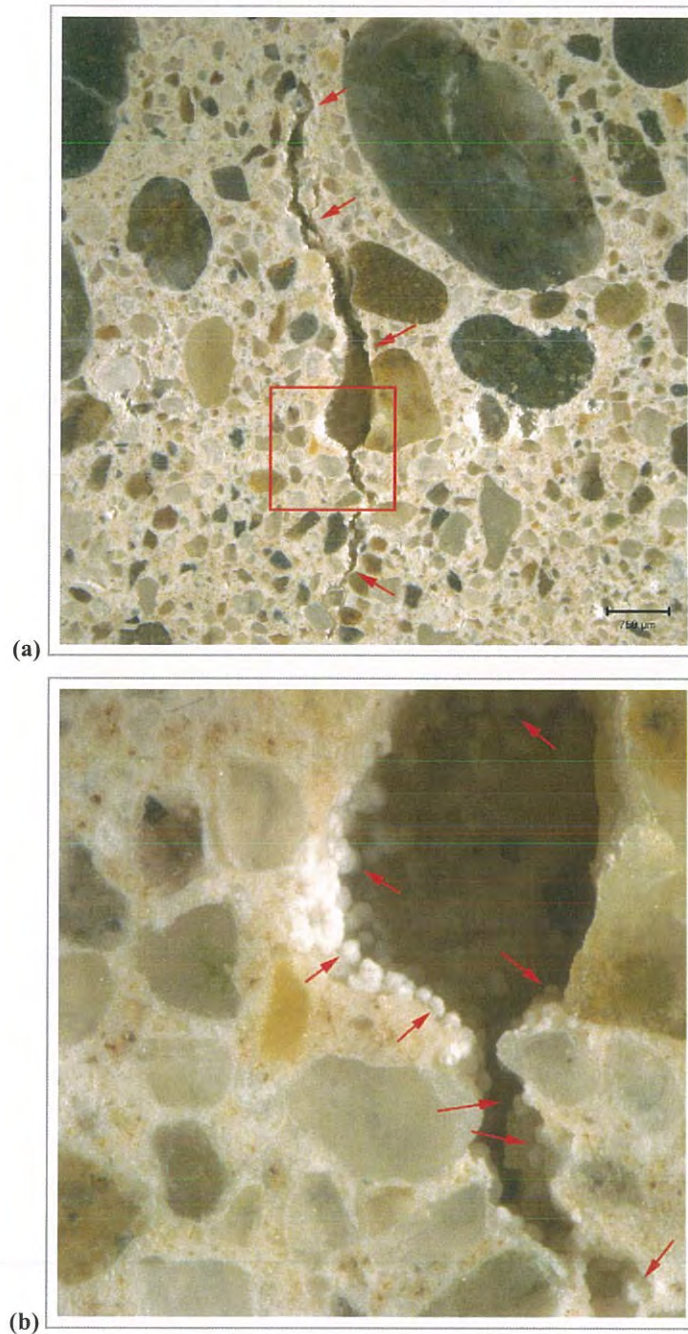
**Figure F5.** Reflected light photomicrographs of polished surface showing microcrack about 19 mm (¾ in.) from the top of the polished surface. The red arrows in (a) indicate the microcrack and the red box shows the approximate area of (b), where the red arrows highlight rosettes of ettringite.

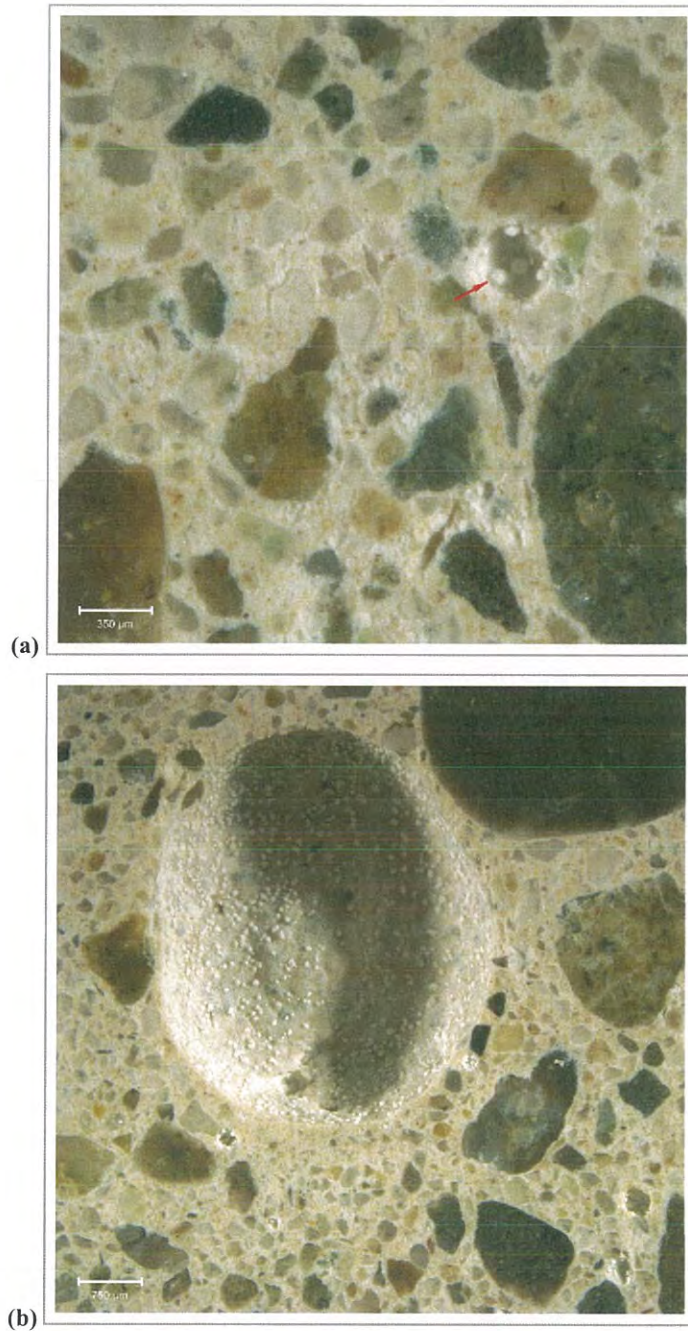
**Figure F6. Oblique reflected light photomicrographs of polished surface showing view of voids. The red arrow in (a) highlights a rosette of ettringite in a relatively fine void. The white spots in the larger void shown in (b) are also rosettes of ettringite.**

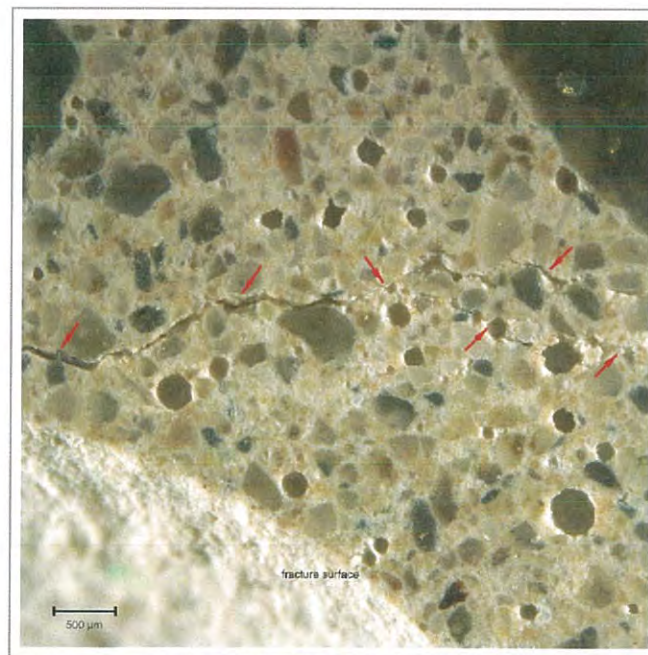
Figure G4. Reflected light photomicrograph of polished surface showing microcracks (red arrows) near the fracture surface. The orientation of the photograph was rotated 180° from the true orientation of the sample.

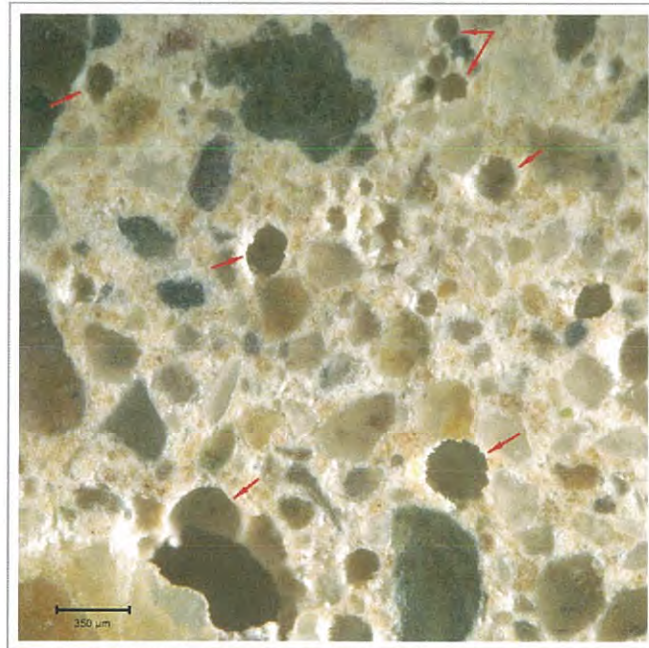
Figure G5. Oblique reflected light photomicrograph of polished surface showing voids (dark circles, with red arrows showing some examples).

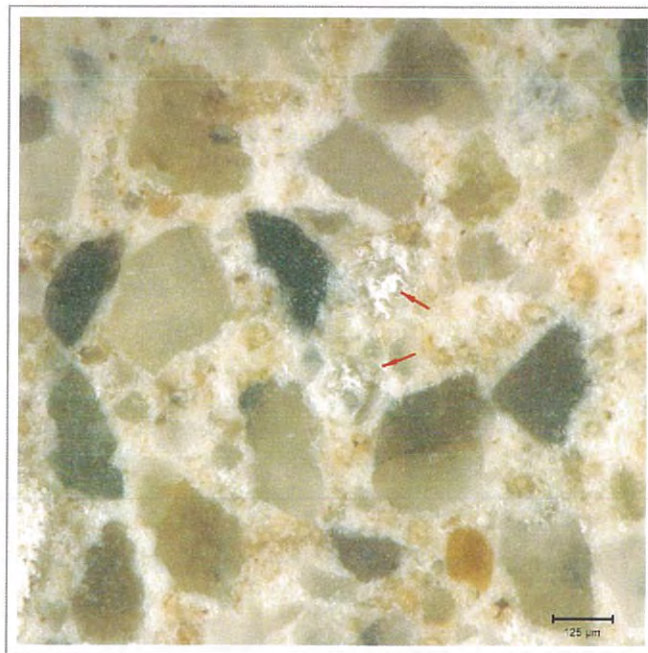
Figure G12. Reflected light photomicrograph of polished surface showing trace deposits of ettringite (red arrows) in fine air voids. Such deposits were observed commonly.
