ROYAL COMMISSION OF INQUIRY INTO BUILDING  
FAILURE CAUSED BY CANTERBURY  
EARTHQUAKES

THE CTV BUILDING COLLAPSE

STATEMENT OF EVIDENCE OF MICHAEL JOHN BROOKS  
IN RELATION TO THE CTV BUILDING

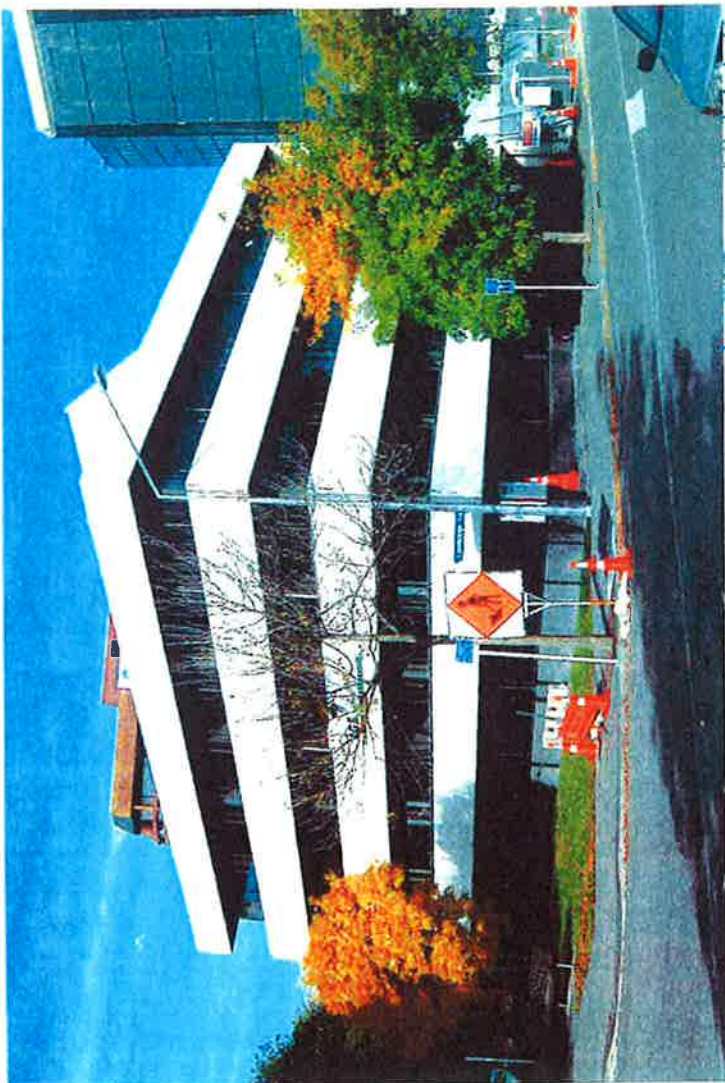
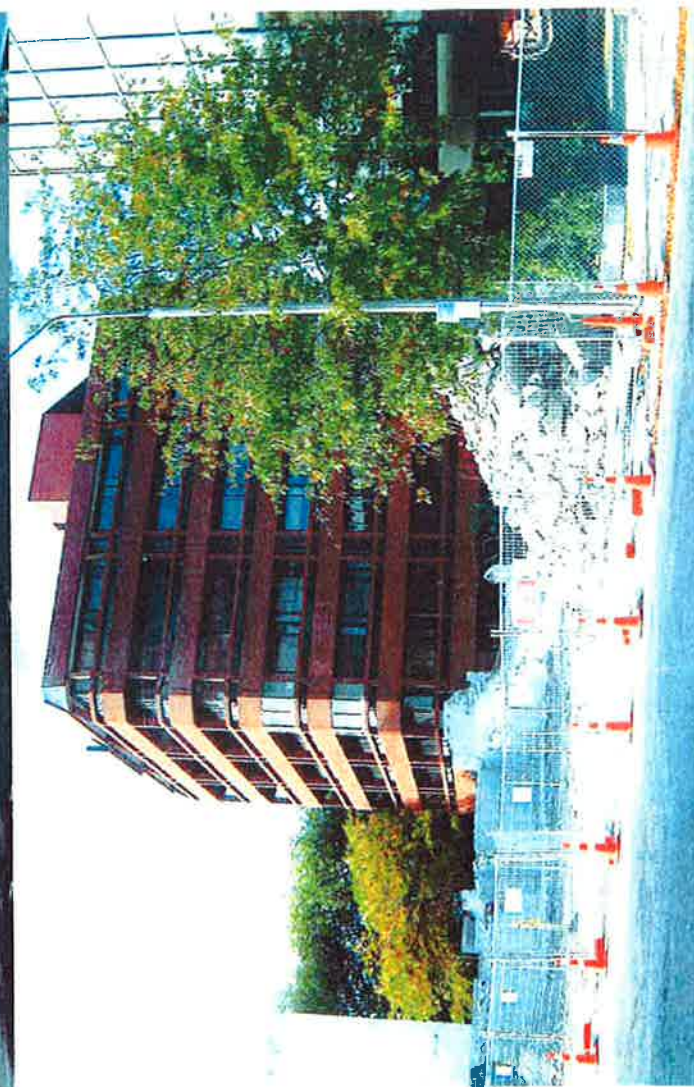
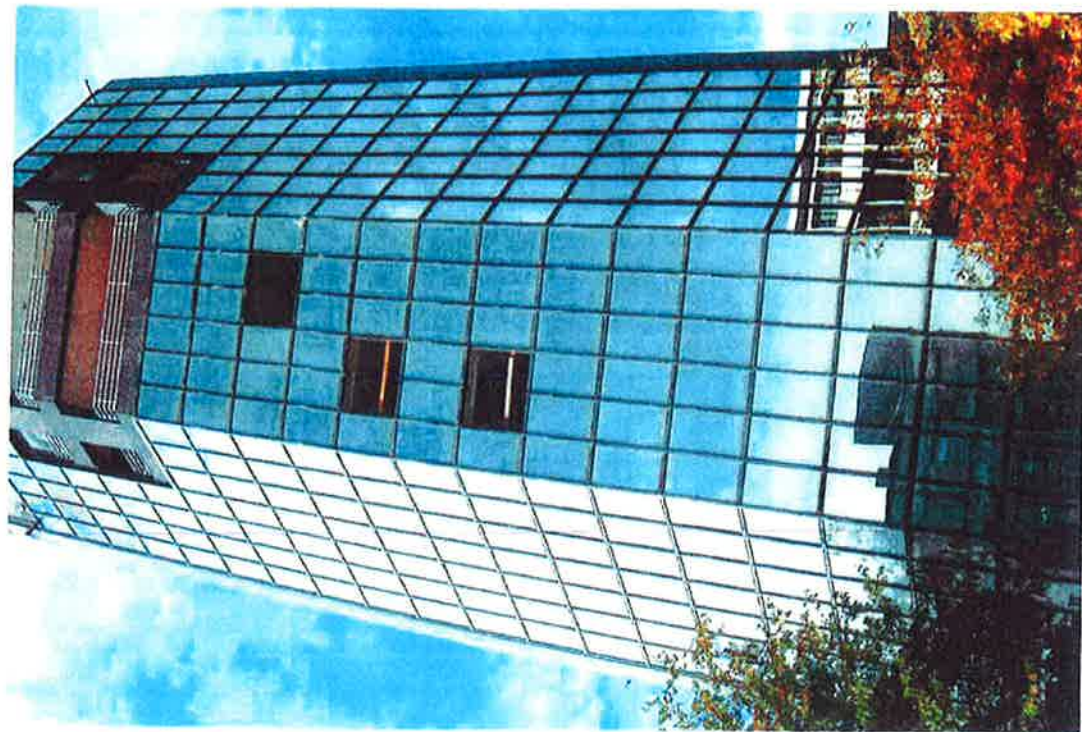
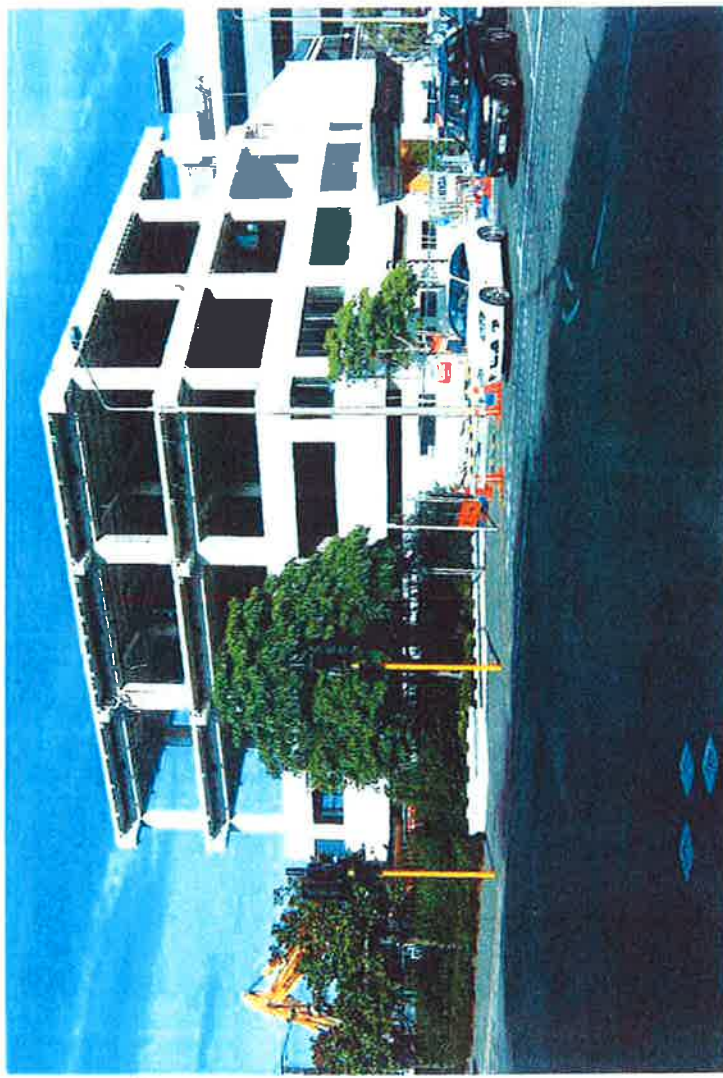
36. The structural frames of reinforced concrete buildings, whilst there being many different methods, are fundamentally alike. I have four photographs to illustrate my point [BUI.MAD249.0423]. Although it is not clearly shown, each building is similar in floor

space and each one with the lift shaft and services on the side. It is what is attached to the frame and what is included in the interior, such as carpets, marble floors, air conditioning which makes a point of difference. These items can add substantially to a building's cost and therefore rental potential.

Cambridge Tee. Buildings  
 NB. [A = Aged Tensons Council]

Former Oxford Clinic, under demolition. 25.3.12.

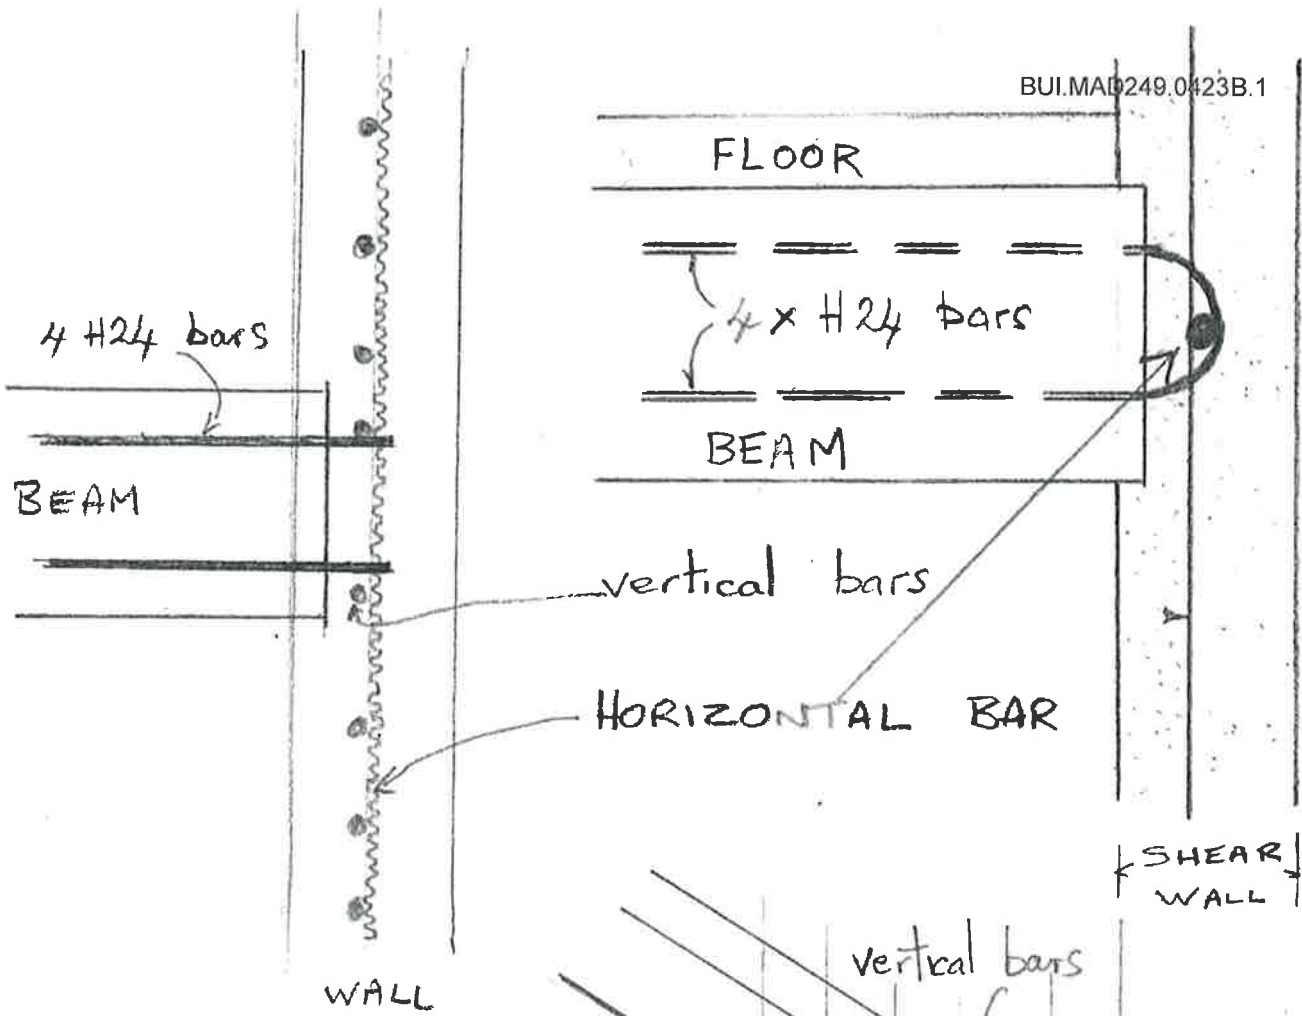
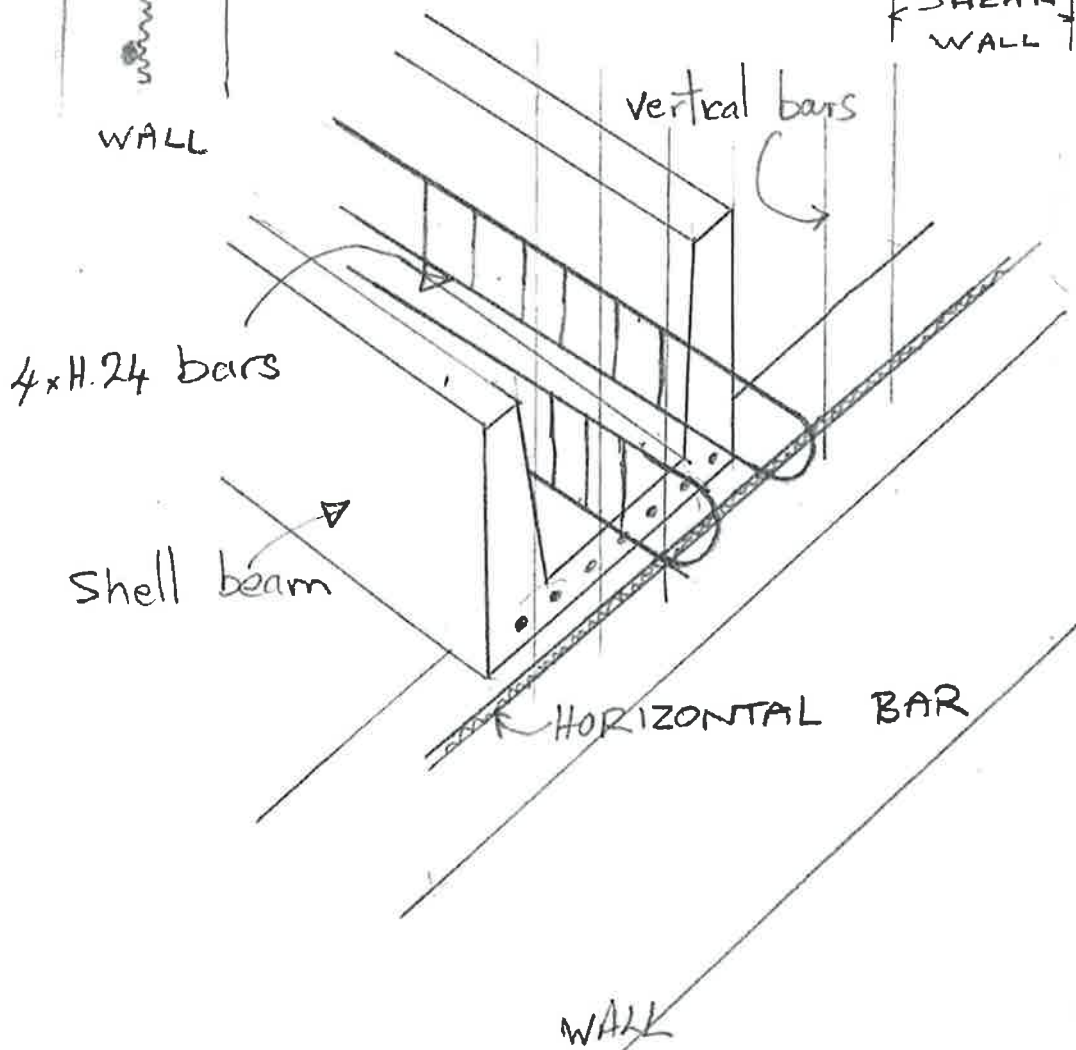
BUI.MAD249.0423B.1

91. It is a fundamental precept to reinforced concrete construction that the steel reinforcing forms a continuous 'flow' without gaps, breaks or other form of interruption. In simple terms the foundation steel must connect to the column steel and in turn to the beam steel and shear wall and so on. Any interruption to that flow must inevitably undermine the integrity of the structure.

92. This is precisely what has occurred in the CTV building and furthermore has occurred at the point where the beam connects to the shear wall.

93. The pair of H24 rods are located in the beam such that each semicircular end protrudes into the shear wall just beyond the line of vertical reinforcing rods. A horizontal H24 rod should then have been inserted through the semi-circular ends and tied in place, prior to the concrete pour. The insertion of this item would have provided continuity to the steel connections and would have gone some way towards frustrating any forceful attempt to collapse the structure, if not to prevent it. I have prepared my own diagram to illustrate this [BUI.MAD249.0423B].

94. This in my opinion is a major contributory reason for the collapse of the building.
