**ROYAL COMMISSION OF INQUIRY INTO BUILDING
FAILURE CAUSED BY CANTERBURY
EARTHQUAKES**

THE CTV BUILDING COLLAPSE

**STATEMENT OF EVIDENCE OF ROBERT DAVID JURY
IN RELATION TO THE CTV BUILDING**

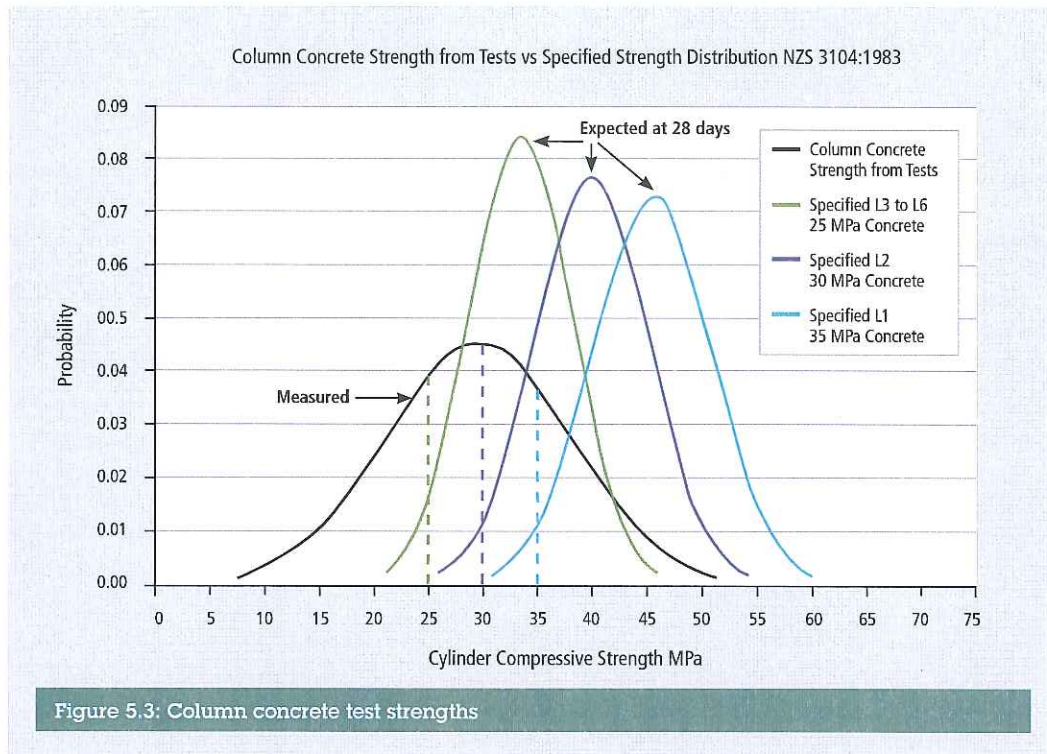
- All reinforcing steel appeared to conform to the standards of the day.
- Concrete strengths in concrete from south wall and north core wall samples were found to be greater than specified.
- Tests on 26 column samples (21% of all CTV Building columns) indicated that, at the time of testing, the column remnants from Levels 1 to 6 had a mean concrete strength of 29.6 MPa, with measurements ranging from 17.3 MPa to 50.3 MPa.

The position in relation to the column samples is summarised in Figure 5.3. The black line indicates the inferred distribution of concrete strengths from the tests. The other three distributions are the expected strength distributions at 28 days from pouring of concrete based on the specified concrete strengths (after 28 days) which were 35 MPa for Level 1 columns, 30 MPa for Level 2, and 25 MPa for Levels 3 to 6. Even though it is not known which of the measurements applies to which expected strength distribution, it can be seen that a higher than expected proportion of the results is below the specified level in all cases.

While it is recognised that the tests were conducted on members that had been involved in the collapse, the results indicate that column concrete strengths were significantly less than the expected strength considering the specified strengths, the conservative approach to achieving specified strengths, and the expected strength gain with age.

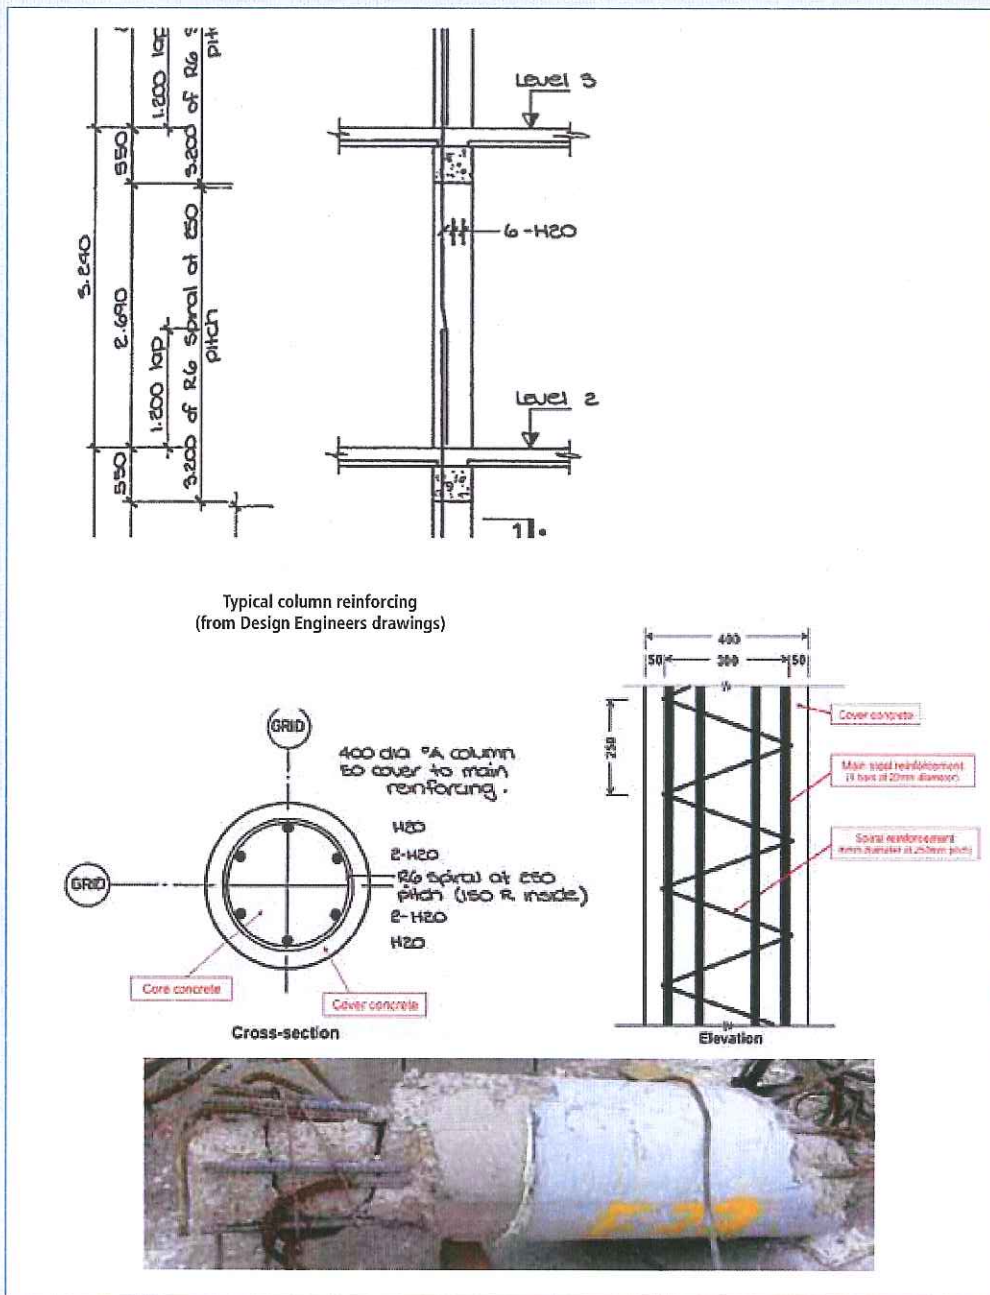
Figure 5.4: Typical 400mm diameter column

- non-ductile reinforcement details in the columns
- less than required minimum spiral reinforcing for shear strength
- relatively large proportion of cover concrete in the columns
- possibility of significantly lower than specified concrete strength in critical columns
- lack of ductile detailing in beam-column connections.

The lack of ductility in the columns made them particularly vulnerable and they were the prime focus of the analyses. The ability of a column to sustain earthquake-induced lateral displacements depends on its stiffness, strength and ductility. Established methods were used to estimate the capacity of critical columns to sustain the predicted displacements without collapse.

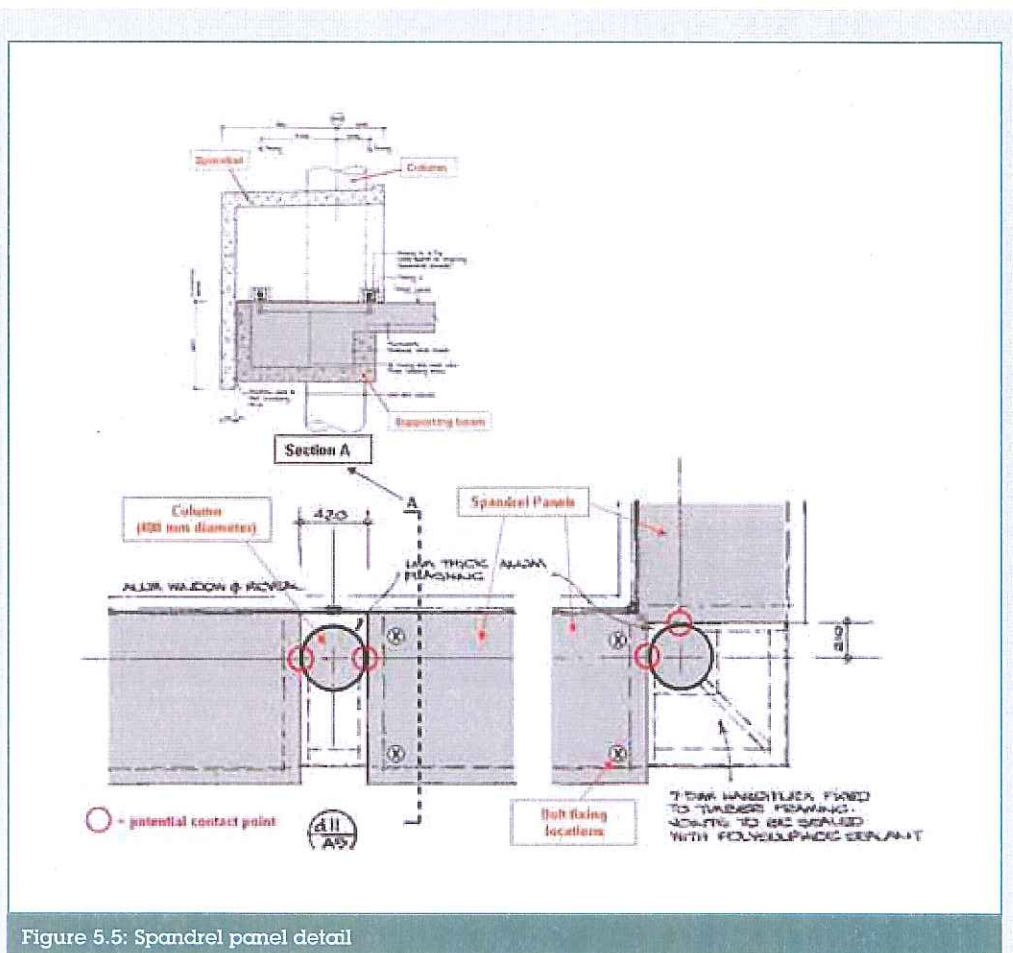
Figure 5.5: Spandrel panel detail

A plan and a cross-section of the typical column and spandrel panel arrangement are shown in Figure 5.5.

The pre-cast reinforced concrete spandrel panels were fixed to the floor slab and were placed between columns. The gap between the ends of adjacent spandrels was specified to be 420mm giving a nominal 10mm gap either side between the spandrel and the column. It is possible that these gaps varied from the nominal 10mm and it is estimated they may have ranged between 0 and 16mm. It is not known what the sizes of the gaps actually were, but analyses showed a significant reduction in column drift capacity for the case where no gap was achieved. Forensic evidence indicated that interaction may have occurred between some columns and adjacent spandrel panels in the 22 February 2011 event. There were also indications of cracking reported in some of the upper level columns after the September earthquake that may have indicated some interaction with the spandrel panels.

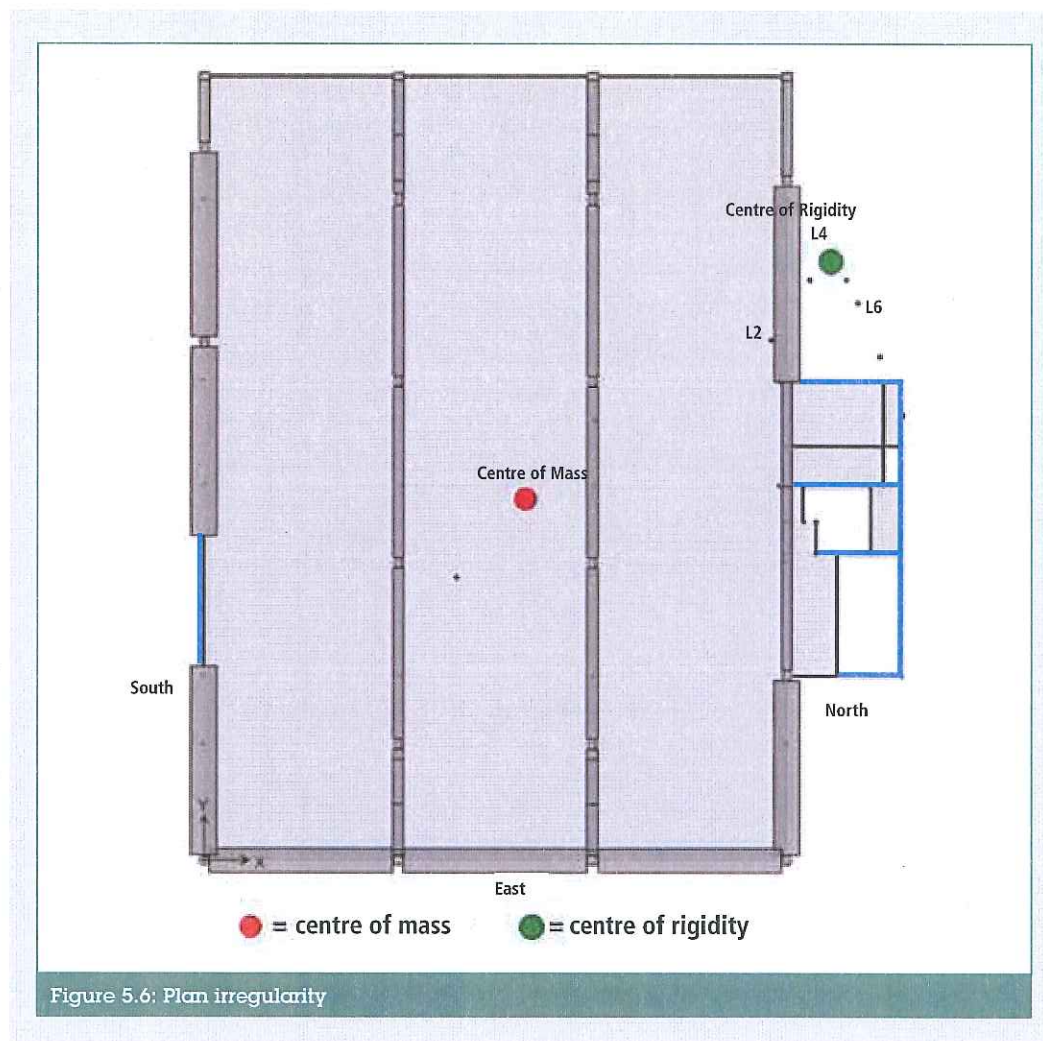
It was considered that the lack of symmetry in plan could cause displacements on the south and east faces to increase as the building rotated in plan. Figure 5.6 illustrates the results of one examination of this effect. The centre of mass indicates where the lateral forces would act. The centre of rigidity indicates where lateral forces, at Level 4, would be resisted. The horizontal distance between these points is a measure of the tendency of the building to twist when subject to horizontal ground motions.

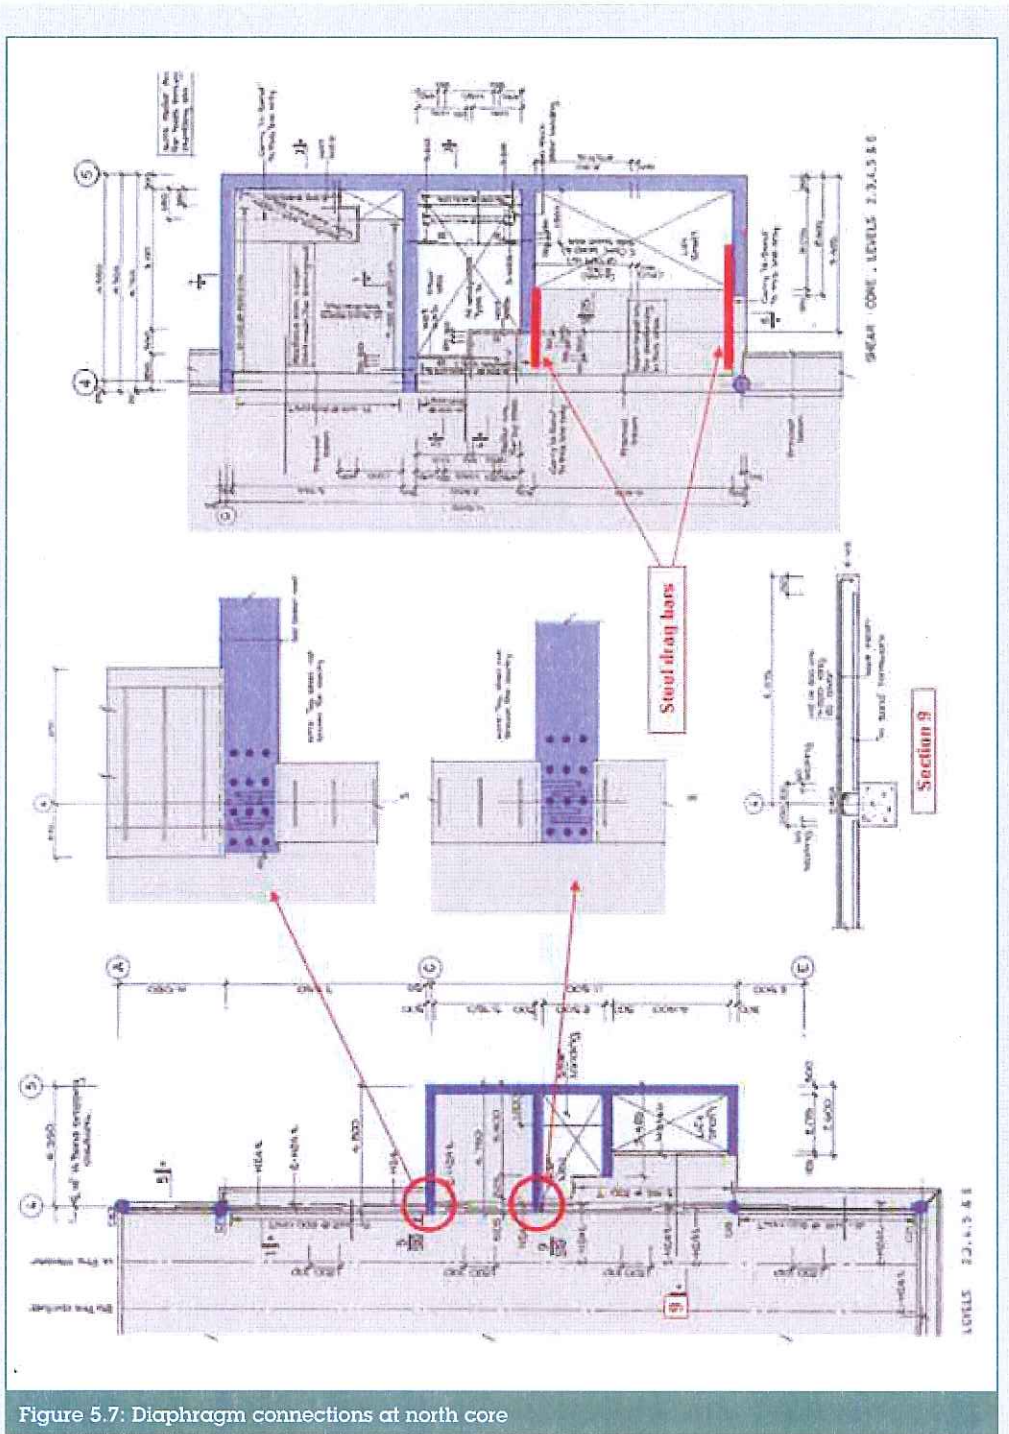
Figure 5.7: Diaphragm connections at north core

Figure 5.7 shows plans of the area where a typical floor slab (shaded grey) meets the stabilising walls of the north core (shaded blue). The large lateral forces from the floor slab must be transferred to the walls at the (limited) places where slab and wall elements meet and through the drag bars (shaded red) which were added at Levels 4, 5 and 6 in October 1991. These connections were seen as vulnerable and there was a possibility that the diaphragm (slab) would separate from the walls, resulting in increased lateral displacements and higher demands on critical columns.

3. Column failure due to diaphragm (slab) disconnection from the north core at Level 2 or Level 3. In this scenario, the diaphragm separated from the north core causing a significant increase in the inter-storey displacements in the floors above and below. The nature of the separation and resulting movement of the slab would have an influence on which of these highly loaded columns was the most critical. It was noted that no drag bars were installed at these levels.

4. Column failure due to diaphragm (slab) disconnection from the north core at Levels 4, 5 or 6. This scenario has similar characteristics to scenario 3 but involves failure of drag bars and adjacent slab connections to the north core. A compounding factor in this scenario is the effect of uplift of the slab/wall connection due to northwards displacement of the north core.

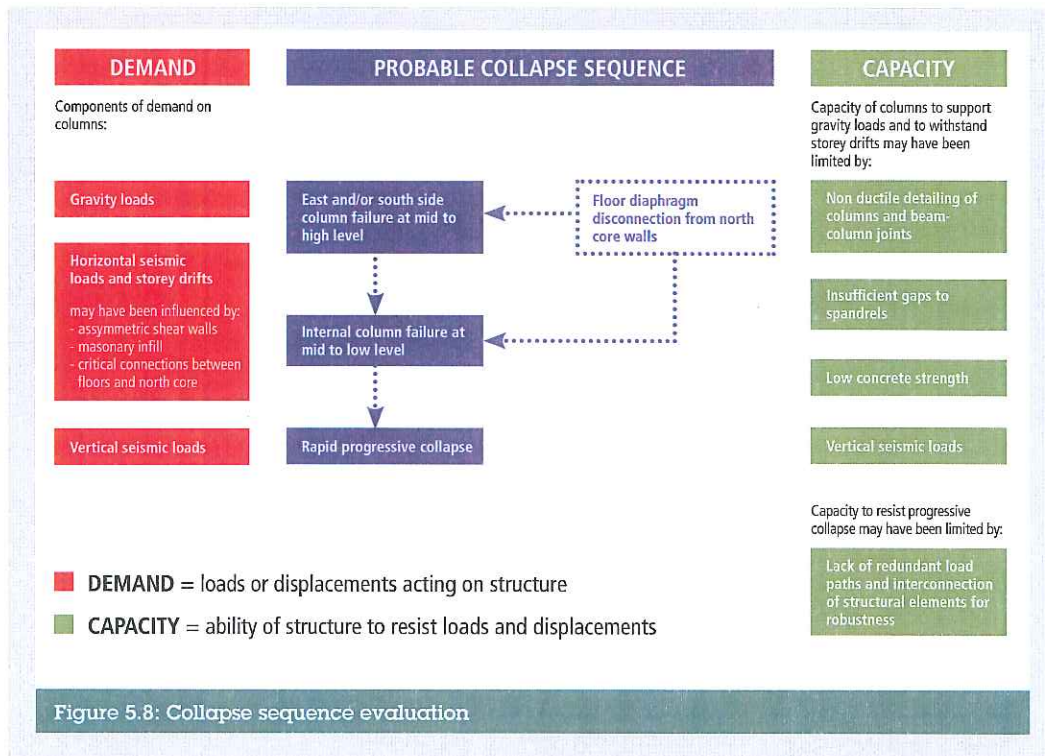
1. Column failure on Line F or Line 1. This involved collapse initiation as a result of column failure on one of these lines, probably in a mid to upper level, with or without the influence of spandrel interaction. A Line F initiation was noted as being consistent with the arrangement of the collapse debris and eye-witness reports of an initial tilt to the east.

2. Column failure on Line 2 or Line 3. Collapse in this case would be initiated by failure of a column at mid to low level, under the combined effects of axial load (gravity and vertical earthquake) and inter-storey displacement. Low concrete strength could have made this scenario more likely.

Figure 5.8 outlines the key considerations involved in evaluating these scenarios.

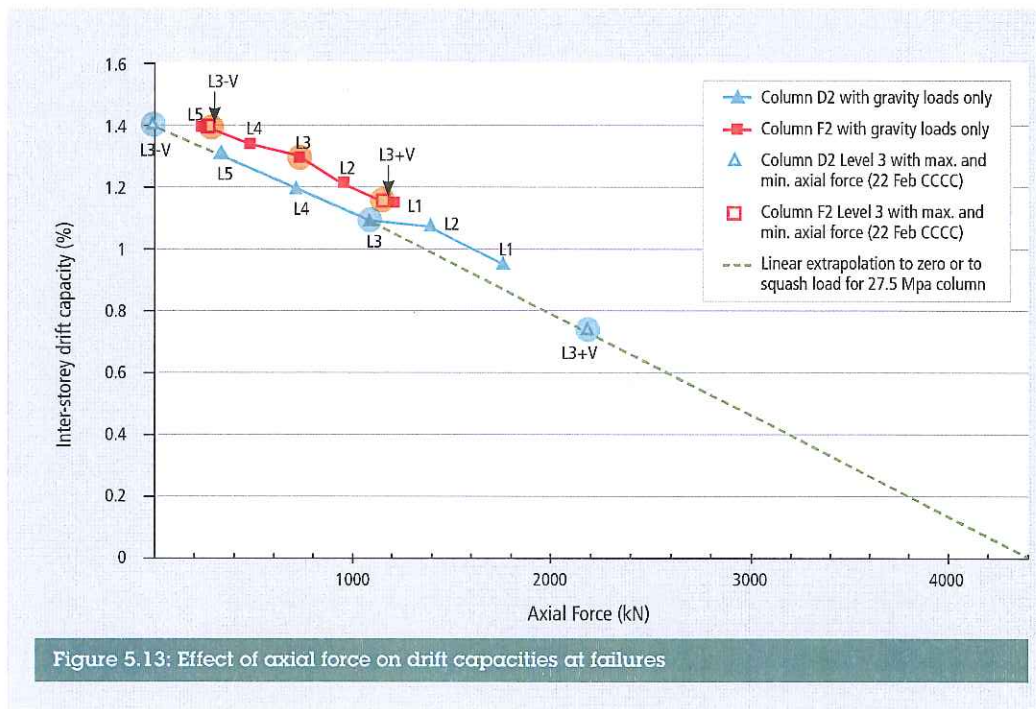
Figure 5.13: Effect of axial force on drift capacities at failures

The vertical accelerations measured in the 22 February 2011 aftershock were exceptionally high and may have contributed significantly to vertical forces and columns and walls. The extent of this contribution is generally difficult to quantify, but analyses of the CTV Building indicated that vertical accelerations could have doubled the vertical forces in some critical, heavily loaded columns and this may have reduced the capacity of those columns to sustain lateral displacements by up to 40%, depending on concrete strength. If concrete strength in those critical columns had been less than the values that the analyses were based on, the displacement capacity would have been further reduced.

The highlighted markers on each plot in Figure 5.13 show the situation for two columns at Level 3. The middle highlighted marker shows the axial force and drift capacity without earthquake effects. The highlighted markers to the right and left show the effects of vertical earthquakes, reducing (left mark), or increasing (right mark) the column axial force (compression). It can be seen that in these examples, the effect on drift capacity is significant, ranging up to more than 30%.

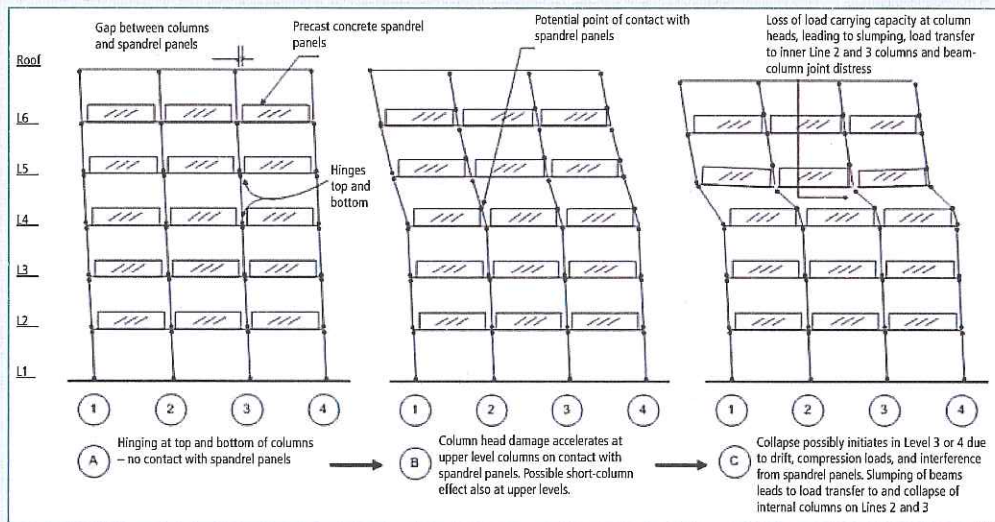
Figure 5.14: Inferred collapse initiation on Line F

Figure 5.14 shows the situation for this scenario with no spandrel interaction (A) and with spandrel interaction (B and C). Figure 5.16 illustrates the case of failure of ground floor columns on Line D for this scenario and the subsequent collapse of the floor slabs and frames for this inferred collapse sequence. Figure 5.15 shows the case along Line 2 of the scenario involving initiation on Line F.

Concrete strengths that were lower than the average used in the analyses would have reduced the load capacities of critical columns. Vertical accelerations from the ground motions may have added to the demands on columns and reduced their capacities to tolerate lateral displacement. The lack of symmetry of the lateral load-resisting elements is likely to have placed further demands on the critical columns by causing the building to twist and displacements to be larger than expected. Failure of diaphragm connections between floors and the north core walls, if it occurred prior to collapse initiating elsewhere, may have resulted in additional displacement demands on the critical columns.
