**From:** David Coatsworth  
**Sent:** Friday, 24 September 2010 4:21 p.m.  
**To:** 'egt@xtra.co.nz'  
**Subject:** 249 Madras Street  
Hi John

249 MADRAS STREET  
SITE INSPECTION  
29.9.10 10.00am - 2.00pm

Table of David Coatsworth's Handwritten Notes 1-36

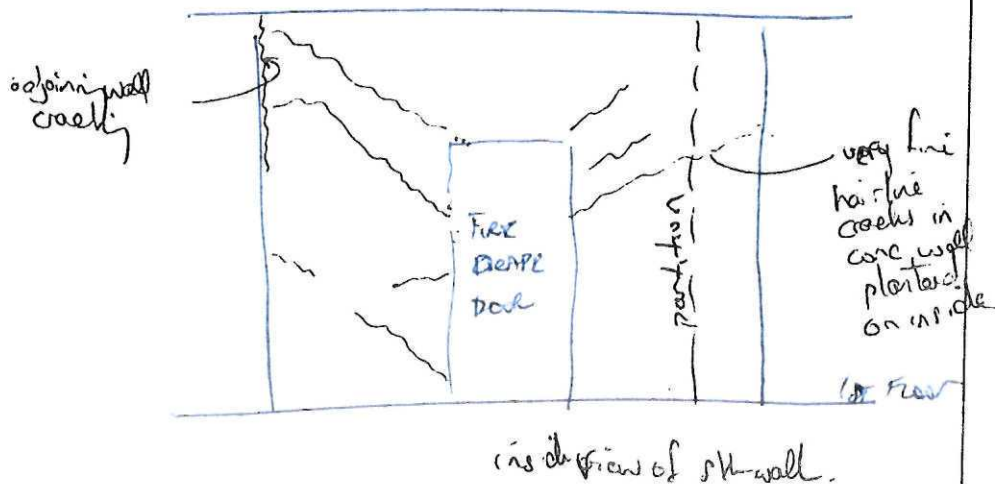
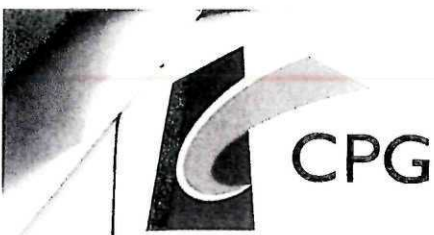
11. sth side office on core wall

Item Number(s)	Explanation
	<i>1<sup>st</sup> Floor</i>
11.	<p><i>South side office on concrete wall. Adjoining wall crack. Fire escape door. Partition. Very fine hairline cracks in concrete wall plastered on inside. 1<sup>st</sup> floor. Inside view of south wall.</i></p> <p>The inside face of the coupled shear wall on the south side of the building at first floor level was finished with a thin skim coat of gypsum plaster. I observed very fine diagonal hairline cracking in the plaster. I identified this as earthquake damage. However, the cracks were very fine, indicating that the reinforcing steel had not yielded, that the aggregate in the concrete was still interlocking and that the general integrity of the concrete wall was not compromised. I considered that epoxy injection of the cracks would be appropriate remediation.</p>

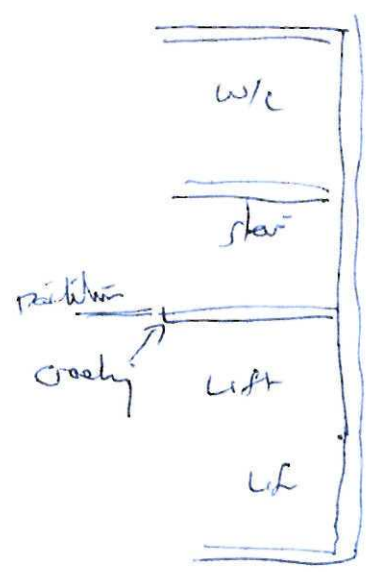
21

21.	<p><i>Partition cracking. W/C. Stair. Lift.</i></p> <p>I believe that this observation was made on the third or fourth floor.</p> <p>A crack was evident in the lift lobby between a timber framed partition</p>

Item Number(s)	Explanation
	wall and the structural shear wall. Movement of the structure had pushed the timber framed wall. The damage was not structural.

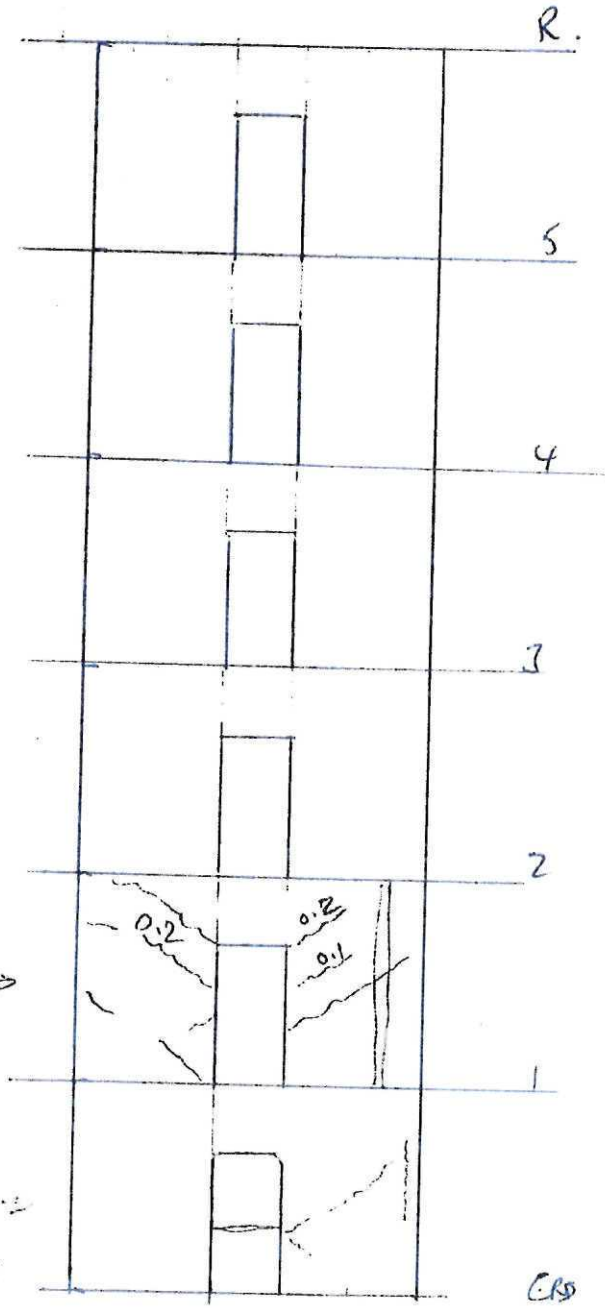
INSIDE OF SOUTH WALL C.

CRACK IN GYPSUM  
DUMPER OVER  
STEEL CONC →

THESE CRACKS ARE  
IN PLASTERBOARD  
LINING. ABOVE  
CEILING TILES INSIDE  
OF GRID FLOOR WALL  
IS PWSHAPT, CANT  
DETERMINE CRACKS.

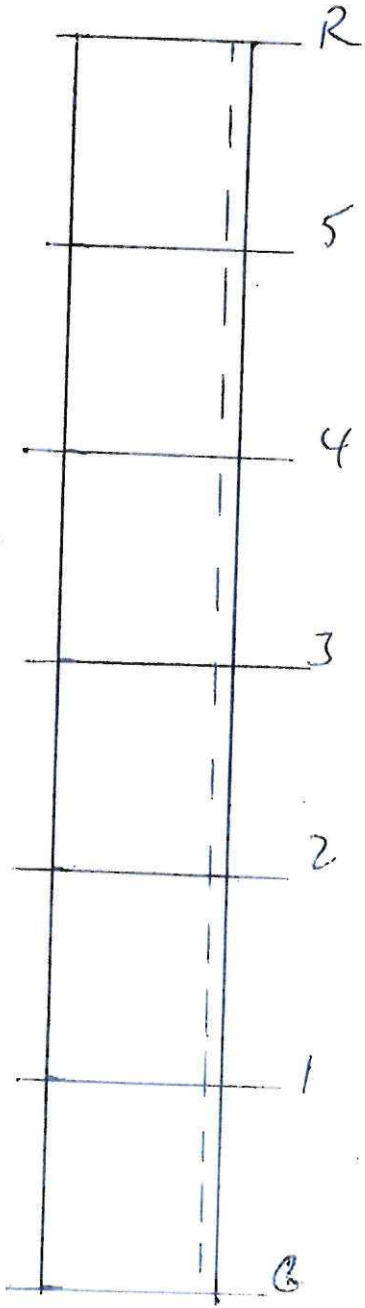
*WALL 4 FROM EAST SIDE*

*This is an outside wall. Inside face is in the lift shaft.*
