**Brief of evidence of Henry John Hare relating to the  
CTV Building (249 Madras Street)**

**Date: 1<sup>st</sup> June 2012**

- 6 This brief of evidence sets out my involvement, whilst employed by HCG, in the preparation of report for a prospective purchaser of an office development located at 249 Madras Street, subsequently known as the CTV Building (**the CTV Building**).

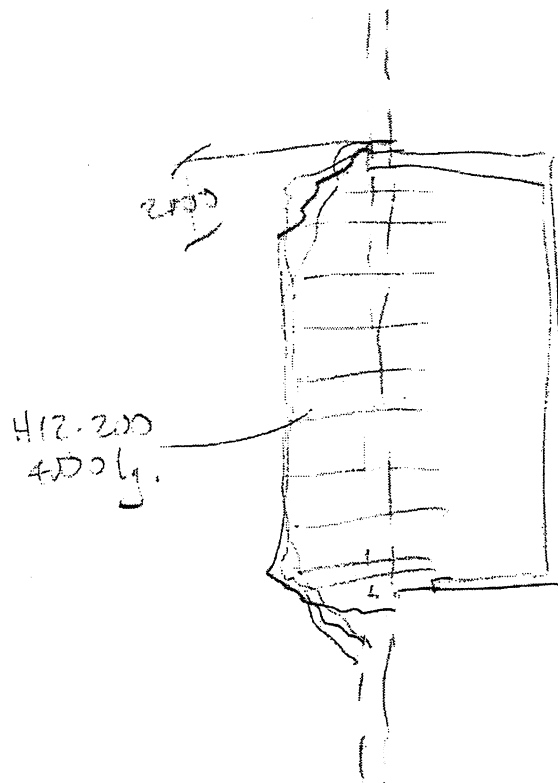
On extra shear core

Cutting as shown.  $\rightarrow$  get 4000 H12-200  
 $- V_s = 410 \times 4 \times 565 = 927 \text{ kN}$

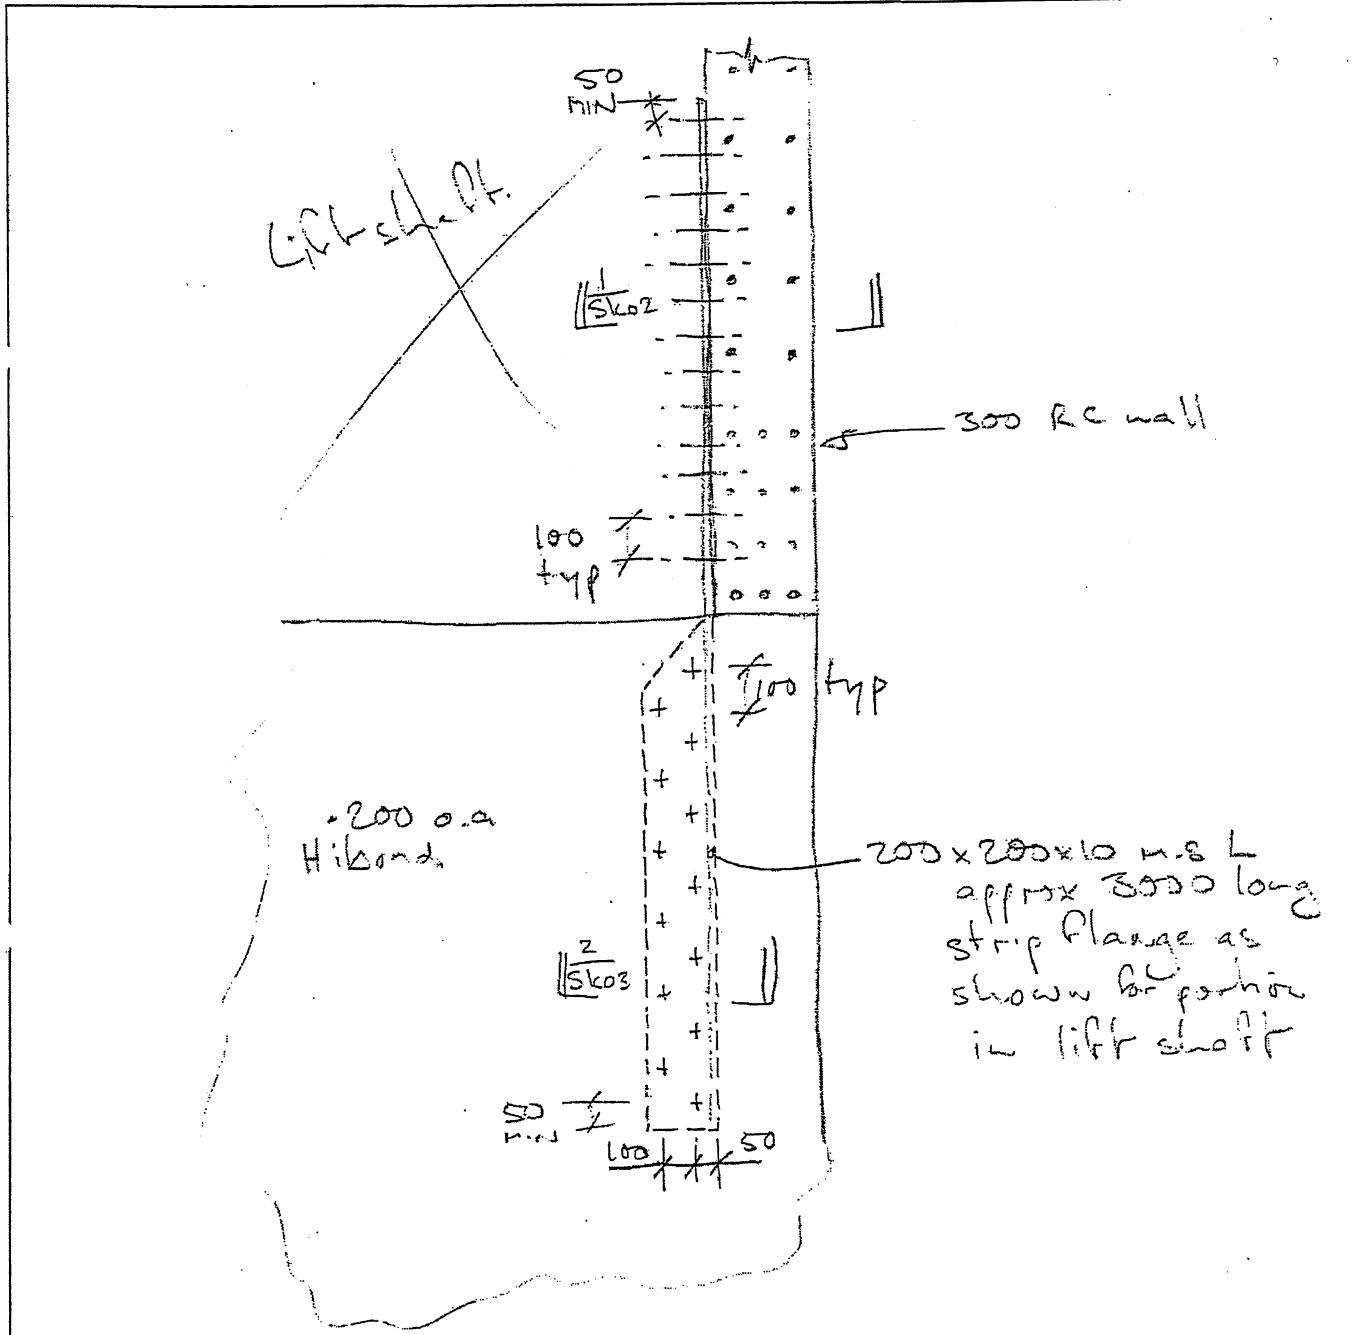
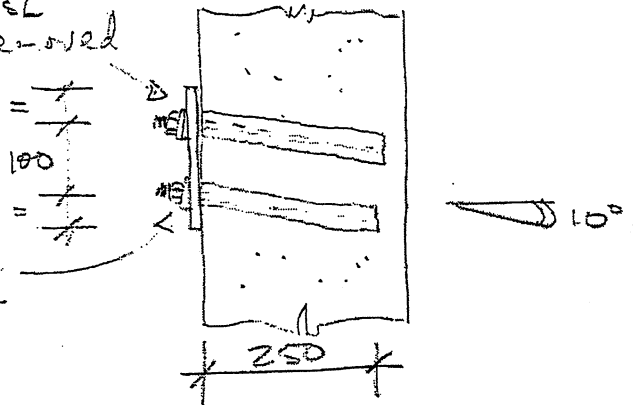
PAGE Sk-01

- 40 I developed a possible remedial detail on 31 January 1990, to give a preliminary estimate of the cost of establishing a connection between the north core and the floors. [BUI.MAD249.0005.19-20].

- 41 My draft remedial detail involved:
- 41.1 The insertion of steel diaphragm strengthening members (drag bars) on Levels 1 to 5 of the CTV Building (by Levels 1 to 5, I was referring to all levels above the ground floor car park. In my calculations and in the HCG Draft Report, HCG refers to the floors in the CTV Building as the Ground floor and then levels 1 to 5 above the Ground floor. In contrast, ARC refers to the Ground floor as Level 1 and the floors above the Ground floor as Levels 2 to 6).

- 41.2 A piece of steel angle being cut to shape and fixed to the lift walls and the underside of the slab, with drilled and epoxied anchors. There were to be two such ties per floor, to the wall on grid D and the east wall part way between grids D and E. In my view, such a detail was required to improve the connection between the floor slabs and the walls of the North core.

- 41.3 Consideration of the specifics of fixing to a thin wall and a thin slab. I recommended the use of 12mm diameter mild steel rods for connection to the wall, being the largest diameter reinforcement that could be practically developed into the 300mm wall. Likewise, I limited the size of the connections into the underside of the slab, and recommended coring and grouting from above, due to concerns I had with overhead epoxying and grouting.

200x200x10 u.s.L  
with flange removed  
over part  
of 130x143 holes

D12 threaded  
bars with tapered  
washers.

- Mark out & drill holes before cutting or drilling steel. Locate steel in wall prior to drilling holes.
- Holes in wall to be drilled using percussive rotary drill. Epoxy bars using Expocrete 'S' or equivalent.
